Tech Notes

EXTERIOR WOODWORK

Proper Painting And Surface Preparation

“OLE JIM” GALLAUDET COLLEGE Washington, D.C.

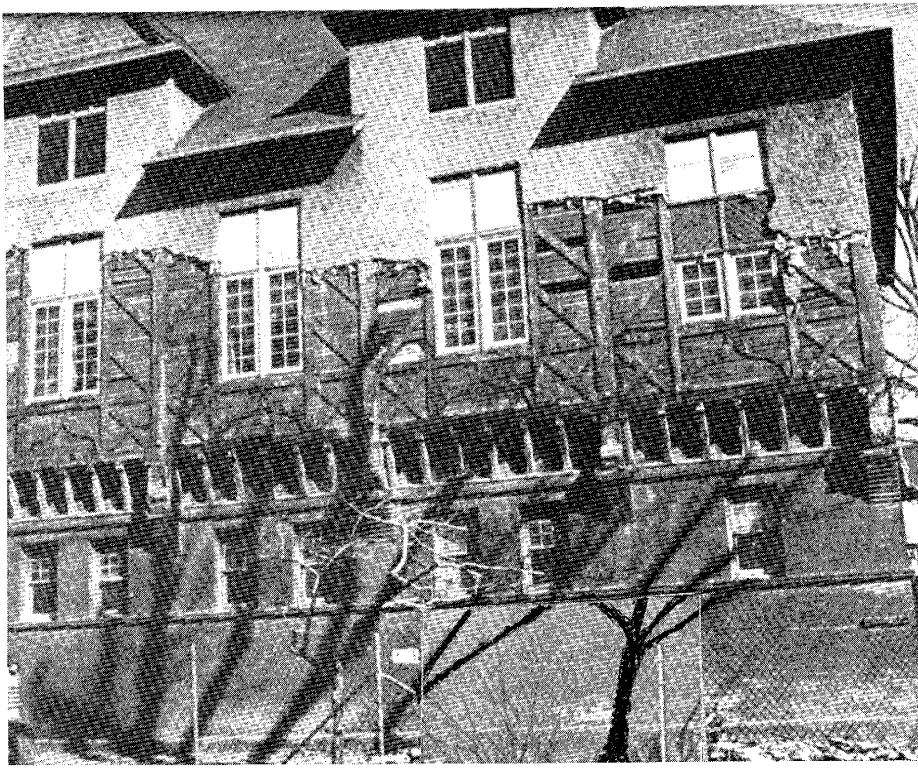
As early as 1910, the second floor wall surfaces were covered with stucco in an attempt to reduce water damage. The most dramatic aspect of the 1980 rehabilitation was the removal of the applied stucco and restoration of the painted half-timbered wooden exterior, much of it still intact (see figure 1). Old paint was removed down to bare wood and a new primer and two topcoats were applied. However, the newly applied paint on the wooden surfaces started failing within a year. By 1984, with the paint blistering and peeling, the college realized that the entire exterior wooden surface once again needed major work.

Figure 1. The stucco, applied circa 1910, is shown here being removed as part of the 1980 restoration. The wooden siding and "half-timbering" was largely intact underneath. Photo: Courtesy of Gallaudet College

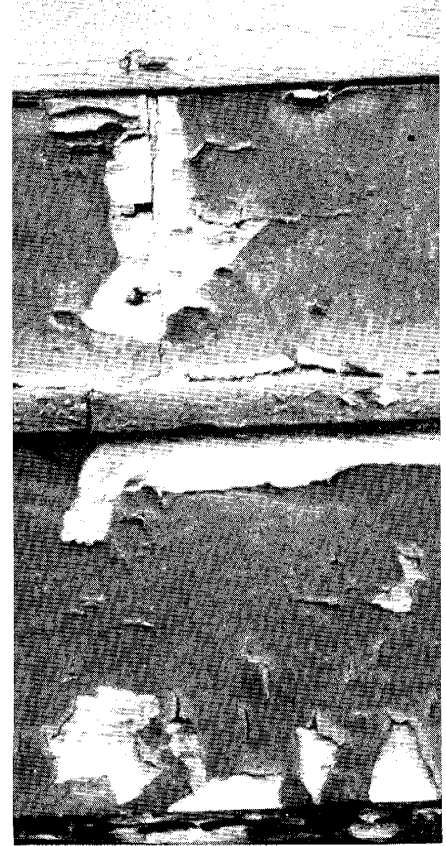
Figure 2. Paint applied in 1980 started to peel within a year, and by 1984 extensive failure had occurred. Photo: Sharon Park, AIA

Paint peeling off the wooden surface indicated that the prime coat had not adequately bonded to the wood (see figure 2). A close inspection using a "cherry picker" revealed three areas of serious deterioration. First it was apparent that moisture was getting behind the "half-timbering" where it covered the tongue and groove siding, and was rotting the wood. Secondly, the joint where the recessed tongue and groove siding abutted the heavy timber posts and lintels was equally difficult to keep sealed once the paint had failed. And finally, extensive dry rot had occurred at the intersection of the structural column and sill plate (see figure 3). The extensive paint failure, together with the deteriorated wood, indicated a serious moisture problem.

The only way to solve the problem was to remove all the paint, properly prepare the wood surface, and repaint.

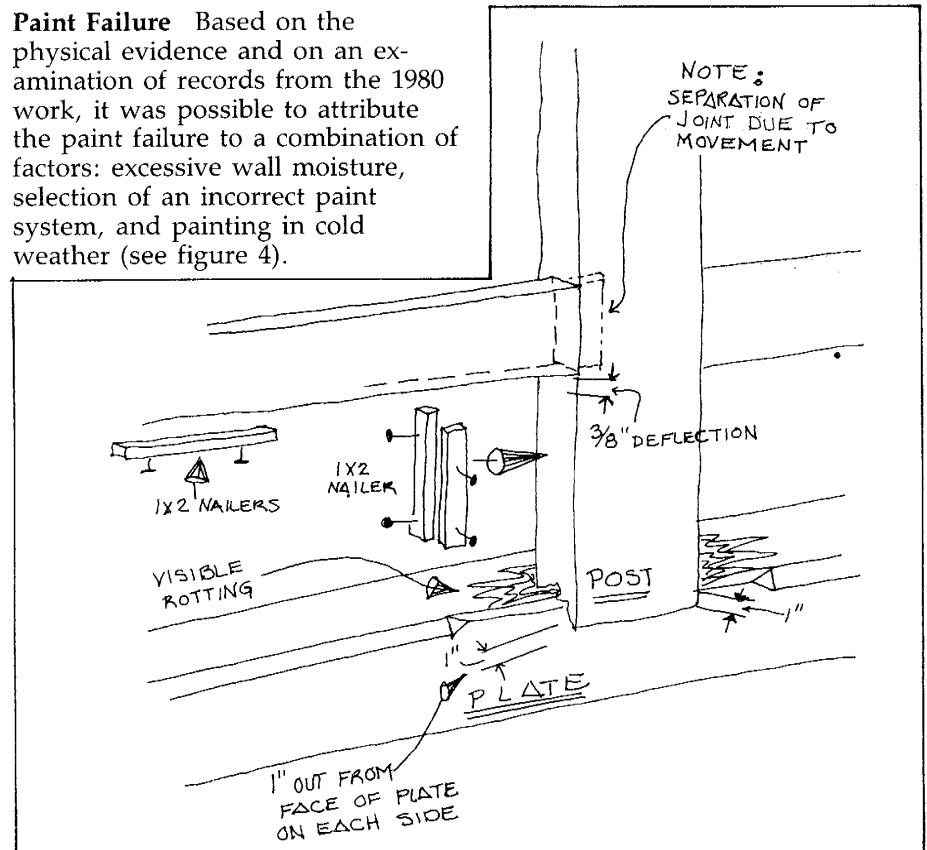
Figure 3. Areas of wood deterioration included the horizontal sill plate at the structural post connection as shown in this sketch made on site in 1985. Drawing: Dell Corporation.

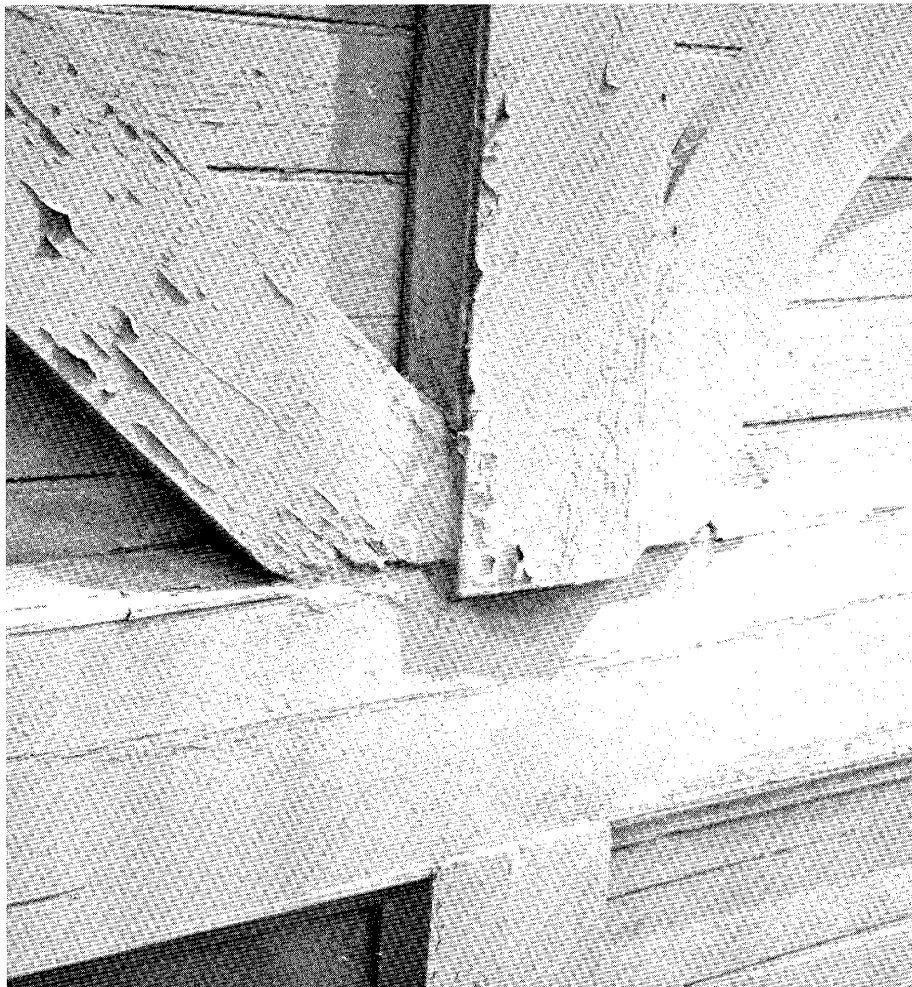
Paint Failure Based on the physical evidence and on an examination of records from the 1980 work, it was possible to attribute the paint failure to a combination of factors: excessive wall moisture, selection of an incorrect paint system, and painting in cold weather (see figure 4).

During the 1980 restoration, a steam pipe had burst, saturating a large section of the exterior wooden wall in the gymnasium. Readings taken after the accident showed a moisture level in the wood as high as 43%. Apparently, the walls were not adequately dried out before batt insulation was installed and the wall surfaces painted, thereby contributing to the paint failure.

The paint selected for the 1980 exterior work was a fire-retardant marine grade epoxy (pigmented polyamide epoxy). The paint had been chosen partly because it contained fire-retardant agents and was therefore consistent with the college's fire safety concerns. Local codes required a fire-retardant coating on the interior wooden surfaces, and the local fire officials had recommended its application on the exterior as well. In addition, the paint was selected because it was supposed to help waterproof the exterior and seal the many troublesome wood joints.

Figure 4. Flaking paint was the result of painting moisture-laden wood, using an inappropriate paint system, and undertaking the work during cold weather. Photo: Baird Smith, AIA

This impervious paint only compounded the problem. Residual moisture trapped in the walls from the broken steam line could not easily escape once the epoxy paint was applied. Furthermore, the paint turned out to be hygroscopic, or moisture absorbing, because of the salts used in the fire-retardant formulation. Once exposed to moisture, the paint swelled and, due to poor surface bonding, blistered off. Records also showed that the painting occurred during weather below 40°F, creating the possibility that the paint had frozen before drying or, at a minimum, that the prime coat had not properly bonded to the wood. As a result of all these factors, there was widespread paint failure, exposing bare wood to further water damage and ultra-violet degradation.

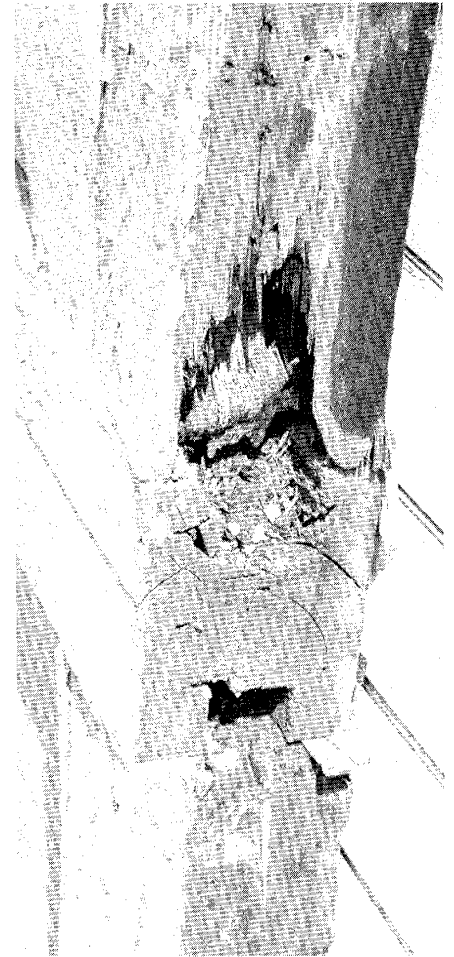
Figure 5. Some internal core deterioration was masked by sound surface wood. Water entering the connection of the post and beam framing rotted out the mortise and tenon pockets. These areas were consolidated and filled with epoxy. Photo: Baird Smith, AIA

Wood Deterioration The architect determined that prior to repainting, the deteriorated wood would have to be replaced or consolidated in order to provide a sound painting surface. While surface deterioration was readily evident in areas, further investigation revealed the rotting of the timbers at the tenon pockets (see figure 5).

The deterioration of the timber joints was from long-term decay probably dating back to the turn of the century. Fortunately, the surfaces of the structural timbers were in good condition; the rotted tenon pockets in the structural members could be consolidated and filled with epoxy resins rather than be replaced. About 10% of these timber joints were in need of such repair.

When wood was consolidated and filled with epoxy resins, the strength of the epoxy fill was formulated to match the strength of the wood as closely as possible. The major areas of deterioration were mortise and tenon pockets of the vertical and horizontal structural members. With the surface wood of these members in generally good condition, only the punky areas of the beam or post had to be dug out. The remaining shell forming the tenon pocket was consolidated as a precaution to stop any future deterioration. The hollow was filled with epoxy resins

to stabilize the joint.

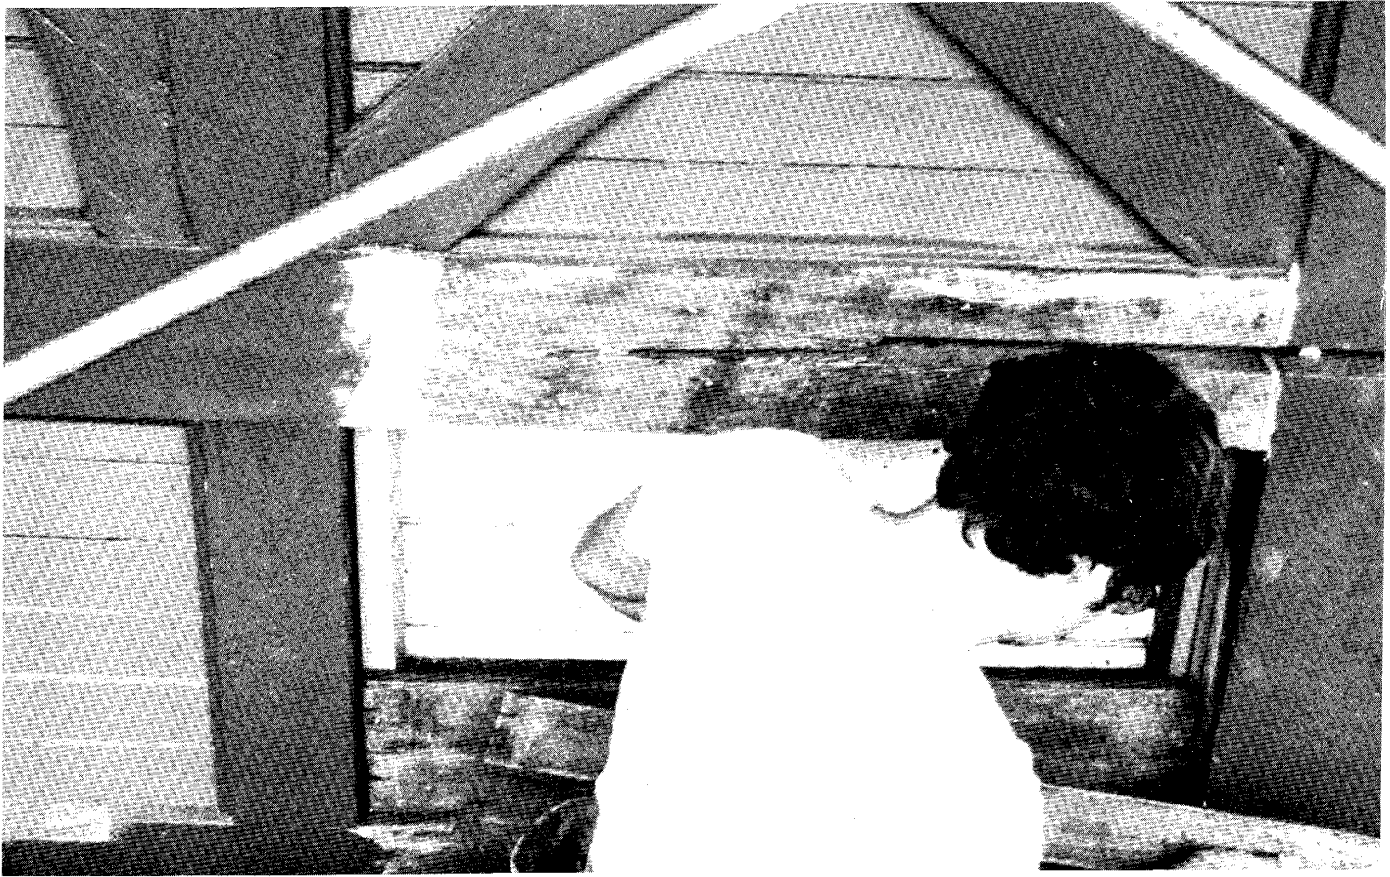
Figure 6. Sound pieces of wood salvaged from elsewhere on the building are being used to replace this deteriorated tongue and groove panel. In most cases, deteriorated wood trim, sills, and paneling were replaced with redwood that was back primed. Photo: Bryan Blundell

Repair or replacement of damaged wood was the next step. This phase involved epoxy consolidation and epoxy infill of damaged structural members and the selective replacement of moderately deteriorated trim and sills. When wood was replaced, primed redwood was used since today's yellow pine is less durable than the heartwood yellow pine originally used on the building. Approximately 20% of the applied decorative trim (diagonals and ogee boards) were replaced along with five panels of tongue and groove paneling (see figure 6). Good sections salvaged from the wood panels were reused for small repairs elsewhere on the building.

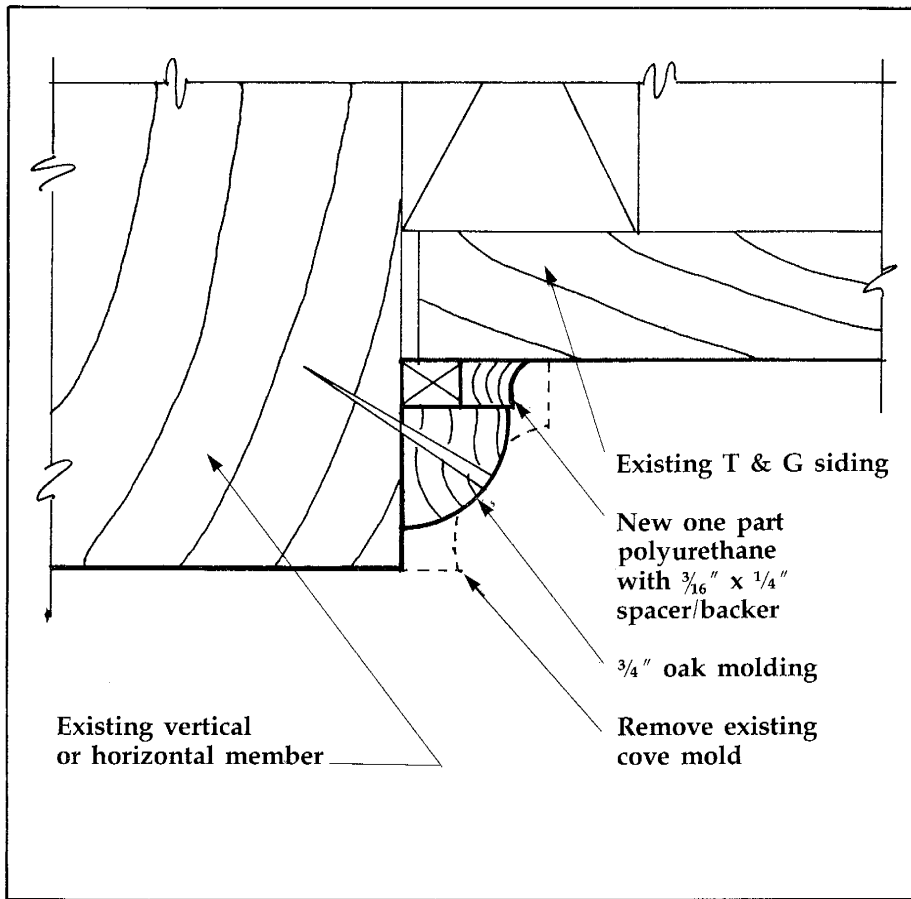
Figure 7. A molding detail was developed to seal the vertical and horizontal reveals. The additional backing strip for the molding provided a channel for a caulking or sealant bead. Drawing: Geier Brown Renfrow, Architects

In the 1980 restoration, a cove molding had been added where the recessed panels abutted the structural posts and beams. The joints, however, were not caulked and water penetrated behind the molding once the paint began to fail. The architect for the remedial work developed a new detail using a combination of a 3/4" quarter-round piece of oak with a 1/4" x 3/16" pine backing (see figure 7). The new wood was back-primed and edge-grain primed prior to installation. The reason for the backing piece was to create a channel to receive a 1/4" bead of caulking/sealant. Without this channel, there was no guarantee that the sealant would hold firm. This detail should allow for an effective seal at the joint—a chronic source of water penetration over the years (see figure 8).

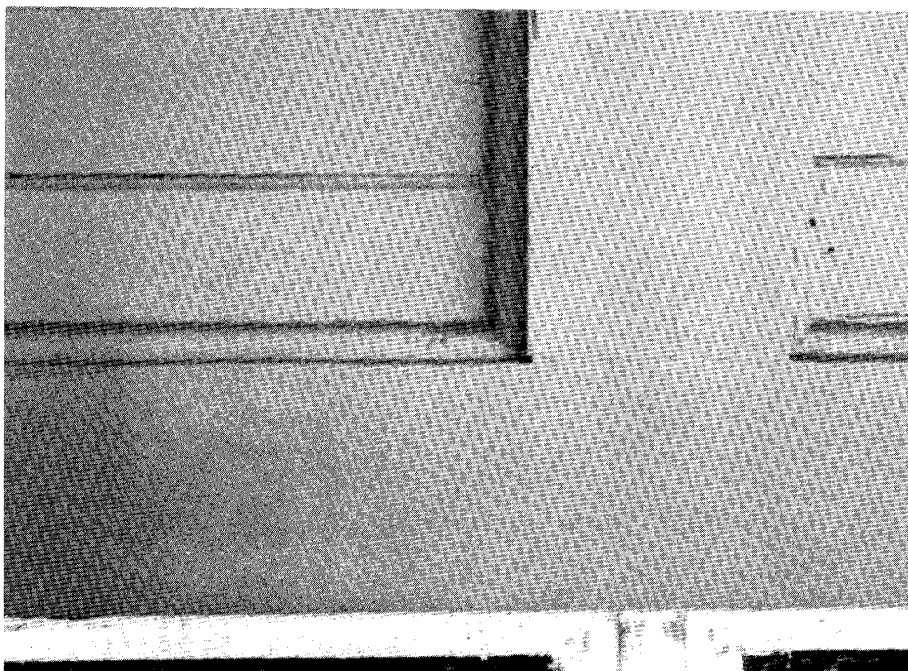
Figure 8. The molding strips blended with the horizontal and vertical boards and in combination with caulking should effectively keep moisture from penetrating behind the recessed paneling. Photos: Sharon Park, AIA

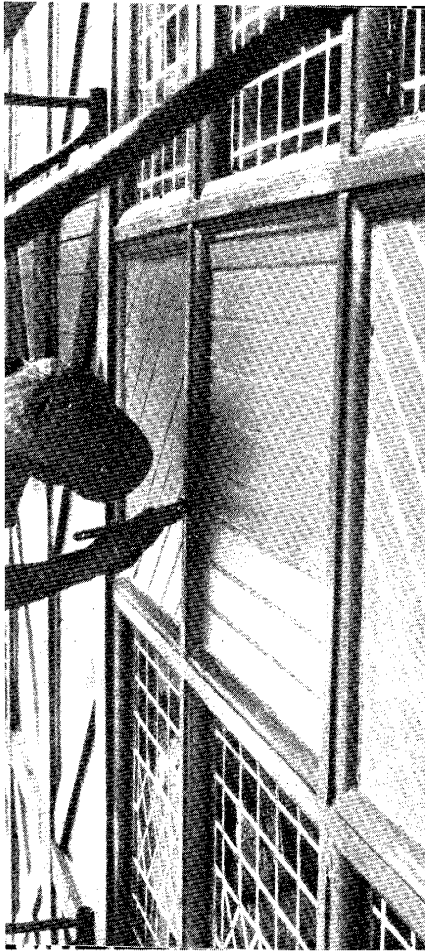
Figure 9. The building was painted with two coats of oil-alkyd primer and two top coats of acrylic latex.
Photo: Bryan Blundell

Acrylic latex paint, with its good color stability, was selected for the two top coats primarily for its durability and "breathability" (see figure 9). Compatible with the manufacturer's oil-alkyd primer, the acrylic latex also has flexibility of movement. This is an important quality since wood naturally expands and contracts.

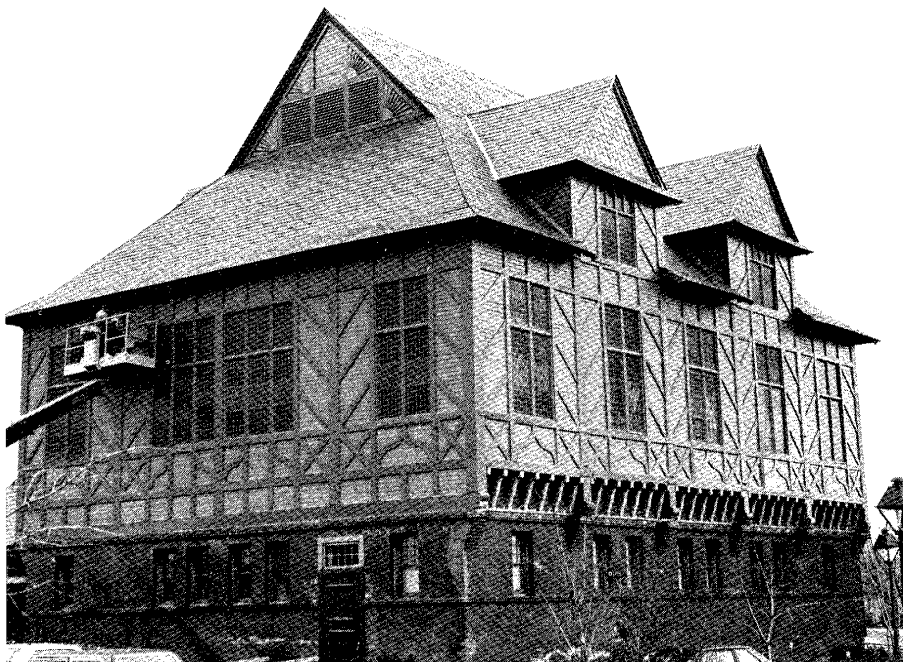
Figure 10. The college will inspect the building on a regular basis to ensure that any problems are immediately corrected. Photo: Charles Fisher

For "Ole Jim," a 7-year life is expected from the new paint job before repainting will be necessary. Under normal conditions, 7 years is the commonly recognized life span for paint applied to bare wood which has been properly prepared. Future repainting should be much easier and cheaper due to the addition of trim pieces and thorough caulking to eliminate pockets where water collected. The owner is committed to regular inspection of the building and the correction of any problems as soon as they are apparent (see figure 10).
