Tech Notes

Restoring Metal Roof Cornices

32 EAST 64TH STREET New York City

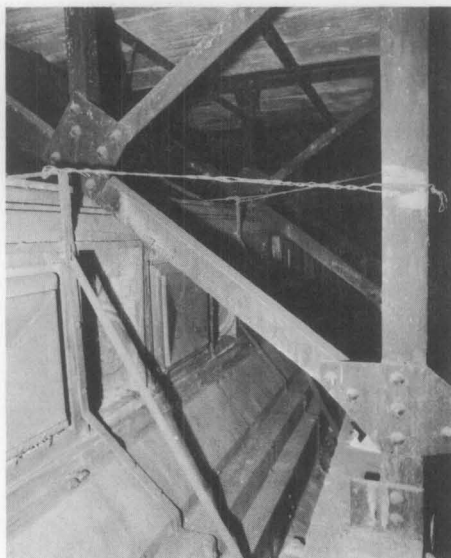
Figure 1. Large steel trusses cantilever out from the masonry parapet to support the cornice. Metal facing of the cornice was bolted to small iron or steel ribs (as at left). Wire ties helped to pull the center of the cornice tight to the bottom member of the truss. Photo: Richard Pieper.

The unusually large size of the cornice made it possible to inspect its interior (see figure 1). It was accessible through two small hatches in the sloped roof covering the rear of the cornice trusses. The cornice itself is supported by steel trusses, which are in turn attached to the structural steel frame of the building (see figure 2). The top and rear slopes of the cornice trusses are covered with structural clay tiles supported by 2" steel tee purlins set perpendicular to the trusses. The tiles served as a base for the terne-plated steel standing seam roofing, which had rusted through in spots on the top slope. The standing seam roof on the rear slope of the cornice had been coated with asphalt but was in

relatively good condition. In spite of recurrent leakage, the tiles were in satisfactory condition, and the trusses showed only small areas of superficial rusting. The galvanized steel facing of the cornice was generally in good condition, but about 30 lineal feet (roughly 10 percent) of the steel at the base of the cornice had rusted where the galvanized facing entered the masonry wall. (Water leaking into the cornice had collected there.) In addition, large rust holes had formed behind nearly all the decorative lions' heads on the crown of the cornice, where holes in the exposed and seldom painted ornament allowed bird nests and moisture to accumulate. The metal of the cornice soffit was in surprisingly good condition, perhaps because water entering there was able to weep through lapped seams of the steel facing.

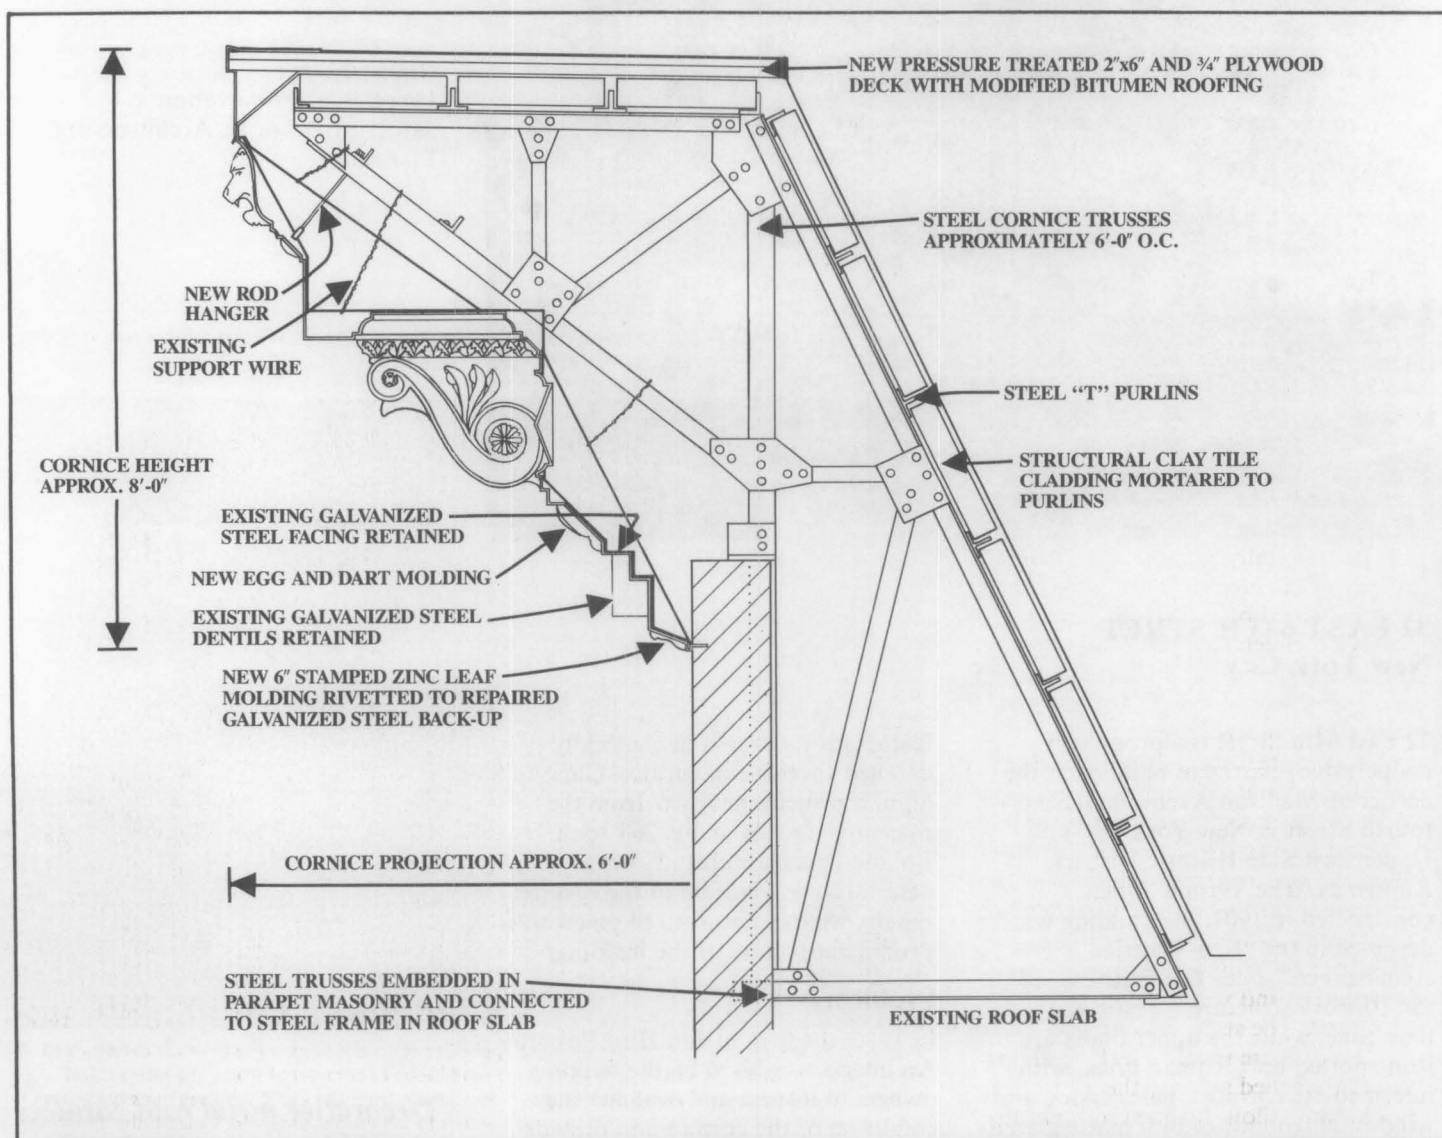
Figure 2. Cornice section shows the manner in which the cornice was supported and attached to the building. Drawing: Michael Devonshire.

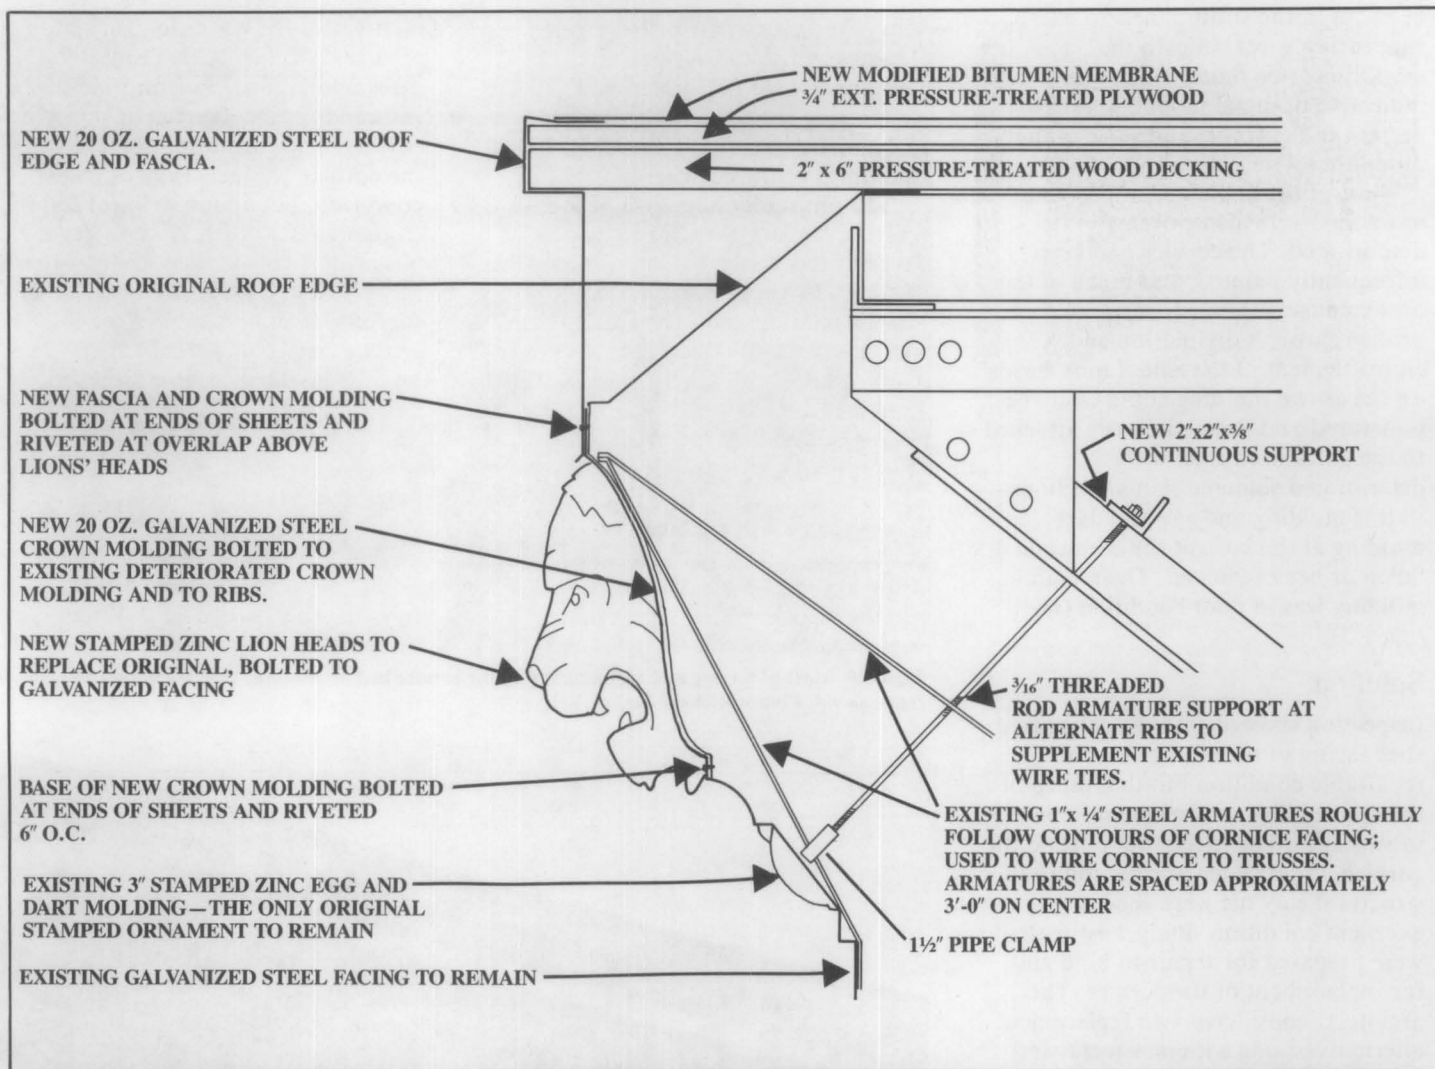
Figure 3. Detail section shows the new cornice crown molding, edge cap and roofing that corrected a construction flaw in the original fabrication. Drawing: Michael Devonshire.

cornice above the crown molding (see figure 3). Perhaps due to a fabrication error, the trusses were too tall to receive the cornice facing as designed. Since the facing could not be raised further vertically without the top inside corner of the modillions touching the bottom chord of the trusses, a gap existed between the top of the sheet metal facing and the cornice roof when the facing was installed. The gap was closed by a short sloped piece of galvanized steel sheet metal that was not visible from the street.

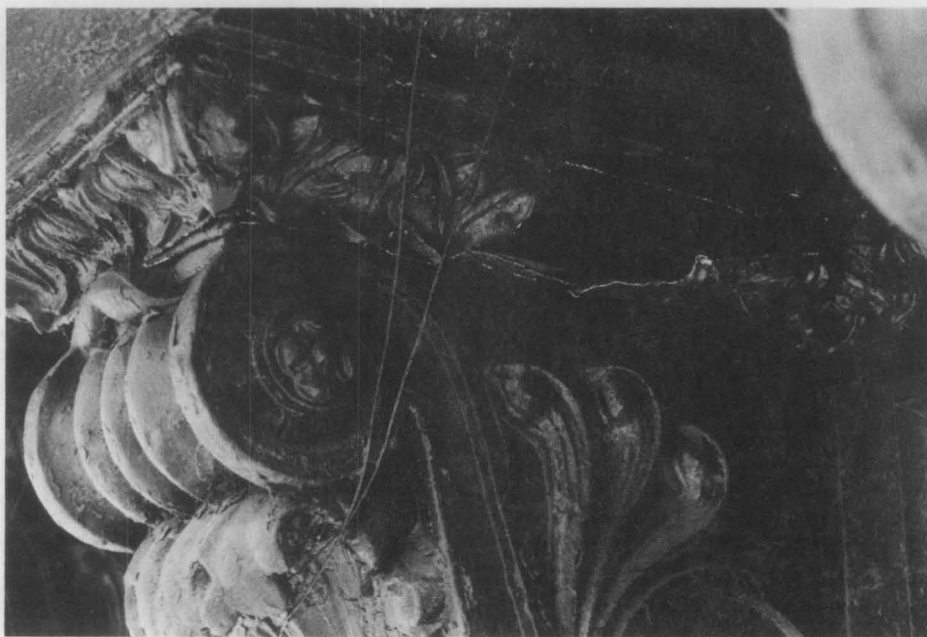
By far the most serious problem with the cornice was the deterioration of the stamped zinc ornament applied to the exterior of the galvanized steel facing. The large 12"-wide zinc modillions projected 24" from the cornice entablature and were in poor condition. The stamped zinc had fractured where integral leaf moldings met the scrolled sides of the modillions, allowing them to separate from the soffit. As a previous temporary safety measure, holes had

Figure 4. As shown in this view, the molding applied to the modillions was extremely deteriorated. A more serious problem was that most of the zinc modillions had fractured where the integral leaf moldings met the scrolled sides, allowing them to separate from the soffit. As a previous temporary safety measure, holes had been cut in the soffit panels to pass supporting wire beneath the modillions. Photo: Richard Pieper.

been cut in the soffit panels to pass supporting wires beneath the modillions (see figure 4). Cracks indicative of metal fatigue were also present in the fronts and sides of the modillions.

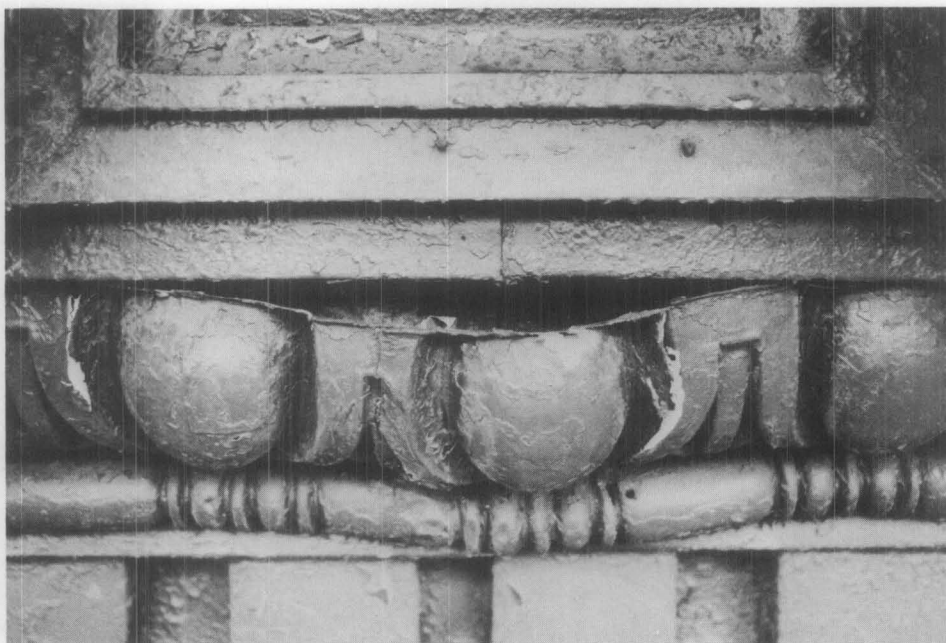
Most of the applied stamped zinc moldings were also extremely deteriorated. The cornice had been infrequently painted, and much of the ornament was thinned, perforated or broken through dissolution and embrittlement of the zinc. Lions' heads on the crown molding could easily be punctured and were tenuously attached to the galvanized steel with deteriorated soldered joints. Sections of leaf molding and egg and dart molding at the base of the cornice had fallen or been removed. The remaining molding was in poor condition (see figure 5).

Figure 5. Most of the egg and dart molding on the cornice had deteriorated over the years and required replacement. Photo: Richard Pieper.

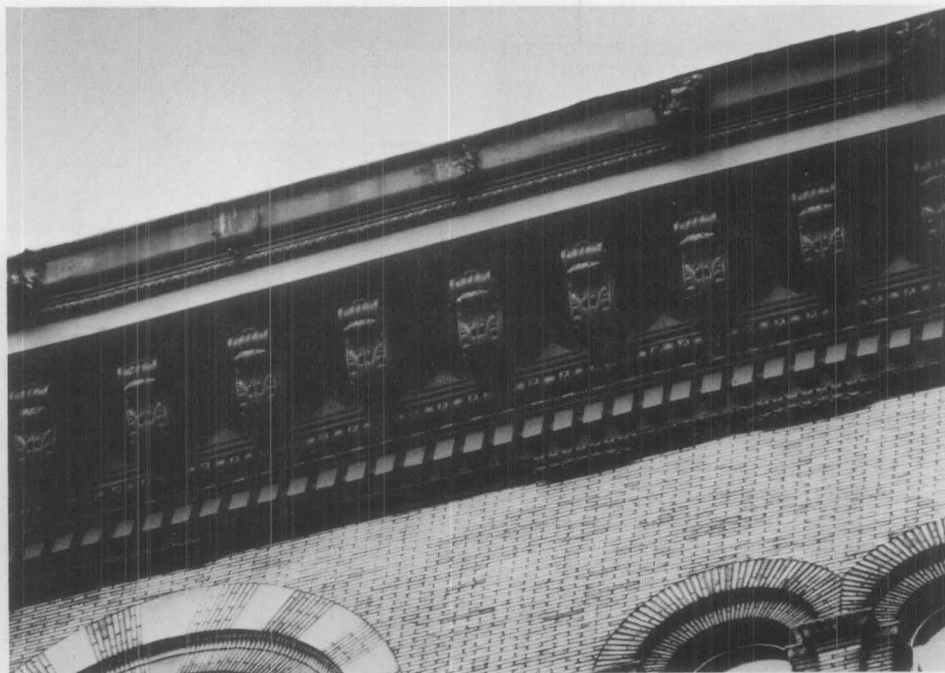
Figure 6. Three of the components of the metal cornice which required replacement because of serious deterioration are shown in this view. They are the lions' heads on the crown molding (several are missing due to failed soldered joints), modillions, and the egg and dart molding at the base of the cornice. The brake-formed galvanized steel that comprised the lineal moldings of the cornice, the soffit and dentil band were in sound condition. Photo: Richard Pieper.

Inspection showed that the galvanized steel facing of the cornice was in repairable condition but that much of the applied zinc ornament was not salvageable. The trusses supporting the cornice, the steel tee purlins and the structural clay tile were generally in excellent condition. Budget estimates were prepared for repair-in-kind and for replacement of the cornice. The architects considered two replacement alternatives; one with new metal and one with glass-fiber reinforced plastic. Repair of the existing cornice facing was the most economical alternative. The New York City Landmarks Preservation Commission also favored repair rather than replacement. Repair of the cornice included replacement of all modillions and nearly all applied zinc moldings; installation of new galvanized steel crown molding and cornice roof edge details; placement of new roofing on the top of the cornice; insertion of new rod hangers to supplement existing wire hangers supporting the face of the cornice, and repainting both the interior and exterior (see figure 6).

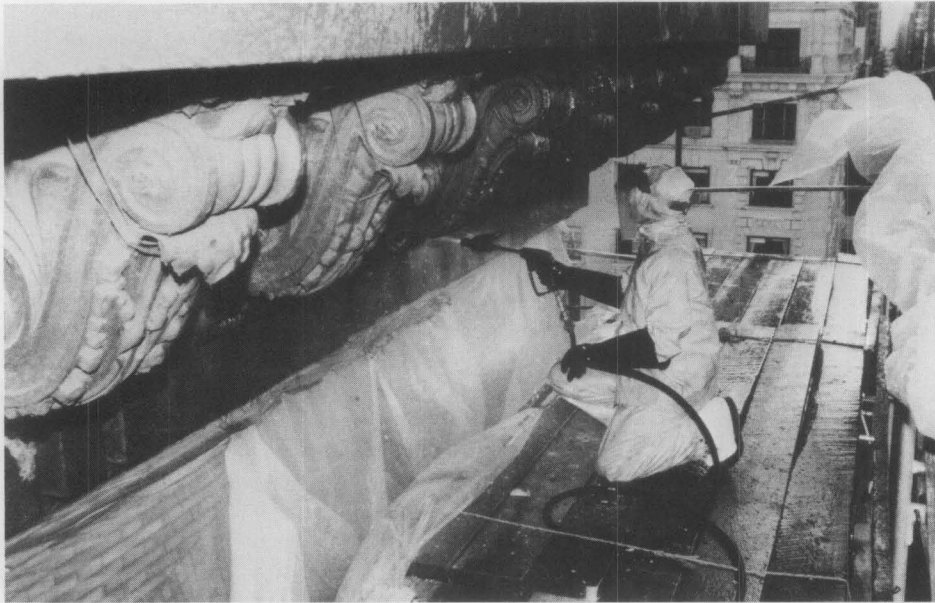
Figure 7. A water spray was used to remove most of the paint from the components of the cornice that were being retained. With the more delicate egg and dart molding, care was required to avoid possible dimpling of the metal. Steps were taken to keep water from collecting inside the cornice. Photo: Michael Devonshire.

removal was dismissed because of environmental and public safety considerations and potential problems of the residue soiling the exterior masonry. Tests of water spray removal techniques showed that successful cleaning was achieved with a rotating tip spray device, which removed nearly all paint without harming the metal substrate (*see figure 7*). Care was required when spraying the zinc molding that was to remain, since the water pressure required to remove the paint was sufficient to dimple the projecting metal of the ornament. Water and paint chips were collected in troughs of sheet plastic. Paint residue was gathered to the extent possible, but the spray effluent was difficult to control and some spilled onto the building and sidewalk bridging. In some areas it was necessary to supplement water removal with light hand scraping, using a flat scraper after most paint had been removed.

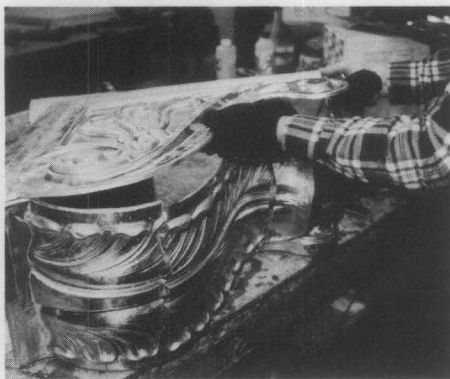
Figure 8. The modillions consisted of 6 stamped pieces soldered together by the installer. Photo: Richard Pieper.

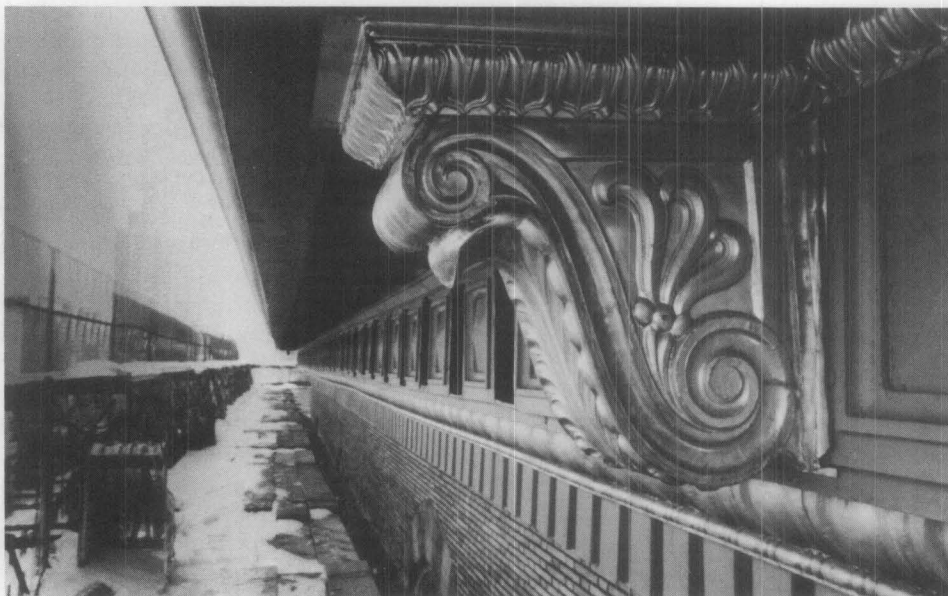
Figure 9. The new modillions, shown here in an installation test, were the same size as the originals but not precisely the same design. Had the difference in appearance been discernible from the street below, matching pieces could have been manufactured at an additional cost. Photo: Michael Devonshire.

New stamped zinc ornament closely resembling the original was available in stock sizes from a Midwest manufacturer. In some cases it was necessary to gang two moldings (an 8" egg and dart and 3" bead and disk moldings for instance) where a larger original molding had incorporated two designs. Modillions were the only zinc elements requiring significant assembly prior to installation. Modillions were comprised of 6 stamped pieces, which were soldered together in a shop by the contractor prior to installation. While preassembled ornament was available from the manufacturer, assembly by the installer greatly simplified shipping and assured that mounting flanges met installation requirements (*see figure 8*). Since the new stock modillions did not incorporate a leaf molding at the top as did the originals, it was necessary to attach new mitered leaf molding sections to the top of each modillion. New galvanized steel back-up was attached at the top of the modillions for better anchoring to the soffit and to avoid riveted zinc to zinc joints which might fracture in this location (as did the originals due to metal fatigue). New modillions were the same size (24"L x 22"H x 12"W) as the originals, but were not precisely the same design (*see figure 9*). This difference in appearance is not discernible from the street below. (New molds matching the original modillions could have been fabricated at additional cost if this had been necessary for authenticity.)

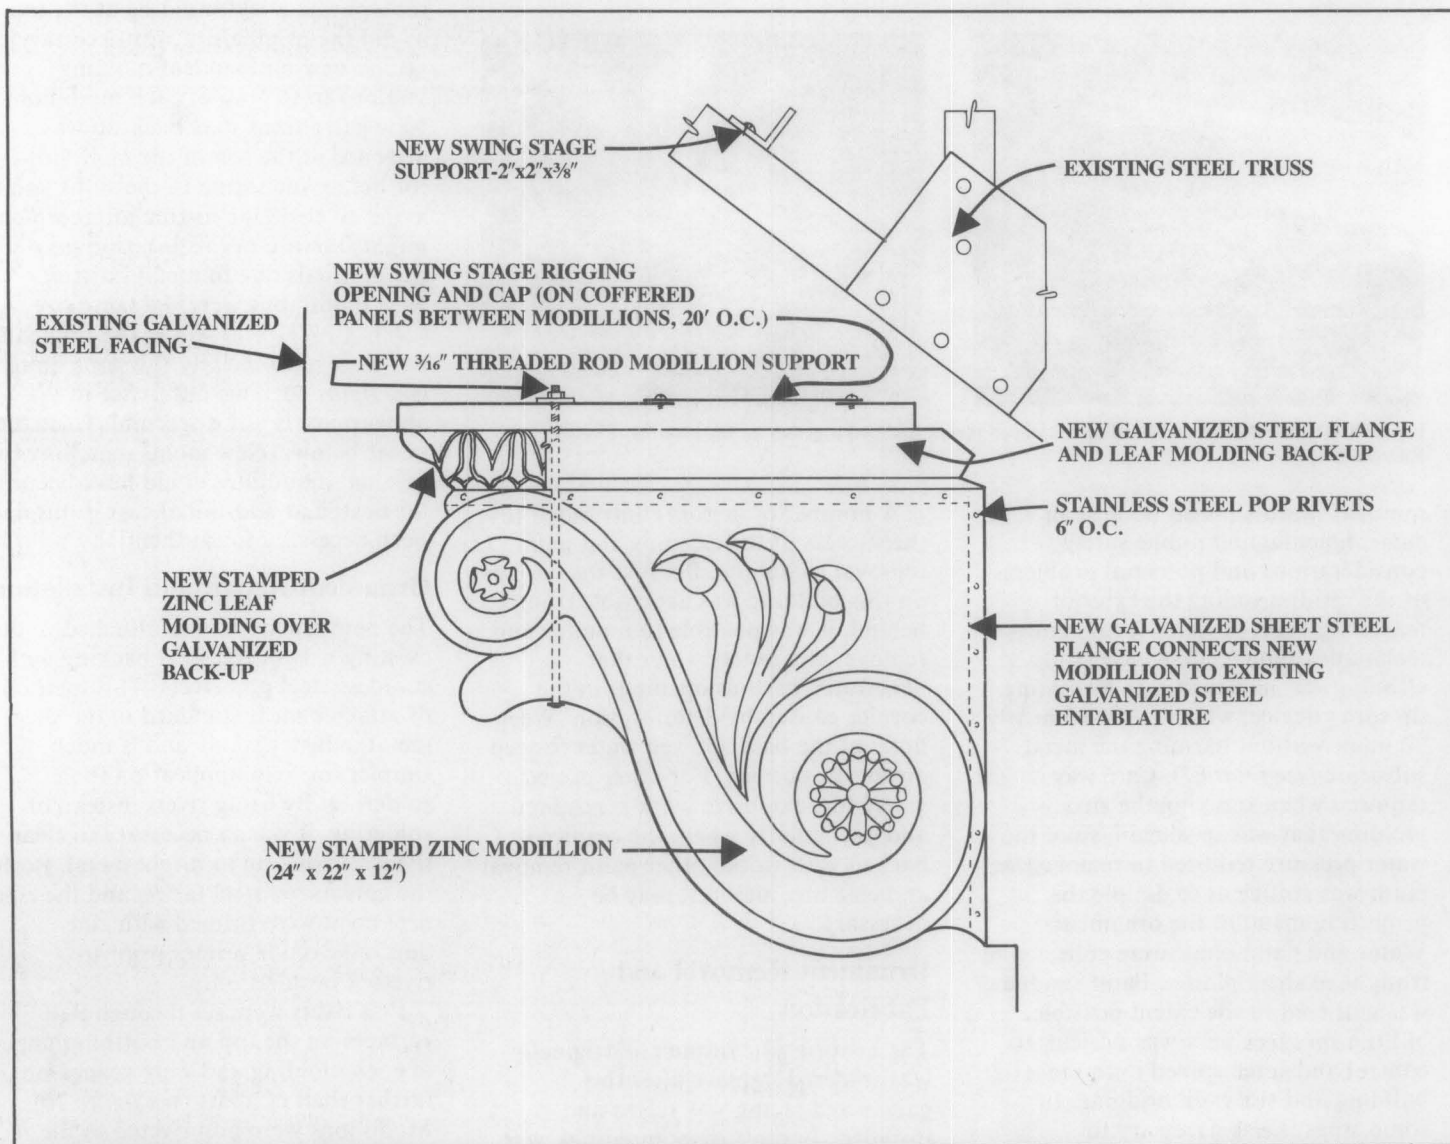
Figure 10. Detailed section shows the supporting technique for the new modillions, which consisted of riveted galvanized steel flanges and threaded rods. Drawing: Michael Devonshire.

Pop rivets were set through flat surfaces on the top and bottom flanges of each molding and were spaced no further than 6" apart (*see figure 10*). Modillions were pop riveted to the soffit through the new galvanized backing used to support the leaf moldings. New galvanized steel flanges

The $1\frac{1}{4}$ " x $\frac{1}{4}$ " ferrous armatures to which the cornice facing was bolted were lightly rusted, but in satisfactory condition. The original system of twisted wires which attached these armatures to the trusses was also in good condition, but appeared haphazard. Additional threaded rod and clamp anchors were added to supplement these wires. Rods were also

added to attach modillions to the soffit in the event that the new leaf molding flange rivets broke.

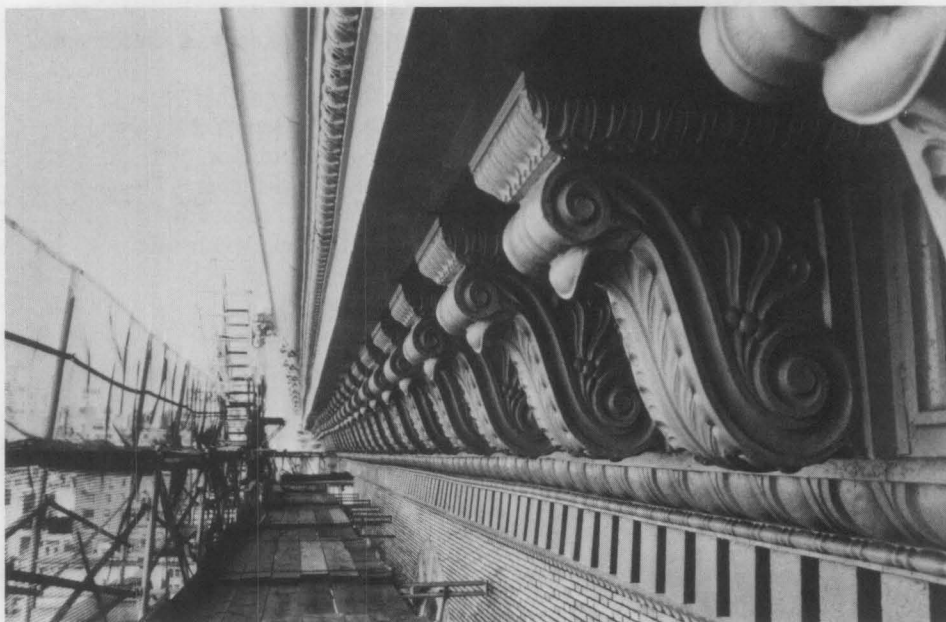
Figure 11. The completed cornice is shown after painting and immediately prior to removal of the scaffolding. Photo: Richard Pieper.

Because it seemed likely that paint maintenance of the cornice would be neglected, a zinc dust/zinc oxide primer was selected to give the cornice a measure of galvanic protection if the paint film was compromised. The primer was used on all surfaces, including the back of the new ornament and the interior of the cornice. The primer and two coats of alkyd finish paint were brush applied (see figure 11).

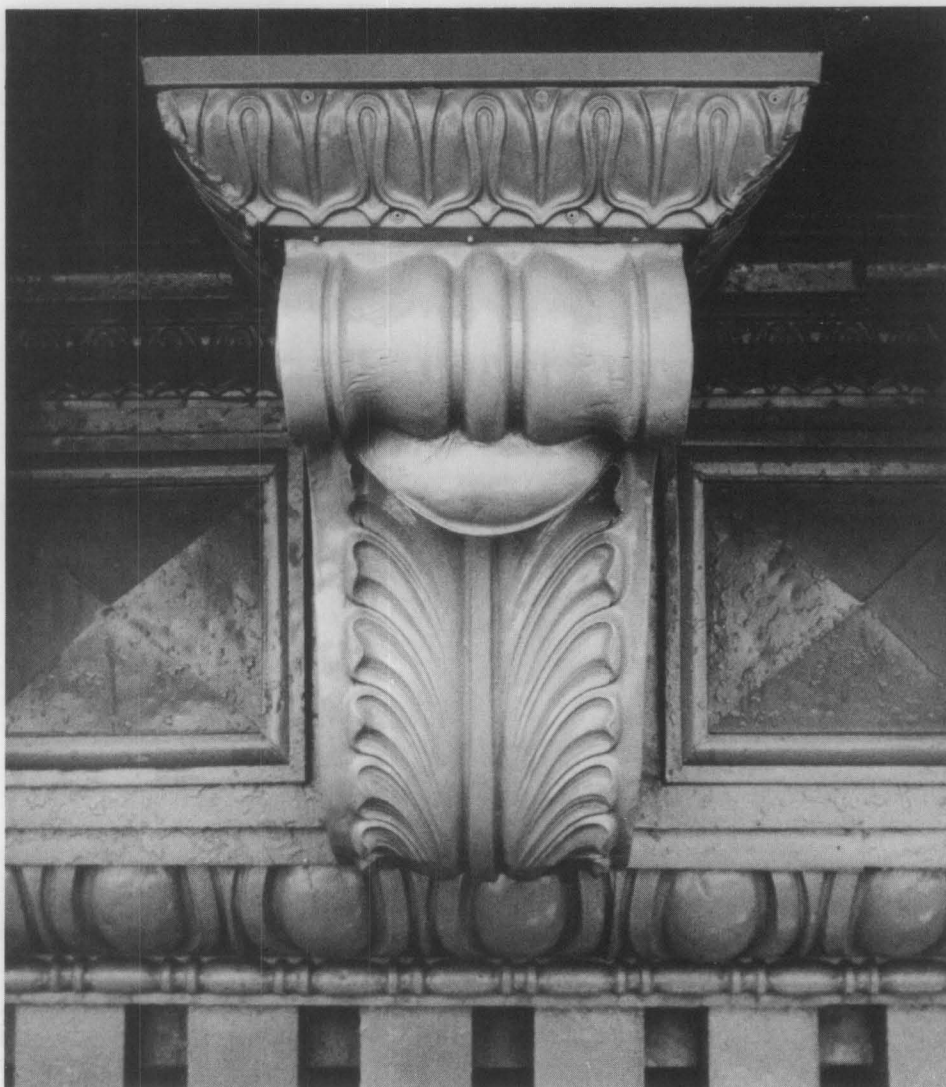
Figure 12. Detail of the completed cornice shows the new zinc modillion and the leaf and egg and dart moldings attached to the historic cornice. This repair approach, which involves in-kind replacement of deteriorated components, is the recommended treatment for such distinctive features as this cornice. Photo: Michael Devonshire.

Repair of the cornice at 32 East 64th Street with in-kind replacement of stamped zinc ornament provided for thorough rehabilitation of the cornice at an acceptable cost (see figure 12). The utilization of stock replacements of lions' heads, modillions, and moldings resulted in some savings and hastened delivery of stamped ornament with little effect on the appearance of the rehabilitated cornice. A change of the cornice roof edge detailing to prevent further leaking was the only significant change made to the original design.
