Tech Notes

**WINDOWS**

Planning Approaches to Window Preservation

MARQUETTE BUILDING

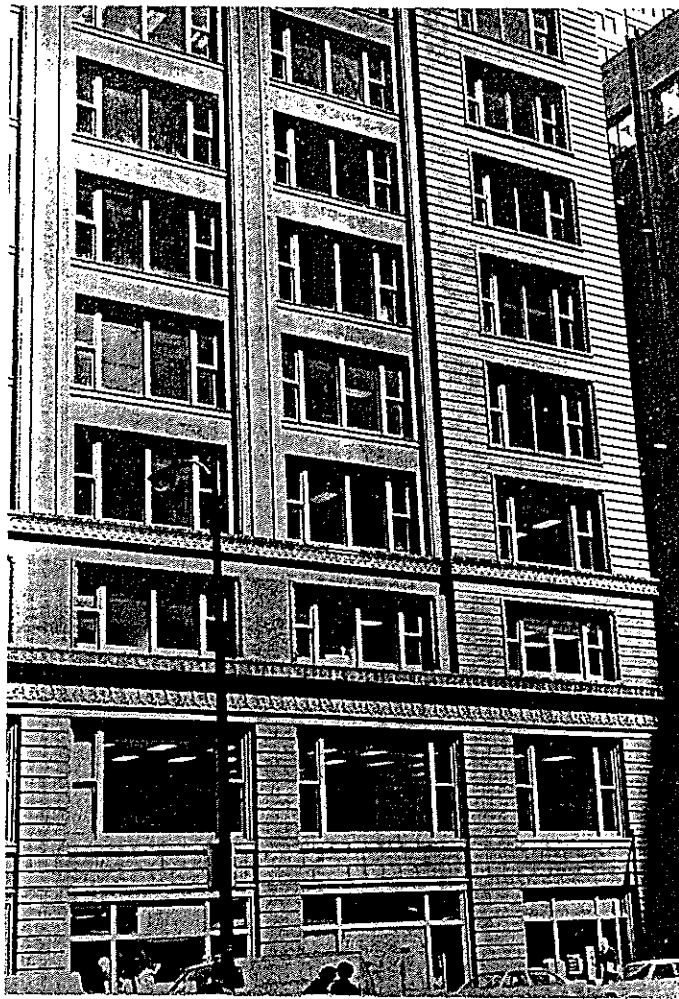
ing on an alley, the 182 Chicago style windows are of greatest interest here because of their style, prominence, and large size. Although the windows vary in size, most measure about 12' wide by 8' high (see figure 1).

Figure 1. The Marquette Building has both Chicago-style windows, as shown above on the second floor, and a modified Chicago-style window consisting of two fixed lights in the center section. Photo: Charles E. Fisher

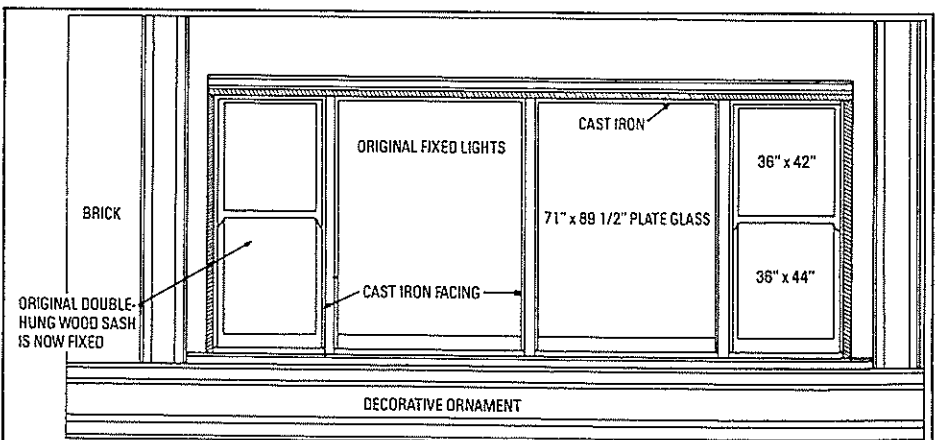
Constructed out of good quality mahogany, the windows were still in sound physical condition despite over ninety years of exposure to Chicago's winter weather and years of neglect due to deferred maintenance (see figure 2). While some of the sills needed repair, the windows primarily needed to be repainted and to have some interior trim replaced. Recaulking around the frames was necessary, but otherwise there was very little air infiltration. The windows had already proven to be very durable and, except for periodic painting, long-term maintenance was expected to be minor. The project architect, Walker C. Johnson, AIA, of Holabird and Root, estimated the life of the windows to be in excess of another ninety years. Even with this information, the architect and owner still had other factors to consider in examining alternatives for the repair or replacement of the windows.

Figure 2. The window sash were well-constructed of mahogany and the frames were faced on the outside with cast iron trim. Drawing: Martha L. Werenfels

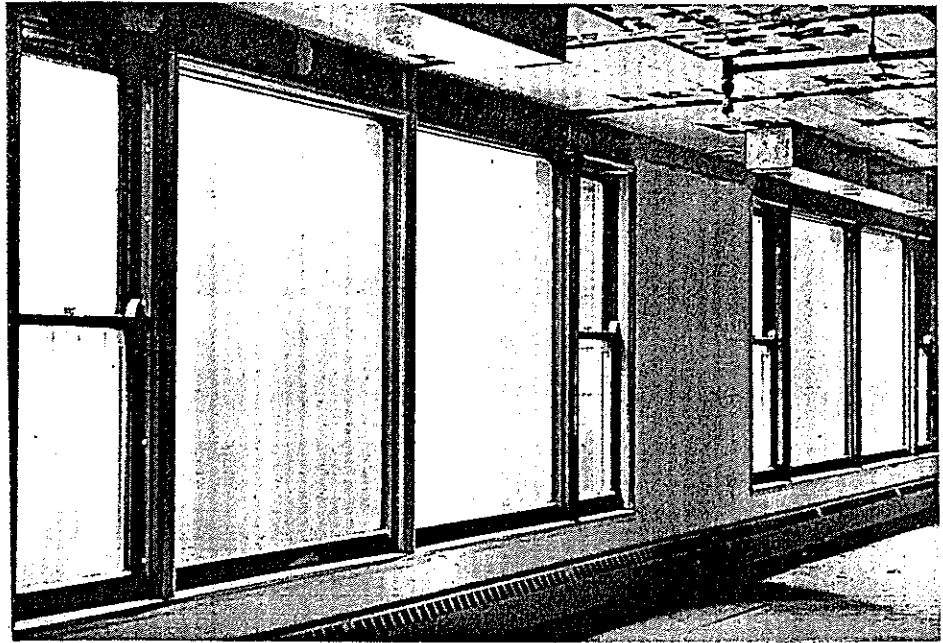
Figure 3. Approximately 1000 linear feet of matching window casing trim had to be installed. In many cases, damage had occurred where later partitions had intersected the windows. Lighter color wood shown in the photograph is the new trim prior to painting. Photo: Charles E. Fisher

Repair work on the windows was conducted at the site, working one floor at a time. Wood stops were removed, and the windows taken out of those frames needing repair. The hardware was cleaned and repaired, or replaced where missing. Only about 7% of the windows and trim required any major work. Most of the required work was due to the use during rehabilitation of two fixed windows per floor for trash removal and the material hoist or where later partitions intersecting the windows had damaged the wooden trim (see figure 3). The wood stops were then reattached using screws in order to facilitate future window work that might arise.

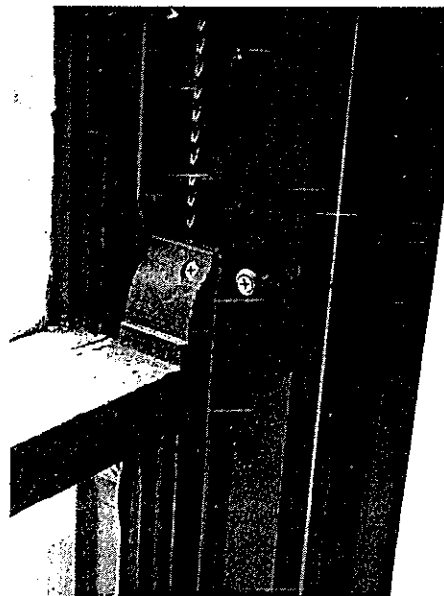
Figure 4. The only modification made to the windows was the addition of a screw through the decorative end of the sash stile to fix closed the operable portions. This decision grew out of the recommendations by the mechanical engineers. Photo: Charles E. Fisher

To prevent tenants from opening the windows, a screw was secured through the decorative extension on the stiles of both upper and lower sash (see figure

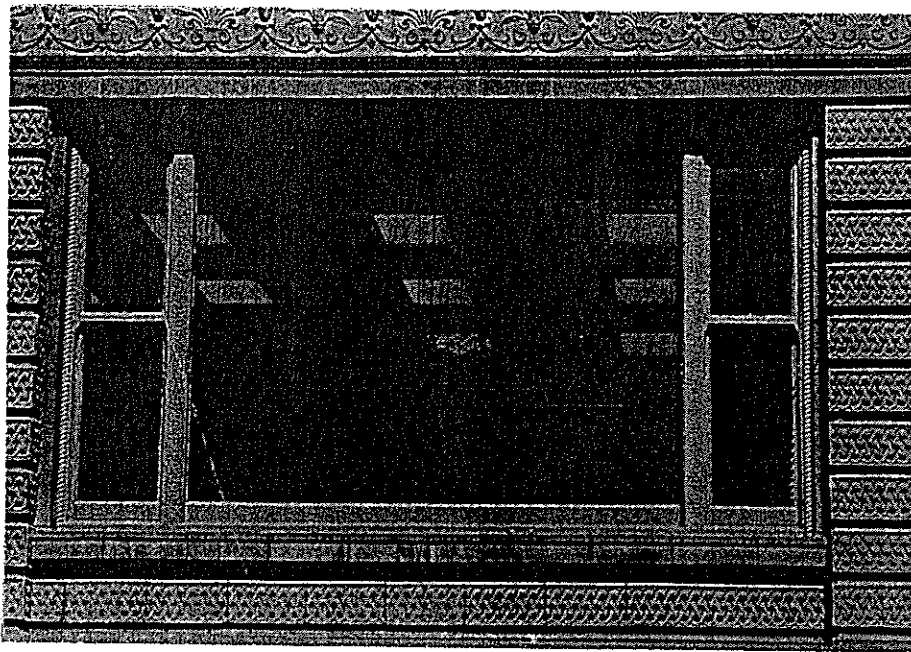
Figure 5. Careful planning and evaluation led to the conclusion that the most cost-effective approach was merely to repair the windows rather than undertake measures to upgrade their performance. Photo: Charles E. Fisher

This and other rehabilitation projects have shown the value of careful and objective evaluation of existing window conditions (*see figure 5*). Sound planning can result in window decisions that take into account good preservation decisions and the realities of the marketplace.
