Tech Notes

WINDOWS NUMBER 2

Installing Insulating Glass in Existing Steel Windows

MERGENTHALER LINOTYPE BUILDING

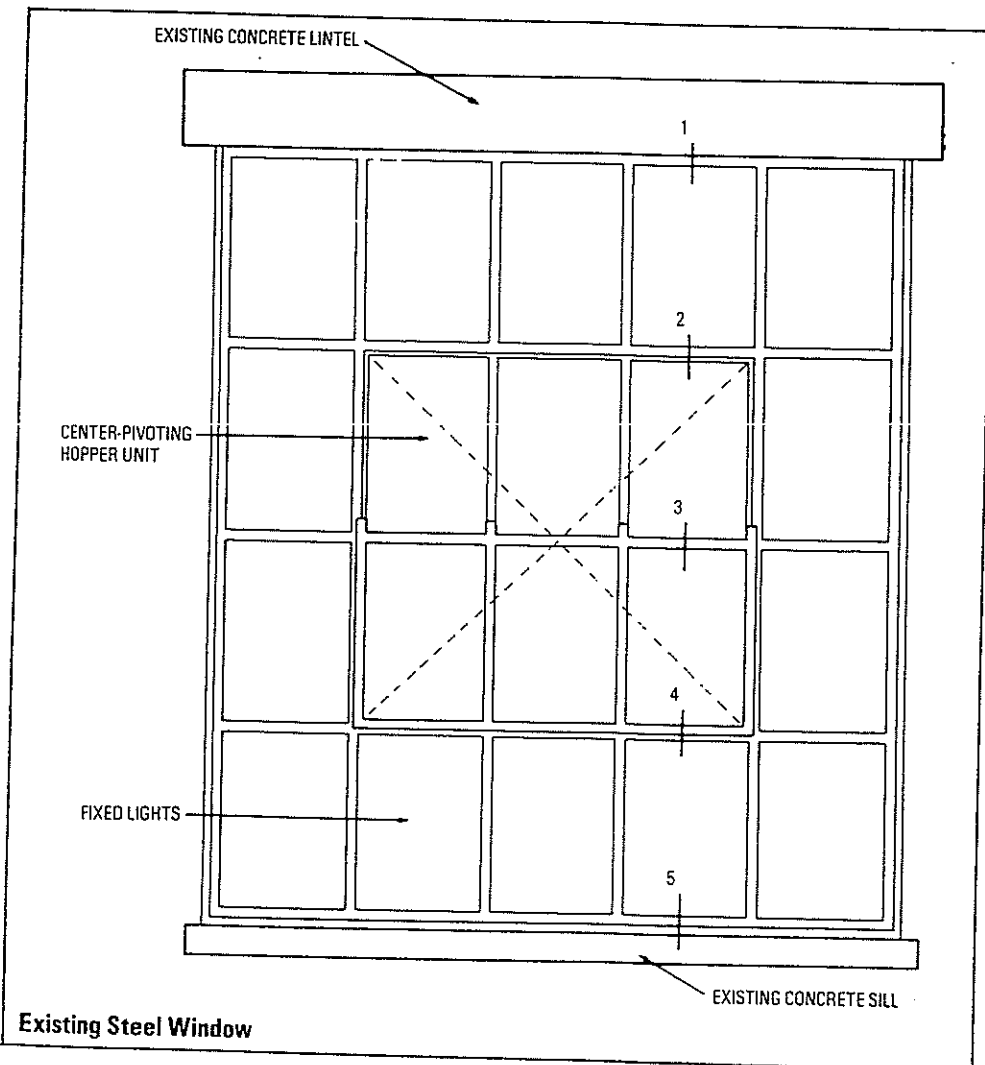
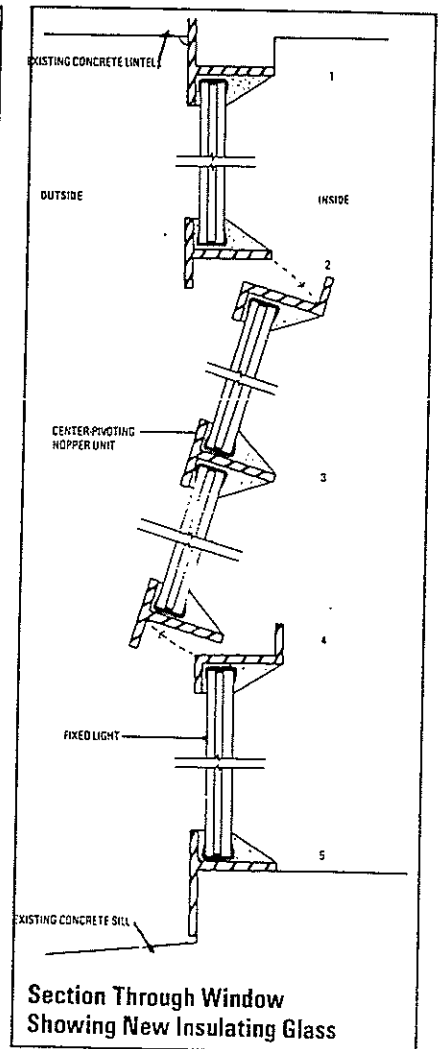
Figure 1. Insulating glass was installed without changing the appearance or operation of the steel window. Drawings: Martha L. Werenfels

Only about half of the glazing cost was directly attributable to the use of insulating glass since from the outset, the residential use of the building tended to dictate from a marketing perspective that the existing wire glass be replaced. Thus it was decided that in lieu of only repairing and reglazing with clear $\frac{1}{4}$ " glass, which would have been the cheapest of the four identified window options, sufficient benefits could be derived by using double glazing to improve the window's energy performance (see figure 1).

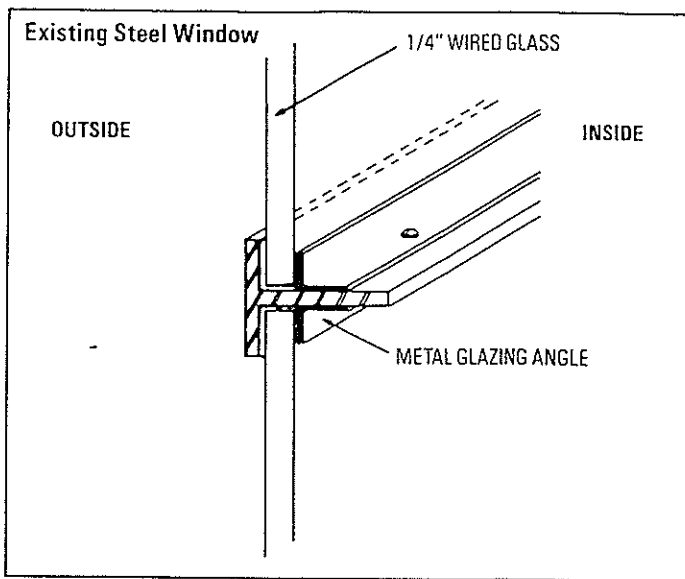
Figure 2. Spring glazing clips and face putty were used instead of the original metal glazing angles in installing the new glass. Drawings: Martha L. Werenfels

The original wire glass had been held in place by glazing angles bolted to the muntin bars. In removing the glass it was decided, due to deterioration of the glazing angles and the labor-intensiveness of reinstallation, that new spring glazing clips and steel sash glazing compound would be used instead (*see figure 2*).

The insulating glass had been delivered to the site, vacuum sealed and with a continuous glazing edge. After the bed putty was applied to the sash, the insulating glass was installed with glazing clips and face putty.

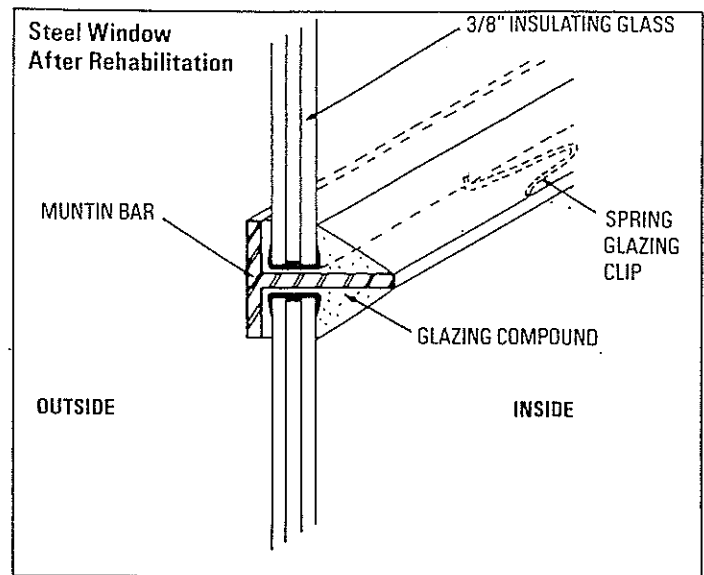
Figure 3. The historic steel windows were repaired and then upgraded through the addition of insulating glass. Photo: Charles E. Fisher

On the whole, the reconditioned windows are performing well and are providing the desired improvements in personal comfort (*see figure 3*). There was no real problem in marketing the condominiums and residents have capitalized on the interior design opportunities provided by the large windows and the loft space.
