OLD WATKINS NATIONAL BANK

Lawrence, Kansas

WINDOWS NUMBER 5

Interior Metal Storm Windows

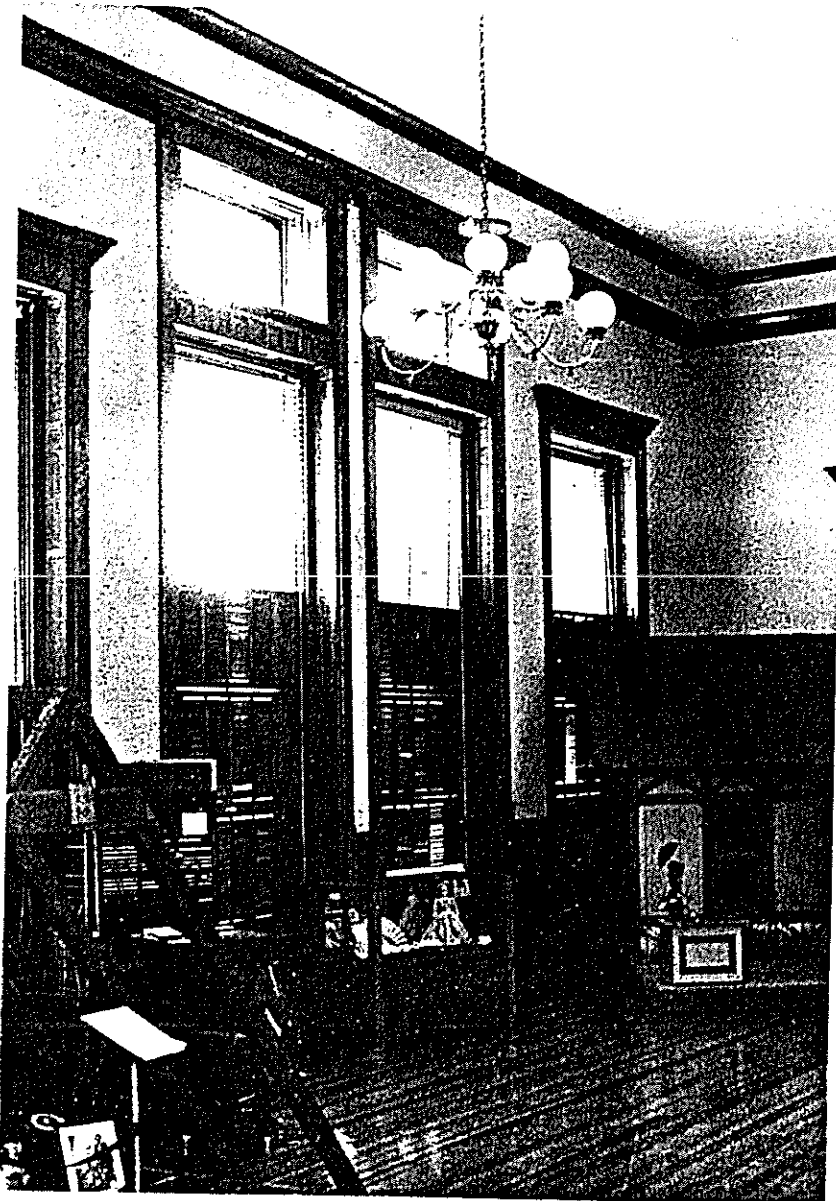
Figure 1. The monumental windows are elegantly detailed on the interior and contribute to the grandeur of the spacious banking rooms. The original interior shutters are still being used for comfort and light control. Photo: Charles E. Fisher

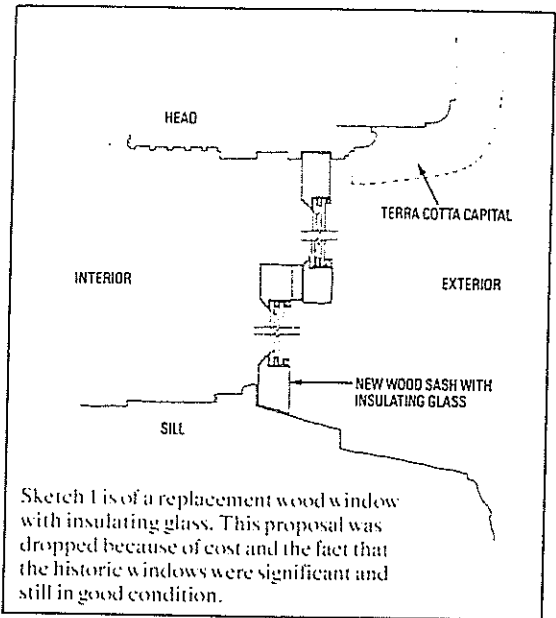
Sketch 1 is of a replacement wood window with insulating glass. This proposal was dropped because of cost and the fact that the historic windows were significant and still in good condition.

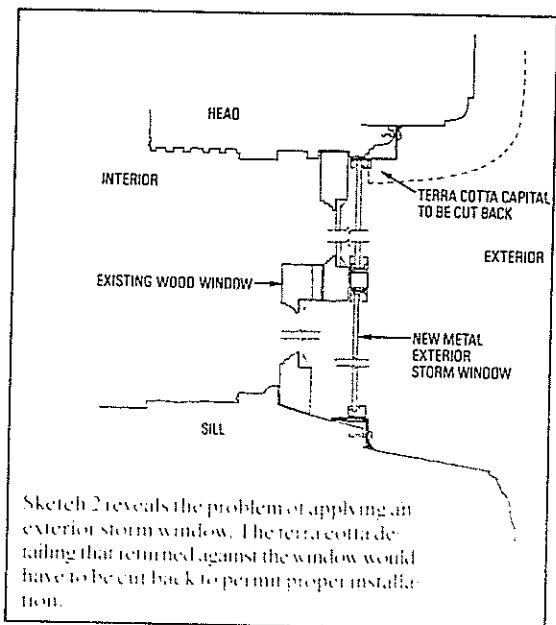
Sketch 2 reveals the problem of applying an exterior storm window. The terra cotta detailing that remained against the window would have to be cut back to permit proper installation.

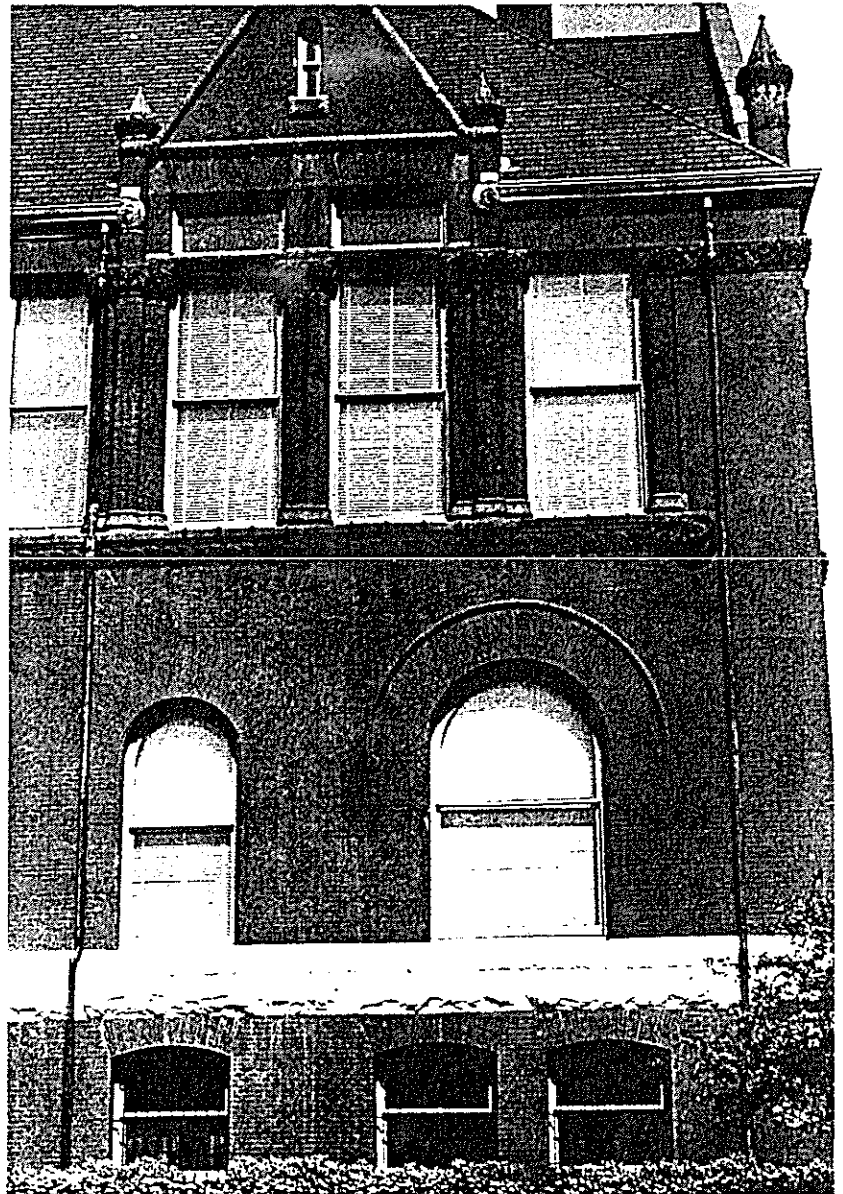
Use of exterior storm windows was initially explored both for energy conservation purposes and as a way to extend the useful life of the original windows (*see figure 2*). Unfortunately, the prices quoted for exterior storm windows by local contractors were around \$65,000, nearly double the budgeted amount. In addition to the high cost of exterior storm windows, one further problem with an exterior storm application arose when it was discovered that the decorative terra cotta capitals adjacent to the upper level window openings returned against the original frames. As a result, the proposed exterior storm windows could not be easily installed in these locations without cutting back or covering portions of the terra cotta (*see figure 3*).

Figure 3. Exterior storm windows were initially considered but presented several problems. The terra cotta capitals on the pilasters returned against the windows, making normal installation difficult without damaging the terra cotta. Many of the windows also had round heads which would require additional custom work—these same windows on the interior had square tops. Photo: Charles E. Fisher

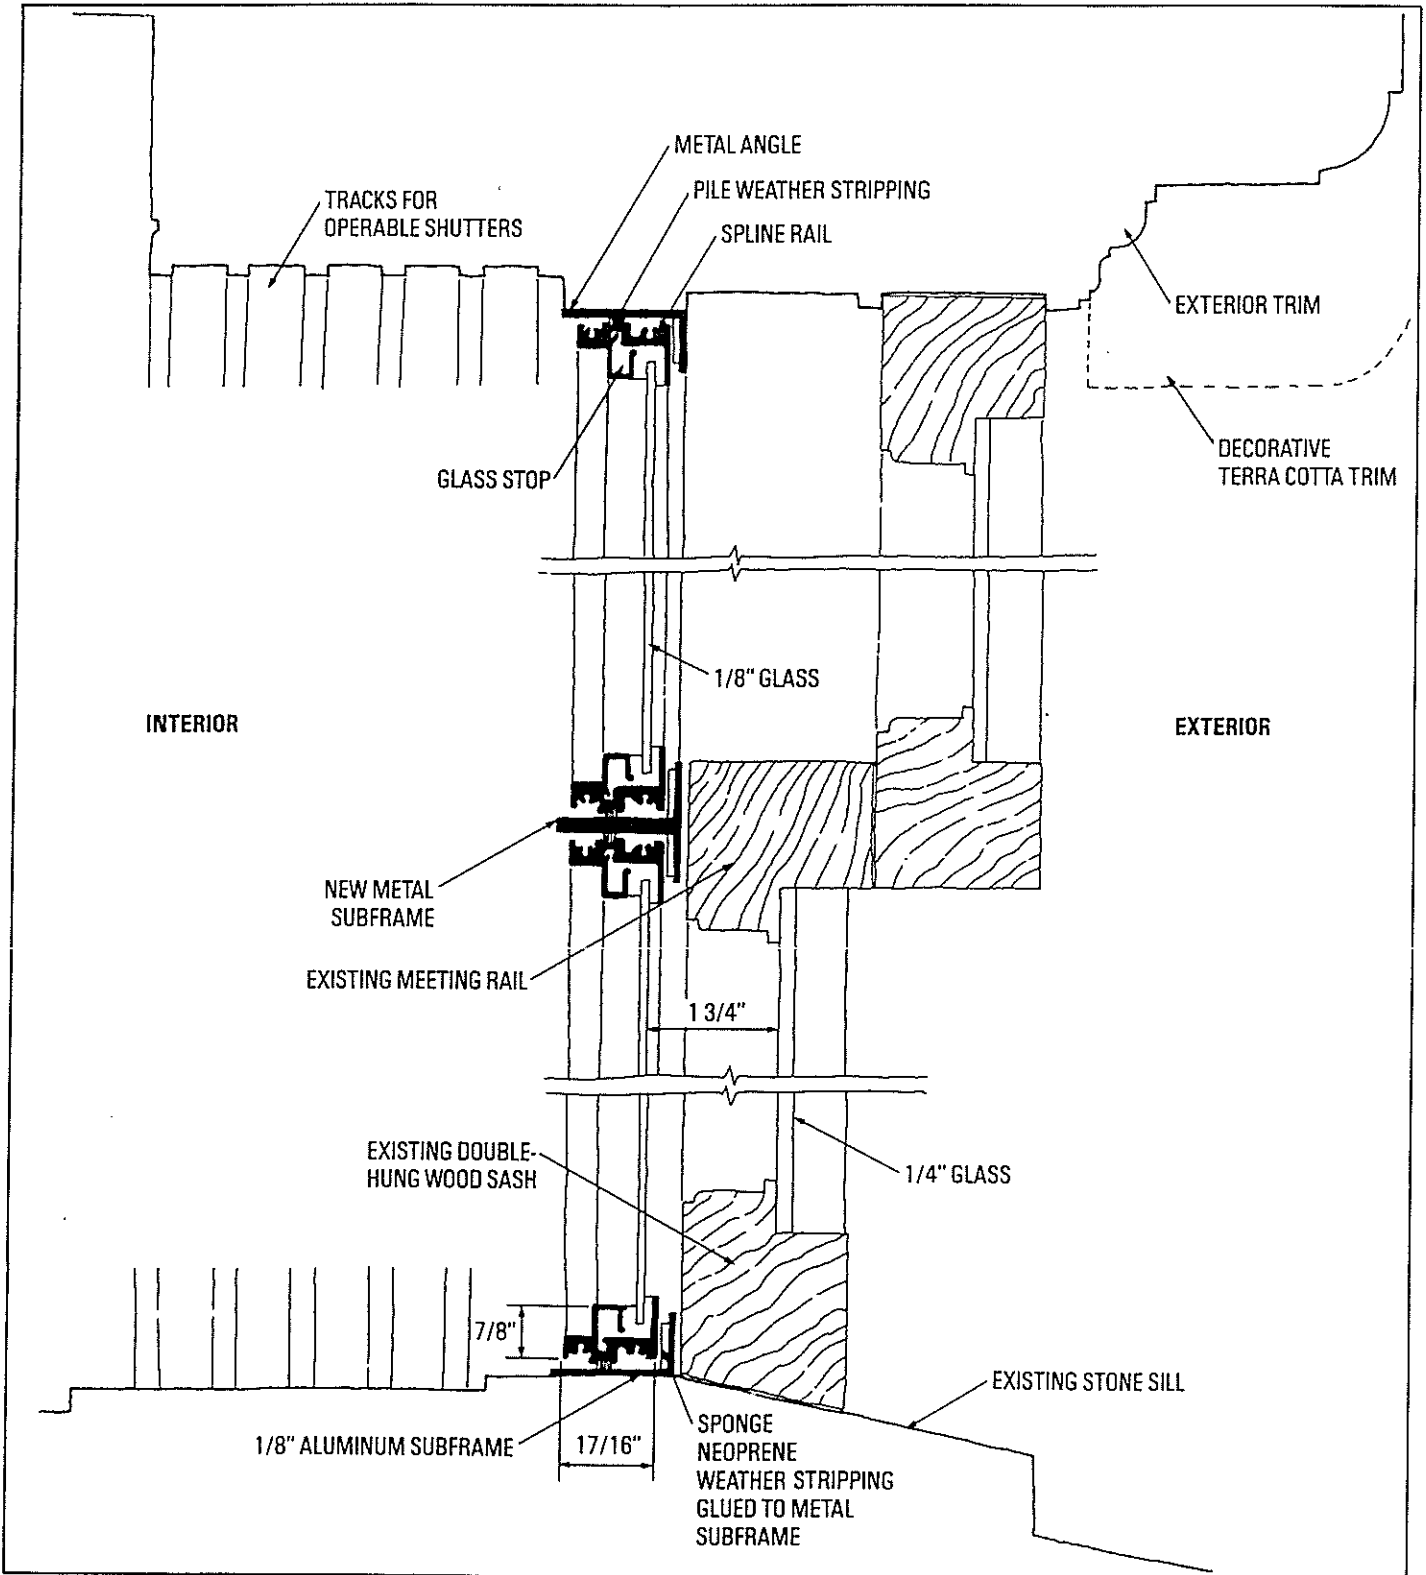
Figure 4. Section showing the new interior metal storm window set behind the historic wood sash. Drawing: Martha L. Werenfels

In searching for an interior storm window that met both the functional requirements and the concerns about visual qualities, the architect chose a commercially available metal storm window system. The storm window was designed to fit within the existing wooden jamb, thus resulting in minimal damage to historic material (*see figure 4*).

Mounted on pivot pins, the storm window relied on the pile weather stripping which ran continuously along the edge of the frame to serve as the seal between the metal subframe and the metal storm (see figure 4). Neoprene weather stripping was also added to the surface of the subframe to serve as a compression seal with the storm frame. Clear silicone caulk between the wood jamb and the subframe completed the seal.

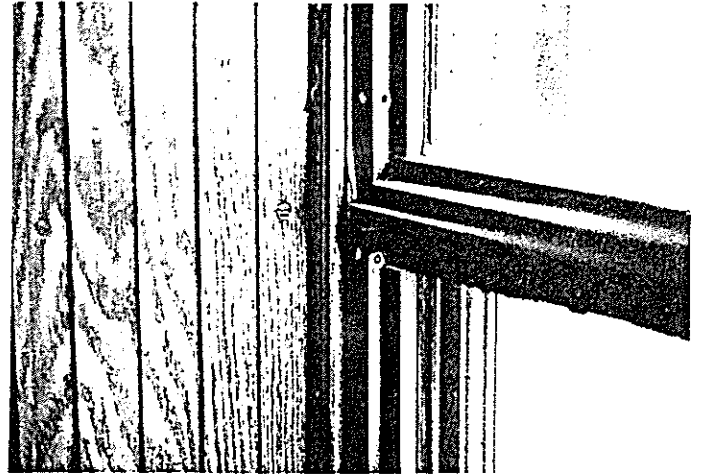
Figure 7. Continued use of the unique shutter system required that the frame of the interior storm window be narrow. The storm windows are set between the shutters and the historic sash. Photo: Charles E. Fisher

vided a sufficiently wide dead air space for energy conservation purposes, yet still allowed the interior shutters to remain operable (see figure 7).

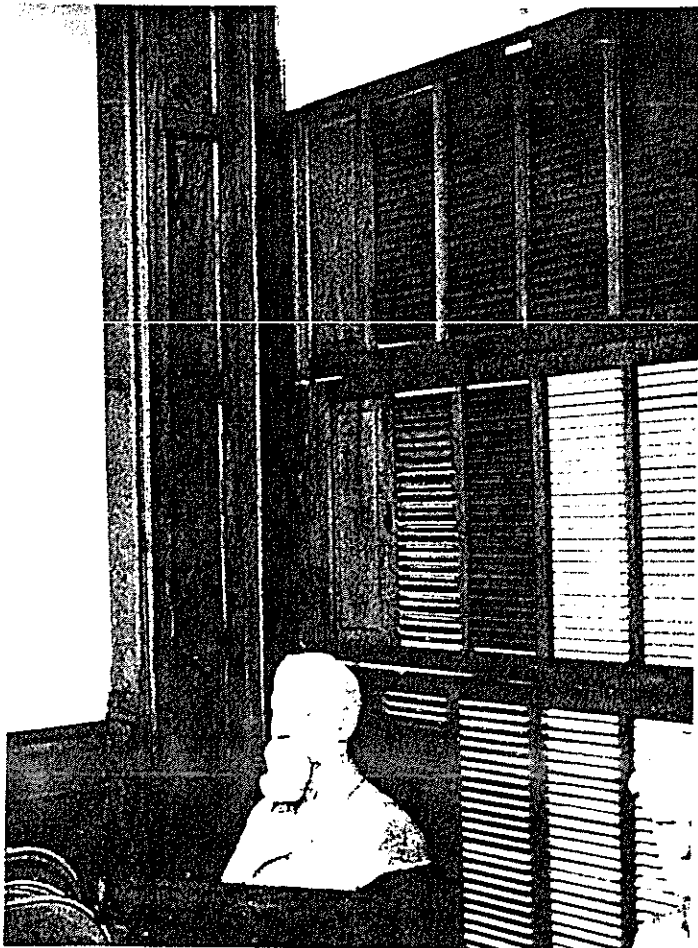
Figure 6. The windows were too large for only a single storm panel, necessitating the use of a structural subframe at the mid-section of the window. Both the upper and lower storm panels are operable and come together opposite the historic meeting rail. This element of the storm window is sufficiently thin that is not readily discernible from the outside. Photo: Charles E. Fisher

The subframe consisted of a $\frac{1}{8}$ " thick metal angle screwed to the wood jamb, serving as support and as a stop for the storm sash. On the large windows, the metal angle was paired to form a horizontal muntin, in line with the historic meeting rail, to accommodate an upper and lower storm panel, both of which pivoted (see figure 6). The frames were mounted in a location that pro-
