Tech Notes

LAWRENCE-WENTWORTH HOUSE

NUMBER 6

Replacement Wooden Sash and Frames With Insulating Glass and Integral Muntins

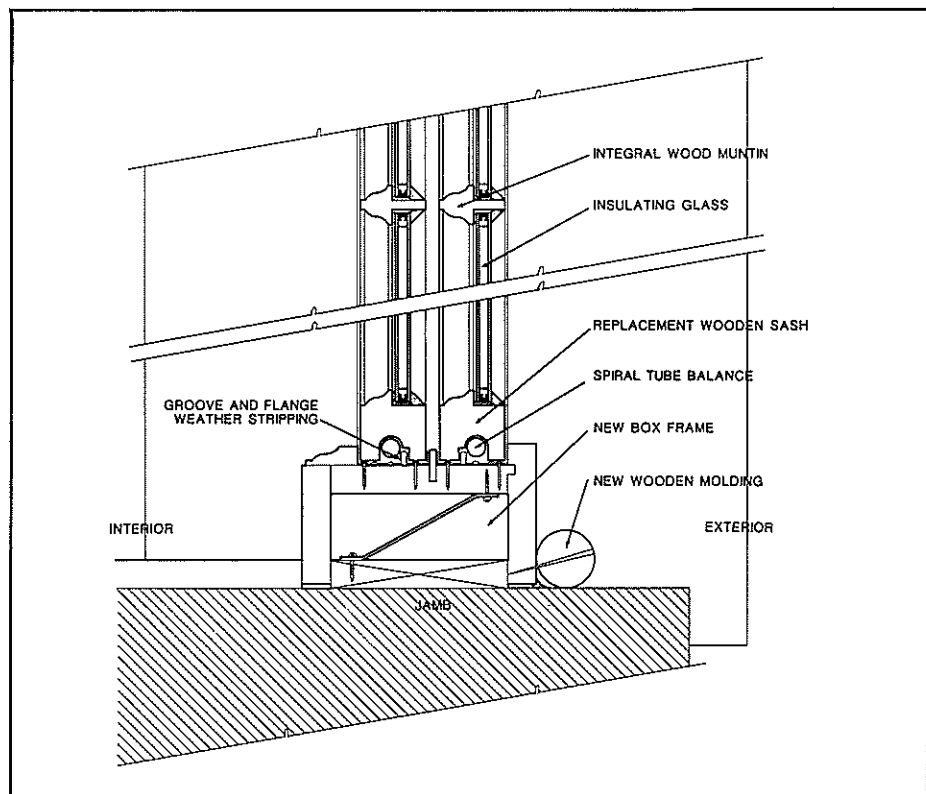
The selected replacement sash were designed to have two individual lights of insulating glass in each sash with an integral (as opposed to a "fake" or applied) muntin. Based on the experience gained by the Lowell Historic Preservation Commission in previous projects, the muntin of the new sash was made only 1" wide, closely matching the appearance of the historic $\frac{3}{4}$ " wide vertical muntins remaining in the upper floor windows (see figure 1). This slight change in muntin width is hardly noticeable. The results might have been different if the old and new sash had existed side by side; if the number of panes had been greater and the panes themselves been smaller; or if the historic muntins had been thinner.

Figure 1. The wooden replacement windows had two individual lights of insulating glass in each sash with an integral (as opposed to "fake") muntin. Drawing: Penelope S. Watson

The historic windows in the Lawrence-Wentworth House were balanced in standard fashion with sash weights and pulleys. Since many were missing on the first floor, less costly spiral tube balances were specified for the new windows (see figure 1). The spiral tube balances were attached at their top to the face of the jamb near the top of the window. The longer balance tube for the lower sash, therefore, is visible above the closed lower sash inside the building, just as the sash cord is exposed on a weight balanced sash. The tube balances, however, are not seen from the exterior and their use permitted a more energy efficient window frame. The empty boxes, which would have held the sash weights, were filled with insulation; air infiltration was further reduced since there were no pulley mortises in the frame.

The spiral balances also allowed the use of a less expensive L-shaped, shop-fabricated frame, and the look of the historic box frame was accomplished with masonry-anchored nailers, steel framing clips, and flat interior casing stock (see figure 1).

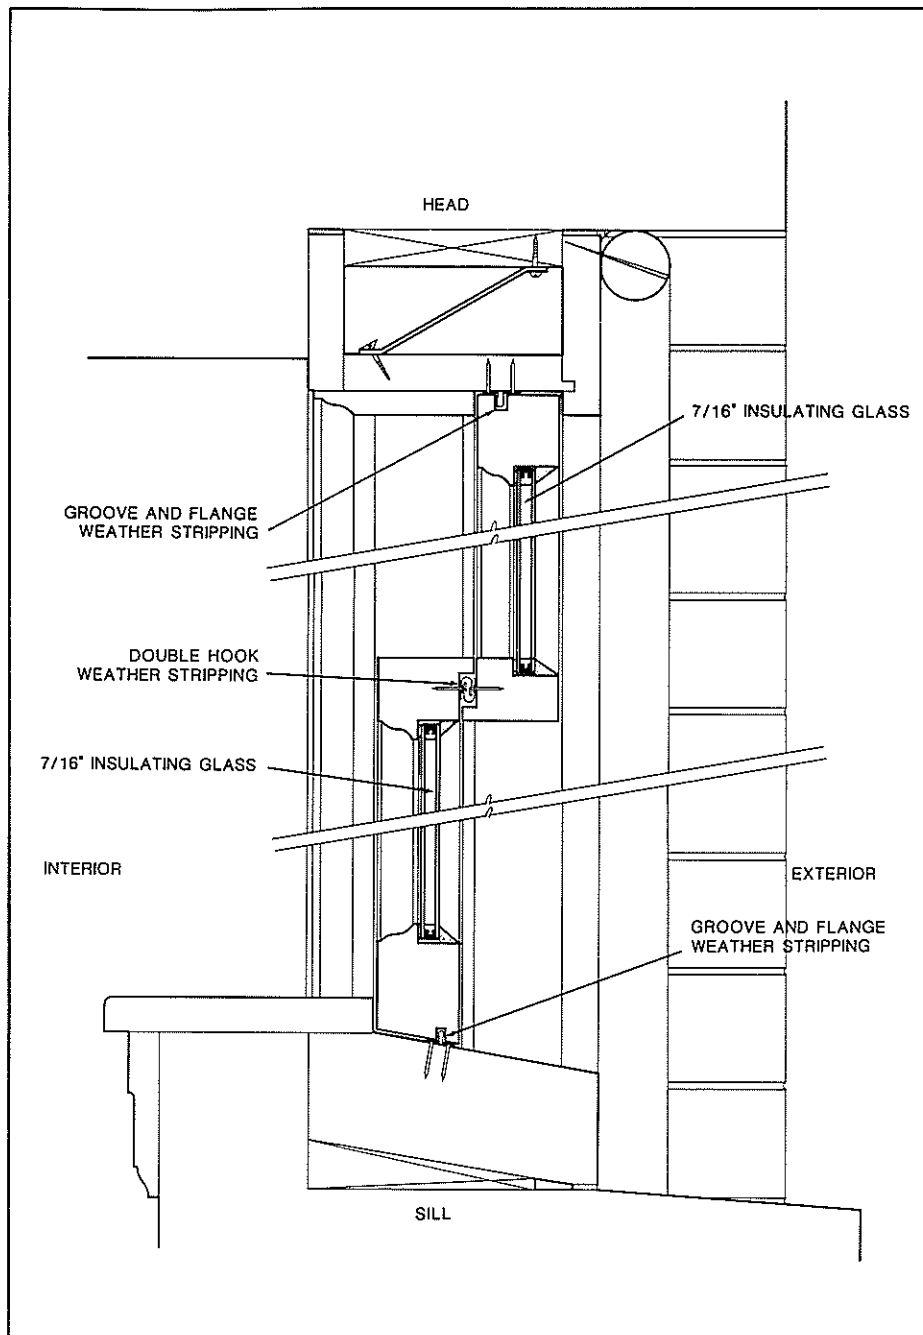
from rolled zinc sheets, were installed in preference to a less permanent vinyl, foamed plastic, or spring-metal weather stripping. At the heads, jambs and sills, the weather stripping consists of a continuous flange over which fit the grooved rails and stiles. At the meeting rail, the weather stripping consists of two interlocking hooks (see figure 2). The weather stripping protrudes only a short distance above and below the meeting rails along the jambs and is almost totally concealed when the windows are shut. It is extremely durable and is virtually unaffected by corrosion or chemical decomposition.

Figure 2. Several types of zinc weather stripping were used. Drawing: Penelope S. Watson

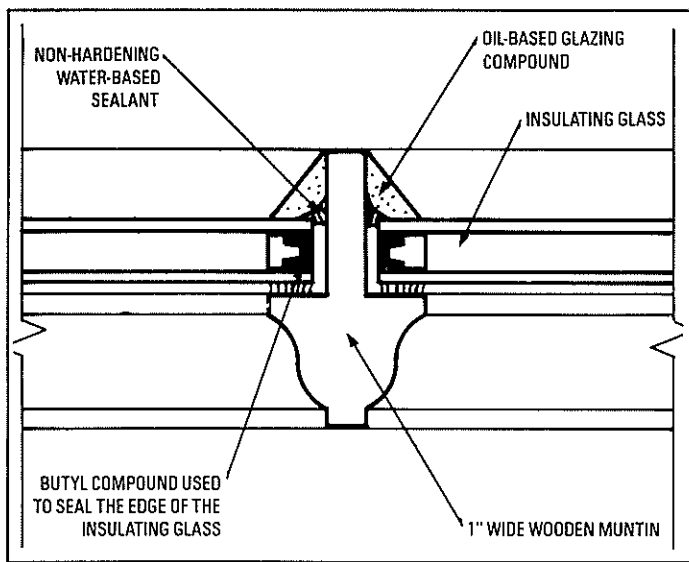
The sealed insulating glass units, installed in the fabricator's shop, were first caulked with a thin bead of non-hardening water-based (containing no oil) sealant. The sealant was applied at the corner of the glass unit so as not to touch the butyl compound used to seal the edge of the insulating glass (see figure 3). The water-based sealant serves as an important barrier between the separate butyl-seal on the insulating glass and the standard oil-based glazing compound as used in the actual glazing. The oil-based glazing compound was chosen in preference to the standard wood molding strips to provide a cheaper, more flexible and more weather-resistant

Figure 3. Glazing detail shows how the non-hardening water-based glazing sealant was used to separate the butyl compound (used to seal the insulating glass) from the oil-based glazing compound. Drawing: Penelope S. Watson

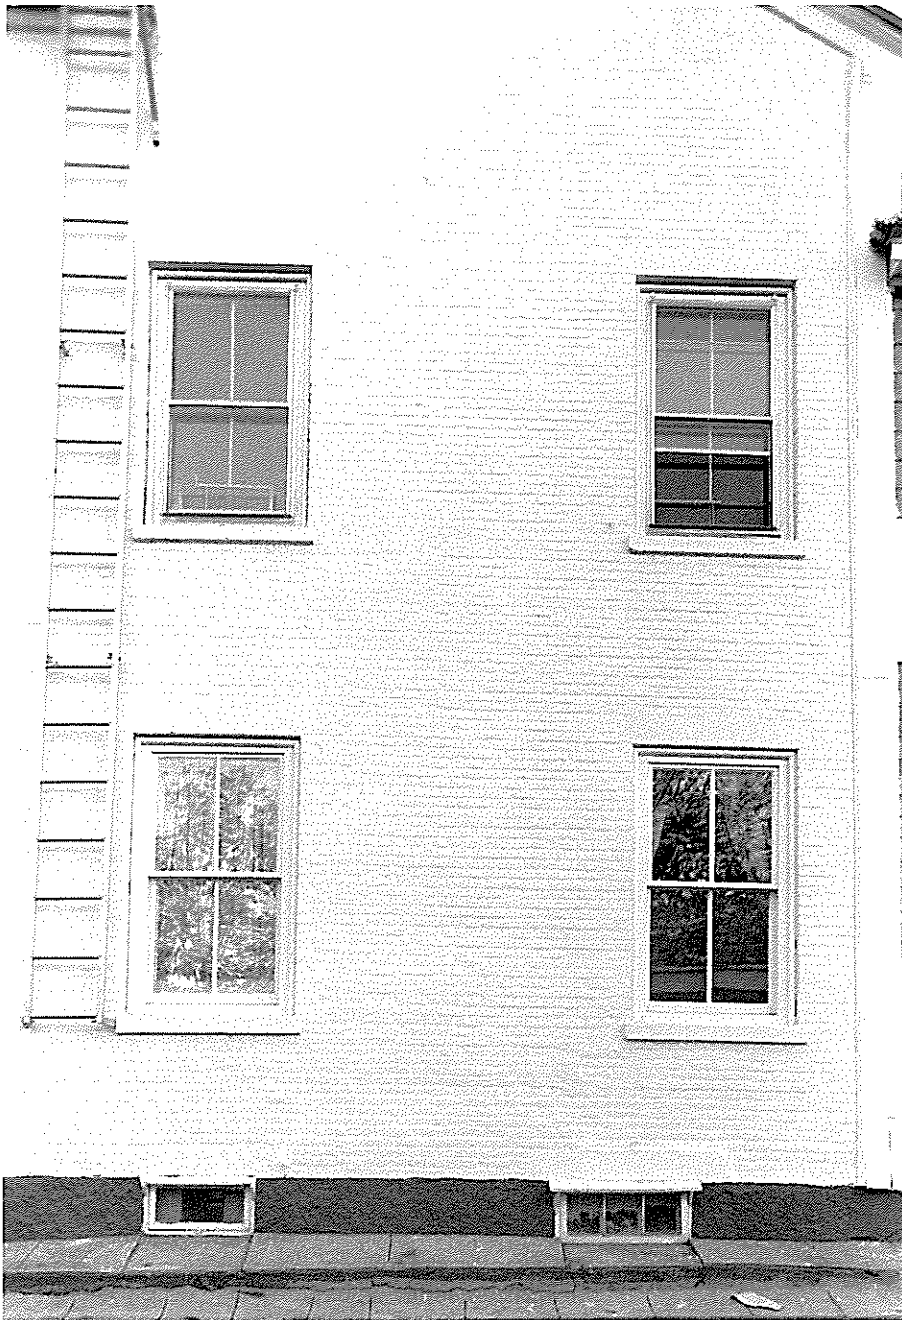
The new wooden frame was thus identical in appearance to the historic frame on the building. The width of the historic frame was reproduced along with the wooden brick molding used to trim the exterior of the masonry openings (see figure 4).

Figure 4. The new wooden windows on the first floor with insulating glass installed closely matched the historic windows which were preserved on the upper floor. Photo: Charles Parrott
