# Tech Notes

## WINDOWS

### Thermal Retrofit of Historic Wooden Sash Using Interior Piggyback Storm Panels

#### COLCORD BUILDING

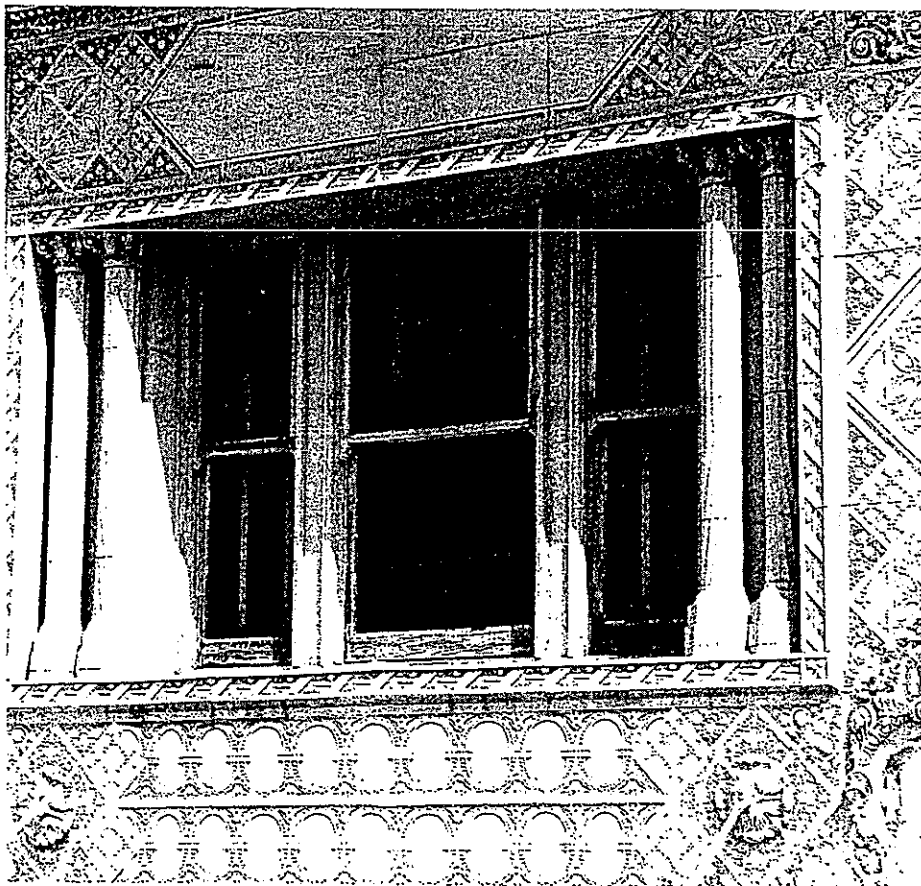
The Colcord Building, constructed in 1910, is one of the few remaining historic office buildings in downtown Oklahoma City. Designed by William A. Wells, the 12 story concrete structure is elaborately decorated with ornamental terra-cotta panels at the first, second and twelfth floors. The bold scale and setbacks of the wooden windows surrounded by terra-cotta are significant design features of this National Register property (see figure 1).

Figure 1. Deeply recessed windows with ornamental terra-cotta surrounds were character-defining features of the building which the owner wanted to retain. Photo: Jack Graves, AIA

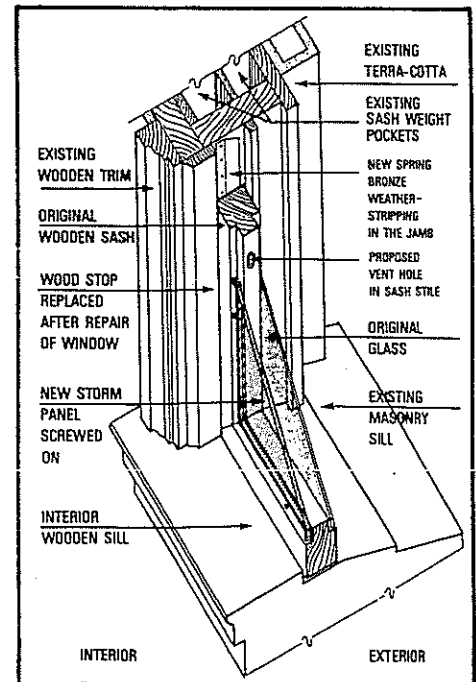
This approach would necessitate routing or cutting out a portion of the historic wooden sash and would add to the weight of the sash due to the attached storm panel. The sash rails and stiles measured 1-7/8" deep by 2" wide and were in sound condition. They were therefore capable of tolerating the required cut—3/8" deep by 1/2" wide. The issue of the additional weight of the storm panels was directly related to the choice of materials selected for the piggyback units. Since acrylics are purported to be 40% lighter than glass and 15% more thermally efficient for the same thickness, the architect investigated their use. Because of expense and the tendency of acrylic to bow or discolor due to sun

Figure 2. Cutaway view of the proposed retrofit solution showing how the historic sash would receive a recessed storm panel through routing or cutting an inside rabbet. Drawing: Sharon C. Park, AIA

While researching new window units, the architect found a commercially available wooden replacement window that incorporated a removable storm panel piggybacked onto the single glazed sash. This second layer of glazing was recessed on the inside of the primary wooden sash, allowing the double-hung window to operate without interference from the applied panel. The architect applied this concept to the Colcord Building's windows and proposed to retrofit a recessed storm panel to each existing sash, provided it would not structurally weaken the sash in the process (see figure 2).

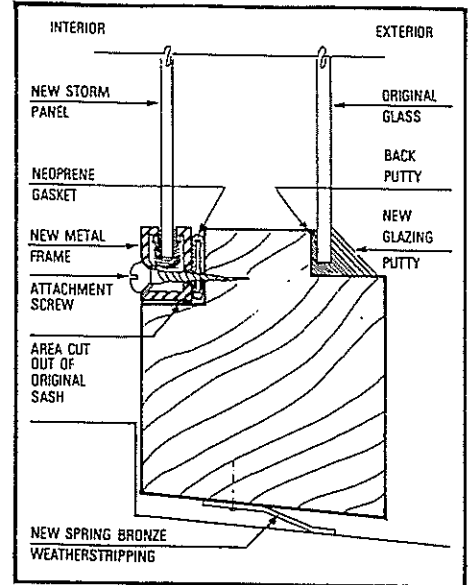
Figure 3. The completed retrofit shows the storm panel screwed onto the historic window. Photo: Tamara Coombs

As the panels would only be removed for maintenance purposes, the architect determined that the panels simply could be screwed in place, using a neoprene gasket set on the back side of the panel as a seal (see figure 3). Should the panels ever need to be removed, an electric screw gun would do the job quickly (see figure 4).

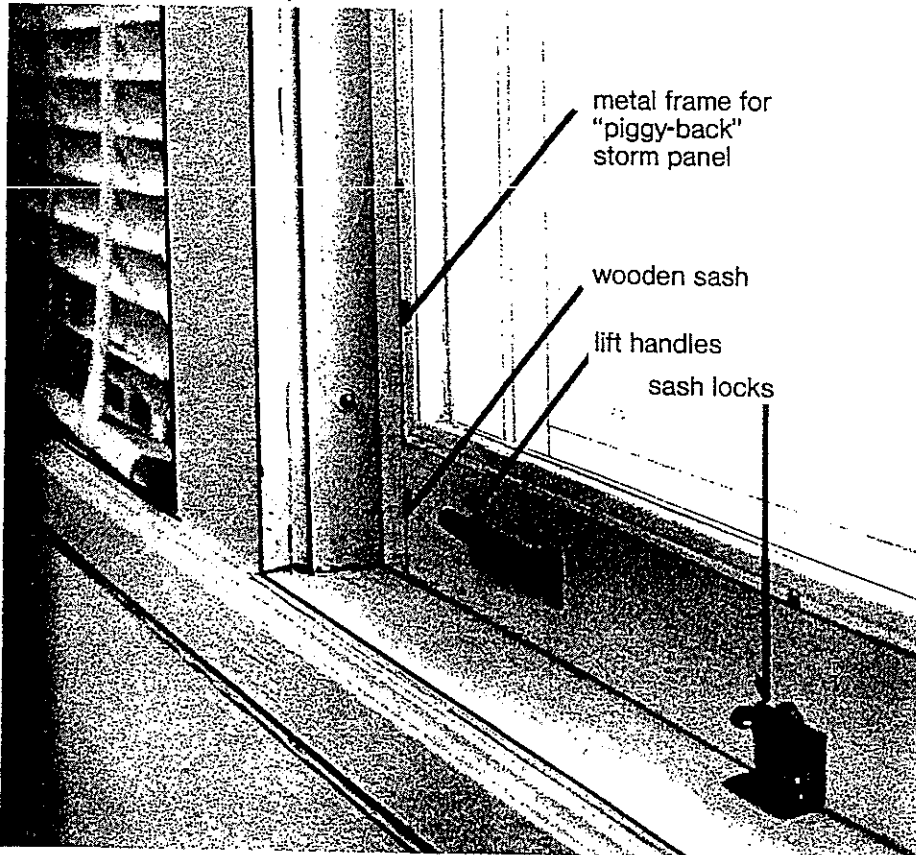
Figure 4. The applied interior storm panel was screwed in place. Note the use of the neoprene gasket, which provides an air seal between the storm panel and the historic wooden window. Drawing: Sharon C. Park, AIA
