## COLONIAL WILLIAMSBURG

# Tech Notes

NUMBER 9

### Interior Storm Windows: Magnetic Seal

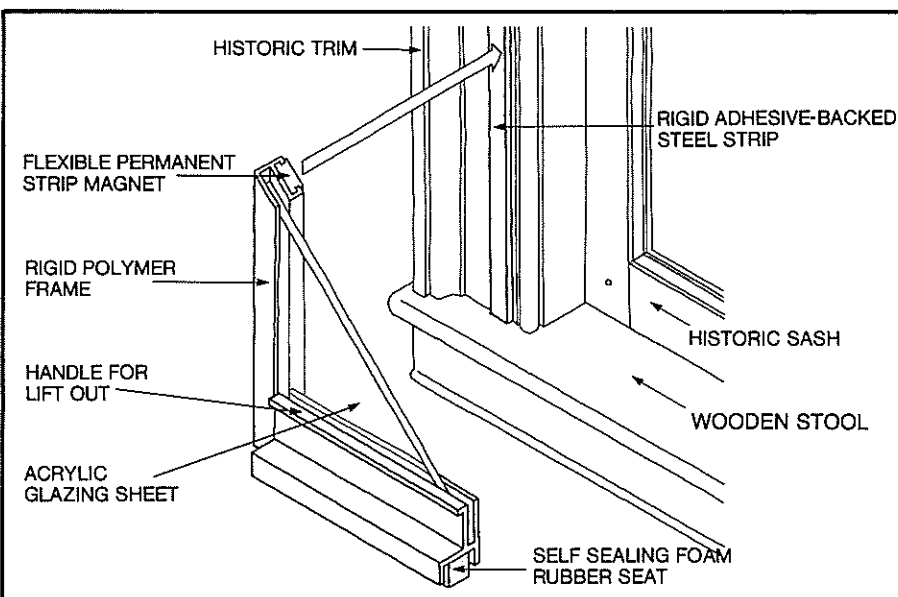
Figure 1. The interior storm window system chosen consisted of a clear acrylic glazing sheet set into a polymer frame that adhered to the existing window trim through use of a magnetic seal. Drawing: Christina Henry.

A slightly different polymer frame configuration was used for the bottom of the storm window in cases where a window stool existed. The sill framing was attached to the acrylic sheet like the typical polymer frame, with the exception that the bottom was extruded with a 1/4" U-channel that had a latex gasket glued in place to form a tight seal (see figure 1).

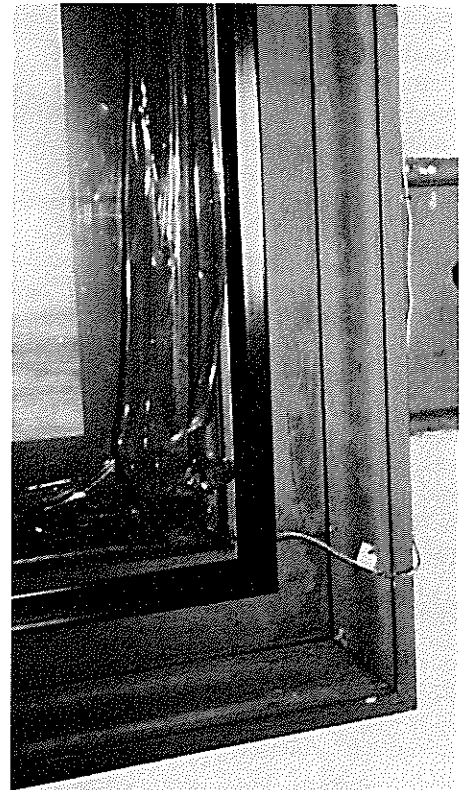
Most of the historic windows at Colonial Williamsburg had been trimmed with a stool so that a magnetic seal was obtained only on three sides of the polymer frame (see figure 2). A small metal angle frame or wood stop could have been added to the stool to permit a magnetic seal on the fourth side but such alterations were avoided.

Figure 2. The thin-framed storm unit is shown attached by a magnetic seal to the existing trim. The protective film on the acrylic will later be removed. Photo: Tom H. Taylor.

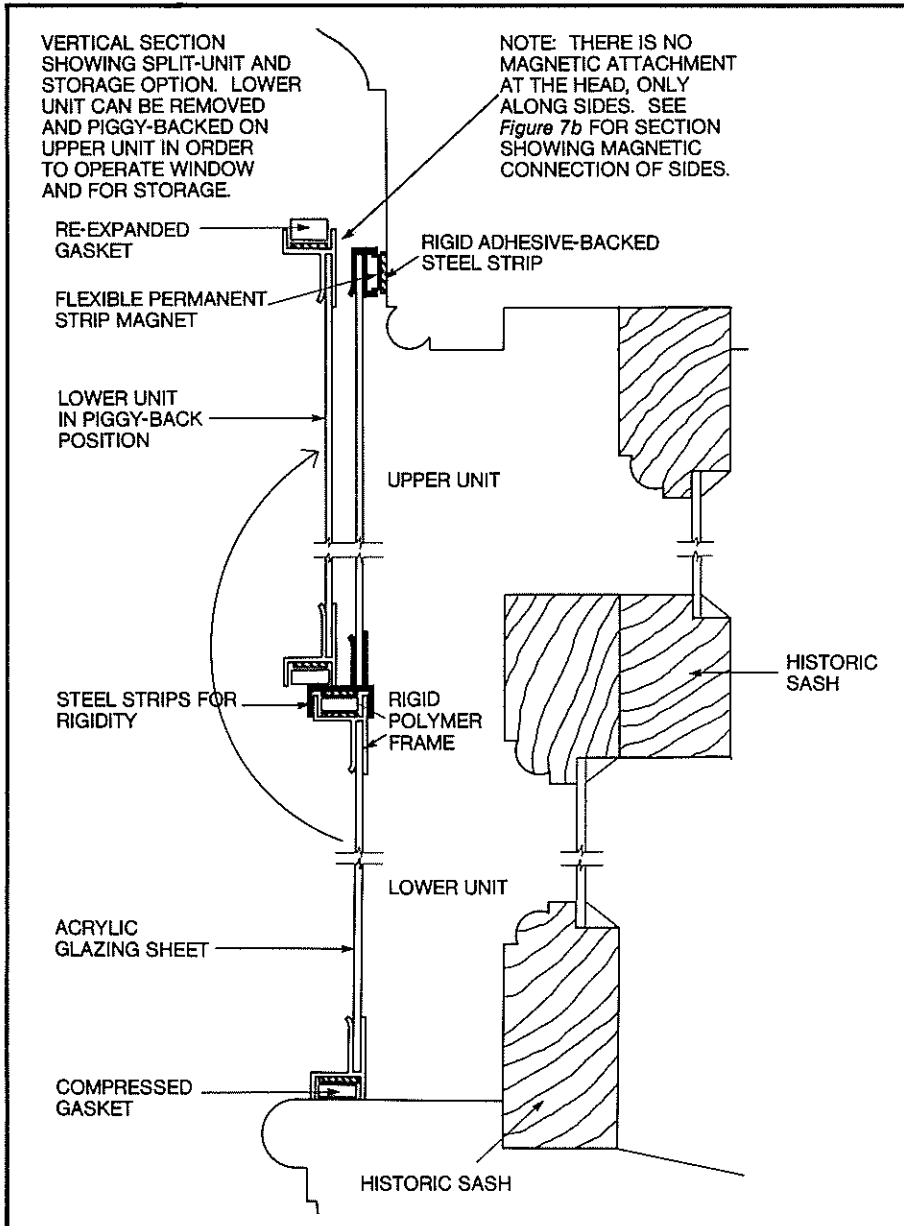
The storm window design most commonly used at Colonial Williamsburg consisted of a separate upper and lower part with an interconnecting meeting bar. This style was used in windows where the original double-hung sash needed to remain operable. A split-unit interior storm window has an advantage over a single unit in that it did not need to be removed and stored in the summer months. By attaching the lower unit to the upper unit via a magnetic seal, the storm window could be left in place, thereby avoiding problems of storage and reducing the chances of the acrylic sheets being scratched or warped (see figure 3).

Figure 3. Vertical section showing a split unit in place and the option of piggybacking the lower unit onto the upper for storage during the summer. See figure 6 for detail on the manner of attaching the piggybacked unit. Drawing: Christina Henry.

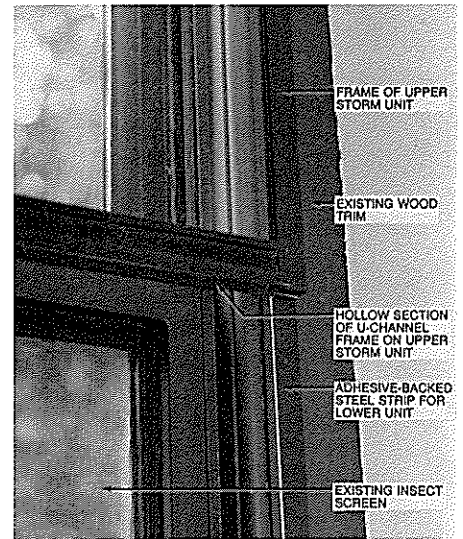
Figure 4. This view shows only the upper unit in place. The U-channel along the bottom of this unit was designed to fit over a similar U-channel at the top of the lower unit. With the lower unit removed in summer as shown, only the adhesive-backed steel strip is visible. Photo: Tom H. Taylor.

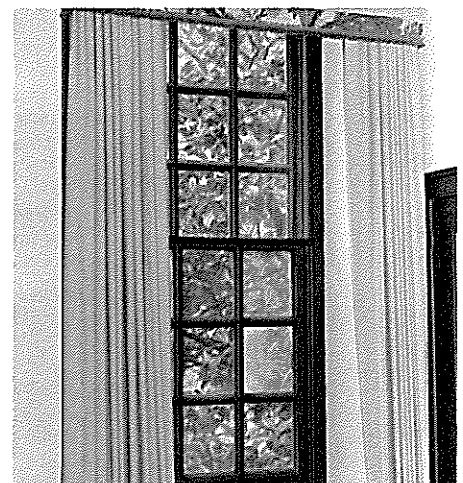
The placement of this meeting bar primarily depended on its visual impact on the outside. Where the historic upper and lower sash were the same size, the meeting bar of the interior storm was lined up as closely as possible behind the meeting rail of the historic sash (see figure 5). In a number of windows, however, the pane configuration made it harder to disguise the appearance of the interior storm meeting bar from the outside. These windows had 6 panes over 9, the bottom sash being considerably larger. In such cases, it was specified that the bottom of the top storm unit would stop at the first horizontal muntin below the meeting rail on the historic sash.

Figure 5. The meeting bar of the split storm unit shown in place was located adjacent to the historic meeting rail in windows where the upper and lower sash were the same size. Photo: Tom H. Taylor.

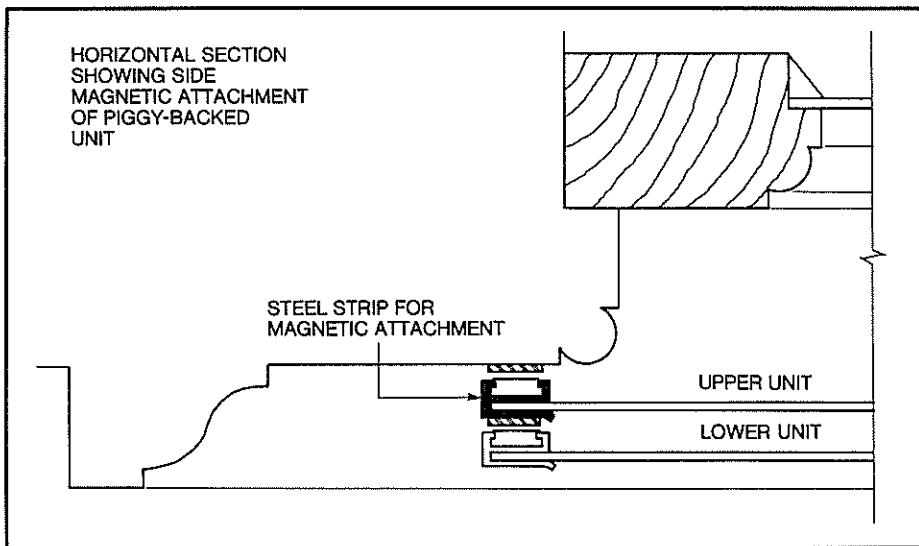
To allow for the storage of the lower unit, an adhesive-backed steel strip was attached to the face of the vertical polymer frame on the upper unit. Thus the two vertical framing members in the upper unit had a magnet on one side and a steel strip on the other. The addition of the metal strip allowed the lower unit to be magnetically attached to the steel on the upper unit when in a storage position (see figure 6).

Figure 6. Horizontal section of the upper storm unit shows how with an additional adhesive backed steel strip added to the sides of the upper storm frame it was possible to piggyback the lower storm unit for storage purposes during the summer.

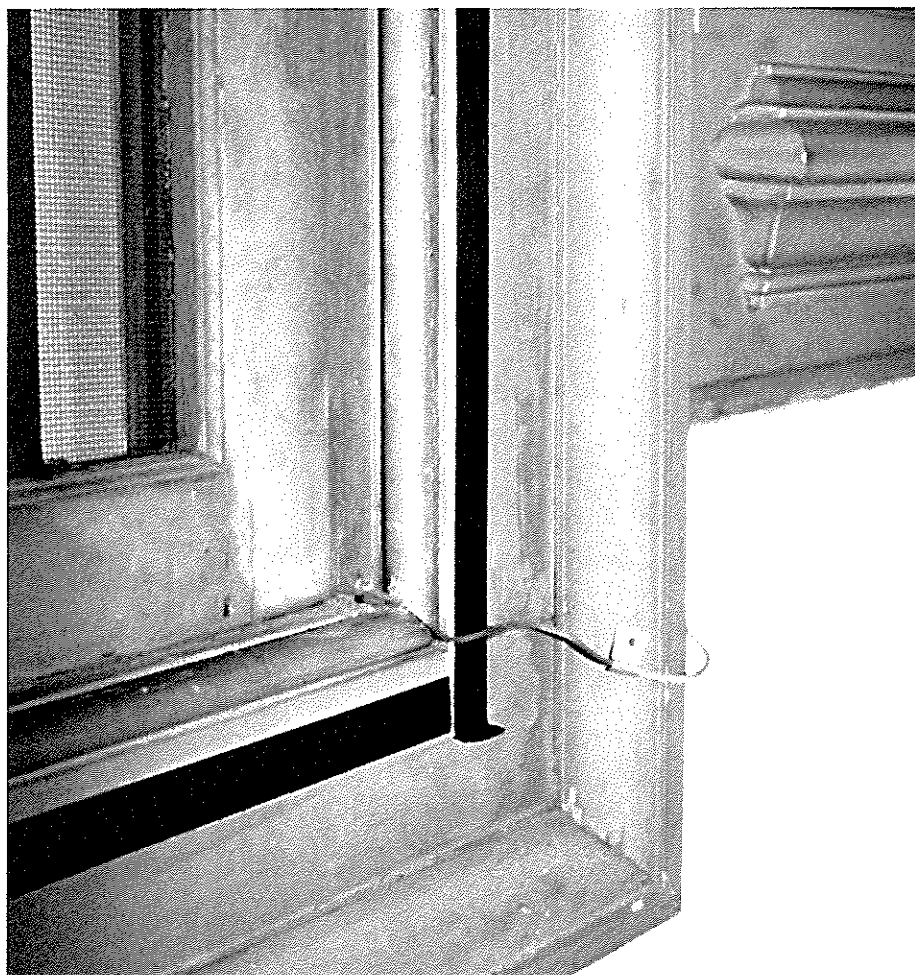
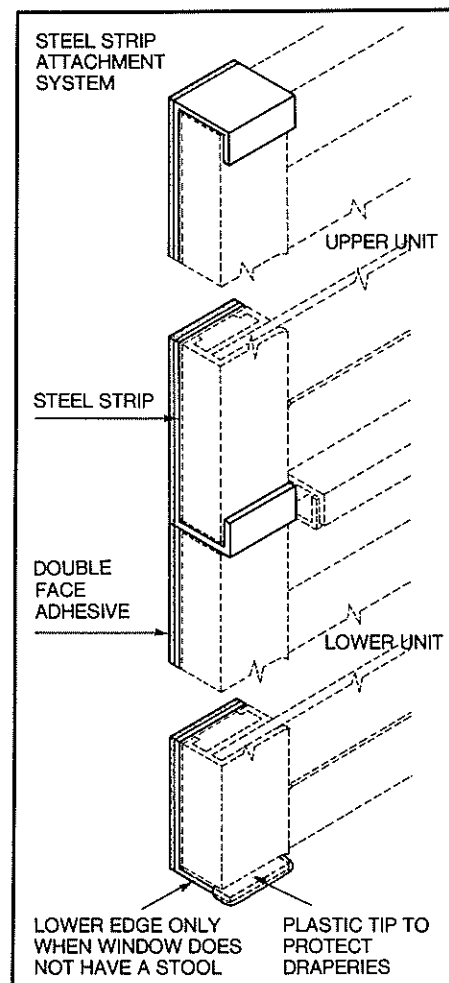
To keep the upper unit from creeping downward due to the additional weight of the piggybacked lower storm, a  $\frac{3}{8}$ " shelf with a  $\frac{3}{16}$ " upward turn was formed in the two wood-adhering vertical steel strips at a point aligning with the bottom of the upper unit (see figure 7).

A similar feature was added at the bottom of both single and split units when no stool existed in the historic window. To deter possible creeping and, as a safety measure, the bottom of the vertical steel strip was turned 90 degrees outward to act as a small shelf for the storm window. A small plastic tip was attached to the sharp edge of this shelf to protect draperies.

Figure 7. (a) In cases where there were no stools and also where a split unit was used to facilitate self-storage, small "shelves" were made in the vertical steel strips to deter creeping. Photograph shows a 90 degree angle at the bottom of the vertical steel strip in a situation where there was no stool. Photo: Tom H. Taylor. (b) The adjacent drawing shows the two "shelves" used with split units as well as a top safety catch formed at the end of the steel strip.

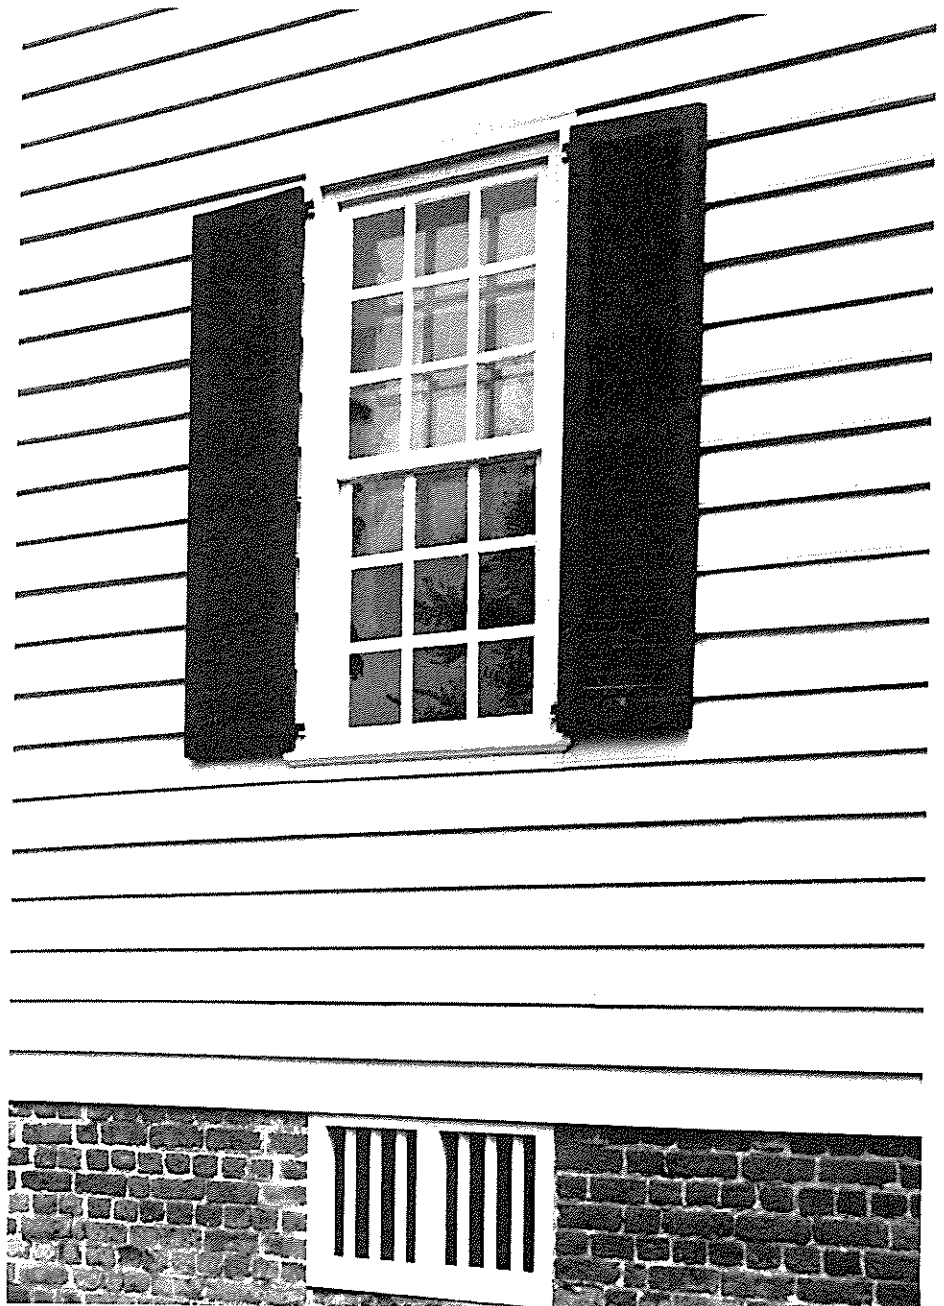
The unobtrusive nature of these storm windows is an advantageous feature, along with the fact that no physical damage or alteration to the original window is required (*see figure 8*).

Figure 8. The unobtrusive interior storm window required no physical damage or exterior visual alteration to the original window. Photo: Tom H. Taylor.
