Tech Notes

WINDOWS NUMBER 11

Installing Insulating Glass In Existing Wooden Sash Incorporating the Historic Glass

DELAWARE BUILDING Chicago, Illinois

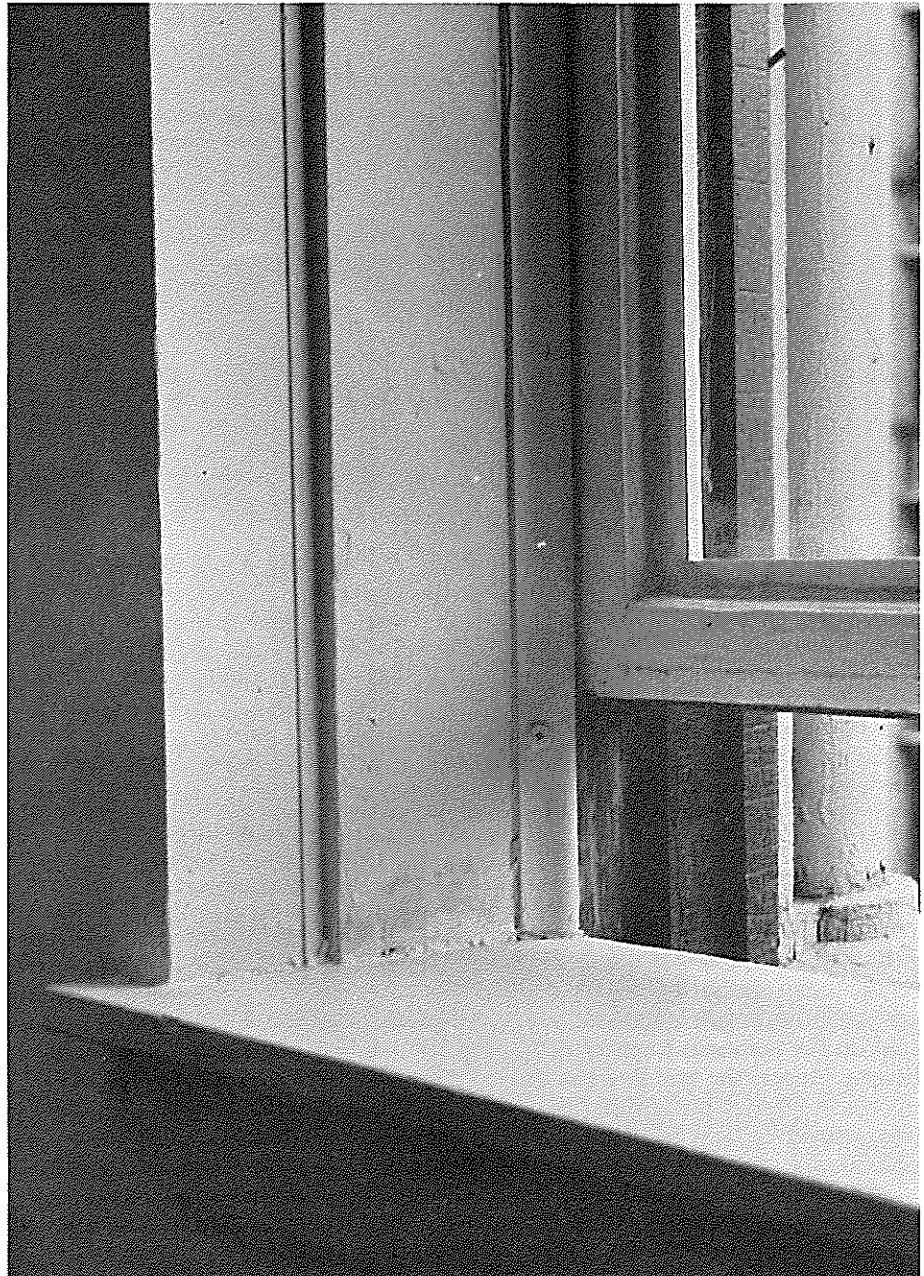
Figure 1. Since the metal spacer placed between the glass sheets is set slightly off the edges of the rails and stiles, the retrofitted insulating unit reduces the historic glass exposure by about 1/2" along all sides. This change on large windows is hardly noticeable particularly once the flat trim piece is glued in place. Photo: Charles E. Fisher.

The technique used for double glazing the windows, incorporating the existing glass, was developed in Europe and in use there since the mid 1970s. This technique uses only one additional sheet of glass, placed off the inside edges of the rails and stiles, to create a sealed insulating unit. Since the metal spacer placed between the glass sheets is set slightly off the edges of the rails and stiles, the retrofitted insulating unit reduces the historic glass exposure by about 1/2" along all sides. This tends to limit the applicability of this technique for double glazing to upper floor windows with large lights since at such distances the reduction in exposed glass area is not readily visible (see figure 1). At the third floor level and

above, the 1/2" encroachment along the edges of the glass on the large sash at the Delaware Building was determined not readily visible from the street. The architect felt that the additional expense to avoid any sight encroachment was not justified for an alternate approach entailing the routing out the 2 1/4" thick sash on the inside putty rabbet to a greater depth in order to accept an all new sealed insulating unit. Such an alternative, however, might have been appropriate had the interior moldings along the inside rail and stile been more decorative, since the added

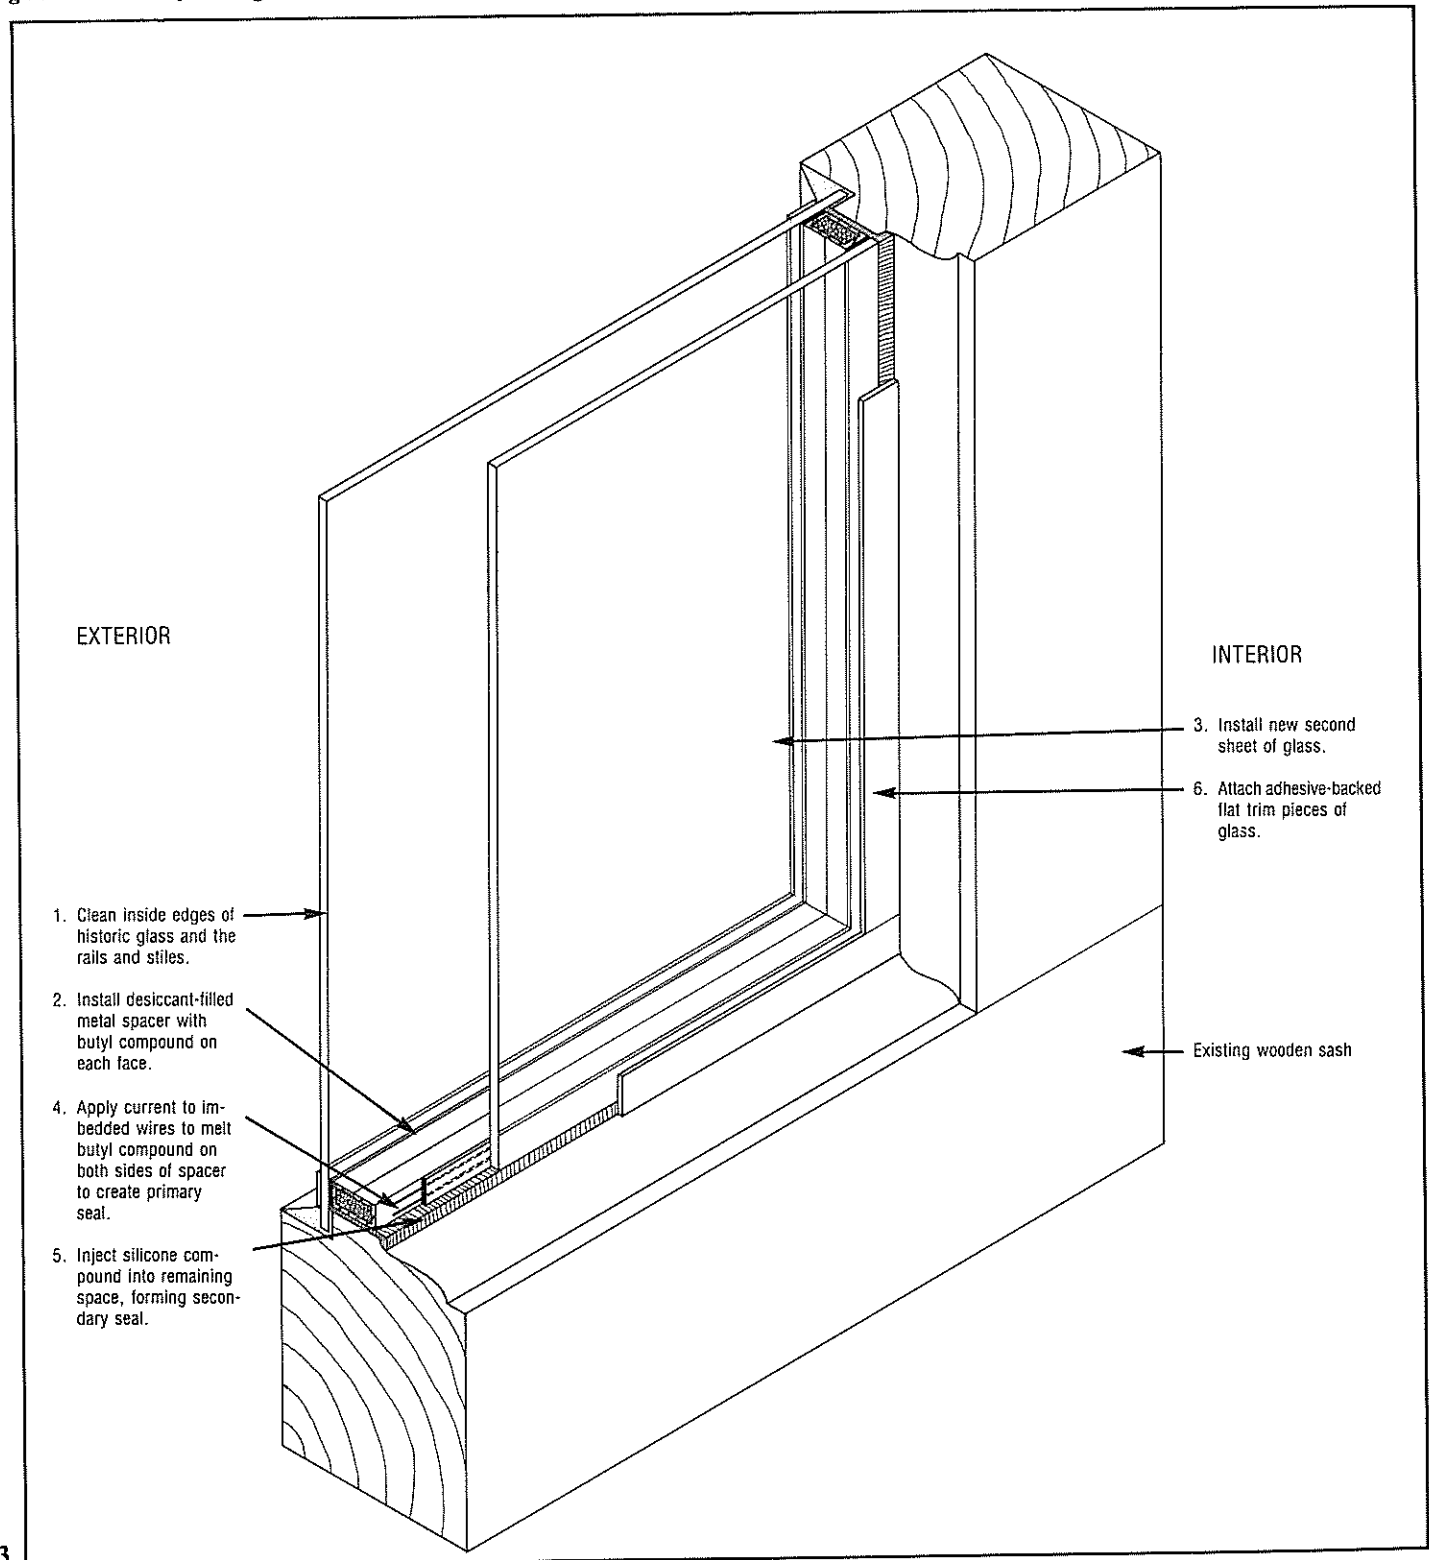
Figure 2. The isometric drawing of the window shows the manner in which the insulating glass units were created utilizing the existing glass without any damage to the wooden sash. Drawing: Christina Henry.

Then a standard hollow rectangular aluminum spacer was sized to fit the opening, filled with a desiccant to absorb any residual moisture that would be entrapped in between the glass sheets, and the corners of the spacer then were edged sealed. Both sides of the spacer that faced the glass were coated with a strip of polyisobuty-

lene. The polyisobutylene strip on the room side also had two parallel copper wires running the entire length, terminating through one corner (see figure 2). With the sash lying flat, the spacer was set snugly up against the inner surface of the existing glass, then the sheet of new glass was placed upon it. Small setting blocks

The primary seal for the insulating unit was then created by applying an electrical charge for about 5 to 10 minutes through the two copper wires. The wire-resistant heating melted the butyl compound on both sides of the spacer since the aluminum spacer easily conducted the heat generated by the wires to the polyisobutylene strip on the opposite face. As a secondary seal to retard moisture collection between the glass and help secure the new glass in the sash, a silicone compound was applied in the space between the wood frame, the old glass and the edge of the new glass and the metal spacer (see figure 2).

To complete the glazing work, a flat piece of 5/8" wide painted aluminum trim was adhered with silicone along the inside perimeter of the light as trim to cover the spacer (see figure 2). A similar trim piece, normally applied to the outside, was judged not to be necessary in this instance.

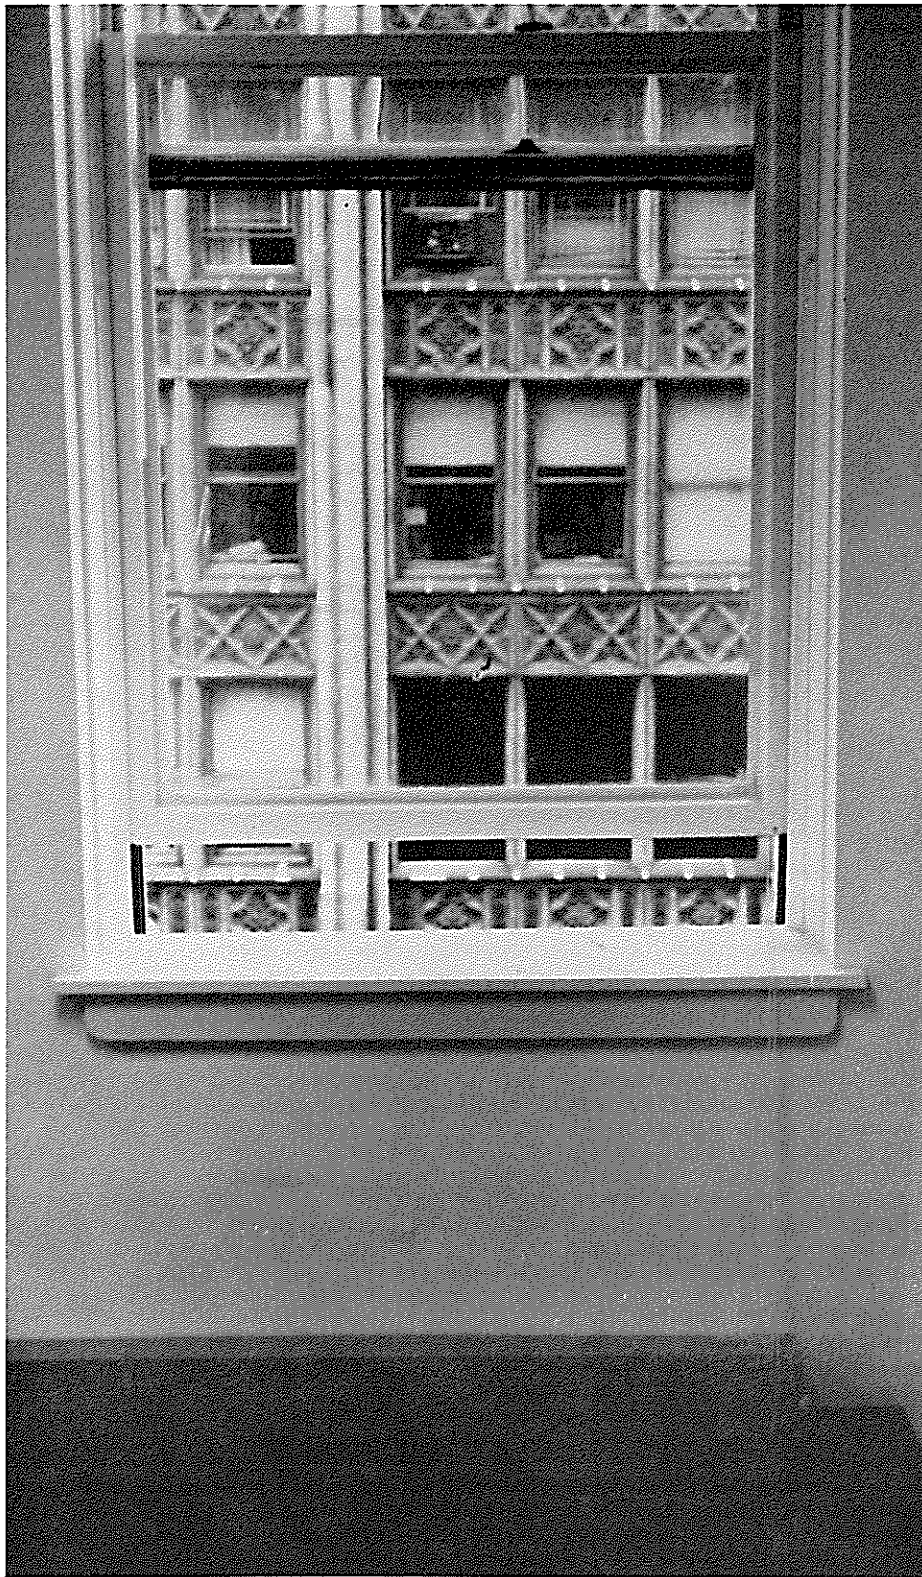
Figure 3. View of the window with the lower sash partially raised following completion of the work. Due to the large size of the sash, the small flat aluminum trim piece covering the spacer had little noticeable effect on the appearance of the windows as viewed from the typical office area. Photo: Charles E. Fisher.

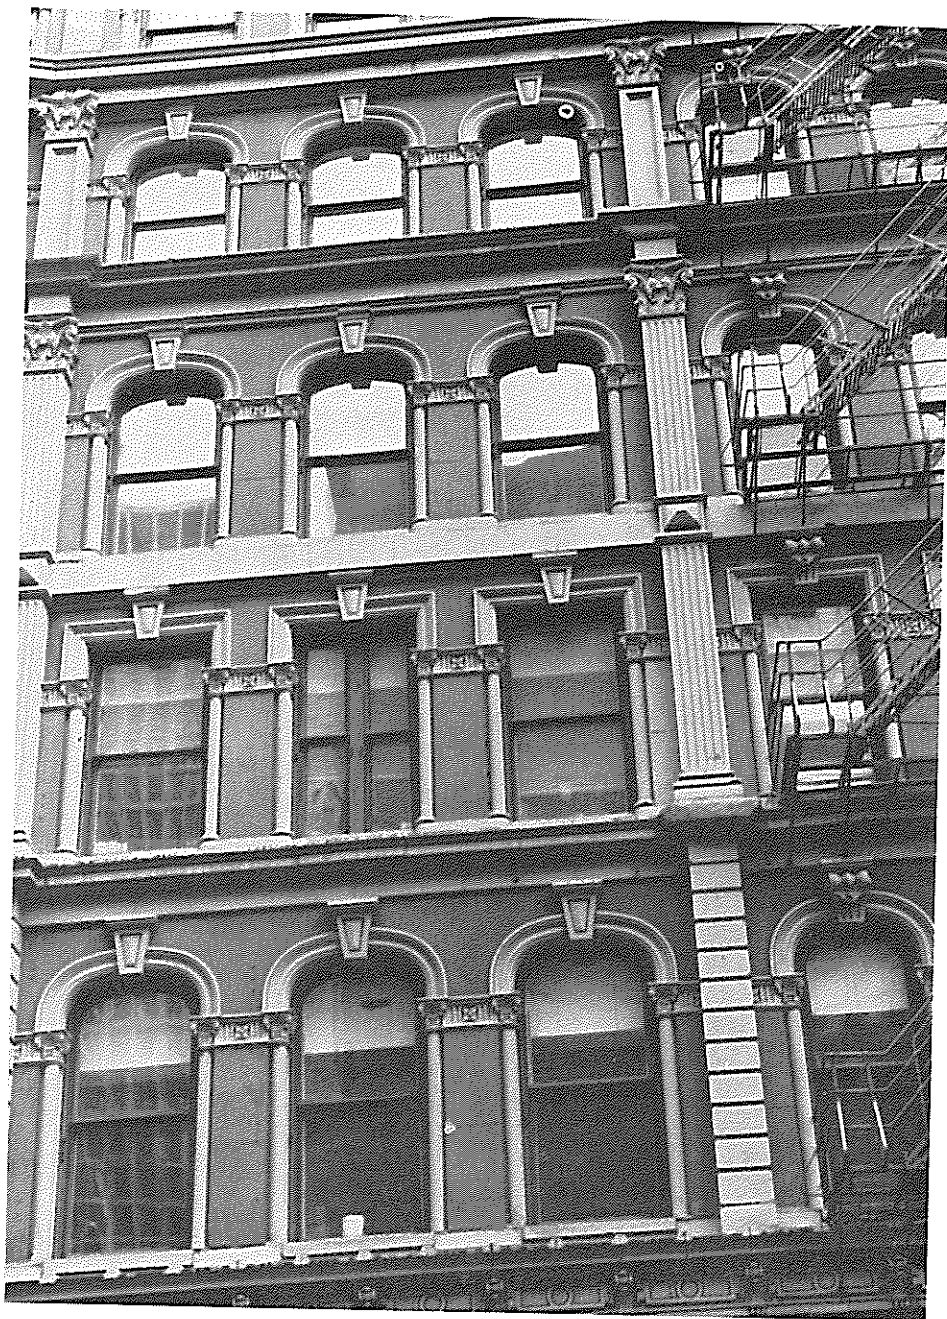
The incorporation of the existing glass into a sealed insulating unit was accomplished in the Delaware Building without any damage to the historic sash and without any loss of historic material (see figure 4). The retrofit work, which is easily reversible, has performed well since its completion in 1982.

Figure 4. View of the windows on floors 3 thru 6 shows that the technique used for creating sealed insulating glass units in the existing wooden sash had no noticeable impact on the historic appearance of the windows as seen from the street below. Photo: Charles E. Fisher.
