Tech Notes

**BUILDING 149
CONSTITUTION PARK
Boston Navy Yard
(Charlestown Navy Yard)
Boston, Massachusetts**

WINDOWS NUMBER 12

Aluminum Replacements for Steel Industrial Sash

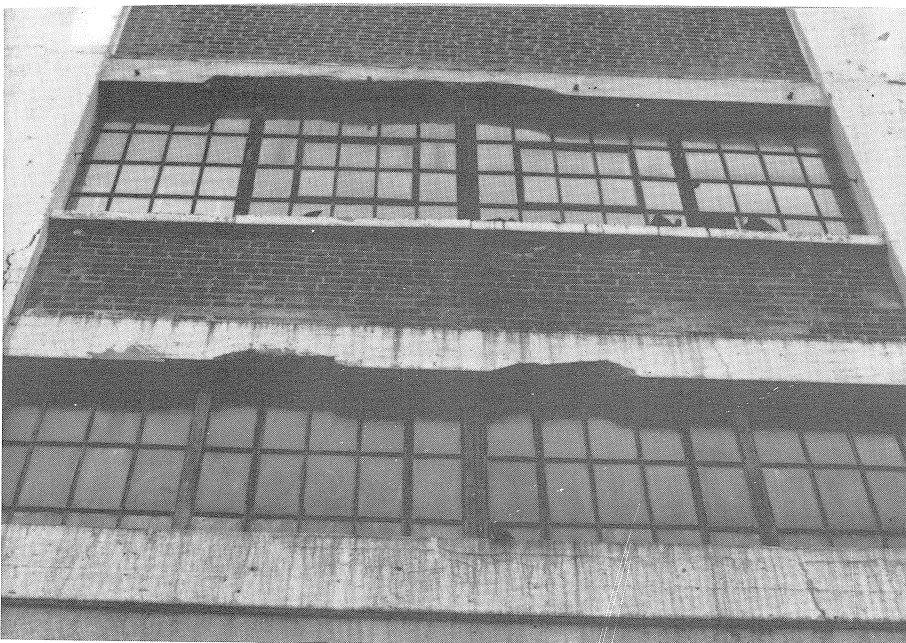
muntins with an exterior cove bead shape profile to the muntin. Most of the openings consisted of a bank of 4 side-by-side window units. Each of the middle two units consisted of 20 divided lites, including a 6-lite center hopper; the two end units were fixed and contained only 16 lites (see figure 1). Typical of pre-World War II steel windows, the glass panes had a narrower width than height. The vertical mullion connecting each unit was approximately 3" wide, noticeably dividing each opening into 4 window units.

Figure 1. Most of the openings consisted of a bank of 4 side-by-side steel window units. Each of the middle two units consisted of 20 divided lites, including a 6-lite center hopper; the two end units were fixed and contained only 16 lites.
Photo: William MacRostie

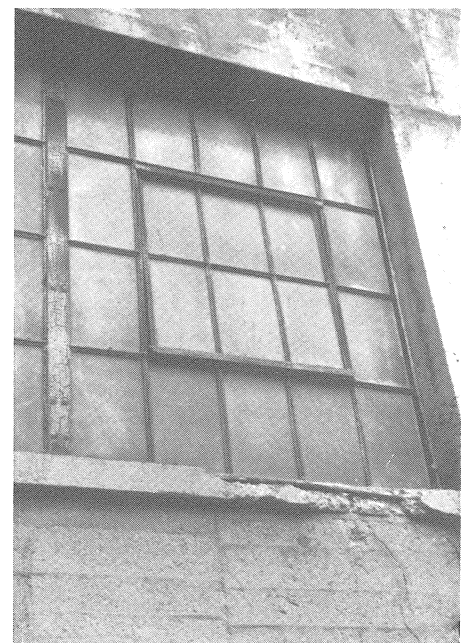
The contractor's survey of the historic windows in the spring of 1984 revealed that extensive rusting of the frames had occurred and that many were racked. The severe rusting had also contributed to the spalling of sections of the concrete sills, jambs, and spandrels (see figure 2). Repair and upgrading options to maintain the historic windows were quite limited due to the size of the glazing bars. The shallow depth of the metal glazing bars (muntins) seemingly precluded the installation of sealed insulating glass within the existing lites, even if the windows could structurally support the additional weight. The only practical way of double-glazing would have involved the use of interior storms with units that were either operable or were removable for ease of cleaning. Even then, however, the severe deteri-

Figure 2. Due to lack of maintenance, severe rusting of the steel frames had occurred, which contributed to the spalling of sections of the concrete sills, jambs, and spandrels. Photo: Charles Fisher

oration of the steel windows still would have needed to be addressed. Considering the size of the bay openings, the decision was made to replace the windows.

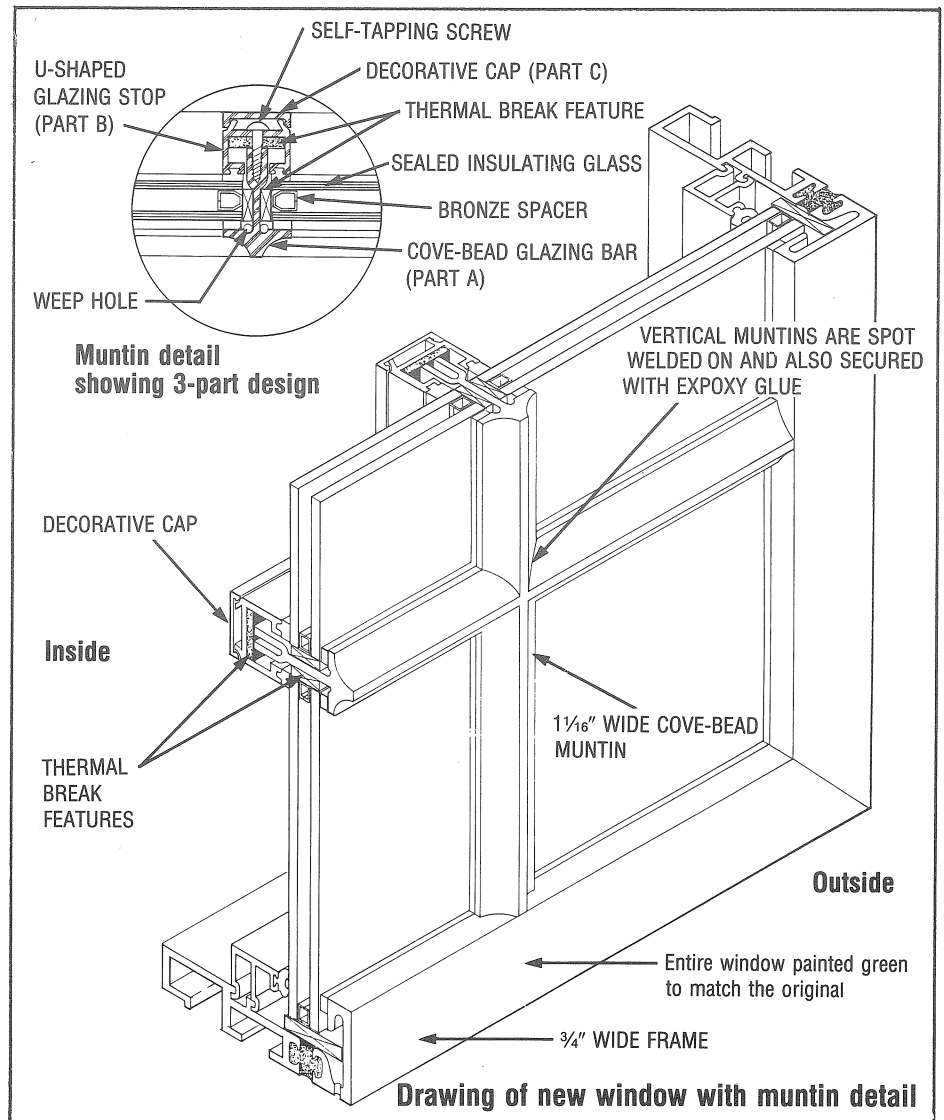
Figure 3. Drawing of the aluminum replacement windows shows how the cove-bead muntin profile of the original steel windows was closely matched in the integral muntin system designed for the aluminum replacement window. A series of spacers and gaskets were used as the principal means of obtaining a thermal break in the window for energy purposes. Drawing: Peter Charles

One of the first major design issues to be resolved concerned the need to match as closely as possible the shape and dimensions of the original 7/8" wide glazing bar (muntin) with its decorative cove-bead exterior profile to simulate the profile of the original steel window muntins. The project team concluded that in order to keep the muntin on the aluminum window as narrow as possible, the traditional cast thermal break (cast plastic) feature of most modern windows could not be used. Instead, a series of spacers and gaskets principally would be utilized to achieve a thermal break for energy conservation. By using this approach, the window fabricator would be able to use a 1/16" wide integral cove-bead muntin. The only short circuit in the thermal break would be at the point where screws were used to connect the inner and outer portions of the muntin (see figure 3).

designed to ensure that moisture build-up behind the glazing tape would seep outside, rather than inside the building (see figure 3). A twenty-foot mockup was eventually constructed and successfully tested according to accepted industry standards.

The basic aluminum window unit consisted of 9 different aluminum extrusions, including the decorative cove-bead muntin. The muntin assembly actually consisted of 3 extruded aluminum sections. The principal muntin section was the cove bead portion that had a long glazing channel with a receptor at the end (see figure 3). Attached to the interior-facing side of the muntin was a U-shaped glazing

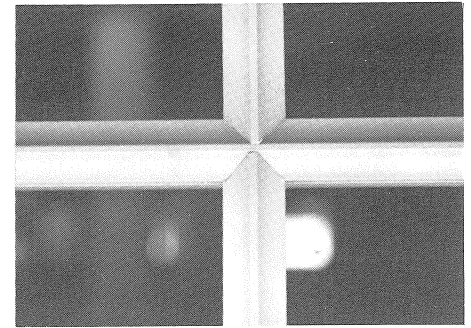
Figure 4. The vertical muntins had mitre joints where they intersected the horizontal muntins and were secured through a combined use of epoxy glue and spot welding. Photo: Charles Fisher

While the horizontal muntins were continuous across the window unit, the vertical muntins had mitre-joints where they intersected the horizontal muntins. The vertical muntins were secured through a combined use of epoxy glue and spot welding (see figure 4). A system of weep holes and channels was provided to ensure that any water trapped between the glazing tape and the glass and muntins would be diverted to the outside of the windows.

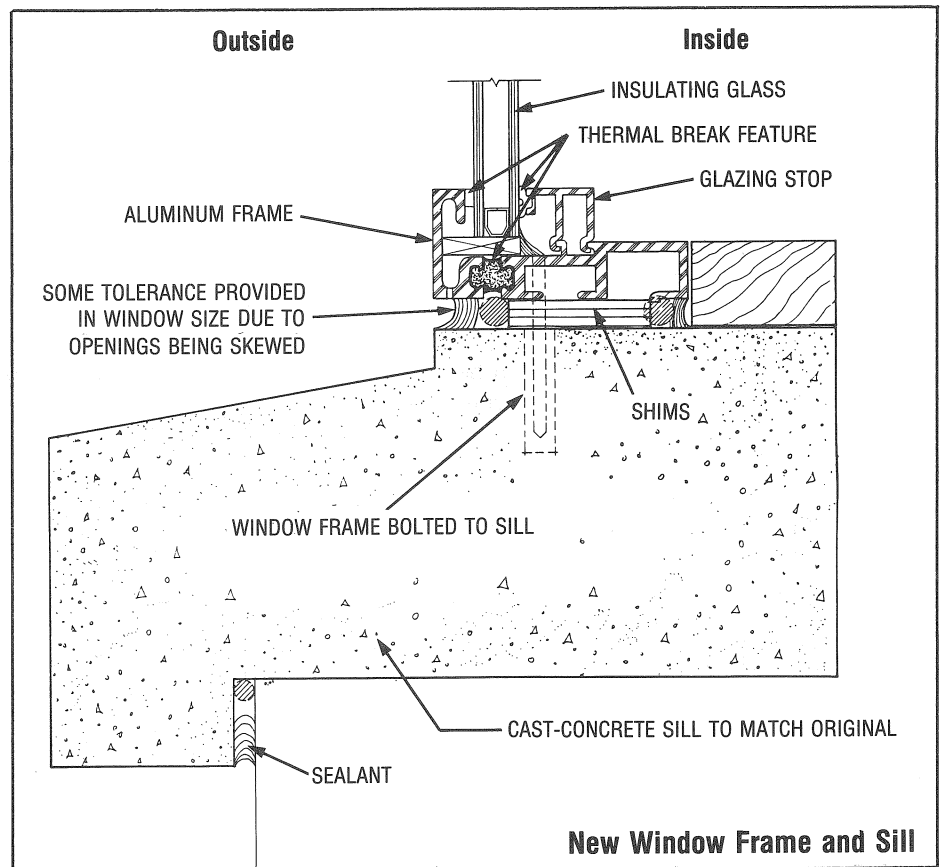
New Window Frame and Sill

Figure 5. The frame of each window unit was designed with a width of $\frac{3}{4}$ " in order to closely match that of the original windows. The frames were bolted to the face of the jambs, sill, and head of the masonry opening. Drawing: Peter Charles

The overall window unit was not set into reglets as were the original steel windows but rather were bolted to the masonry because of the greater depth of the aluminum jambs. To keep the width of the frames sufficiently narrow to match the historic appearance, a $\frac{3}{4}$ " wide jamb was designed, narrower than standard window jambs (see figure 5). Due to high wind loading requirements for Boston, steel reinforcing bars were needed at certain corner windows, but other-

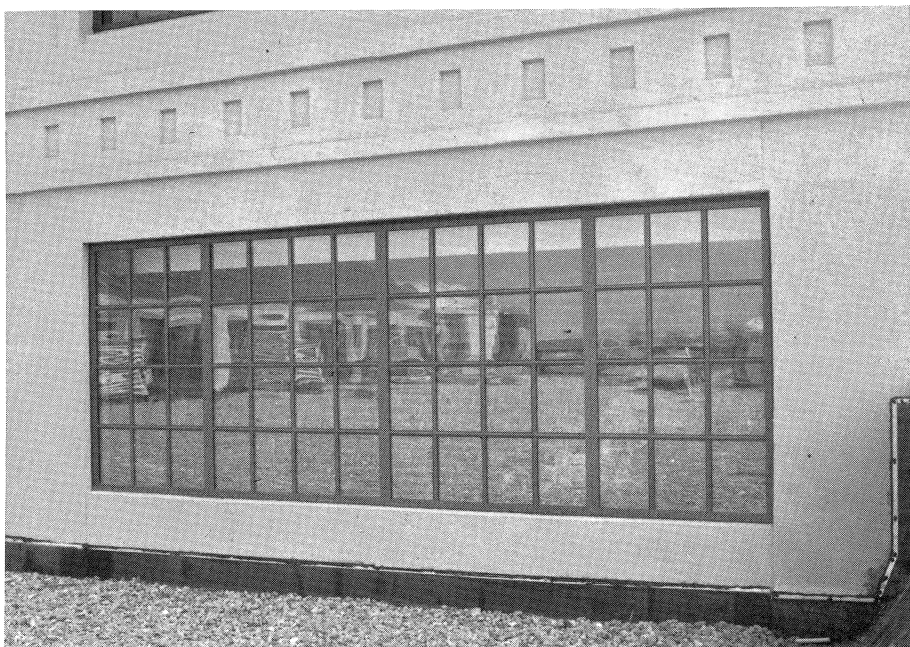
Figure 6. Fabrication and installation of the window units were complicated by the nine different types of windows in the building and by the considerable variations in the window heights for each type. Approximately 500 of the 2000 window units were the same size. Photo: Chuck Parrott

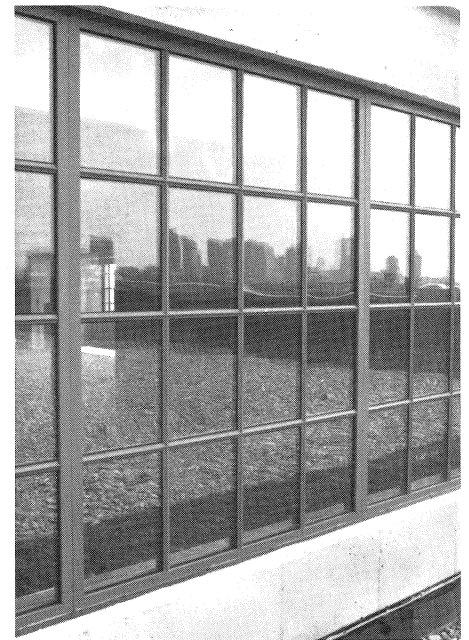
the greatest problem and biggest expense, since the limited tolerance for encroachment onto the glass area required very careful work (see figure 7).

Figure 7. Despite the difficulty encountered with proper glass sizing and spacer alignment in the sealed insulating glass, the end result is an innovative window that is both aesthetically pleasing and closely matches the historic appearance of the original steel design. The slight encroachment of the bronze spacer onto the visible glass area is not readily detectable from general view.

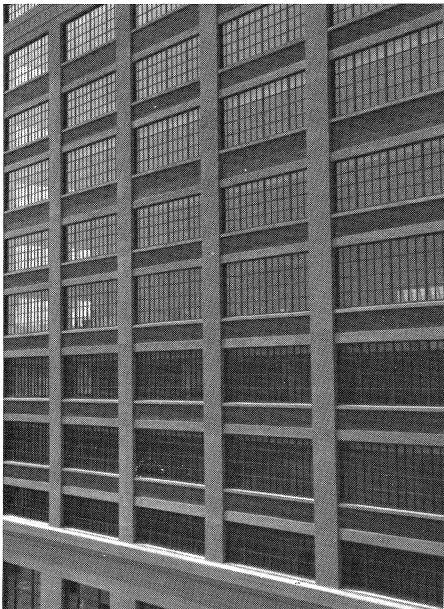
The window work at 149 Constitution Park was noteworthy in several ways. First, it represented a significant improvement over past attempts to recapture the distinctive qualities of a steel industrial window with narrow cove-bead glazing bars, using an aluminum replacement system with insulating glass (see figure 8). Equally important was the manner in which the new window system was developed for the project.

Figure 8. The window work at 149 Constitution Park represented a significant improvement over past attempts to recapture the distinctive qualities of a steel industrial window with narrow-bead glazing bars, using an aluminum replacement system with insulating glass. Success was achieved through careful and well coordinated planning. Photo: Charles Fisher.
