# Tech Notes

## WINDOWS

### CHALMERS UNITED CHURCH

### Reinforcing Deteriorated Wooden Windows

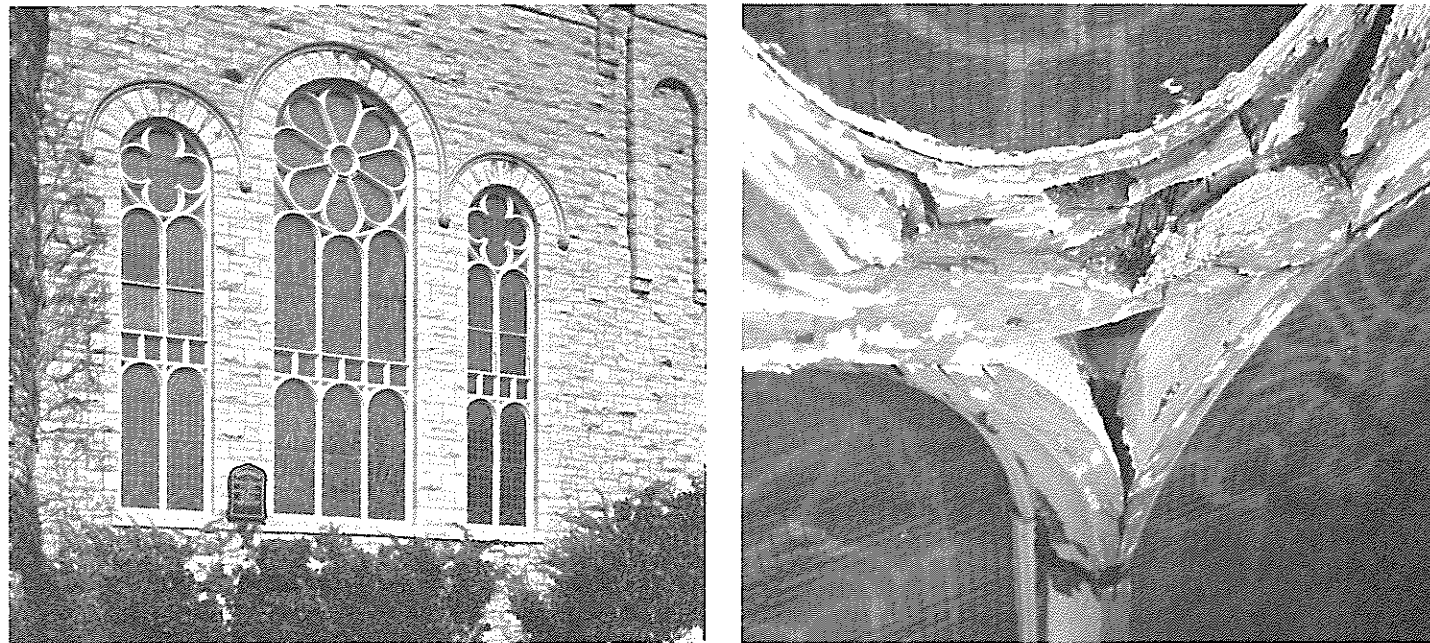
Over time the windows had suffered severely on the southern facade of the church, which is exposed to sun and constant strong winds blowing in from nearby Lake Ontario (see figure 1). This wind not only carries dust and dirt, but also has a high moisture content. Because of weathering and the lack of regular maintenance, the wooden frames which secured the stain glass panels had gradually deteriorated. The decay finally became so acute that by 1982 the windows were in imminent danger of collapsing. The parishioners at that point had no choice but to ar-

Figure 1. Considerable deterioration had occurred to the tripartite windows as shown in the close-up view of a portion of the mullion. (The stained glass is protected by individual sheets of wire glass set within the wood mullions)

The first step in the restoration process was the careful removal of the remains of old paint on the wood frame. This exposed the true extent of the deterioration. In some areas, as much as 40-50% of the wood had been lost. The wooden parts of the window frame that were found to be crumbling were saturated and consolidated with a commercially available liquid epoxy.

of damage during removal and transportation. Instead of making new mullions, the decayed frame was reinforced in an unusual manner, using a method developed by Paul Stumes, the consulting engineer for the project. The method involved the use of epoxy consolidants along with steel reinforcement rods (see figure 2). To permit the work to take place undisturbed by the weather, a "cocoon" formed out of vinyl sheet was attached to the temporary bracing installed to stabilize the windows while the restoration work was underway (see figure 3).

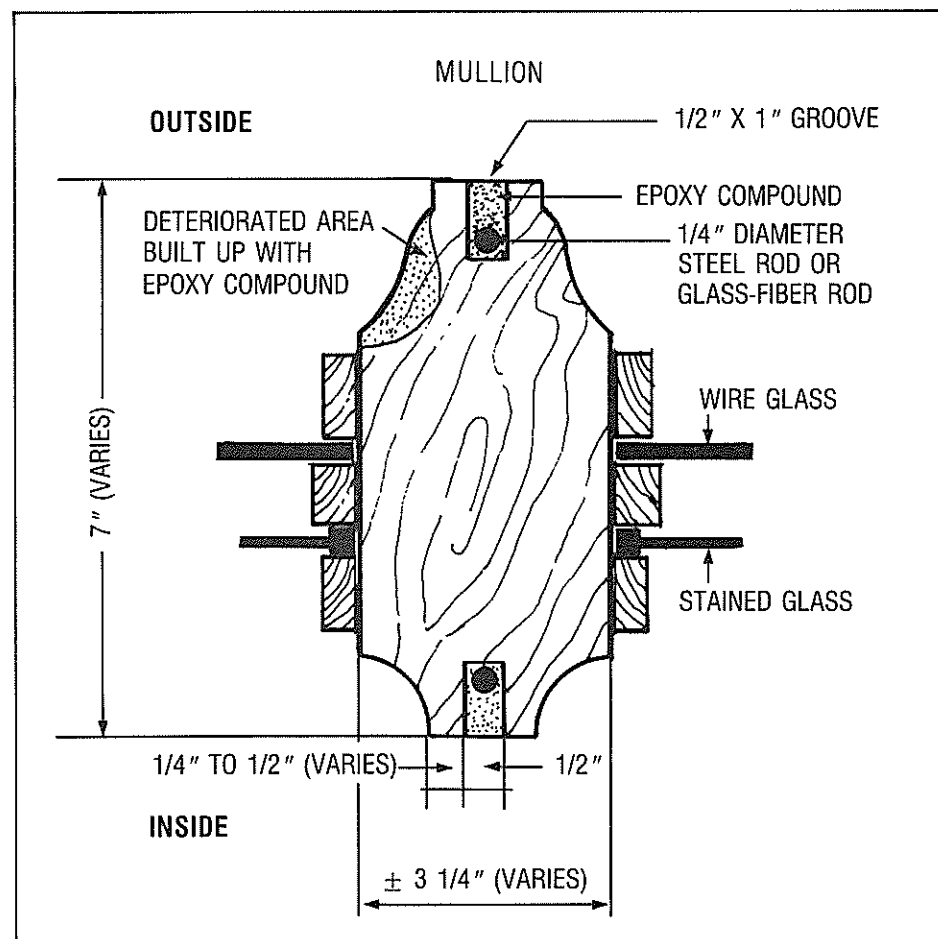
Figure 2. Cross section of the historic mullion shows the manner in which the pre-formed steel reinforcing bars were inserted in order to strengthen the windows. The grooves that were cut for the steel bars were filled with an epoxy compound.

Next, a 1/2" wide groove was cut into the mullions on opposite faces to receive a steel reinforcement rod. The depth of this groove ranged from 3/4" to 1 1/4", depending on the location. This delicate exercise was carried out with utmost care. After some experimentation was carried out on scrap wood, a hand-held electric router was adapted for the job. Special rollers were installed to guide the rotating cut-

For reinforcement, 1/4" diameter steel bars (the same type used to reinforce concrete) were painstakingly bent to match the curves of the mullions. The shape of the bars had to be accurate, within a tolerance of 1/8" in any direction, in order to fit comfortably in the 1/2" wide grooves which followed the complex curves of the windows (see figure 5). Because of the deteriorated condition of the wood, the steel bars could not be forced into the grooves without the danger of splitting the frames apart. In a few instances where the steel rods could not be suitably shaped, braided fiberglass strands were used instead.

With the reinforcement in place, the grooves were filled with an epoxy compound, thus completely embedding

the steel in epoxy. The epoxy used for this project — the high-modulus, thixotropic Sikadur gel in which some Union Carbide phenolic microballoons had been added for more firmness and improved workability — had the consistency of a stiff paste. This mixture had the advantage of remaining in position and retaining its shape wherever it was placed. If a fluid epoxy had been used on these vertical windows, special molds would have had to be fabricated and positioned to prevent the liquid from spilling out before it hardened. After this paste epoxy cured, it achieved a strong adhesive bond with the wood of the mullions and the reinforcing steel bars, creating a sturdy composite window frame.

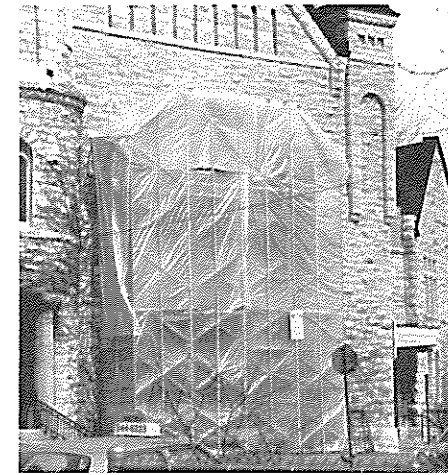
Figure 3. A vinyl cocoon placed over the windows allowed the repair work to be carried out even in inclement weather.

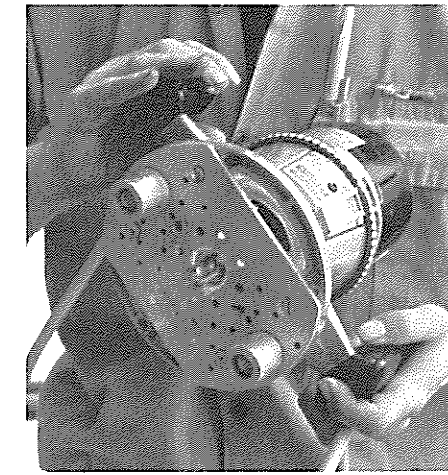
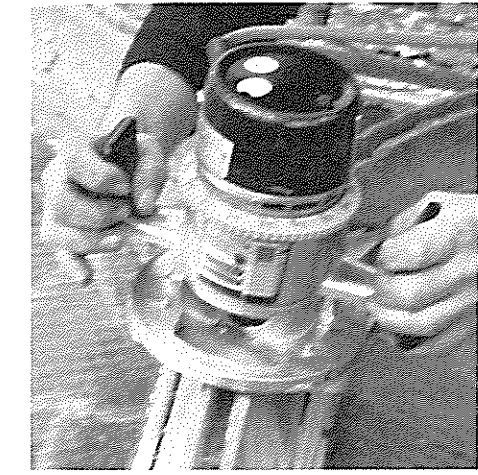
Figure 4. Once the old paint had been carefully removed, grooves were cut in the mullions using an electric router fitted with special guide rollers.

ting bit (see figure 4). Notwithstanding the usefulness of this apparatus, the real success of the operation can be attributed to the skill of the craftsman who guided the tool. The wooden mullions varied in size; on a typical 3 1/4" wide mullion, the outer edge where the groove was cut was 1 1/2" wide. In cutting a 1/2" groove on the outer edge, only 1/2" of wood remained on either side. A slight deviation of the tool could have seriously damaged the mullions.

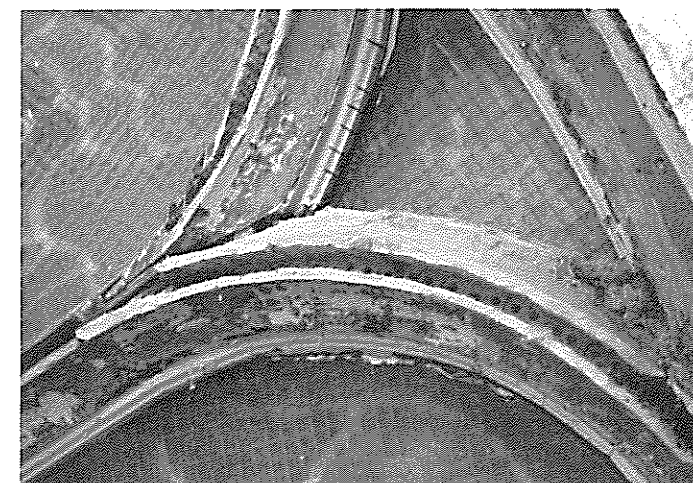
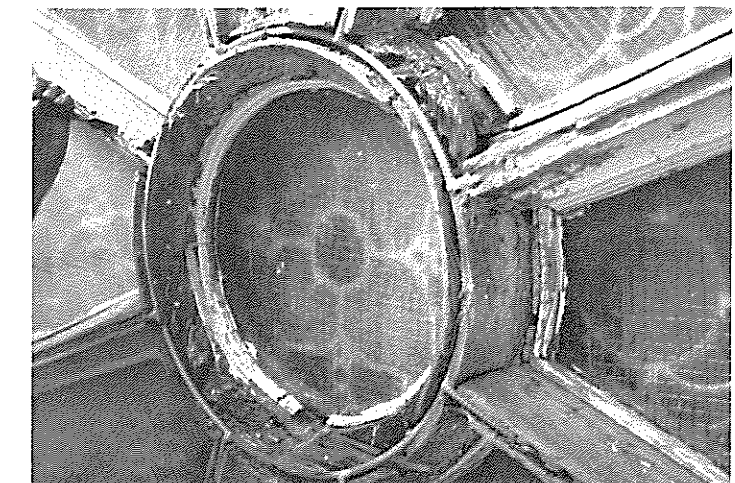
Figure 5. Details of the mullions as the strengthening process was carried out. Left: The grooves had to be carefully cut both because of the deteriorated condition of the wood and due to the relative thinness of the outer edge of the mullion. Right: Reinforcing bars are positioned in the grooves prior to being encased in an epoxy compound.

In many places, due to the advanced decay, the fine details of the mullions crumbled into unrecognizable shapes. In these areas, the original form was recreated using the epoxy

paste like modeling clay. Skillful hands of the craftman sculpted fill-ins which blended perfectly into the curvature of the wooden mullions. After the epoxy paste hardened, only the color was different from the wood; the shape and the texture were the same. To complete the work, the windows were then primed and painted (*see figure 6*).

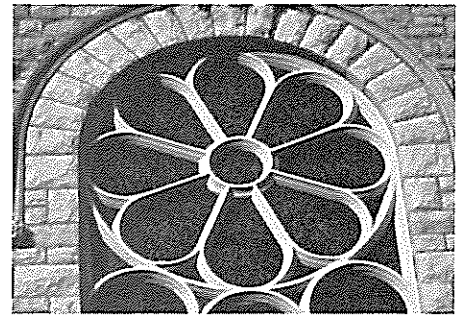
**Figure 6.** Repairing the historic frames resulted in a 25% savings over fabrication of new ones. The work included paint removal, reinforcing of the mullions, consolidation of the deteriorated wood, and repainting.
