Tech Notes

NUMBER 15

Interior Storms for Steel Casement Windows

THE DRAKE HOTEL (DRAKE TOWER) Philadelphia, Pennsylvania

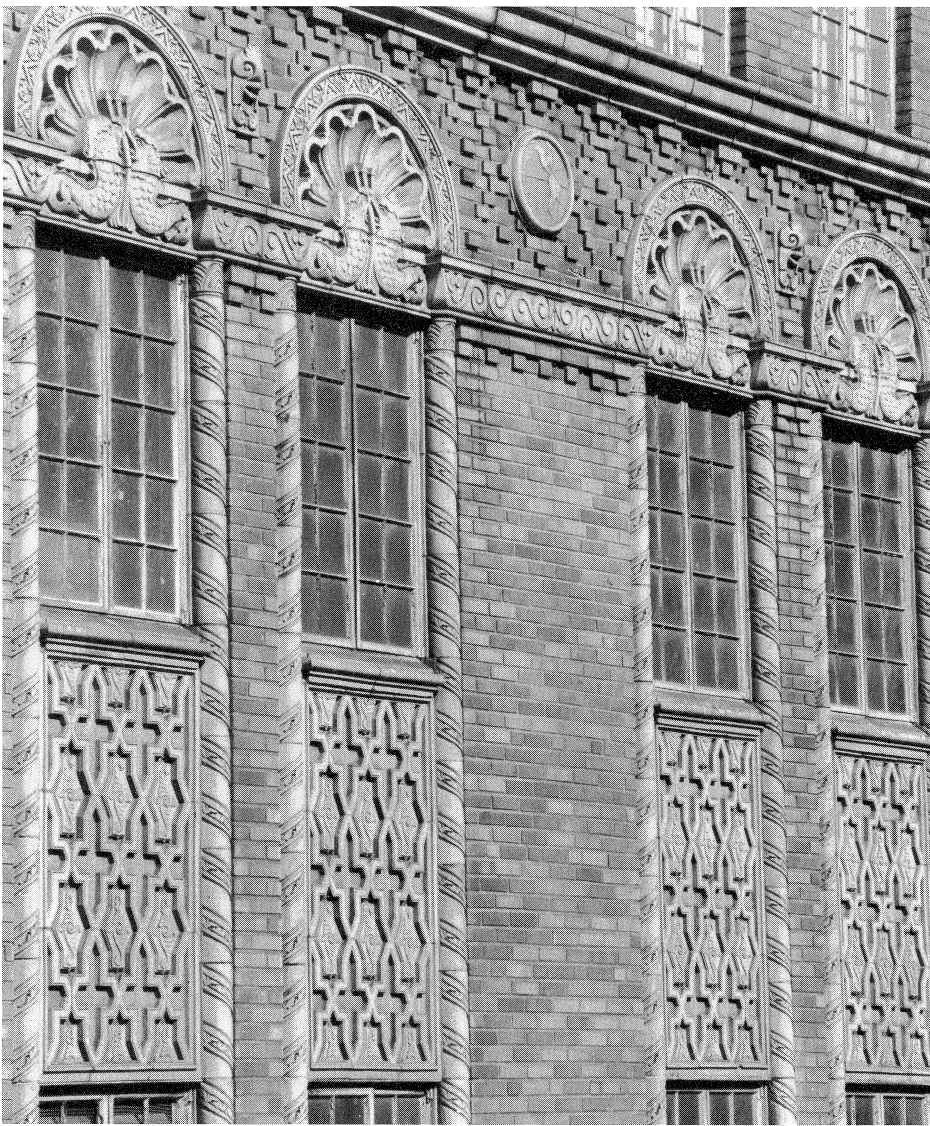
The Drake Tower, as it is known today, has over 1600 steel casement windows, richly adorned with terra cotta detail on the lower and uppermost floors (see figure 1). In between, the wall is simply detailed, characterized by the expanse of masonry and the organization and appearance of the steel casement windows with their multi-pane configuration and vertical meeting line. During the recent renovation, the steel casement windows were maintained and their energy performance enhanced inexpensively through addition of interior storm windows.

Figure 1. The steel casement windows on the lower and uppermost floors were richly adorned with terra cotta detail. Photo: Mort Bond/National Register Collection.

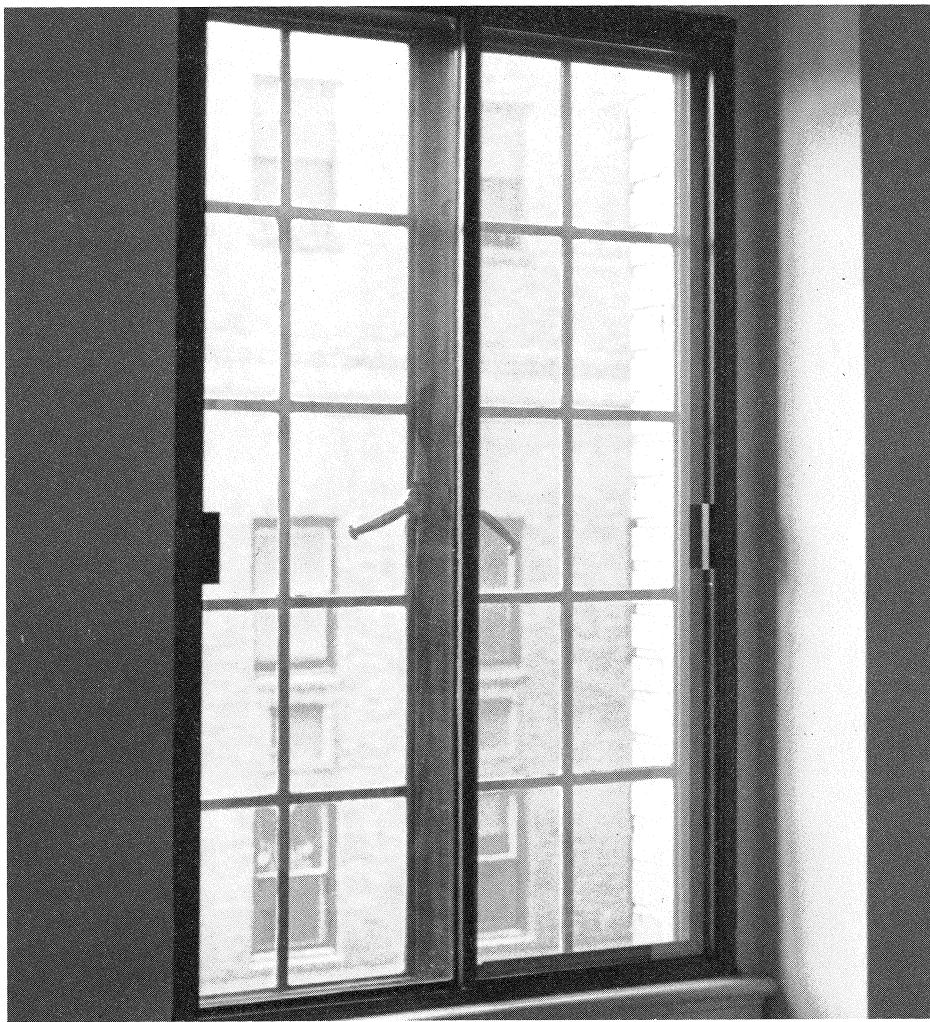
Figure 2. A horizontally sliding storm window unit was installed on the inside of the casement windows for improved energy performance. Photo: Christina Henry.

A system to improve the energy performance of the windows was developed by the architect, based on an approach that the firm had specified for other similar projects. It involved the installation of a new horizontally sliding storm window unit, mounted on the interior of the window jamb. The 2 storm panels would run the full height of the opening and would slightly overlap to allow for an effective weather seal (see figure 2). The intersection of the 2 storm panels thus would align at the vertical mullion of the existing paired casement windows. Since the interior face of the steel mullion was 2¼ inches wide, the visual impact on the windows of the intersection of the frames of the two storm panels would be minimal. For insect control, especially on the lower floors, a screen panel half the width of the opening was specified, set within a third track of the aluminum subframe (see figure 3).

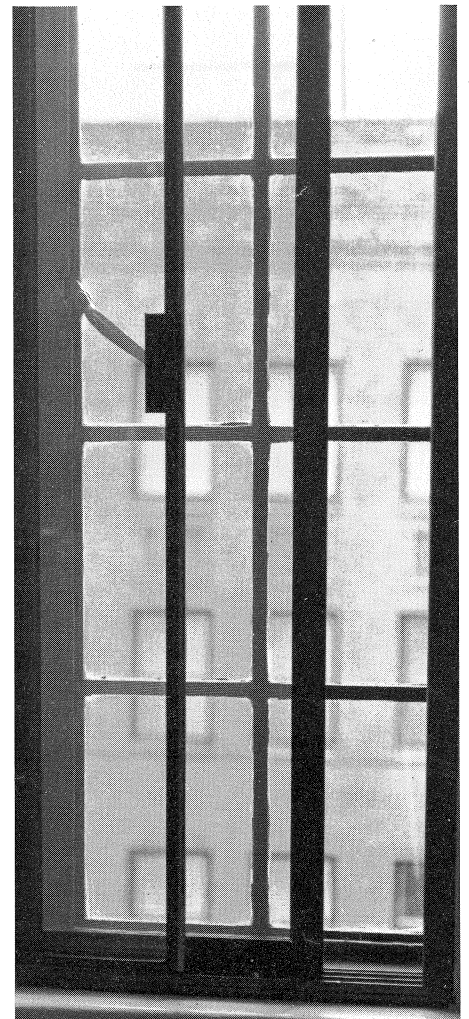
Figure 3. View of the storm unit showing a screen panel and one of the glazed panels partially opened. Photo: Christina Henry.

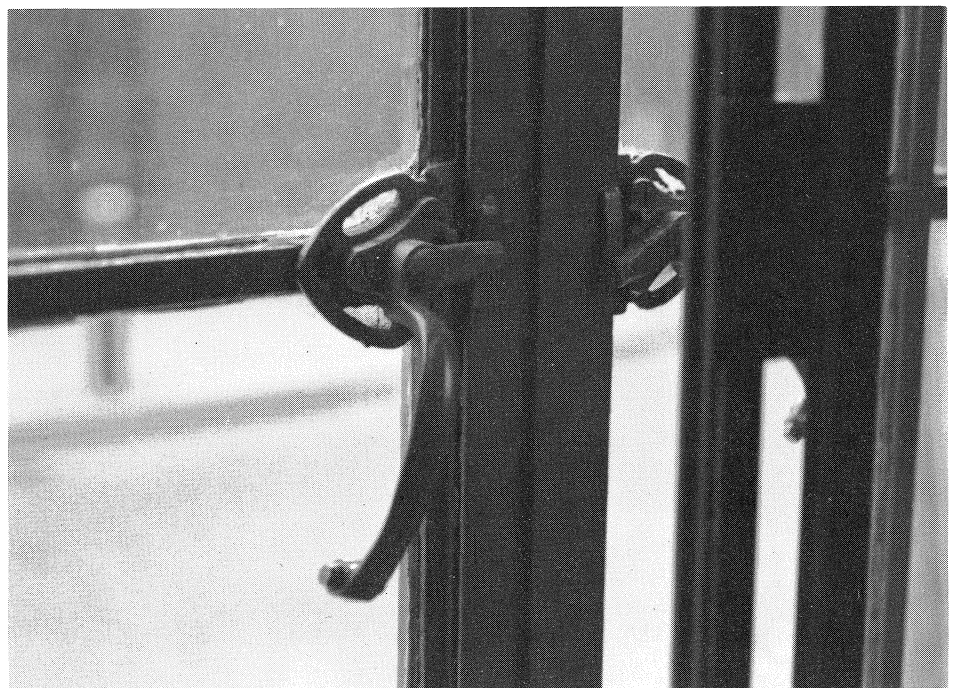
Figure 4. The hardware was cleaned and oiled as part of the maintenance and repair work undertaken on the steel casements. Photo: Charles Fisher.

The steel casement windows required basic maintenance work. This work included cleaning, reputting where necessary, limited replacement of cracked glass, and the application of an anti-corrosive paint. The hardware was cleaned and oiled (see figure 4), and the frames caulked on the exterior both to keep water from entering and rusting the steel subframe as well as to reduce air infiltration. The relatively tight closure of the cleaned and repainted casements, coupled with the planned installation of the interior storm unit, rendered the additional expense of retrofitting weatherstripping to the casements unnecessary.

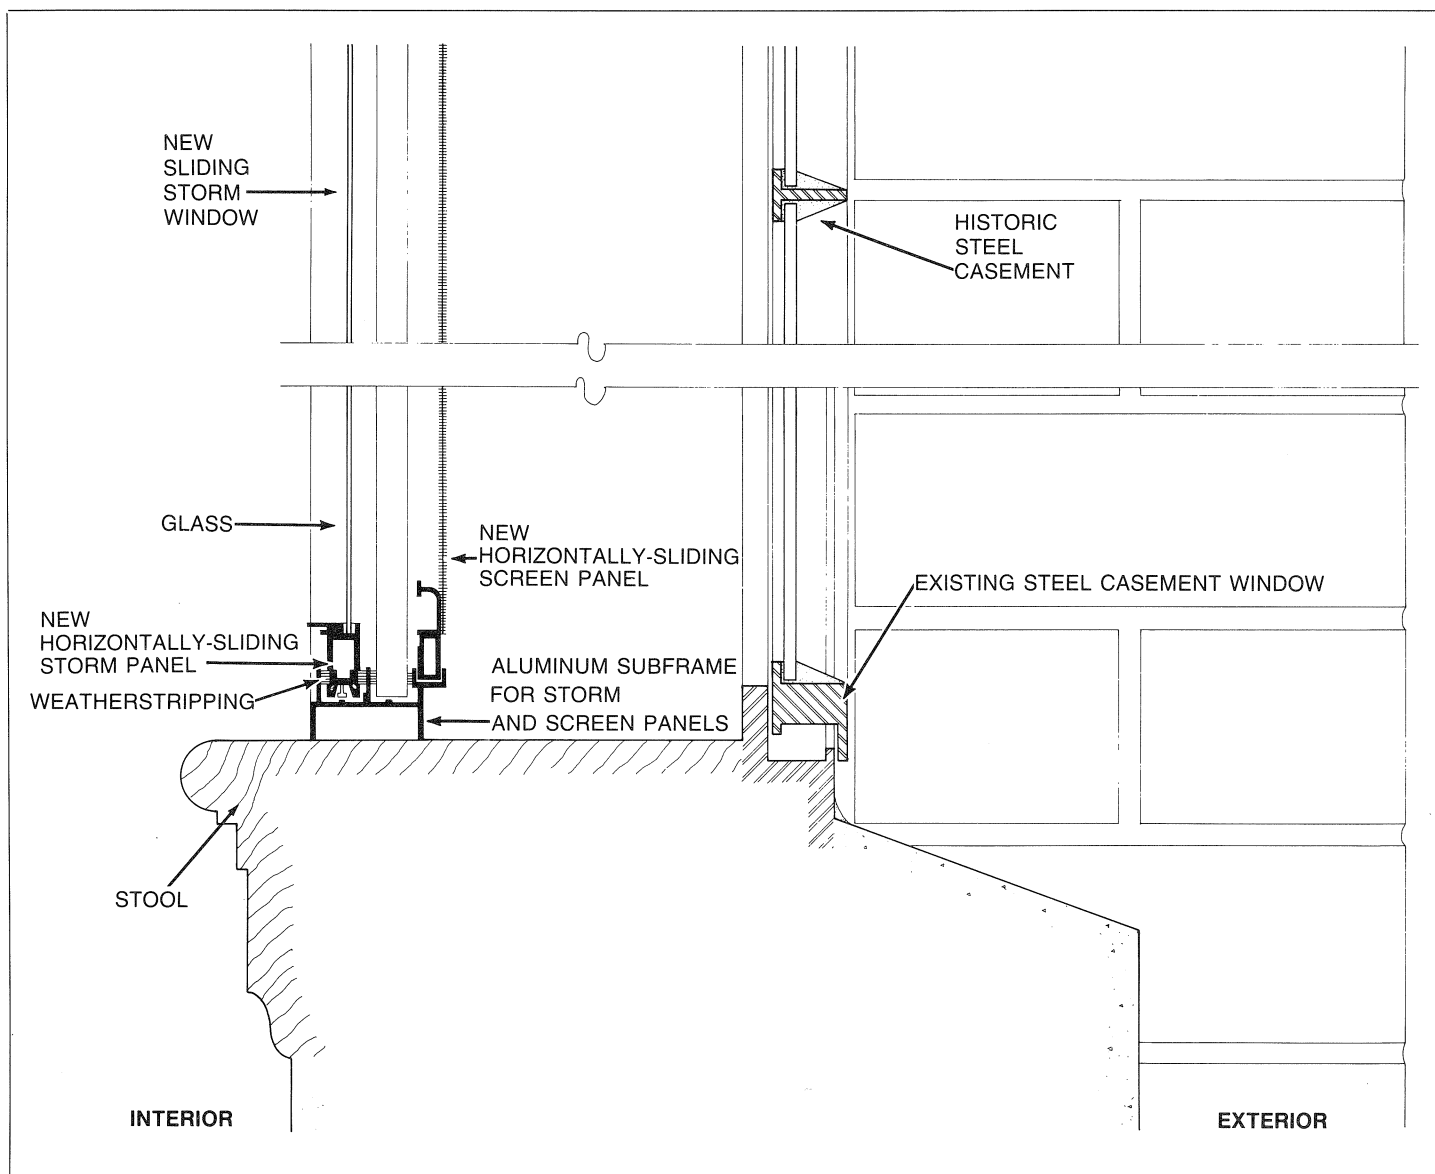
Figure 5. The interior storm window system consisted of an aluminum subframe and sliding aluminum-frame panels with glazed and screened units. Drawing: Christina Henry.

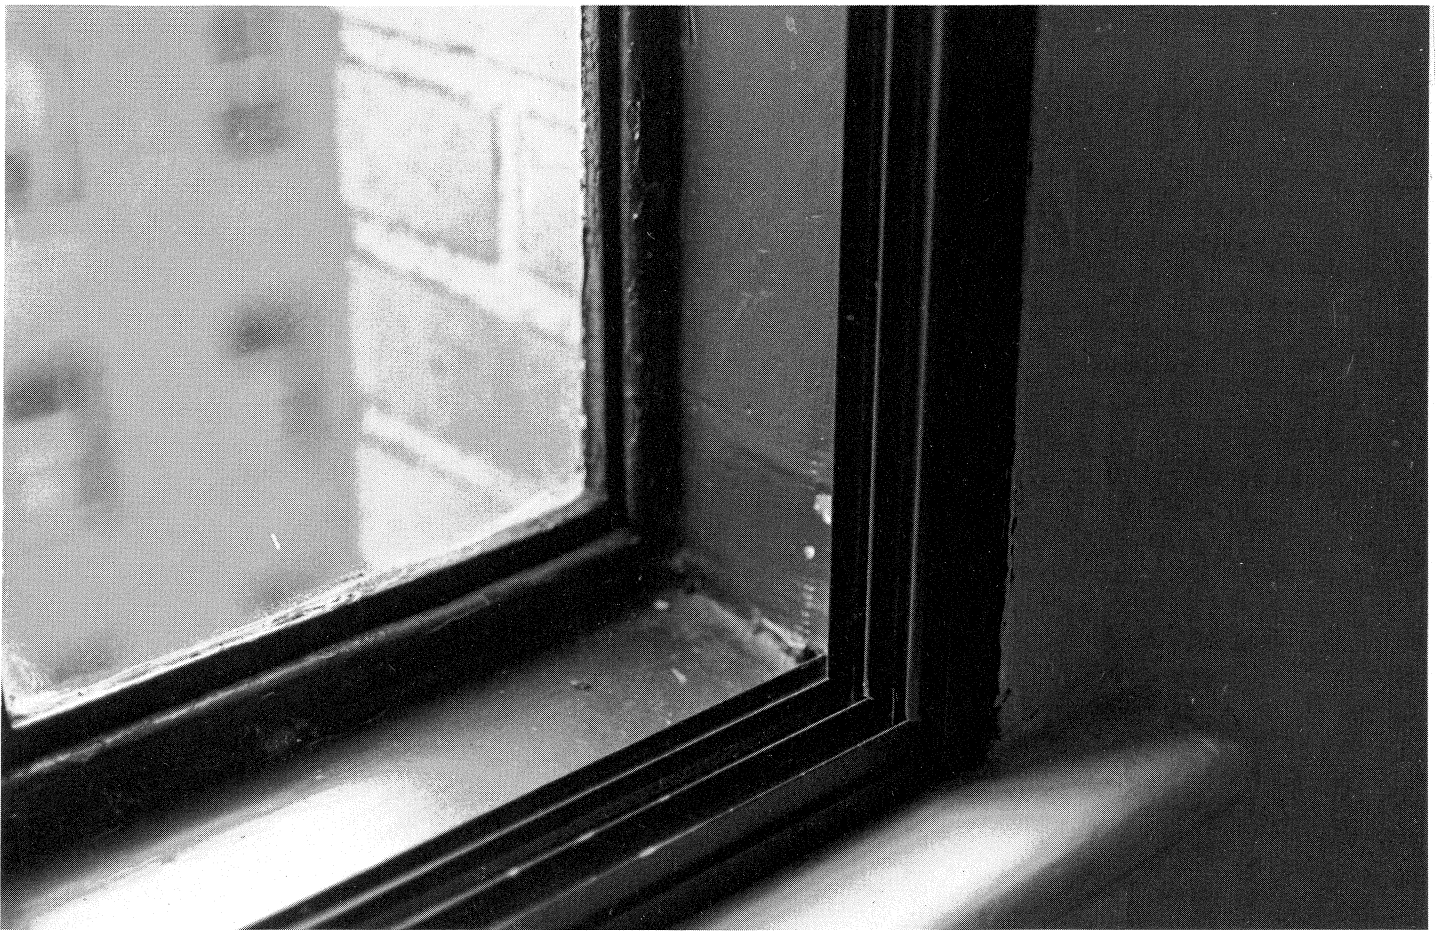
Figure 6. The subframe had to be squared off when installed in each window opening to prevent racking of the sliding panels.
Photo: Christina Henry.

Several important factors were taken into account to ensure the successful installation and operation of the storm windows. First, care was taken to make sure that the aluminum window section was thick enough to prevent racking of the sliding sash. For the 3' by 4¾' opening, a 5/8" thick sash frame was used, set into an aluminum 1¾" subframe screwed to the existing jamb (see figure 5). Openings larger than these may require thicker frames. Second, correct installation procedures were essential to ensure that the slider unit functioned properly. This required that each subframe be squared off when installed in the existing jamb, since changes in alignment may have

occurred to the window opening over the years (see figure 6).

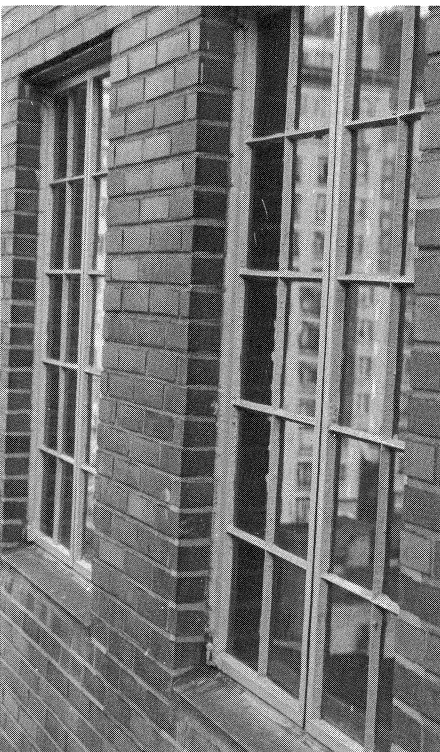
The installation of the storm units had little visual impact on the exterior appearance of the Drake (see figure 7). This is largely due to the selection of an interior application, use of a dark color for the storm frames, the alignment of the intersection of the two storm panels at a point behind the steel mullion on the historic window, and the setback of the storm unit nearly flush with the interior wall. On the inside, the storms are neatly set within

Figure 7. The dark frame color and careful installation of the interior storm window resulted in little visual impact on the exterior appearance of the building.
Photo: Charles Fisher.

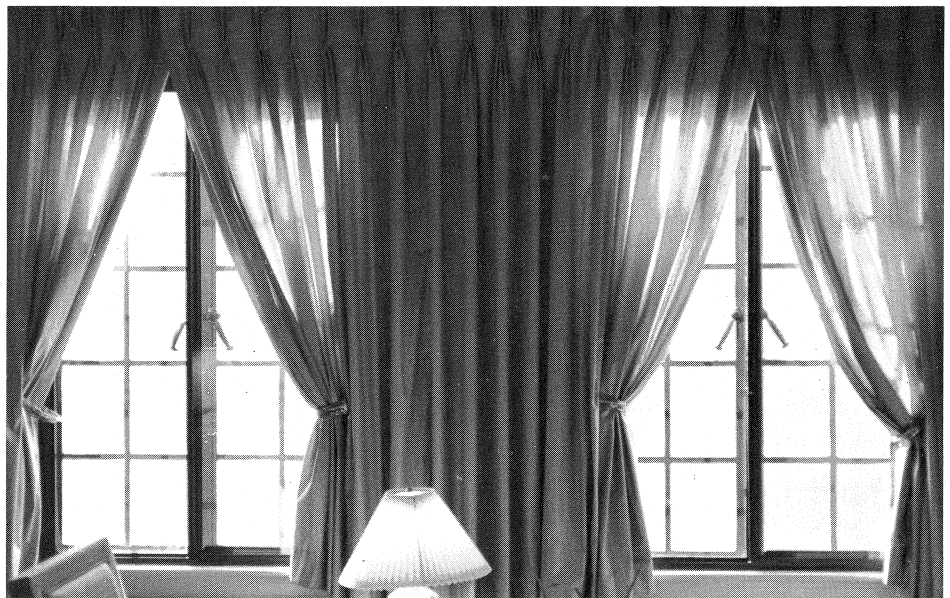
the opening and aesthetically are not disruptive (see figure 8).

Figure 8. The storm units are neatly set within the opening and aesthetically are not disruptive.
Photo: Charles Fisher.
