Tech Notes

WINDOWS

Repairing and Upgrading Multi-Light Wooden Mill Windows

SAWYER MILLS Dover, New Hampshire

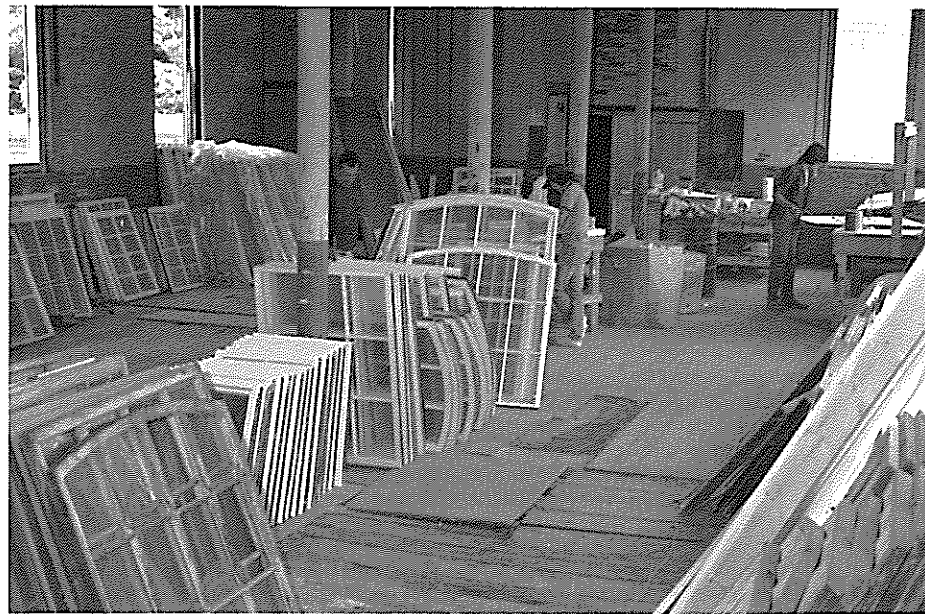
Figure 1. Window repair shop in operation. Photo: Christopher Closs

labor force in a logical sequence (see figure 1). The decision was made to undertake the work on the site and to establish a mobile millwork shop adjacent to the window repair shop so that the former could continuously supply the latter (see figure 2). The shops had to be relocated only once during construction. A key factor making the on-site window repair approach feasible was that the millwork shop's variable workload from window repairs was supplemented by specialty orders from outside contracts, eliminating costly down-time.

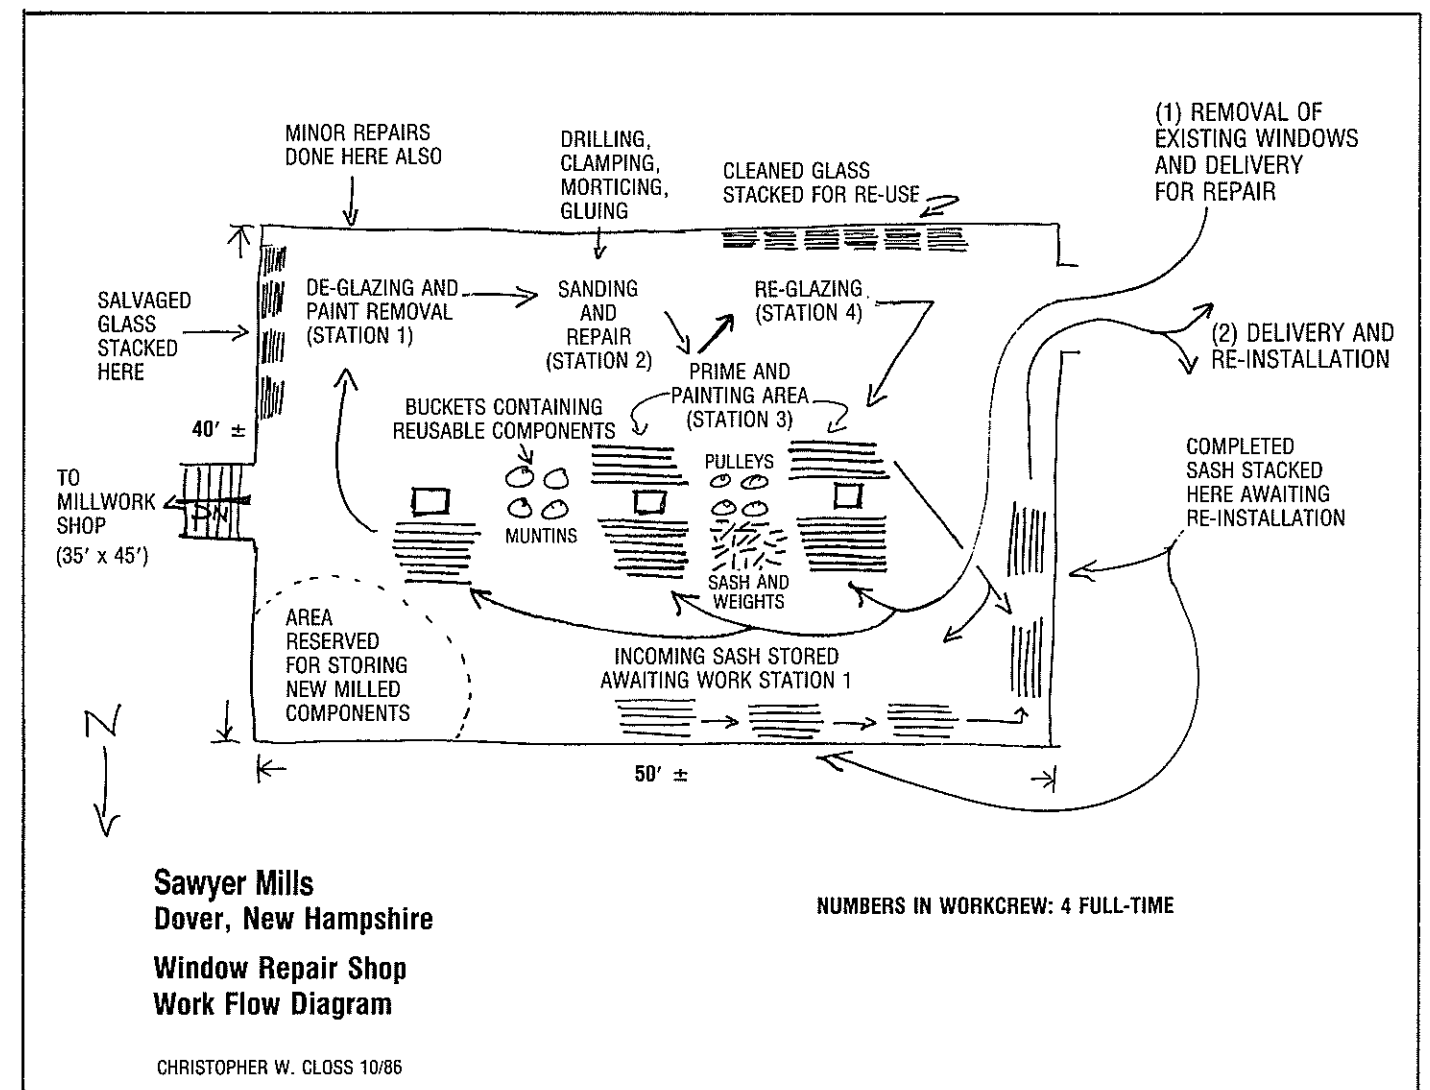
Figure 2. Drawing shows the plan of the window repair shop set up within Sawyer Mill during renovation work. The mobile millwork site was located in a room immediately to the left of the repair shop. Drawing: Christopher Closs

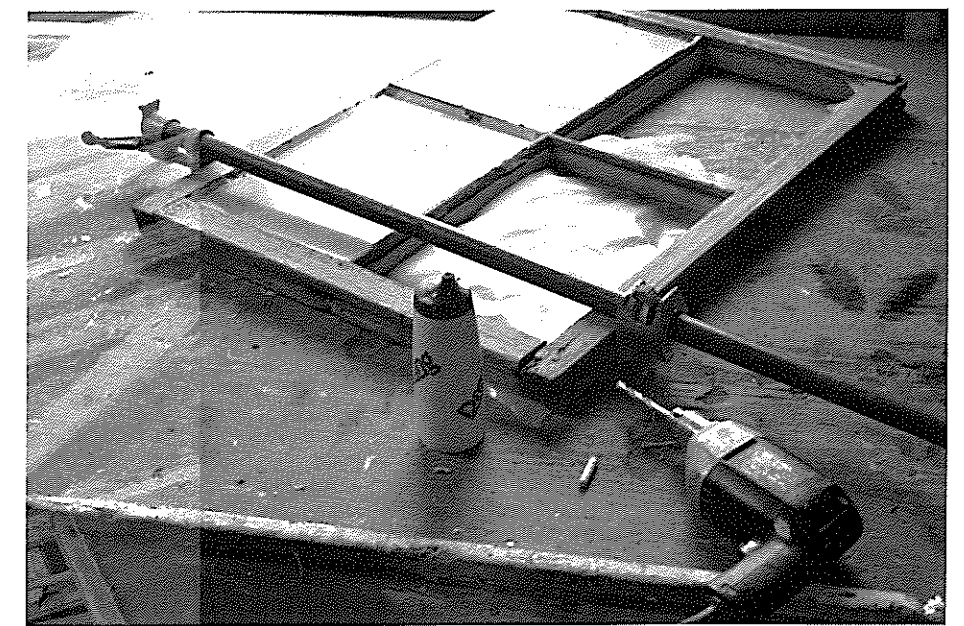
The most typical problem encountered was loose or failed mortise and tenon joints; this was remedied by drilling out the old pegs with a slightly oversize bit and then drawing the sash frame together tightly with pipe clamps (see figure 4). Fluted,

Figure 4. The basic repair: cleaning sash frame and drilling out pegs to tighten corner joints. Glue purchased in bulk was transferred to squeeze-bottles for ease of application. Oversize bit and new hardwood dowel shown ready for use. Glazing has not yet been completely removed. Photo: Christopher Closs

hardwood cabinet dowels, liberally coated with waterproof glue, were then driven in to secure the joints. To allow for natural movement, the mortise and tenon joints were not glued. In some instances, deteriorated tenons were cut off and bored out, and new tenons installed, using glue to secure the tenons in their seats but not inside the joints. This worked well providing the receiving mortises were sound. If muntins required selective replacement, this was done before clamping. It was critically important to "true" each sash square before re-pinning the corner joints.

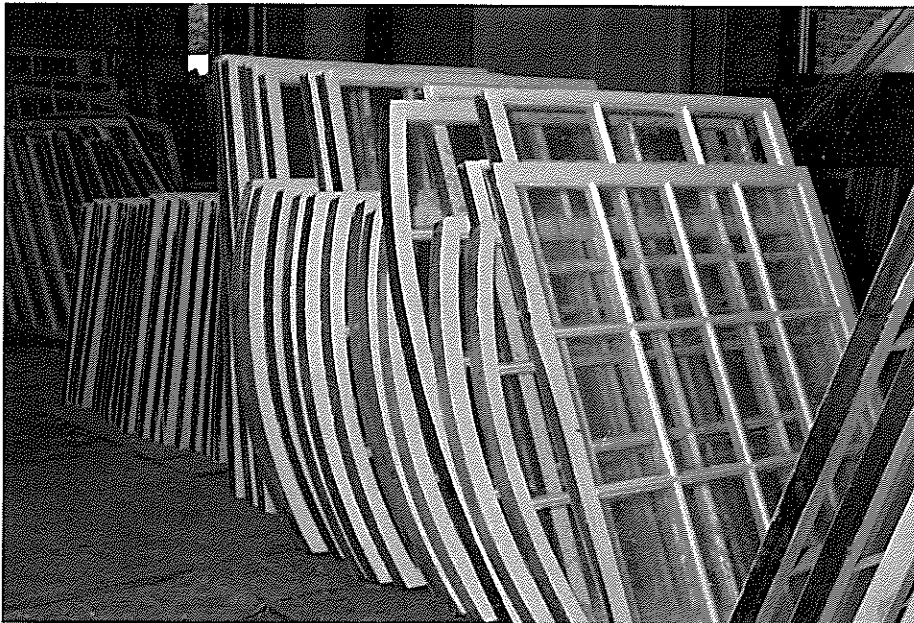
Figure 5. Repaired sash primed and awaiting reinstallation. Glass was cleaned of smudges after final installation. Photo: Christopher Closs

Once the sash for a complete window were made structurally sound, frames were hand-sanded and fully primed with a shellac-based sealer. Sash were then reglazed in conventional manner and stacked to await final finish with two coats of exterior-grade, oil-based paint (see figure 5). The wood edges of the sash were left

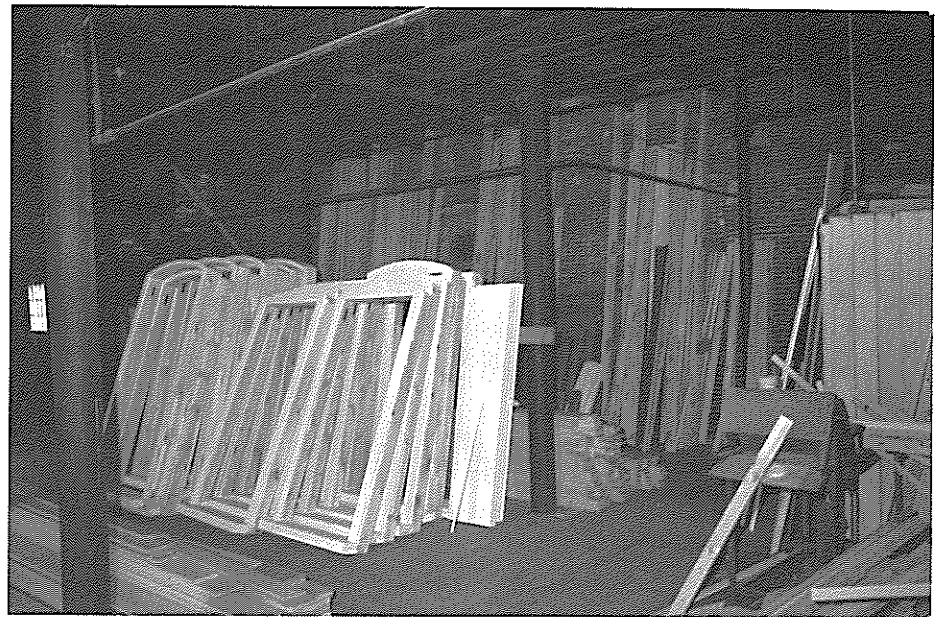
Figure 6. Newly milled replacement window frames awaiting installation. Photo: Christopher Closs

New matching wood sash, manufactured in Springfield, Massachusetts, were required to fill three hundred openings where the originals were missing or beyond repair (see figure 6). Deliveries of the new sash were scheduled to match the installation capacity of the project crews with the

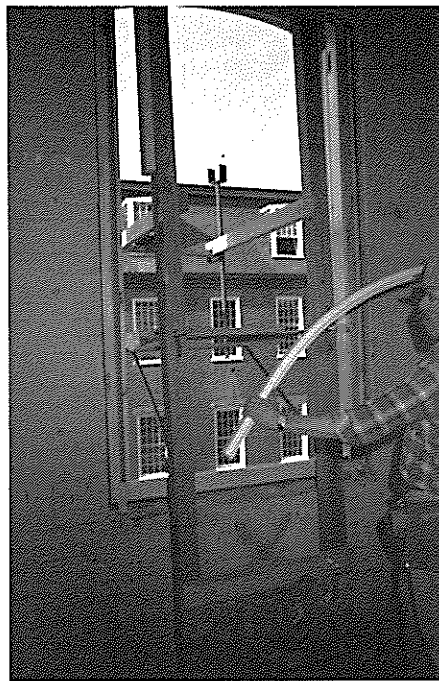
Figure 7. "Gun carriage" (scaffolding) in use by the window re-installation crew who are preparing to replace missing brickmold with replacement made by the millwork shop. Note saw kerfs used to create arc in molding for use in the window head (same method as used in the original molding). Photo: Christopher Closs

The re-installation crew was responsible for repairing or installing new frames, mounting brickmolds and installing repaired and new sash. Two "gun carriages" were constructed to facilitate frame installation and to ensure safety for the crews (see figure 7). Each carriage served as a cantilevered work platform (if fitted with dolly wheels they would have resembled a naval gun carriage). They permitted the installation crew to work safely on the exterior of the window opening without staging (much of this work had to be done over the river). The carriages had stops on the interior, were counter balanced, and were moved from opening to opening as frame repairs and brickmold work proceeded.

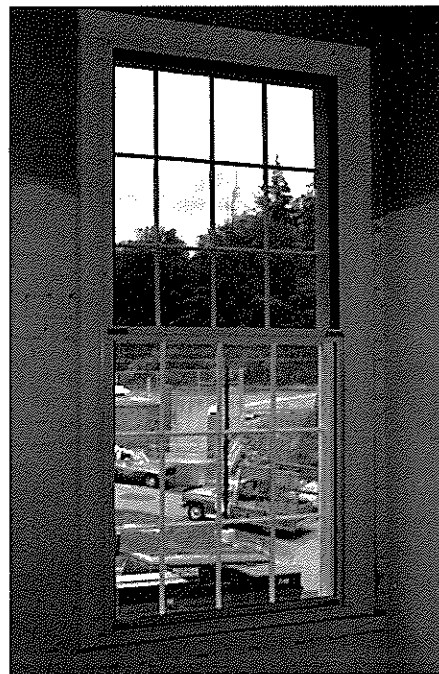
Figure 8. Typical interior aluminum combination storm window unit with insect screen shown at top. Beveled stops around the perimeter were added and the windows were caulked to provide for a good energy seal. Photo: Christopher Closs

The installation of the aluminum interior storms occurred after the primary windows were in place (see figure 8). Installation of the storm windows was monitored carefully to ensure that aluminum frames were set in a continuous bead of silicone caulk to provide a tight weather seal. This was made easier by the absence of decorative casing on all of the windows; storms were simply screwed fast to the flat, three-inch weight pocket covers (see figure 9). A new beveled 1" wooden strip was applied around the outside perimeter of the weight pocket covers and the heads, and caulked forming an uninterrupted seal with the brick masonry wall. Weight pockets were not insulated since the counterweights remained operable.

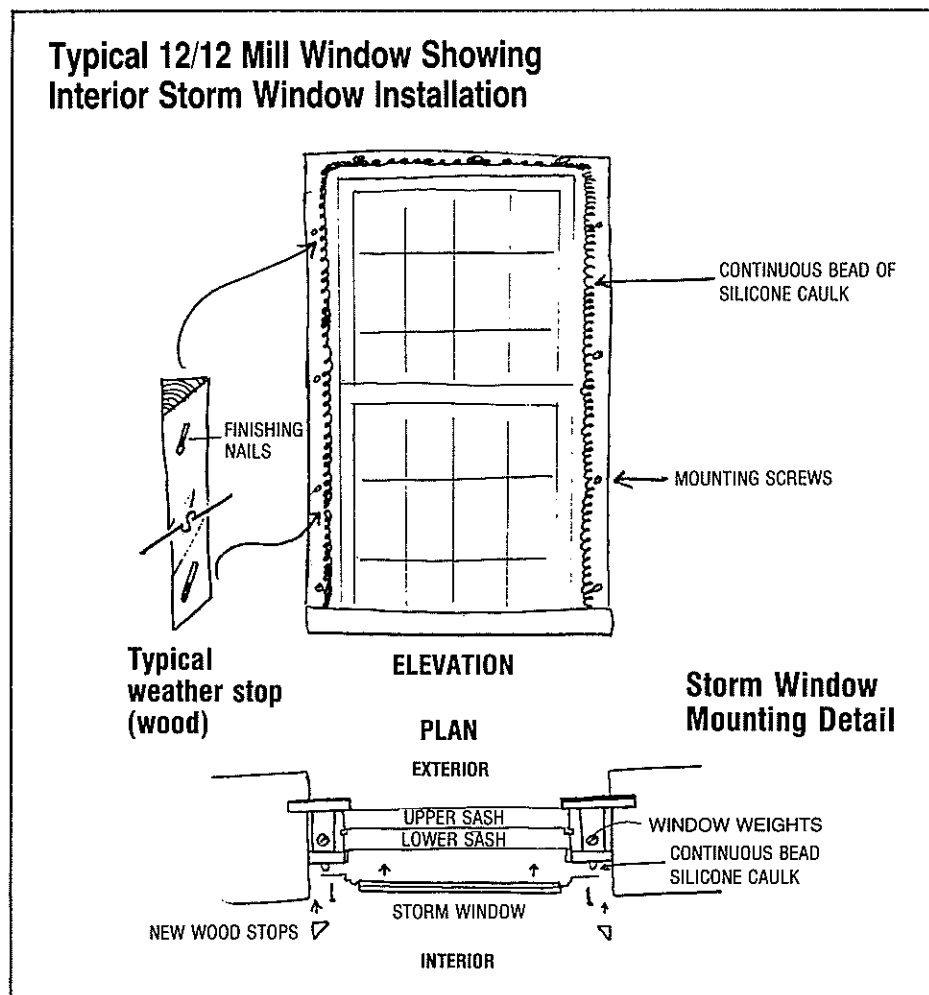
Figure 9. Drawing showing installation of the interior storm window. Drawing: Christopher Closs

To reduce the chances of moisture being entrapped between the storm unit and the primary window, the repaired wooden sash were fitted somewhat loosely, thus allowing for adequate venting. In practice, this approach worked well. The first units installed were checked during the winter of 1984 and exhibited no excess moisture or frost build-up.
