LIPPINCOTT PRESS BUILDING

Tech Notes

NUMBER 17

Repair and Retrofitting Industrial Steel Windows

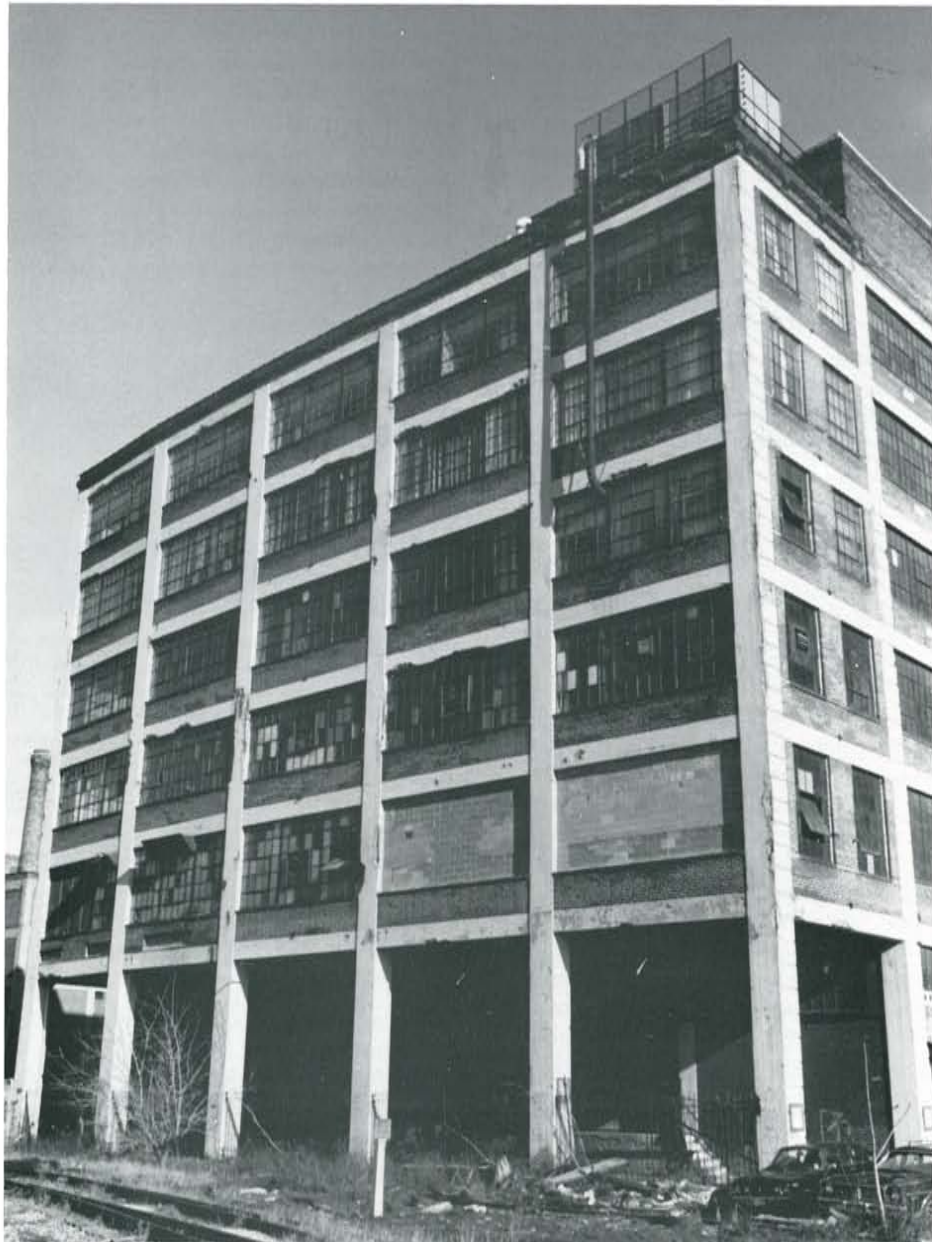
Since the Lippincott Building was used for a long time as a storage facility, the windows had not been painted, oiled, reglazed, or caulked, nor had missing or damaged parts been replaced in well over twenty years (see figure 1). Naturally, many of the windows exhibited problems typically found on inadequately maintained steel windows, including corrosion, bent and bowed metal sections, non-operable ventilators, missing or non-functional hardware and broken glazing. Furthermore, some of the original windows had been removed and replaced with double-hung aluminum windows, and other window openings had been infilled with glass and concrete block, metal louvered air vents, ductwork and other mechanical equipment (see cover photo).

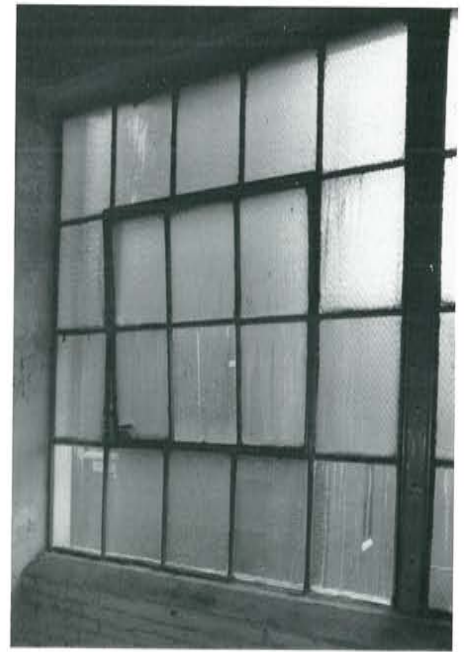
Figure 1. Typical multi-light steel window with ventilator as seen from the interior. This window exhibits typical pre-rehab conditions including silt corrosion, missing hardware and a poorly operating ventilator. Photo: Clio Group.

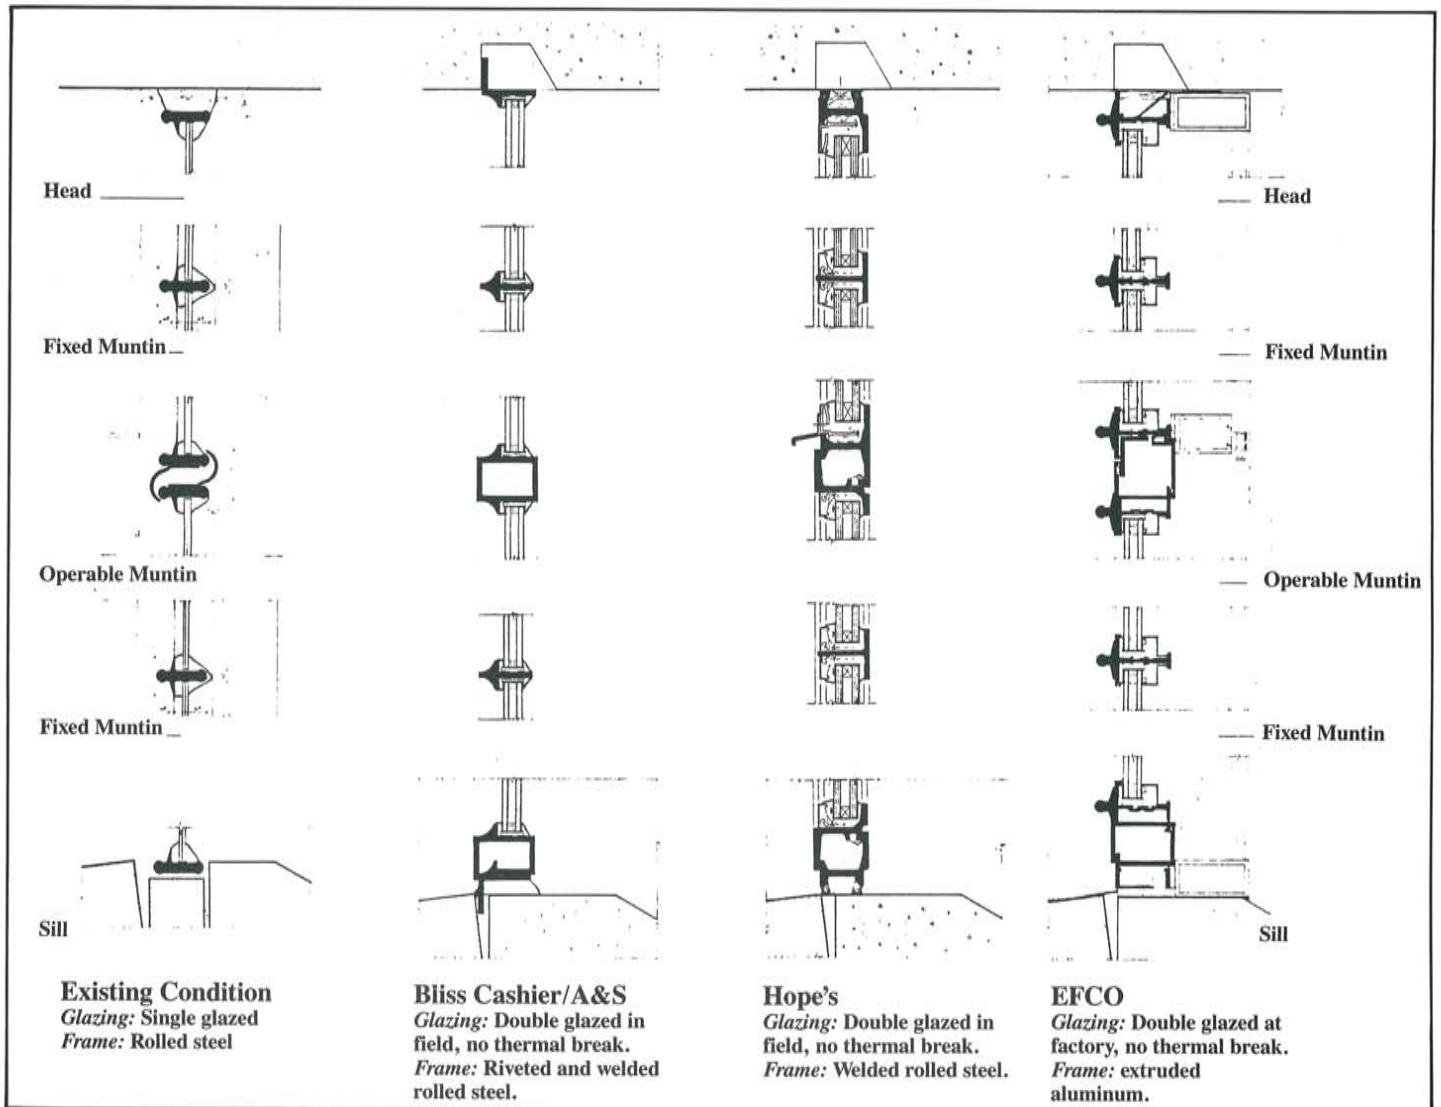
Figure 3. Comparative window sections showing the existing steel window on the left and the three thermally glazed replacement proposals on the right. Drawing: H2L2 Architects.

As seen in the comparative drawings and as evident from the mock-ups, the new double-glazed windows did not match the proportions, dimensions, thin profiles and sight lines of the historic steel windows due to the increased dimensions of the new window members. Thus, although the new proposed windows promised increased energy performance, the installation of these non-matching windows would

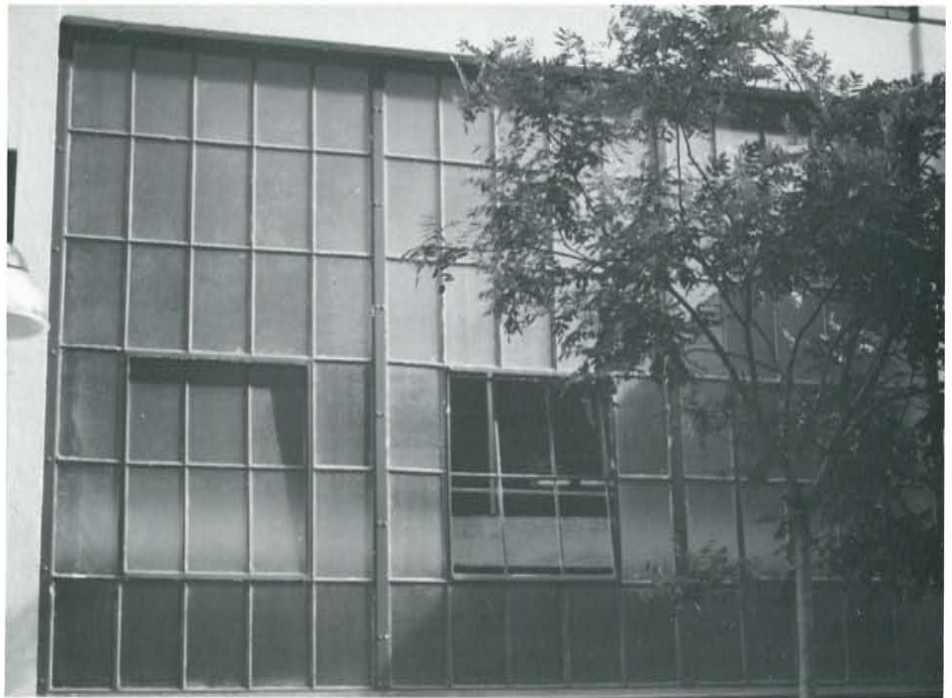
Figure 4. First floor, garage level showing the frosted glass and the center ventilator without glazing. Photo: Robert Powers.

To accommodate the first floor lobby and parking garage, the decision was made to repair and reglaze with frosted glass the existing steel windows in the garage area, and to install new windows in the newly created lobby area where no windows previously existed. The garage windows retained their operable pivoting sash, since compliance with energy requirements was not applicable. To provide for adequate garage ventilation, glazing was omitted from a number of the ventilators (see figure 4).

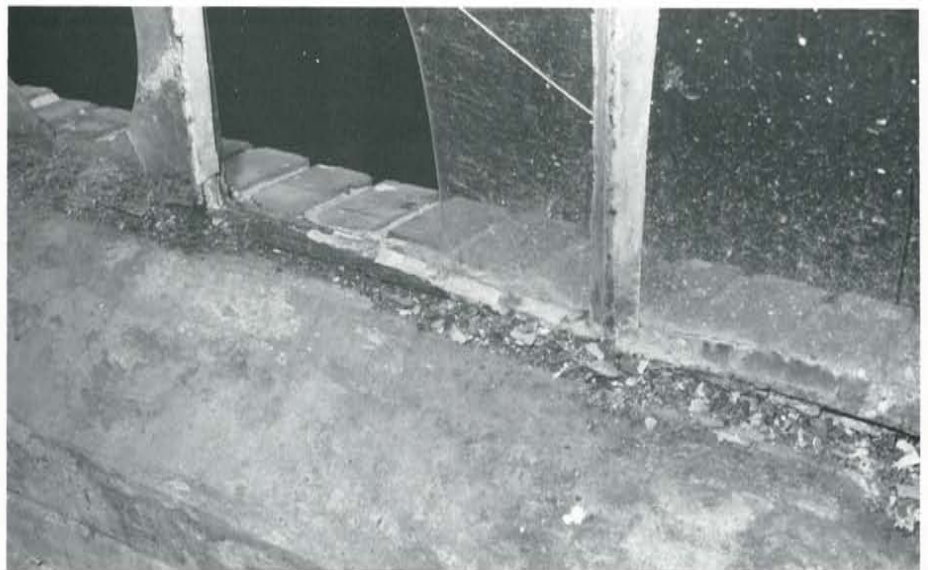
Figure 5. Sill corrosion typically found on 95% of the windows. Photo: Clio Group.

Generally employing three crews of three to four men, each contractor began by cutting out all the severely corroded and/or heavily bent metal sections from each window. Severe corrosion occurred primarily in the sill areas where the original steel sill section was embedded in concrete—a condition existing in approximately 95% of the window sills to be repaired (see figure 5). The spalled concrete and the corroded metal sill sections were chopped out with a portable band saw. In addition to the corrosion in the sill areas, extensive deterioration typically extended up the window muntins approximately three to six inches. These members were cut at a 45 degree angle with a five-inch grinding wheel using a five-inch disk, usually at a point four to seven inches from the sill or where the steel was no longer corroded.

Once the muntins and mullions were set plumb, the final steps in the steel repair process began. In most of the sill areas, lengths of new steel sections were installed to replace the original corroded members. The new cavetto-shaped steel sections did not match exactly the bullnose profile of the historic windows (see figures 9 and 10). However, the original profile was no longer available and the new profile was close enough so that the overall proportions, profile, and shadow lines were compatible with the historic window appearance. The new steel sections at the sill and the lengths

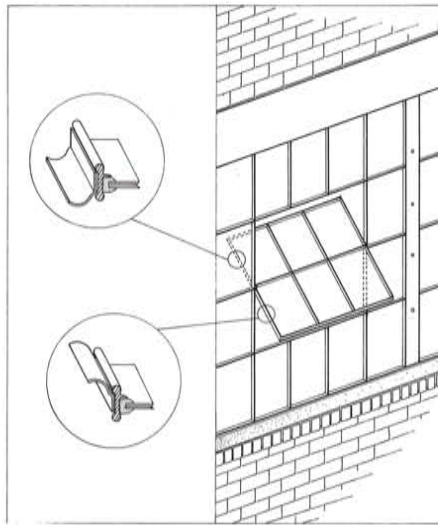
Figure 6. Pivot ventilators prior to retrofitting on the upper floors. Bullnose trim pieces to be modified as part of the retrofitting from pivot to projecting ventilators. Drawing: Martha Raymond.

Concurrent with the cutting out of the window's corroded steel members, each of the existing pivot window ventilators on floors two through six were cut from their jambs, labeled and brought to an on-site work station. At the work station, the pivoting ventilators were modified to operate as projecting windows (see figure 6). This was accomplished by cutting off the bullnose outside face of the side and bottom rails on the sash and riveting a new water-shed steel angle at the same locations. To allow the ventilators to swing out, two 16", heavy duty, 6 bar, zinc chromate plated steel, TRUTH hinges were screwed to each ventilator (see figure 7). New right-hand, cast iron, bronze lacquered, locking handles were installed on the bottom rail by face-mounting and screwing to each ventilator.

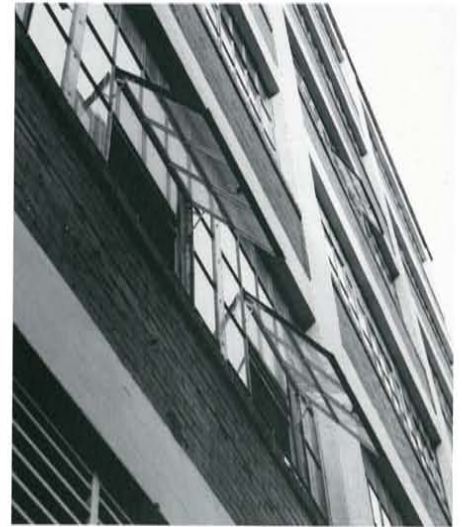
Figure 7. Retrofitted projecting ventilator with the TRUTH hinges. Photo: Robert Powers.

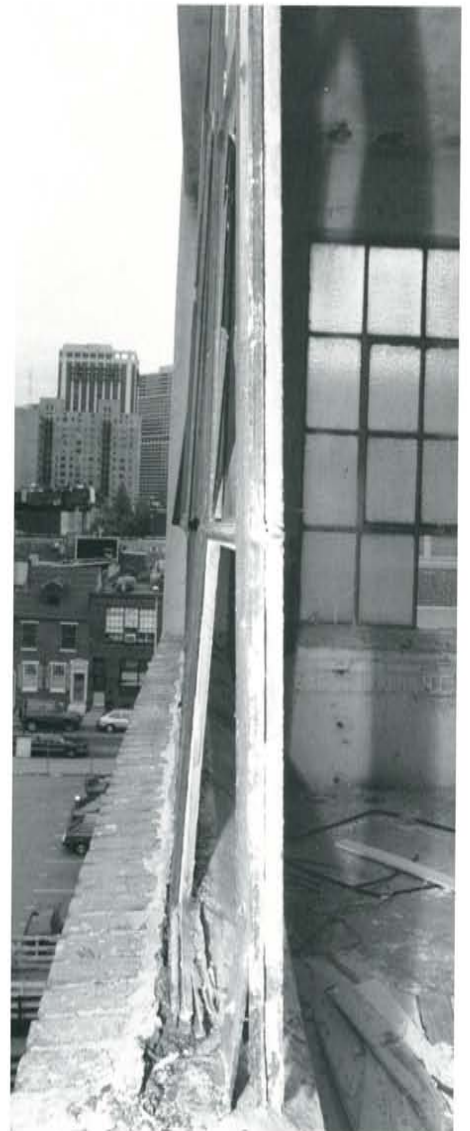
In addition to the retrofitting of the ventilators, many of the window muntins and structural mullions needed to be straightened, patched and repaired (see figure 8). Members that were seriously bowed and could not be adequately straightened were cut off using grinding wheels and salvaged;

Figure 8. Bowed and corroded window during construction. Photo: Clio Group.

replacement members were welded into place. Two relatively simple techniques were used to straighten the less seriously bent and bowed steel members. With mullions, a wooden brace (usually a two-by-four) was attached to the mullion; a wire cable was wrapped around the wooden brace and the mullion; and slowly the cable was pulled with a "come-along" winch hooked to the ceiling of the building. Since the mullions had typically bowed toward the exterior, the member was pulled in the direction opposite its bowing, towards the inside of the building. To straighten out bent and bowed muntins, the contractor applied constant pressure through the use of 14" bar-type clamps on the muntin. All indentations and gouges left in the steel members were filled with an auto-body patching compound containing steel fibers and an epoxy binder, sanded smooth and primed with a rust-inhibiting primer.

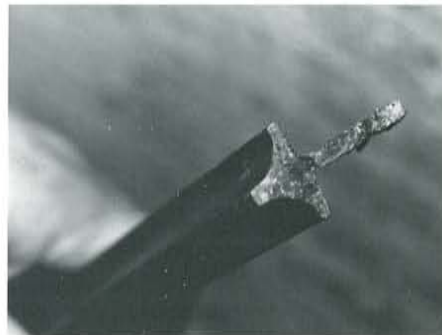
Figure 10. Replacement steel window section used primarily in the sill areas. Photo: Clio Group.

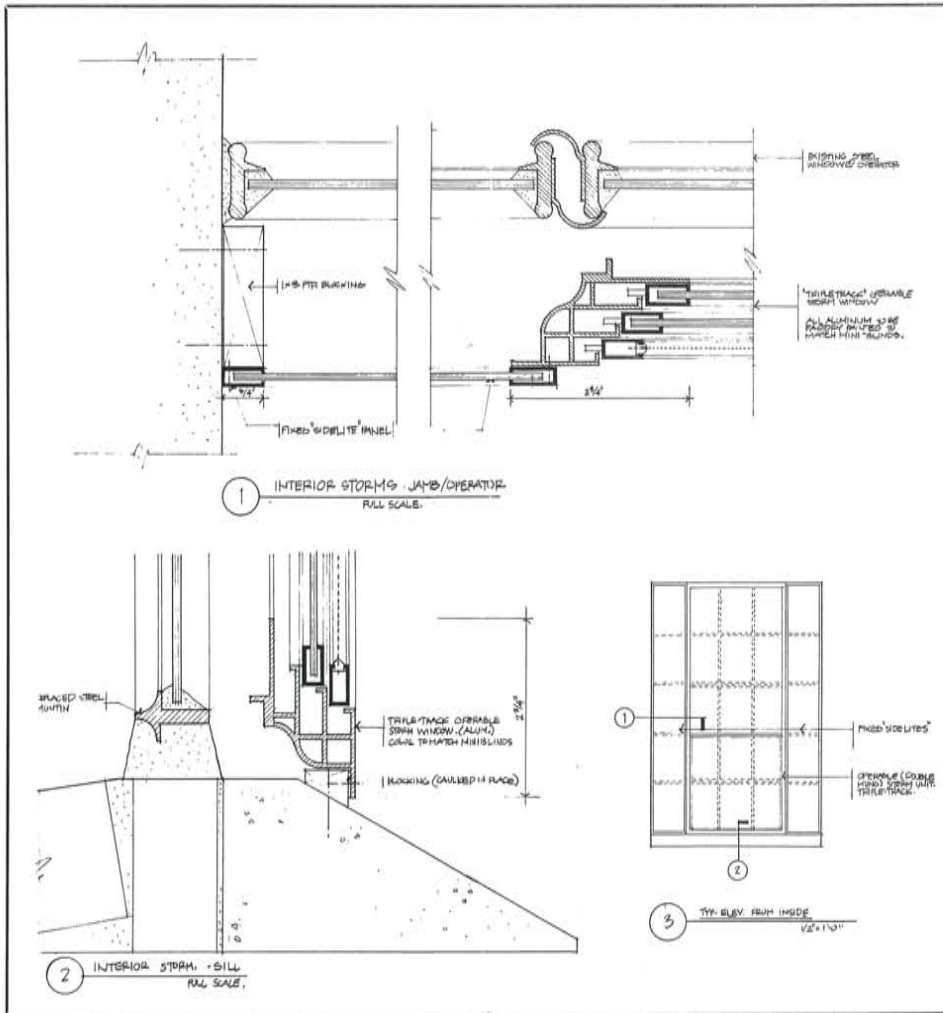
Figure 11. Interior storm window drawings, showing the alignment of the storm and steel window members. Drawings: H2L2 Architects.

the existing steel windows in and of itself was not sufficient in bringing the windows up to code. The development of an interior storm window system provided the additional thermal performance for code compliance. The solution involved an aluminum, triple-track, interior storm unit with flanking, fixed "sidelites" (see figure 11). A major consideration in the development of this storm system was the desire to minimize the outside visibility of the storm unit by aligning as closely as possible the meeting rails and other aluminum members with the steel window members (see figure 12). The exterior face of the storm windows was painted the same color as the steel windows so as to be as inobtrusive as possible (see figure 13). Although, the aluminum members do not match exactly the width of the opposite steel members, the storm windows were not readily visible from the exterior.

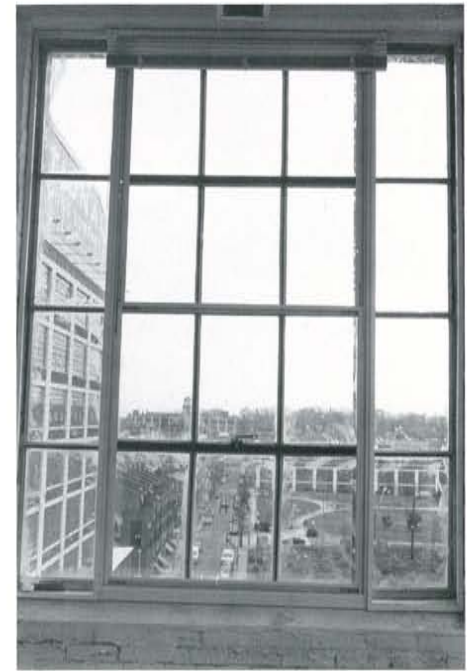
Figure 12. Installed interior triple-track storm window with fixed sidelights. Photo: Clio Group.
