MASONRY

Water Soak Cleaning of Limestone

Robert M. Powers
Mid-Atlantic Regional Office
National Park Service

THE WIDENER BUILDING Philadelphia, Pennsylvania

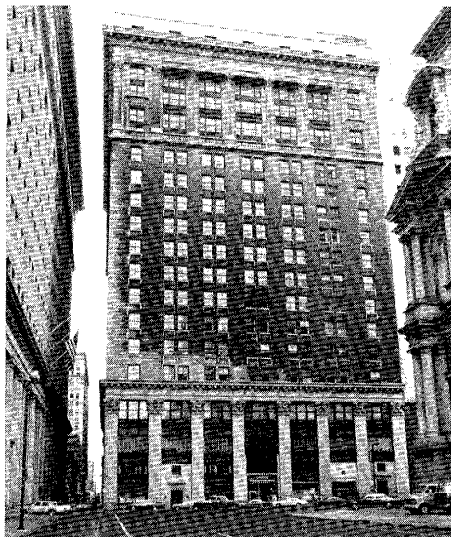
Figure 1. In 1989, just prior to the onset of the rehabilitation project, the Widener Building was showing the effects of 75 years of exposure to an urban environment. Note the lighter color of the left side of the building regularly washed by rain. Photo: John Milner Associates.

to seventy-five years of exposure to an urban/industrial environment and had never been cleaned, the masonry surfaces were heavily coated with typical deposits of air-borne particulates of soot, fly ash, tar and clay matter as well as localized areas of organic matter. These deposits in conjunction with sulfur oxides accelerate the decay process of the calcareous stones such as limestone by forming non-stable, highly soluble and chemically-reactive crusts that increase the stone's surface area and ultimately leave the stone more vulnerable to damage from continuing deposition attack.

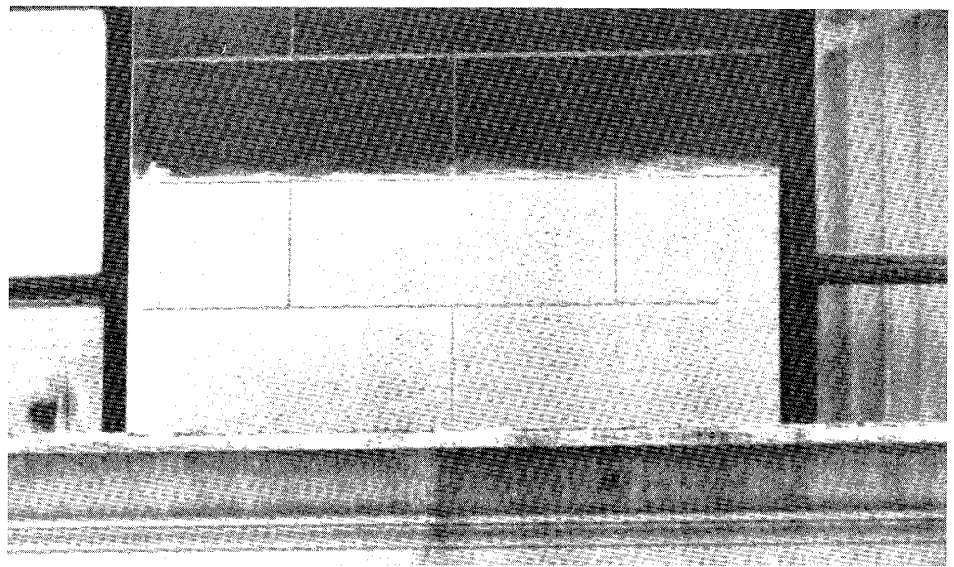
Figure 2. The three test panels were carried out on the right side of the 4th floor of the South Penn Square elevation directly above the cornice that tops the 3-story storefront columns. (a) The completed panel on which the water soak method was tested; (b) the second completed panel after testing with the two-part alkaline chemical cleaner; and (c) the third completed panel after testing with the one-part alkaline chemical cleaner. Photos: John Milner Associates.

For this test, the limestone was soaked for 4 hours with low-pressure water from an oscillating sprinkler in order to dissolve and loosen the pollutant crust. After the 4-hour soak, the loosened crust and remaining particulate matter were rinsed off the stone surface by a pressure washer with a 45 degree fan tip nozzle at 400 pounds per square inch (psi) using approximately 5 gallons of water per minute (gpm) (see figure 2a).

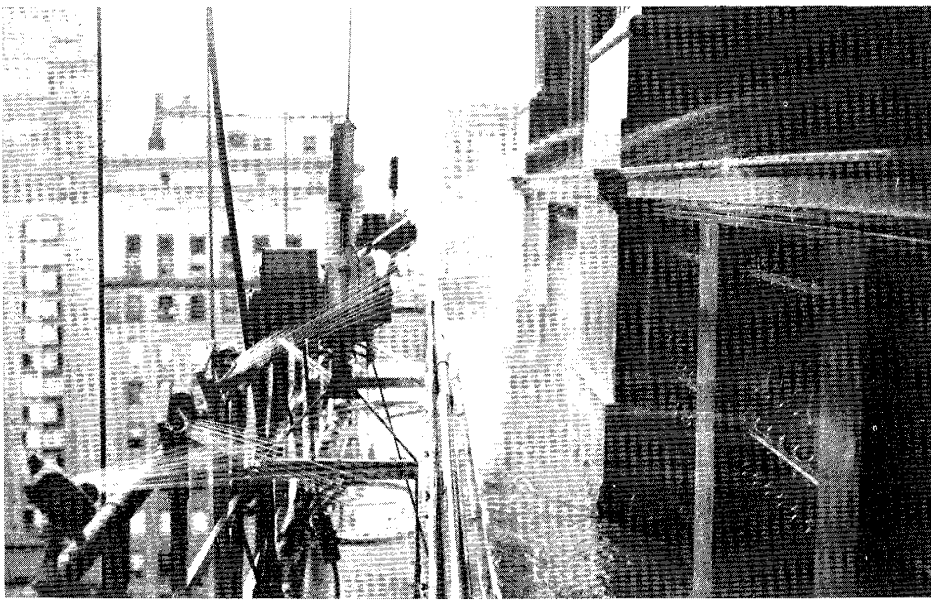
Figure 3. Close-up view of the oscillating sprinklers spaced 3 feet apart and connected to 1/4" PVC piping attached to the rear bar of each scaffold. Photo: P & R Masonry Restoration, Inc.

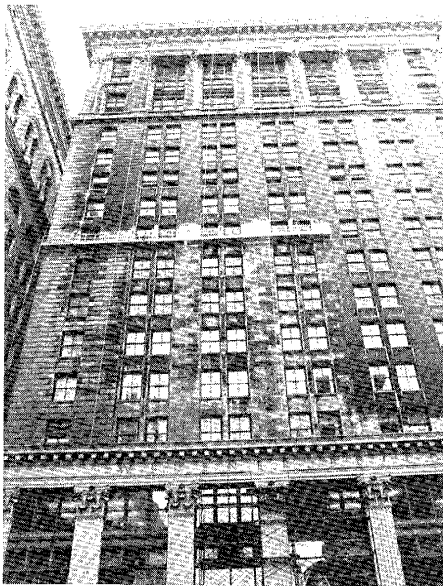
Figure 4. South Penn Square elevation after the completion of two drops from the 9th-4th floors of water soaking only, and prior to beginning the rinse process. Photo: P & R Masonry Restoration, Inc.

soaking had been completed on both drops (a “drop” is the amount of vertical wall surface that can be covered by one scaffold moving vertically up or down a building), the crew began the rinsing process this time moving down the elevation, starting from the 9th floor and proceeding to the 4th (*see figure 4*).

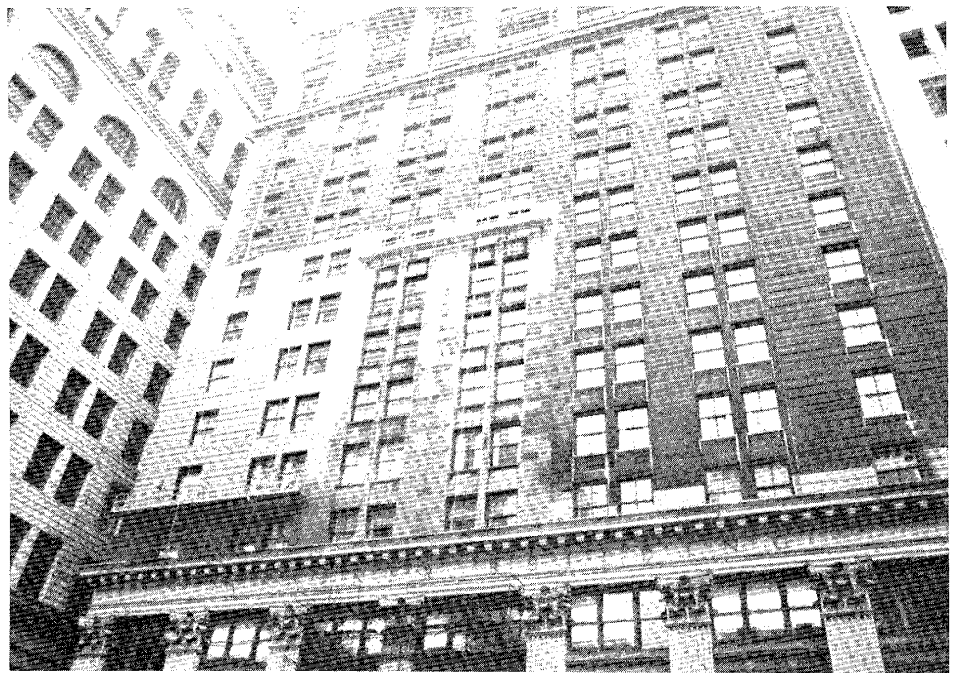
Figure 5. The drop on the left side of the building has been water-soaked and rinsed, while the drop on the right has been soaked only. Note the amount of soil that still remains on the right side before rinsing. Photo: P & R Masonry Restoration, Inc.

For the rinsing process, two pressure washers were placed atop the building with pressure hoses extending to the scaffolds. Each machine generated a pressure of 400 psi and 5 gpm. Throughout the cleaning, one worker per scaffold used a short-handled spray wand with a 30 degree nozzle to rinse away loose material and clean out the pores of the stone. The nozzle was kept a minimum of two feet away from the masonry surface at all times (*see figure 5*).

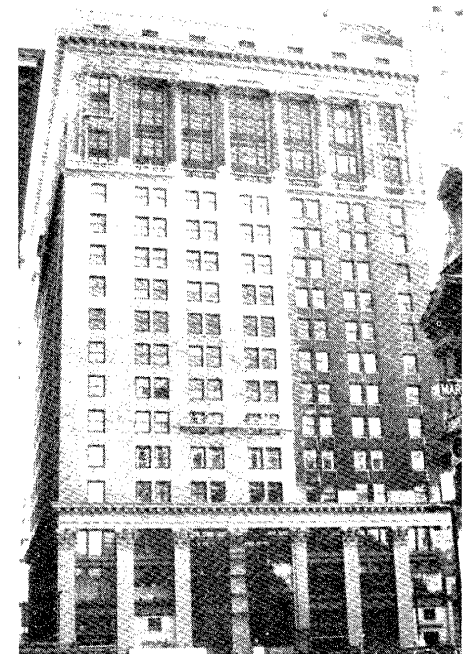
Figure 6. The contrast between the cleaned and the uncleaned portions of the facade after completion of both the water soak and the washdown rinse of these two drops from the 14th-4th floors is dramatic. Photo: Robert M. Powers.

After cleaning (soaking and rinsing) the 4th through the 9th floors, both scaffolds were moved up to the 10th floor where the soaking process was begun again and was continued up through the 13th floor (*see figure 6*). This section was then rinsed, and the soaking process recommenced at the 14th floor and proceeded to the cornice at the top of the building.

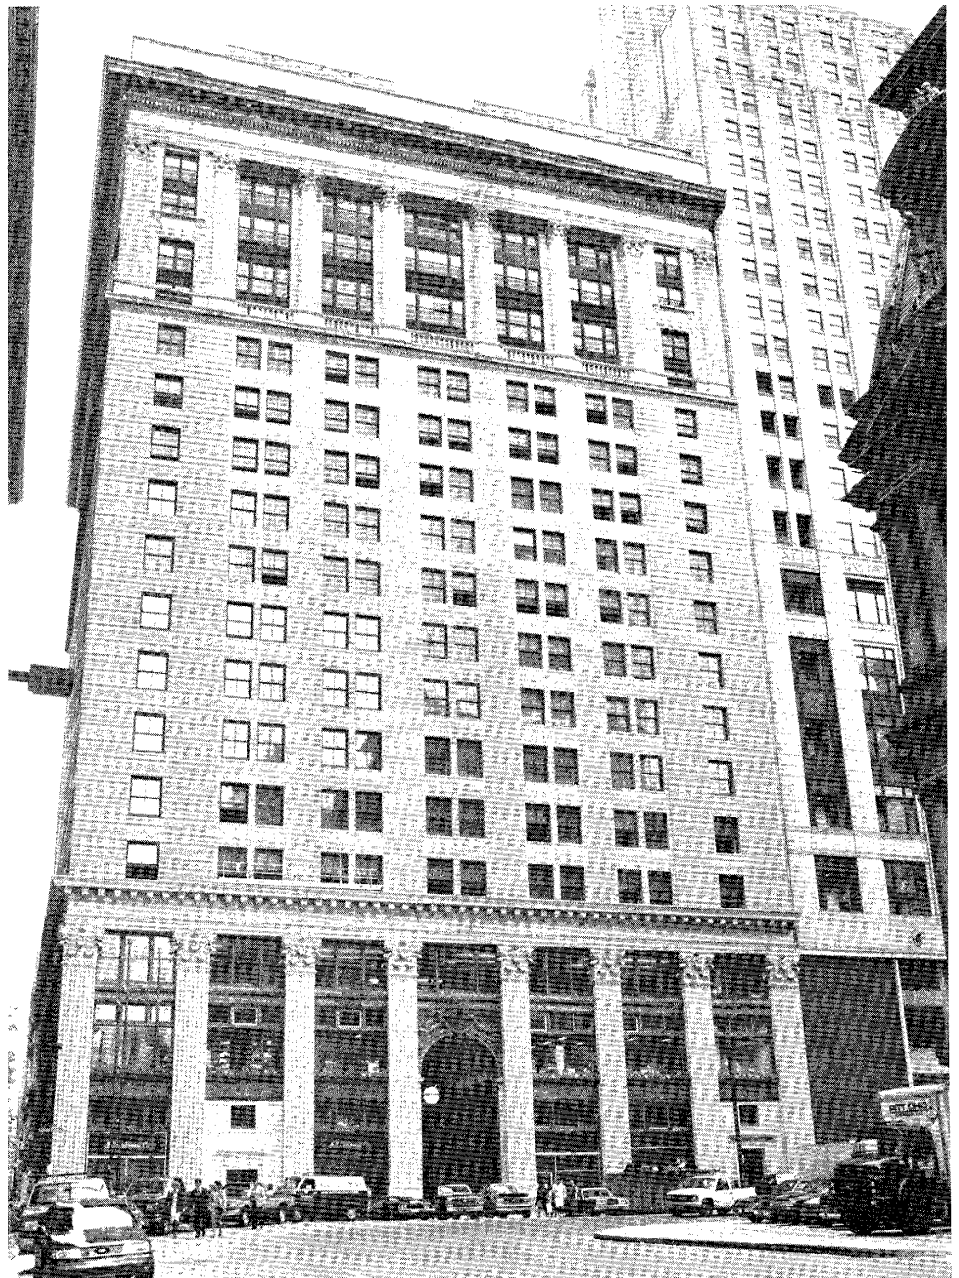
Water soaking is a cost-effective cleaning process for both large and small limestone buildings. The results of the cleaning of the Widener Building are startling, especially when compared to the appearance of the stone prior to the start of the project (*see figure 7*). Although the cleaning team was on the job site for a longer

Figure 7. The South Penn Square elevation after its successful cleaning using the water soak method. Photo: Faherty/Kelter Associates, Inc.
