Tech Notes

The Monadnock Building
Chicago, Illinois

Preserving Historic Office Building Corridors

Thomas G. Keohan
Division of Cultural Resources
Rocky Mountain Regional Office
National Park Service

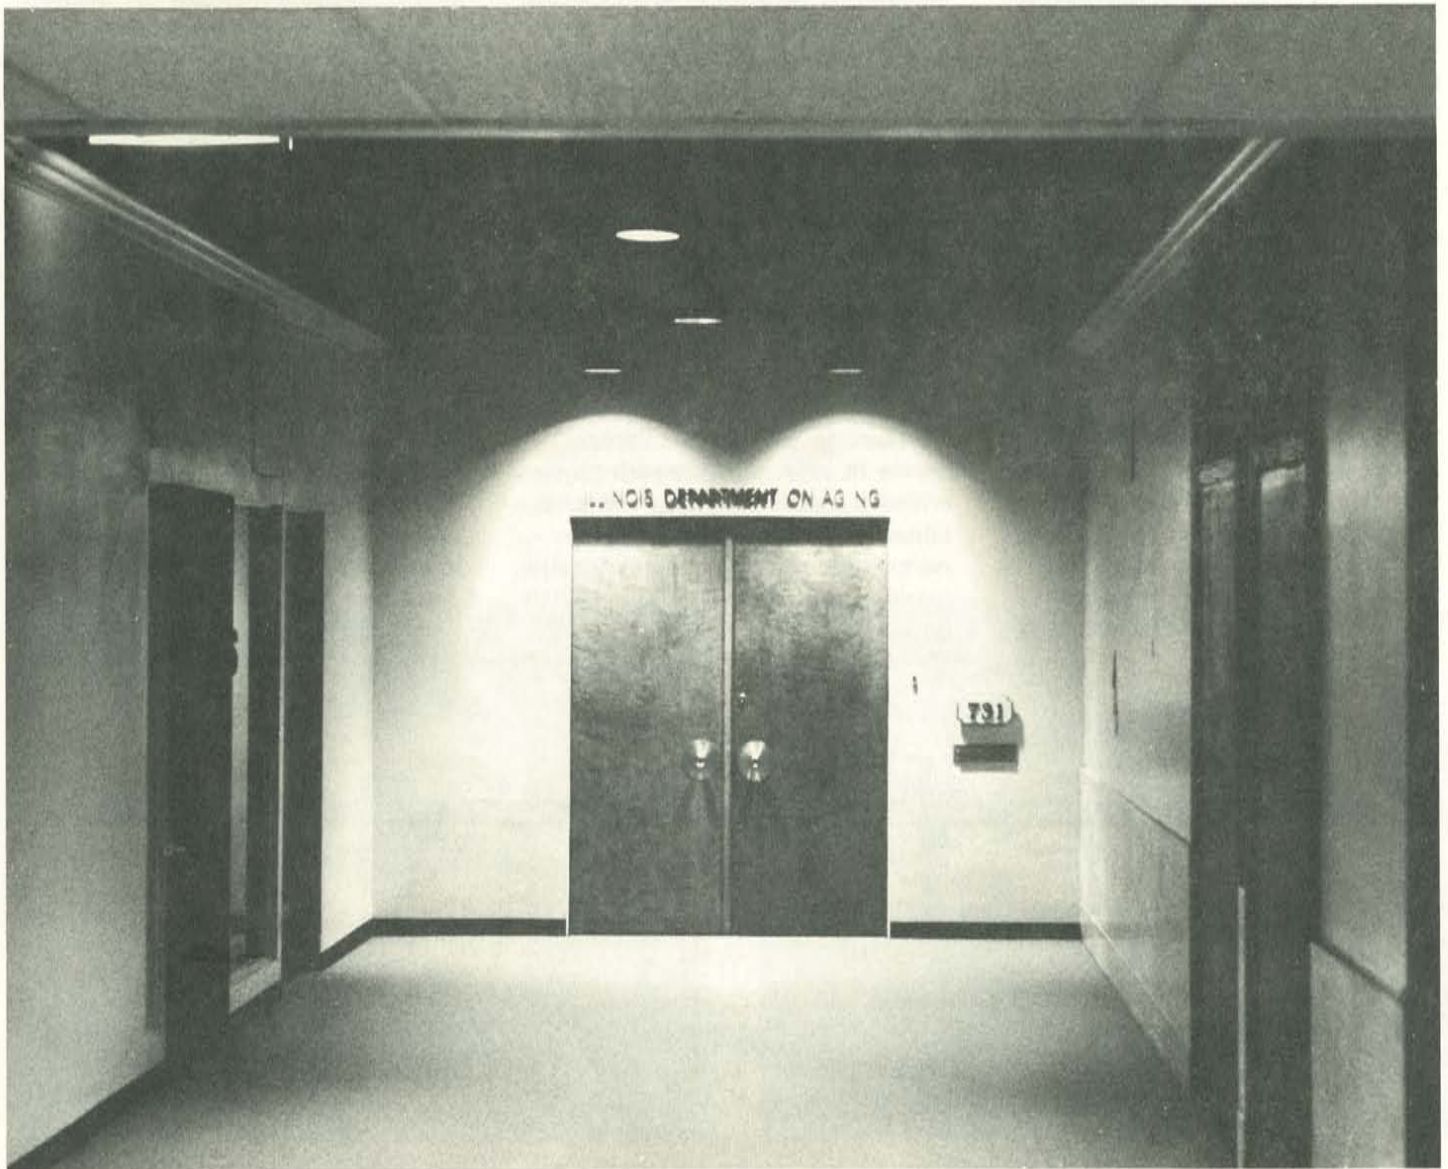
The Monadnock's historic interior corridors and office suites had suffered considerably because of past insensitive remodeling. Prior owners had dropped ceilings for mechanical equipment, removed large sections of the historic marble wainscotting, and painted over the ornamental cast-iron staircases and bronze door hardware. Almost all of the feather-chipped glass partitions, oak trim, and glass

office doors and transoms had been removed or covered over. On several floors the corridors had been entirely removed or shortened to accommodate open floor plan offices. (See figure 2).

Figure 2. Typical condition of public corridors prior to rehabilitation. Glass and oak corridor partitions and much of the marble wainscot was either removed or covered. Ceilings were suspended and sections of the corridor plan were shortened or removed.

A third, more historically sensitive option was chosen. This option involved retaining the existing historic corridors and re-establishing corridors to match the historic ones on floors where they had been removed. The plans also called for smaller individual offices with a basic office module of about 600 square feet, which was close to the size of the historic office suites. (The marketing plan targeted lawyers and other professional businesses requiring smaller office spaces).

Approximately one-third of the corridors were missing before the rehabilitation began. Such areas were rebuilt to the historic configuration. Another one-third required some remodeling of existing wall finishes and floor plans, while the remaining one-third required minimal work such as repairing and replacing office doors and door hardware, removing paint, and refinishing wood trim.

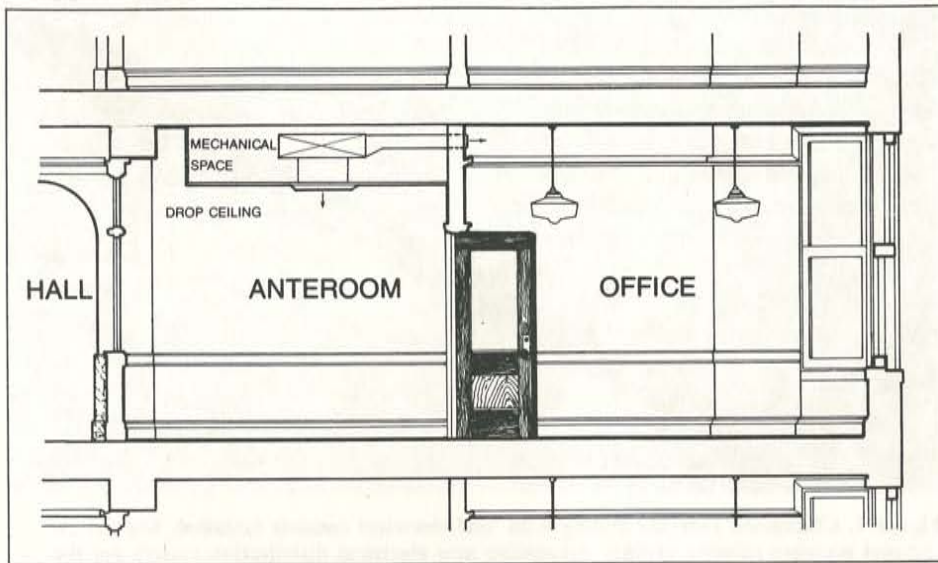
Figure 4. The innovative rehabilitation solution places dropped ceilings only in the anteroom, thus preserving the important historic features in the public corridors and private office spaces. The dropped ceiling area is large enough for future expansion of mechanical and electrical systems. Drawing: Neal Vogel

Typically, the ceilings in office building corridors are dropped to allow for mechanical chases to run longitudinally through the building. Retention of the Monadnock's historic plaster ceilings in the corridors was possible by locating mechanical systems above dropped ceilings in the non-public space adjacent to the corridors. These secretarial anterooms are located between the corridors and private office bays (See figures 1, 3, and 4).

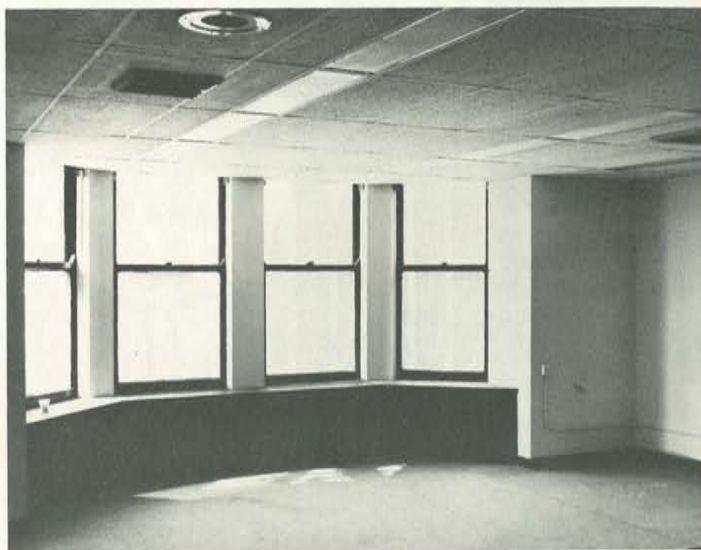
Figure 5. Typical pre-rehabilitation condition in private offices. Approximately 60 percent of all office interiors had suspended ceilings, blocked-down windows and radiator enclosures. Note inappropriate way dropped ceiling abuts windows. Photo: William S. Donnell

The Monadnock was purchased in 1979 by the current owners for \$5 per square foot. The original one-pipe steam heating system was still in place at the time. Rather than replace the existing system with a more costly forced-air unit, the steam system was repaired for less than \$1 per square foot. This included new boilers and controls, asbestos abatement, and new Ammark valves at the radiators.

The German Ammark valves are thermostatically controlled and regulate both steam and return condensation in one pipe. Considerable space was saved by using the existing steam system, and avoiding massive forced air duct work or piping for a new steam system (see figures 5 and 6).

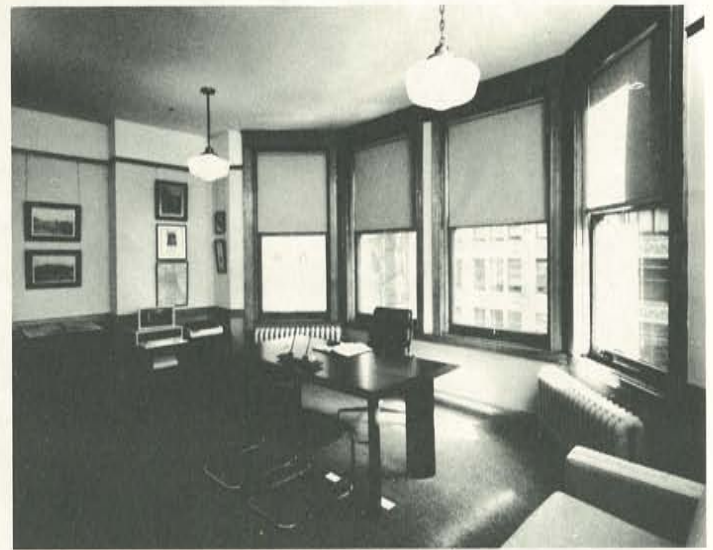
Figure 6. Typical 600 square foot office module after rehabilitation, with full ceiling height and one stand pipe radiator heat. Photo: Ron Gordon

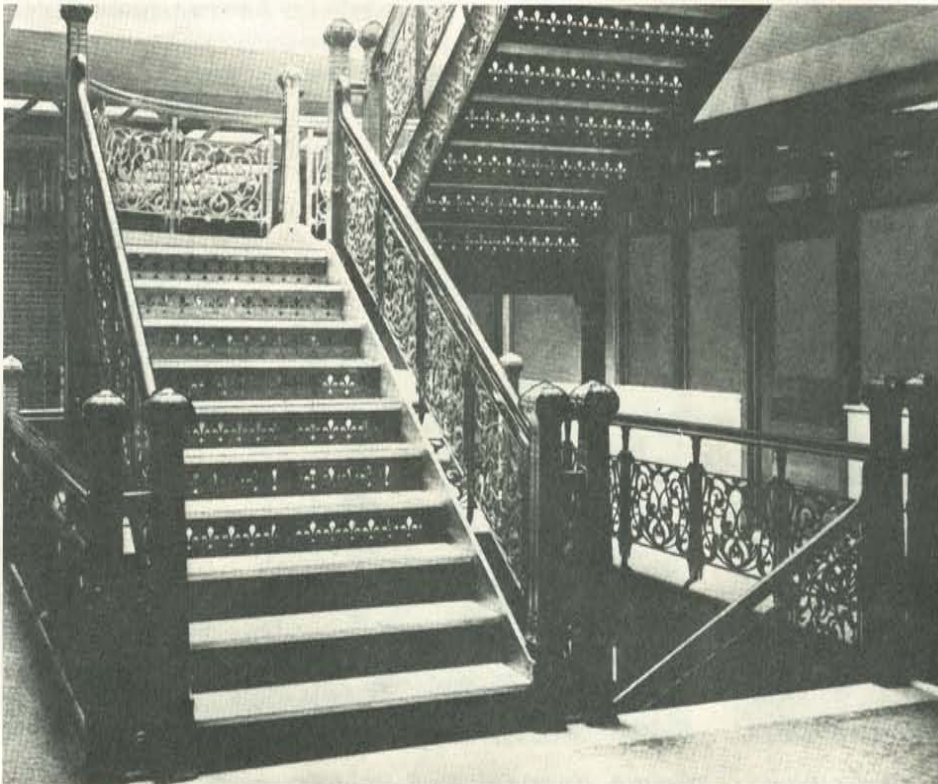
Figure 8. Burnham and Root's aluminum and bronze plated cast-iron stair remains the most notable architectural feature in the north half of the building. Minor repair work and a few missing elements have been replaced with cast aluminum. Favorable building codes allowed the open design.

The ornamental open staircases are significant architectural features and a major focal point of the corridors in both the north and south halves of the building (See figure 8). Beyond their architectural significance, the stairs in the north half of the building from street level to the first floor are cast aluminum and represent the first use of this metal in a building. Upper flights are made of bronze-plated cast iron. These open stairs were allowed to remain intact under a provision of the Chicago Building Code that waives certain code requirements for buildings where

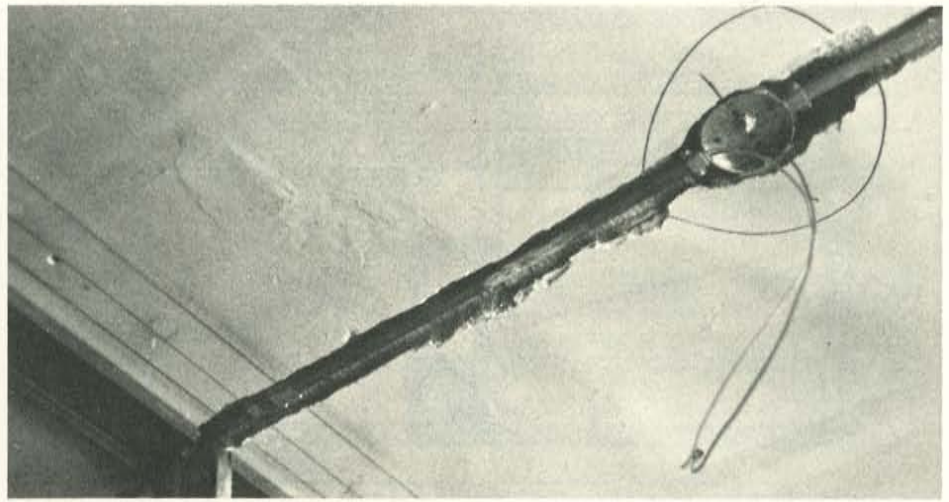
Figure 7. Channeled corridor ceiling with oval electrical conduit installed. Replastered channel matches existing ceiling, concealing new electrical distribution system for the entire building. Photo: William S. Donnell

installed in the building by carefully channeling the ceiling plaster and attaching 3/4-inch oval conduit to the hollow terra-cotta floor sections. The channels were then replastered to match the surrounding ceiling (See figure 7). Dropped ceilings in the anterooms also provided for electrical chases servicing secretarial and private office spaces.

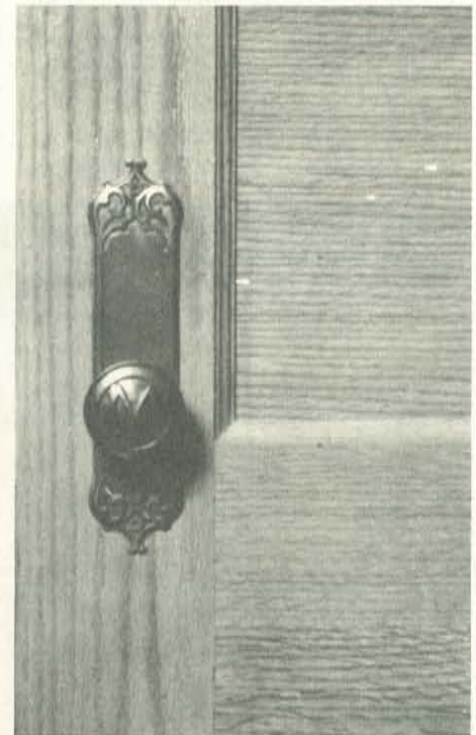
Figure 9. Original cast-iron door hardware retained in corridors. Photo: Ron Gordon

reheated in the manufacturing process to form a dark corrosion-resistant finish simulating cast oxidized bronze. During the course of the rehabilitation, missing and damaged hardware was replaced with actual cast oxidized bronze (See figure 9). As a result, these important historic features remain significant elements within the Monadnock's corridors.

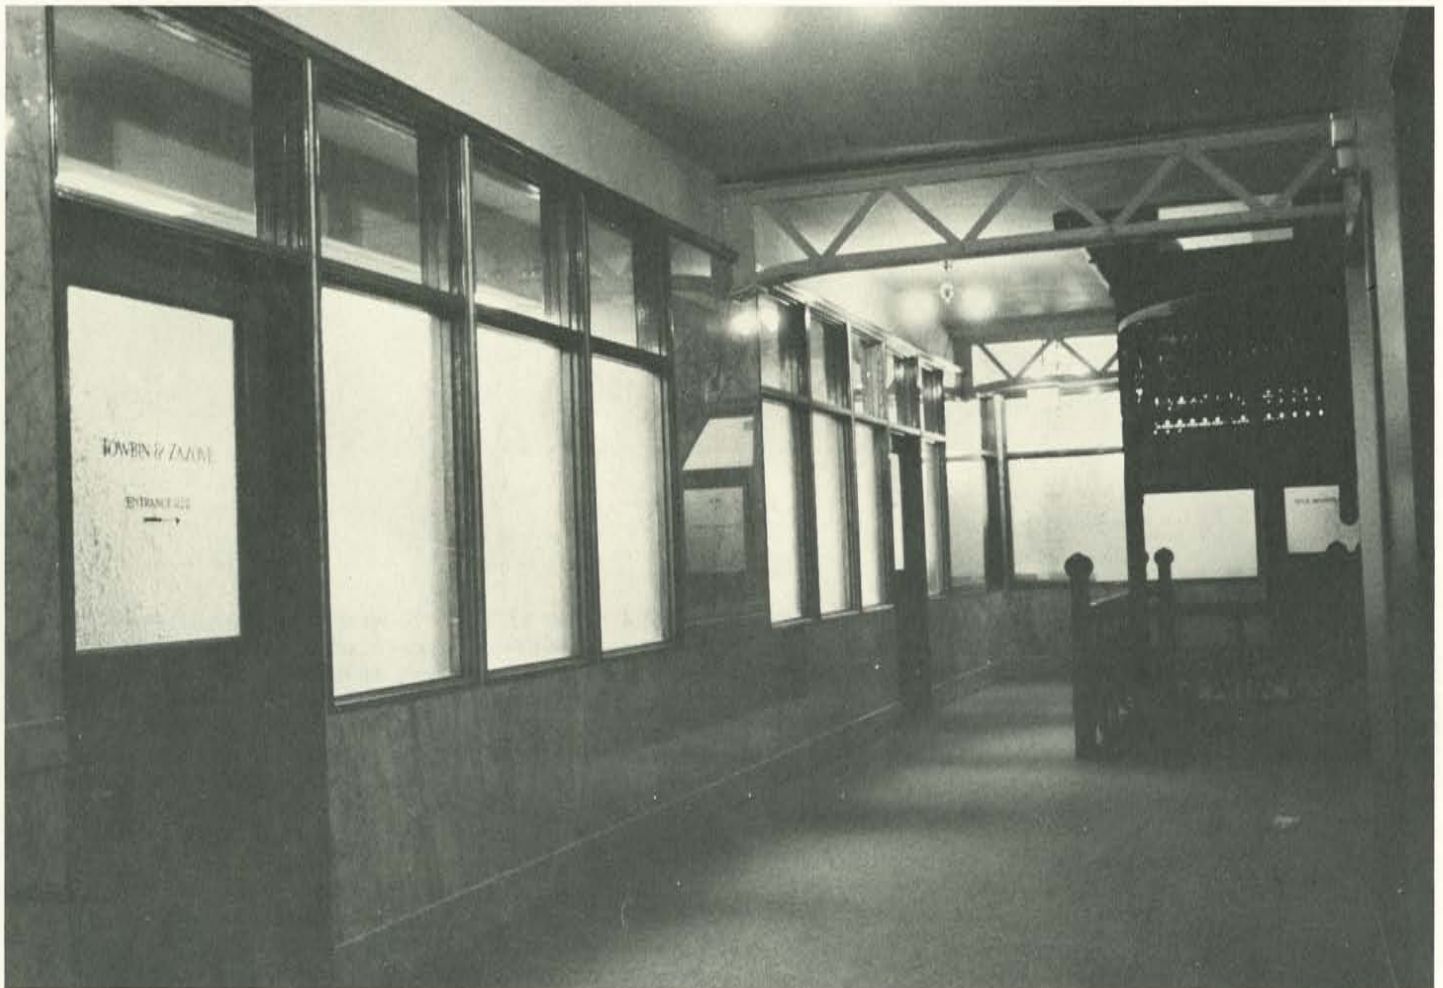
Figure 10. Rehabilitated corridor showing marble wainscot, oak and feather-chipped glass corridor partitions, full ceiling height and open ornamental stairs. Photo: Ron Gordon

The rehabilitation philosophy of retaining and repairing historic corridor fabric where possible and replacing missing elements to match the historic plans proved to have an economic advantage over comparable new construction. While typical office rehabilitations in Chicago require an average investment of \$100 per square foot, the rehabilitation of the Monadnock cost under \$50 per square foot (See figure 10).
