## **THE LAND TITLE BUILDING** **Philadelphia, Pennsylvania**

# **Tech Notes**

## **Stabilization and Repair of a Historic Terra Cotta Cornice**

**Jeffrey S. Levine**  
John Milner Associates

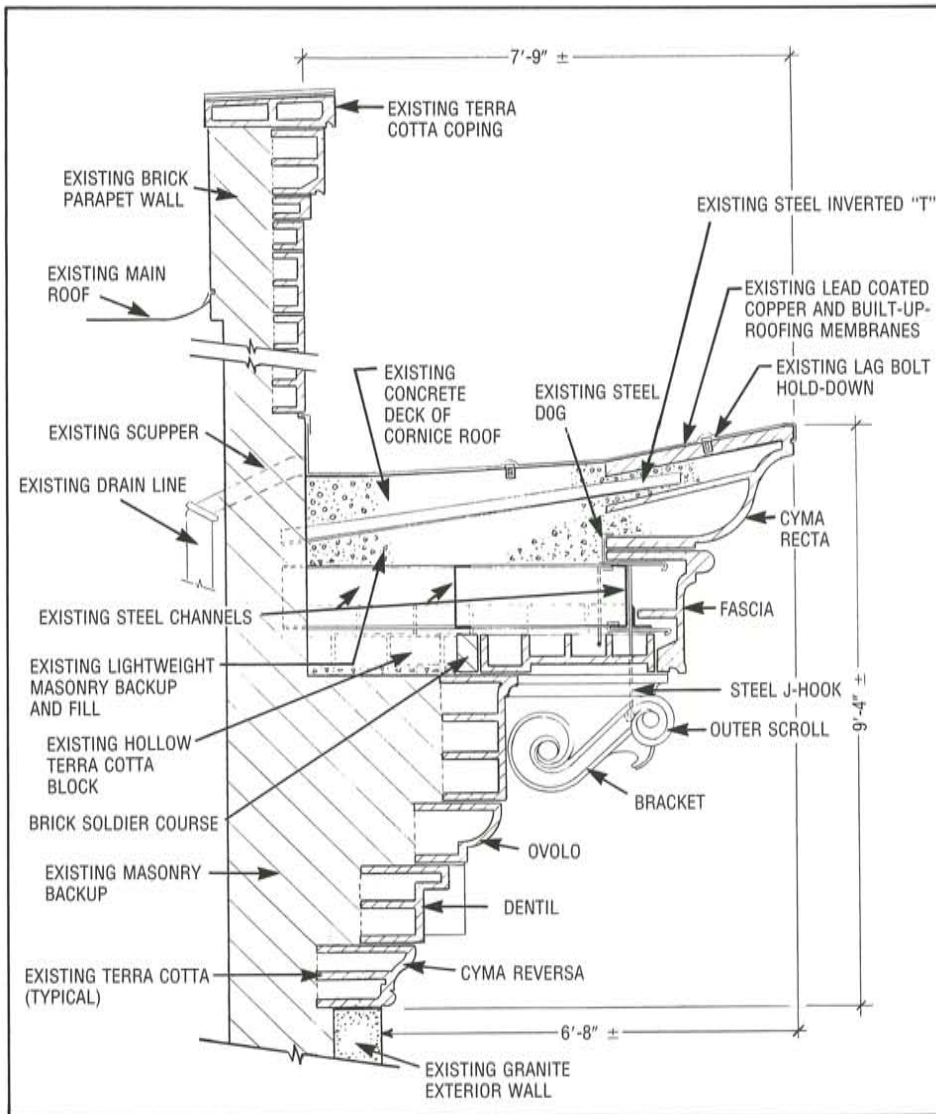
Figure 1. Section through the cornice and the parapet showing the structure's construction and attachment to the building. The inverted T's are embedded in concrete and act in friction to help support the cyma recta unit from rotating outward. The test openings did not penetrate below the soffit level of the cornice. Drawing by Jeffrey S. Levine.

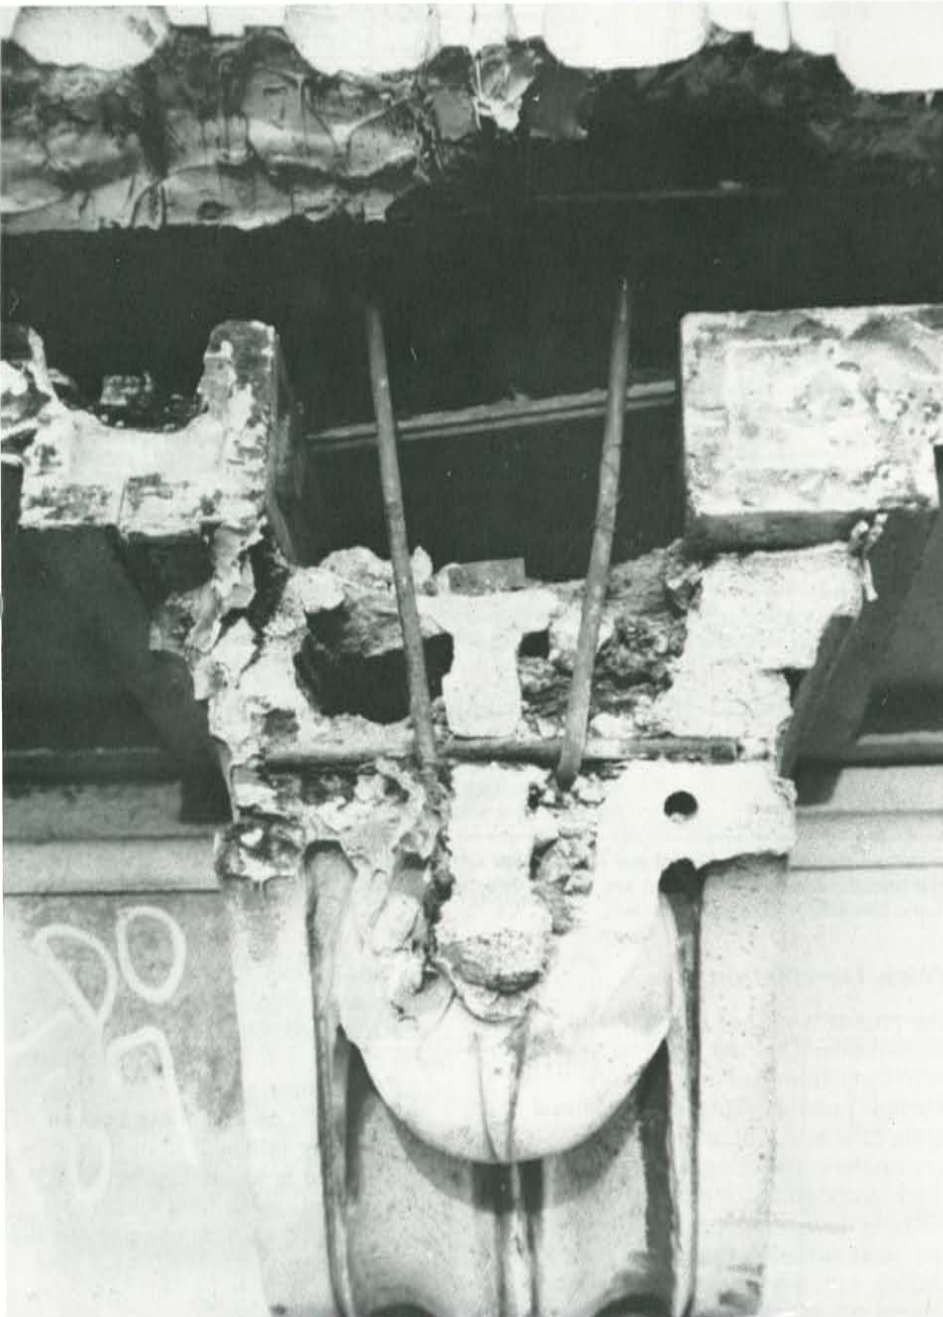
Visual inspection of the terra cotta revealed four common types of deterioration: spalls, glaze crazing, cracking, and open mortar joints. In addition, sounding the terra cotta units with a wooden mallet indicated that roughly 10% of the terra cotta units had cracked internal webs. Deterioration resulting in loss of material appeared with less frequency and was found principally at the outer scroll of the brackets (see figure 3) and at the scalloped fascia (see figure 4).

Figure 3. Numerous brackets were found to be missing their outer scrolls due to oxide jacking of the steel J-hooks, steel pencil rods, and temporary support wires located within the units that were used for installation. Cracking in the brackets whose outer scrolls had not yet broken off indicated potential for further loss of material if stabilization measures were not undertaken.

During the original construction of the cornice, the brackets were hoisted into place and temporarily supported by the wires cast into the nose of the bracket units. J-hooks were then dropped down from the outermost steel channel above into the upper and outermost cells formed by the unit's internal webbing. A steel rod was then inserted horizontally through holes cast into the exterior sides and internal webs of the unit such that, with minor adjustment in the length of the J-hooks, the rod sat in the trough of the J-hooks; the weight of the bracket were thereby transferred to the J-hooks (see also figures 1 and 5). Photo by Jeffrey S. Levine.

Figure 5. Detail section through the cornice showing the manner in which the vertical and angled outer scroll anchors were installed in the bracket units. The vertical hash-marks represent a typical crack pattern found in brackets which had not yet lost their outer scrolls. All 128 brackets received angled outer scroll anchors and about 80 received vertical anchors. Drawing by Jeffrey S. Levine.

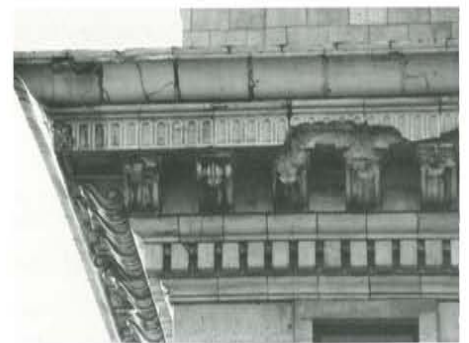
Figure 4. Extreme loss of material was noted in the scalloped fascia above the brackets at the south end of the east elevation of the cornice. This deterioration and corresponding cracking in other fascia units was due to rusting of the structural steel angle iron which supports the fascia units at their center webs (see figure 1). A likely point of water entry was a large open joint located immediately above the fascia, at the bed joint of the cyma recta units. Photo by Jeffrey S. Levine.
