## **BOOTT COTTON MILLS (The Boott Mills) Lowell, Massachusetts**

### **NUMBER 18**

### **Aluminum Replacement Windows With True Divided Lights, Interior Piggyback Storm Panels, and Exposed Historic Wooden Frames**

**Charles Parrott**  
Lowell Historic Preservation  
Commission

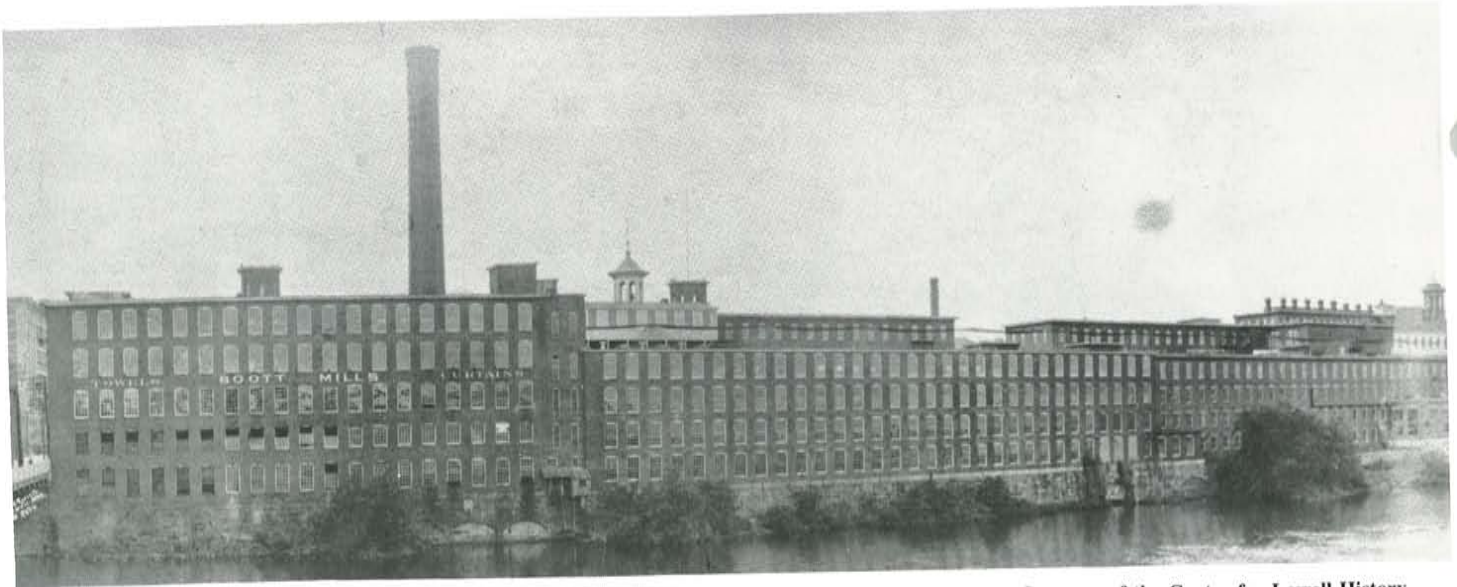
Figure 1. The windows are the dominant element of detail and decoration in the Boott Cotton Mills. Photo: Courtesy of the Center for Lowell History

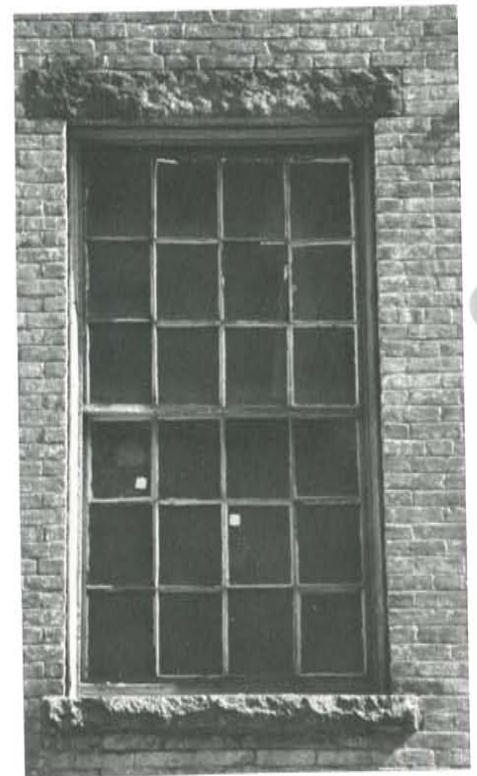
The projected three-phase, \$63 million rehabilitation of the Boott Mills involves 700,000 square feet of space. An appropriate window treatment was foremost among several important preservation design problems. The developer and the historic review commission agreed that one-over-one aluminum replacement windows with exterior muntin grids were not desirable. Because of the significance of the complex, it was established that the windows needed to have true divided lights and that the dimensions and profiles of all visible elements would be near copies of the originals (see figure 2).

Figure 2. Because of the historic character and significance of the complex, replacement sash needed to have true divided lights and the dimensions and profiles of visible elements needed to be close copies of the originals. Photo: Courtesy of Huygens DiMella Shaffer

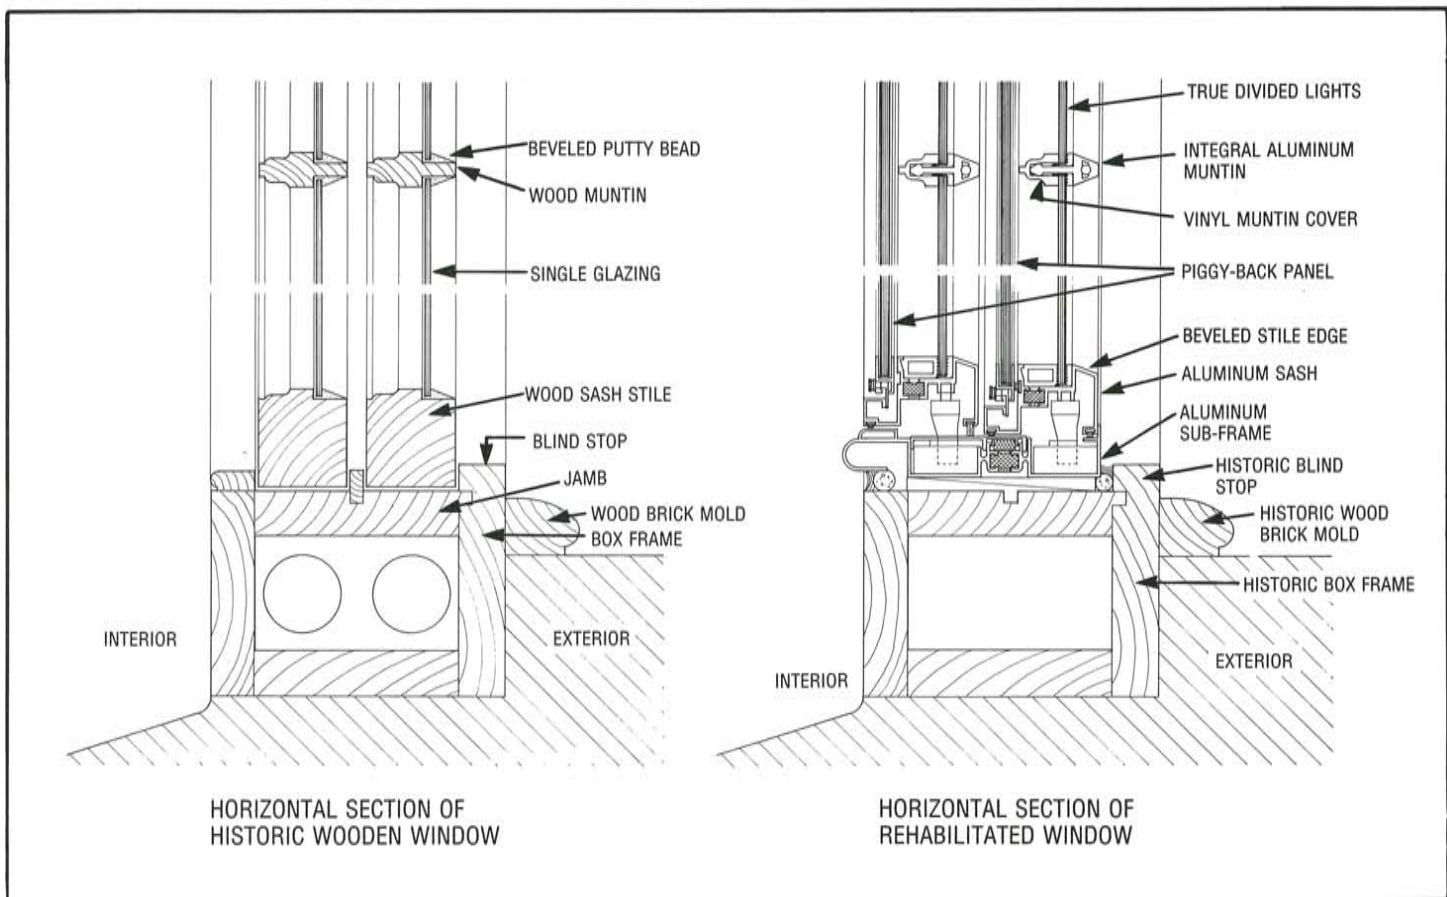
Figure 3. Horizontal section of the window shown with old and new sash. Drawing: Timothy Buehner

Boott Mills, it was necessary to limit the muntin-supported glass panes to single glazing, as in a historic window, and to achieve double glazing with a secondary window system (see figure 3). This secondary window consisted of a "piggy-back" interior glazing panel, which left exposed on the exterior the multiple facets of the true divided lights so characteristic of historic multiple-pane windows. The interior glazing panel was attached to the room side of the sash. It was also decided that the existing wooden frames would be retained and used to receive the aluminum sub-frame for the new window. Finally, new aluminum extrusions were to be made for all members to ensure a very close match to the historic units.

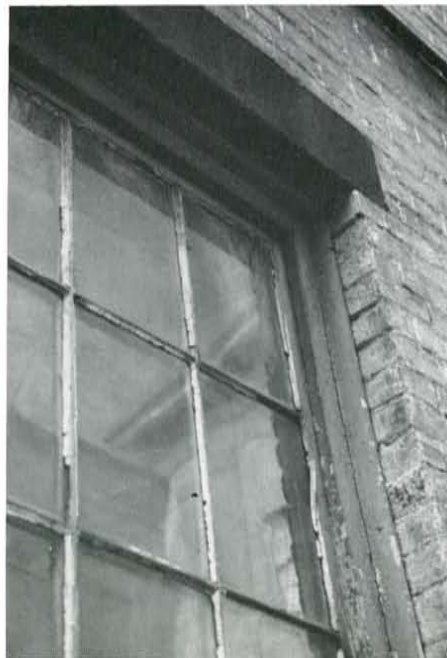
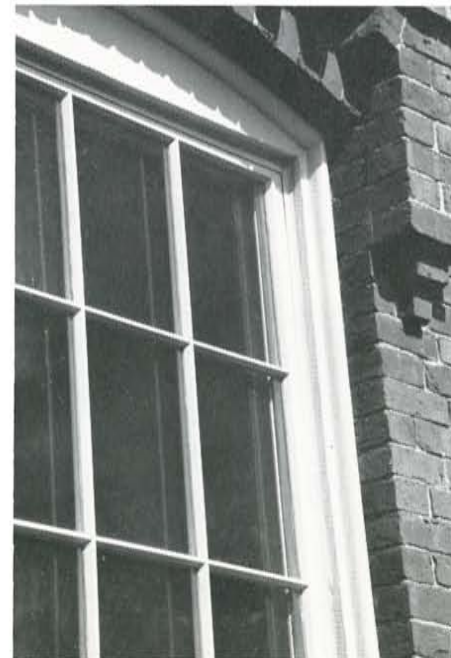
Figure 4. The decision to use an integral muntin for the outer glazing and a piggy-back interior glazing panel was an important component of the successful window solution. Sash shown before and after rehabilitation. Photos: Charles Parrott

was narrowed and profiled to approximate the beveled glazing bead and sticking of the historic wooden muntins. However, it was found that the technology of the 1985 three-piece muntin system could be reduced only to about  $\frac{7}{8}$ " in thickness. A new two-piece true muntin was then developed by the manufacturer that met the general dimensions and profile of the putty-glazed historic muntin; it provided the needed strength and proved to be simpler in design and less expensive to fabricate. This muntin consisted of an aluminum tee extrusion with a trapezoidal flange and a web terminating in a triangle-shaped point over which a profiled cover of extruded rigid PVC was snapped to hold the glass panes in place. Plastic was used for this cover to provide the flexibility needed to remove the cover in case of glass breakage and to provide the thermal break to insulate the aluminum tee member. The snap cover extrusion was to be made in the pre-selected custom color chosen for the window (see figure 4).

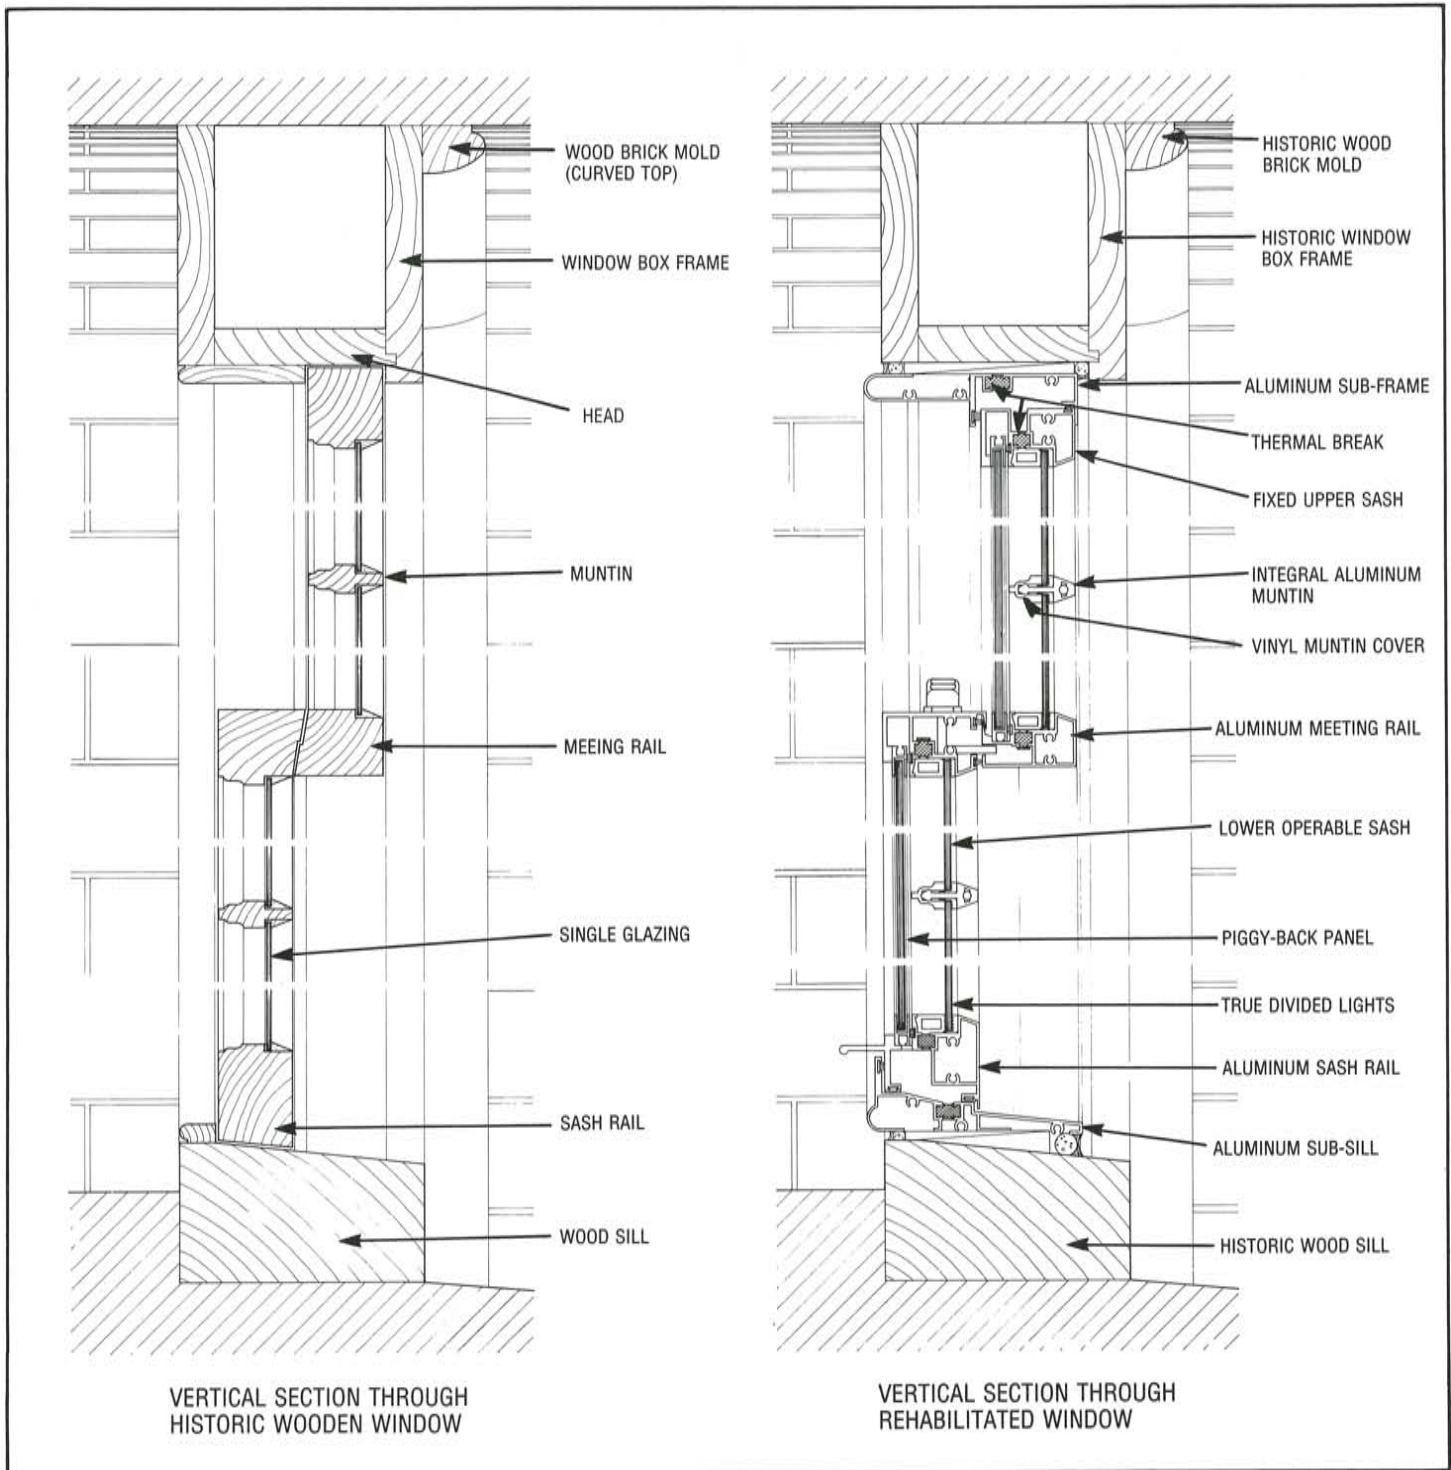
Figure 5. Vertical section of the window shown with old and new sash. Drawing: Timothy Buehner

On the sub-frame, a drip edge that broke the sight line at the head was eliminated as unnecessary. The detailing of the sub-frame was also revised to facilitate installation into the existing frame from the building interior. This resulted in a cleaner interior finish; however, it also increased the height of the sub-sill, making it somewhat more visible on the exterior. The overall depth of the early design was also reduced, resulting in a final depth only about  $\frac{1}{2}$ " larger than the historic window. Because the muntin had to clear the piggy-back panel behind it, the overall muntin depth was to be  $1\frac{1}{16}$ ", just  $\frac{3}{16}$ " less than the historic ones (see figure 5).

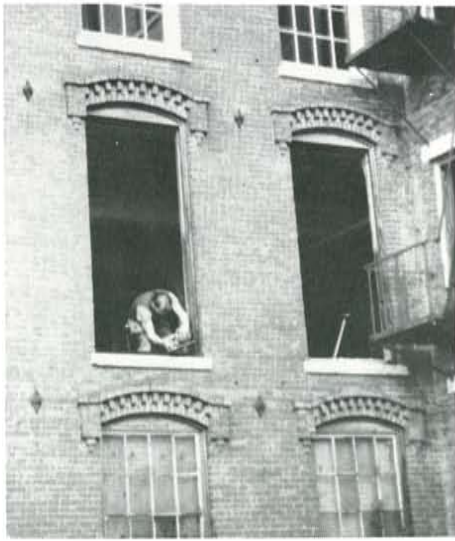
Figure 6. Work on the frames consisted largely of making dutchman repairs to the pulley stiles where required; renailing or replacing brick moldings; replacing some sills; and surface preparation. Photo: Charles Fisher

The exterior of the wooden frames were not to be panned or covered in aluminum. Thus it was important both for aesthetic consideration and good paint performance that the wood frames be repaired and surfaces properly finished. Work on the frames consisted largely of making dutchman repairs to the pulley stiles where required; renailing or replacing brick molding; replacing some sills; and scraping, filling and sanding wood surfaces. Painting consisted of priming and two coats of alkyd oil paint (see figure 6).

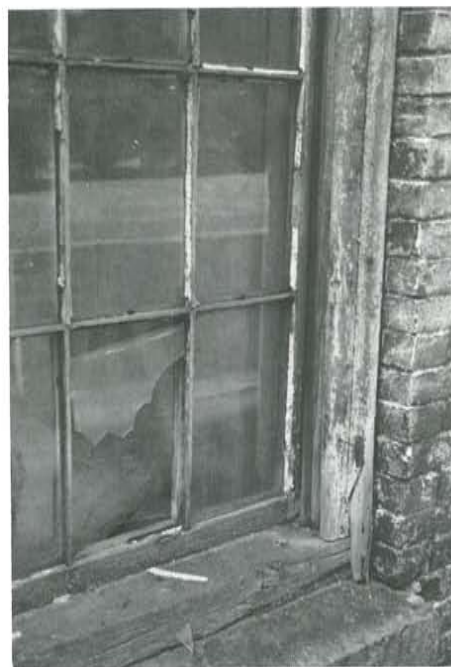
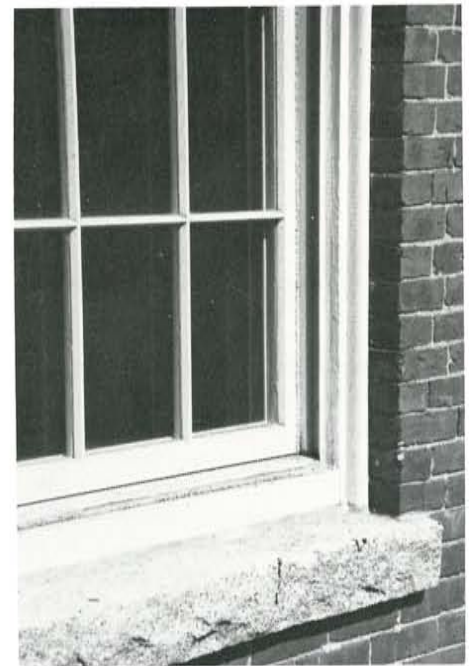
Figure 7. The retention of the exposed outer face of the historic wooden frame and the sill detailing were important qualities of the window treatment. Before and after photos: Charles Parrott

Installation of the new sash went quickly and smoothly. First, the sub-frame was inserted in the prepared opening from the room side, shimming to plumb, line and level before attaching screws through the head and jambs into the old frame. The sash were then installed and the windows were caulked on both the interior and exterior to complete the work (see figure 7).

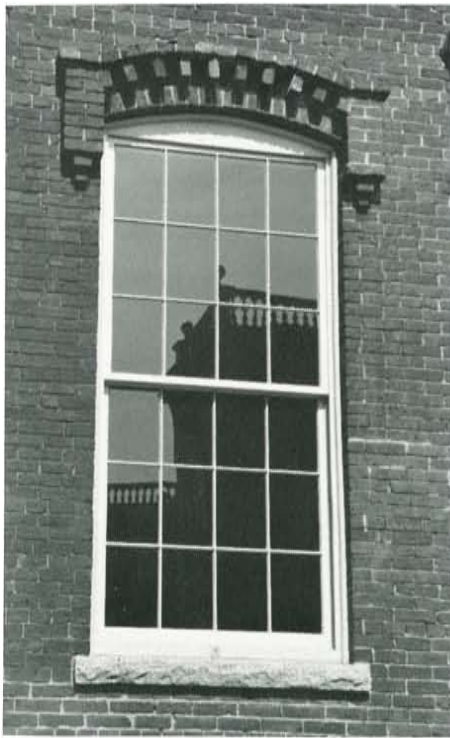
Figure 8. Replacement window sash after installation. Photo: Charles Parrott

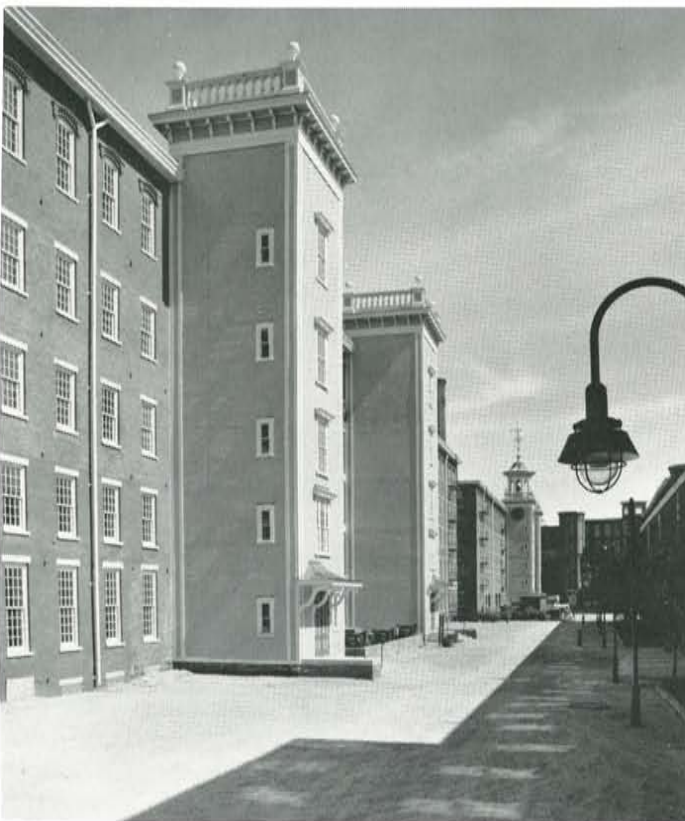
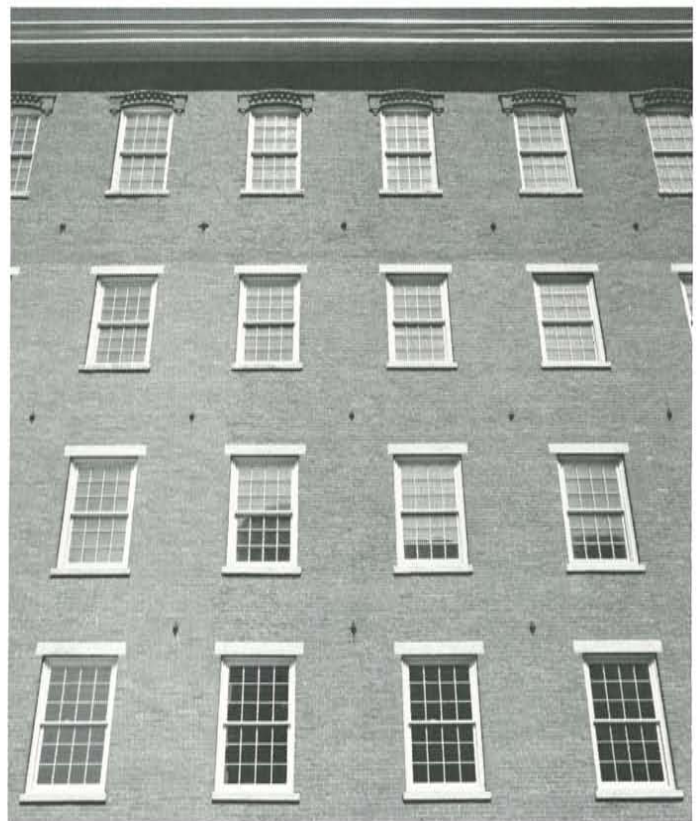
Figure 9. The window solution represents an important advance in the way in which aluminum windows can be designed to capture more fully the appearance of historic windows in larger buildings. Right photo shows wood sash in bottom row and aluminum in the upper three rows. Photos: Jim Higgins ©
