## THE STILLWATER ROAD (SHEA) BRIDGE Cumberland, Rhode Island

## METALS NUMBER 4

### Rehabilitating a Historic Iron Bridge

Joseph P. Saldibar, III

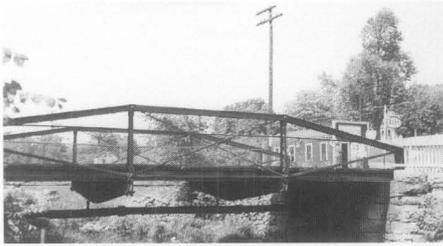
Figure 1. The Stillwater Road Bridge is shown on its original site in Smithfield, Rhode Island, in 1942. Following the decision to replace the historic iron bridge, it was subsequently dismantled, rehabilitated, moved, and re-assembled in nearby Cumberland. Photo: Rhode Island Department of Public Works.

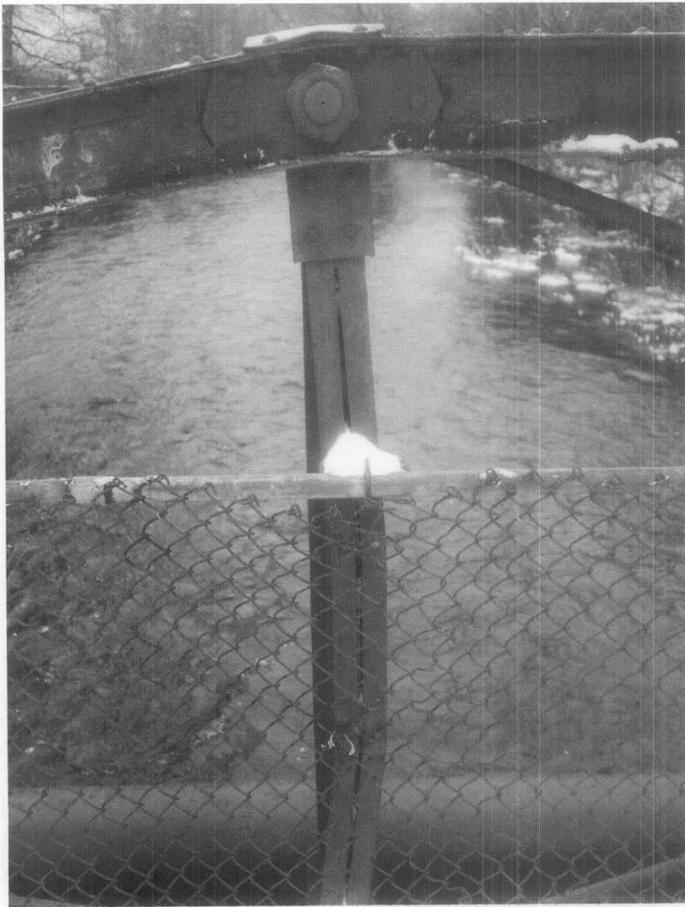
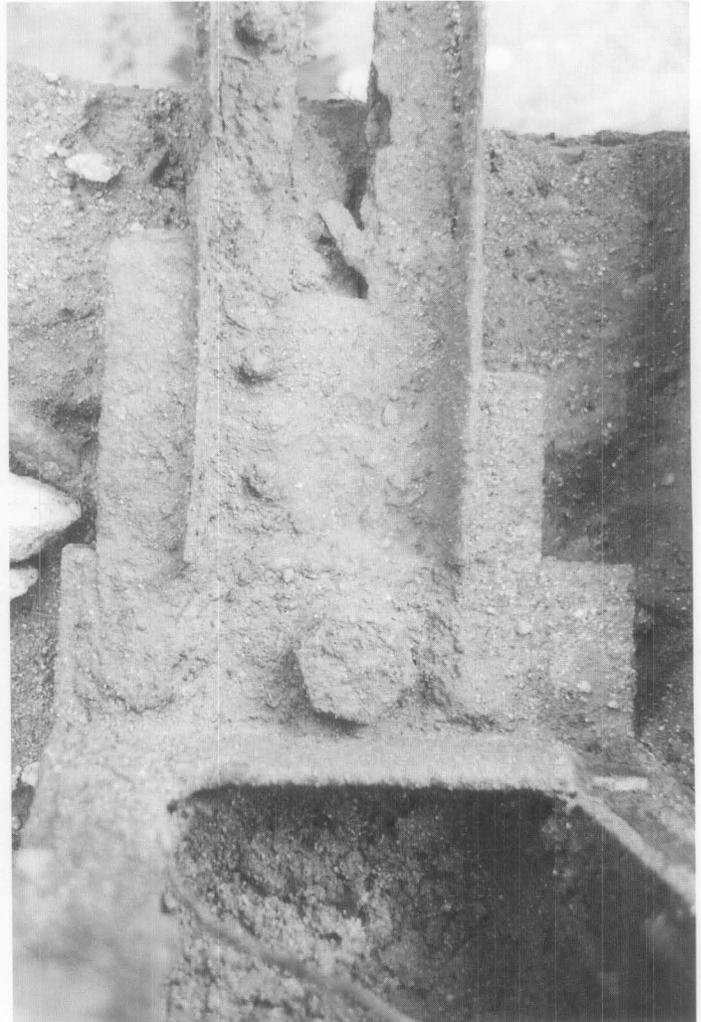
After a century of use, the bridge showed signs of major deterioration. Three of the four upright posts were bent from automobile collisions. The U-bolt floorbeam hangers had rusted, the result

of moisture and dirt collecting on the flange. The lattice girder stiffeners (zero-force members which serve to prevent "racking" or lateral movement) had lost their latticework and were severely corroded. In addition, the endposts of the bridge showed signs of serious decay (see figures 2 and 3).

Figures 2 and 3. The extent of damage can be seen in the bent vertical post member (below, left) and the heavily corroded end post (right). Similar problems existed throughout the structure. Photo: Beta Engineering.

Some parts were so deteriorated that they could not be preserved and re-used as planned, including the end posts, lattice girder stiffeners, and all four vertical (lattice girder) stiffeners. This was somewhat disappointing, as the original specifications called only for the removal of the floorbeam hangers, and the intent was to save as many of the original parts and fasteners as possible. The new, matching members would be more cost-effective and actually stronger than repairing the original pieces. The other drawback was that the new elements would need to be fabricated of steel, rather than higher-priced wrought iron. Once completed, however, the

Meanwhile, the endposts, lattice girder stiffeners, and vertical posts were being fabricated from steel (see figure 8). The original end posts had been constructed as a box section; one plate and two angle iron pieces were riveted together to form a column with one lattice side.

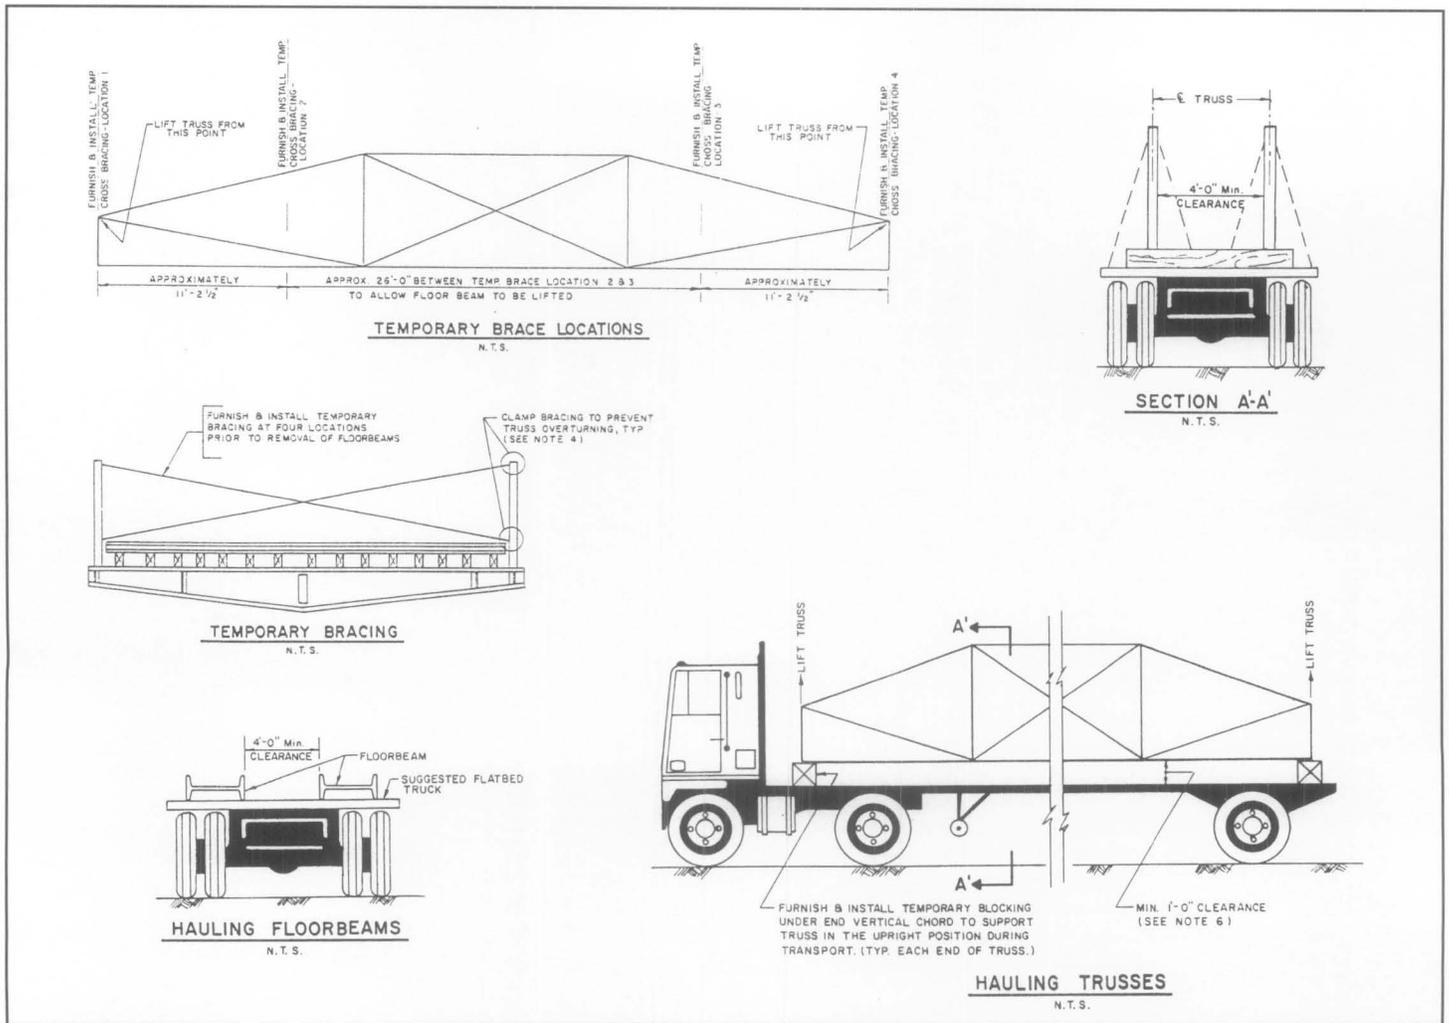
Figure 5. A temporary bracing system assured the protection of the bridge during disassembly.

At this point, a temporary bracing system was built to stabilize the trusses before construction work proceeded (see figure 5). This wooden system was extremely important—without it, the trusses might have twisted or overturned during the remaining disassembly work.

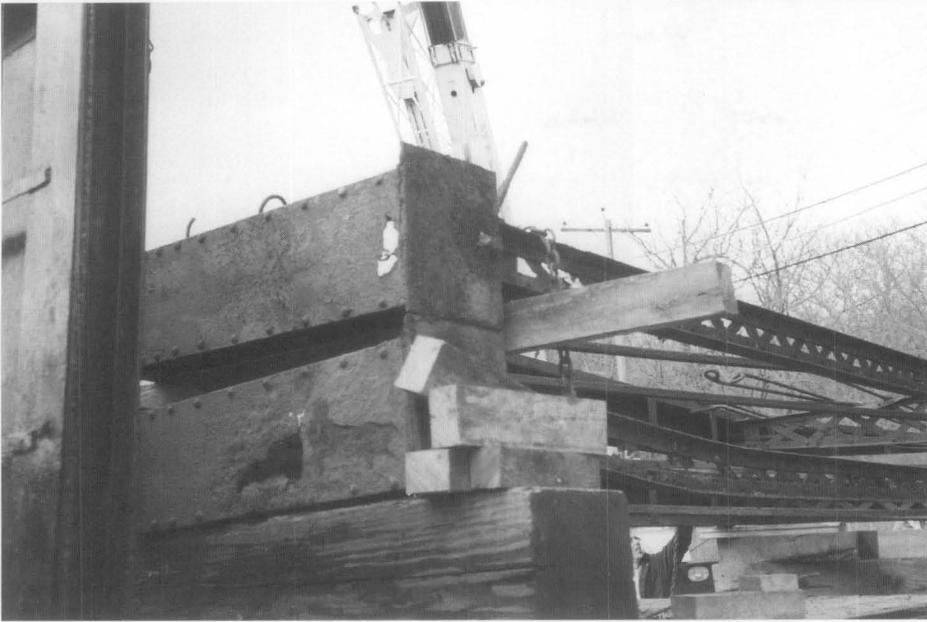
With the trusses stabilized, the deteriorated floorbeam hangers were removed. The floorbeams themselves were lifted, one at a time, by crane onto a flatbed truck, and transported to the shop. With the temporary bracing removed, the trusses were then attached to the crane and lifted in one piece, then placed on their sides on the truck (see figure 6). The plans had specified that the trusses be placed on the truck in an upright position, with protective bracing. But when the first truss was mistakenly laid on its side, the deteriorated lattice girder stiffener was severely bent. Fortunately, this lattice girder was slated for disposal before the damage occurred. The other truss was removed without damage.

Figure 6. Although plans specified that the trusses be placed in an upright position, they were placed on the truck on their sides (left). The lower truss was damaged during the loading operation. Photo: Beta Engineering.

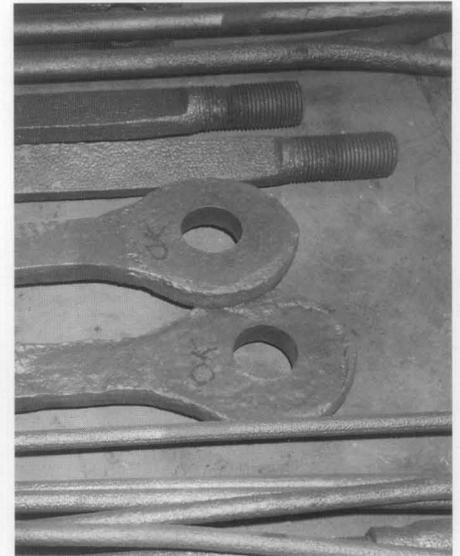
Figure 7. The pieces were disassembled in the shop, then cleaned of rust and paint. The worn condition of the eye bars can be seen in the center of the photograph. Photo: Beta Engineering.

The salvageable parts were placed in a Wheelbrator, a machine which removes rust through repeated vibration. The iron members were then sandblasted to remove paint and any remaining rust, then subjected to magnetic particle testing to determine which pieces had unseen damage or decay. The test was useful in determining wear in some of the parts, particularly the eyebars of the lower chord and the middle panel tension rods. In addition, some of the pins had worn by more than 1/4" over time.

In order to reuse as much of the historic material as possible while ensuring sufficient structural integrity, it was decided to "build up" through welding those pieces that were worn down. In order to match the metallurgical composition of each part, a chemical test was undertaken. This testing allowed for an exact metallurgical match between the new built-up welds and the original metal of each part. Such a match reduced the possibility that a harmful physical or chemical reaction would take place between the weld and the wrought iron.

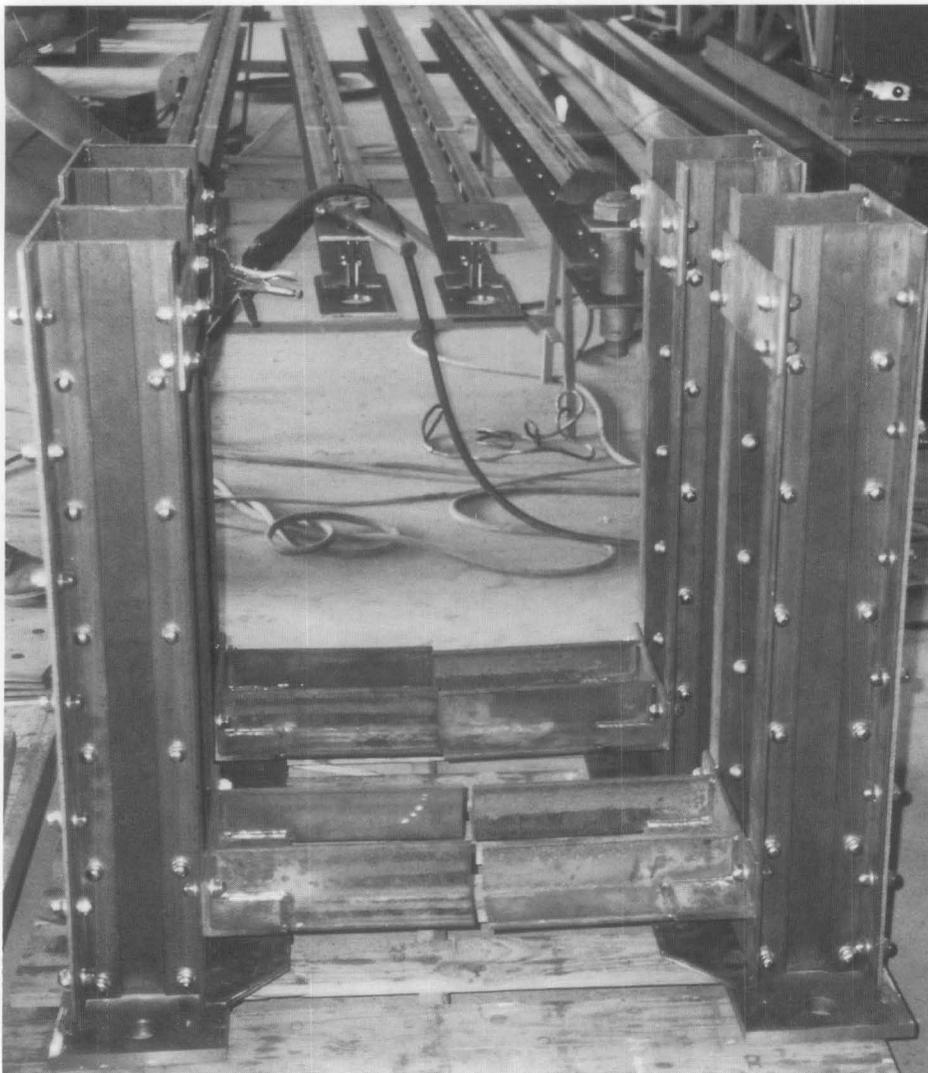
Figure 8. New endposts (foreground) and lattice vertical posts (background, center) were fabricated from steel. The rivets are actually threaded; hidden bolts help keep the pieces together. Welding provides additional strength. Photo: Beta Engineering.

Only the rivet heads could be found, and there seemed little use for them. But after some thought, a creative solution was formulated. The shanks of the rivet heads were threaded, and the plates screwed together. For structural strength, the pieces were also welded, but this weld is invisible from the outside. The result is a welded box girder that looks, from the outside, like an authentic riveted member. Had no rivets been found, a similar procedure could have been followed using hack bolts. (These are bolts with heads that look like rivets but have nut fasteners.)

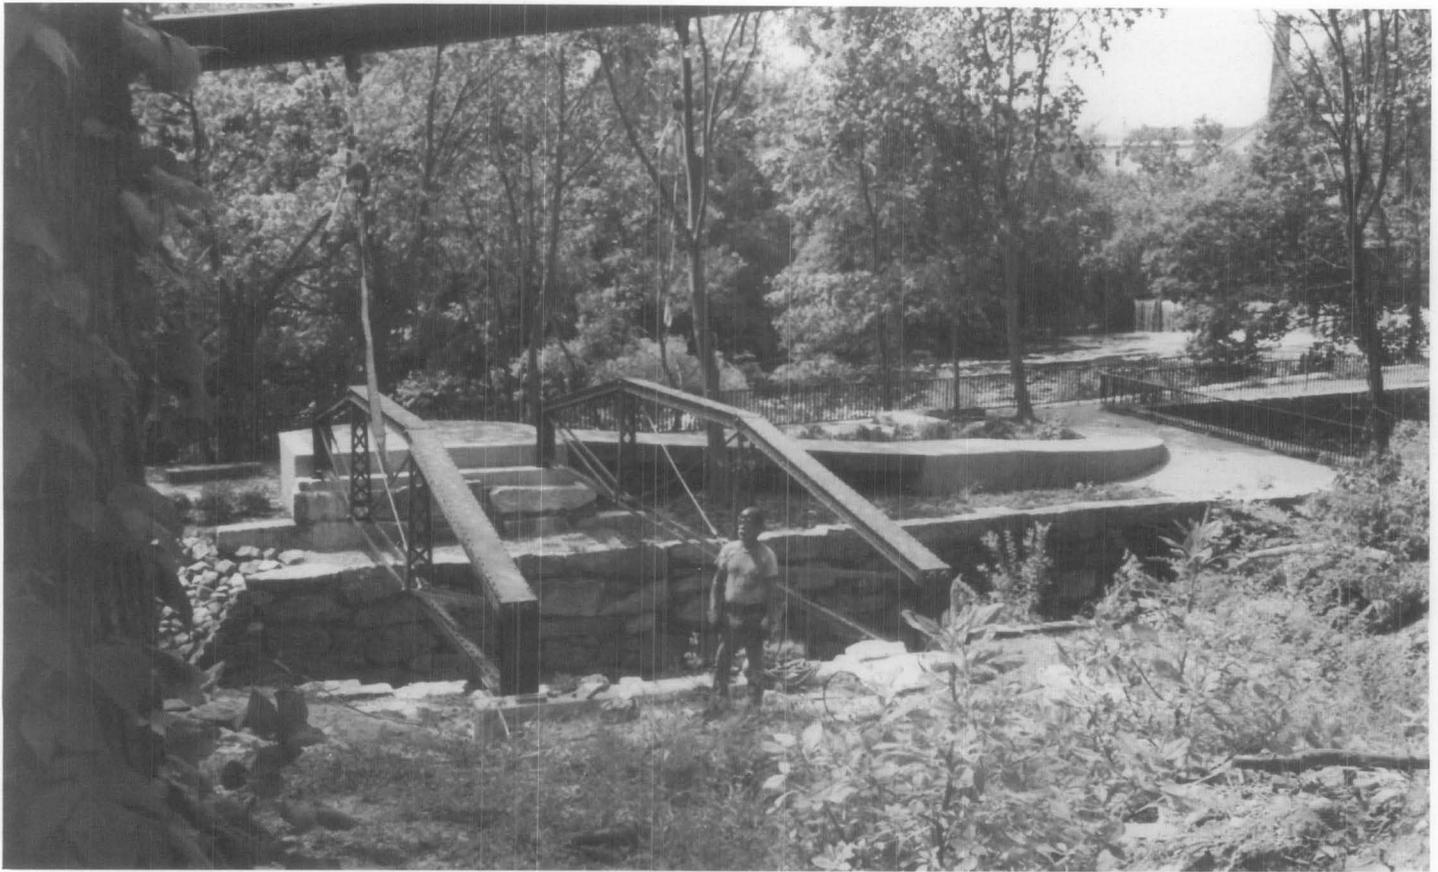
Figure 9. The trusses were lifted by crane and set into position on the new site. Photo: Beta Engineering.

When the new foundation was completed, the trusses were lifted by crane to the site, installed in place, and secured with temporary wooden bracing (see figure 9). The rest of the bridge (floor beams, hangers, stringers, etc.) was then

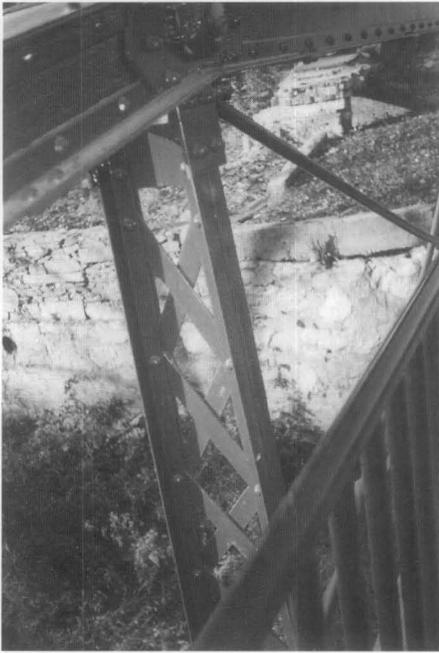
Figure 10. The new lattice girders are shown as installed on the bridge. Photo: Joseph P. Saldibar, III.

assembled, in the reverse of the dismantling process (see figure 10), and a new hardwood deck was installed.
