## 9 ROXBURY ROAD SCARSDALE, NEW YORK

## WINDOWS NUMBER 19

### Repairing Steel Casement Windows

Technical Preservation Services  
National Park Service

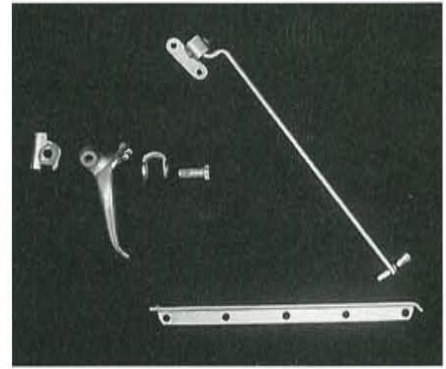
Figure 3. The window hardware at 9 Roxbury Road included a two-part "lift and stay" operator (right) and a common locking handle (disassembled at left). The hinged portion of the lift and stay (upper right) is attached to the sash while the perforated length is connected to the frame. To open the window, the pin is lifted from the hole on the far right, the sash is pushed open and the pin reset in one of the adjacent holes.

When a close fit had been achieved and the window opened and closed freely, servicing began. Paint was scraped from hardware joints and contact points. Locking handles that did not function smoothly were disassembled, cleaned, adjusted and reinstalled. Loose handles were tightened. Dirt was removed from hinges and operators and then all working parts were lubricated. After repair and servicing were completed, areas of the window that had been stripped of paint were coated with an oil-based primer. This protected the bare metal from corrosion until the entire window could be repainted in the next phase.

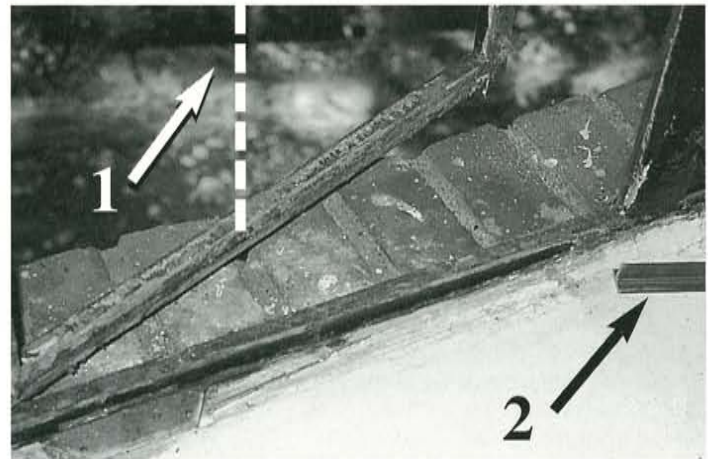
The windows on 9 Roxbury Road showed deterioration and damage typical of historic steel casements. In the course of over seventy-five years, corrosion, wear and some distortion of the sash and frame had occurred. Rust was particularly prevalent along the lower parts of the sash and frame where water had penetrated the distorted opening and the cracked perimeter

caulk (see figure 4). Originally tight fitting, all of the sash were bent out of alignment with resulting gaps from 1/16" inch to 3/4" inch between sash and frame. Hardware was corroded, stiff, and in some windows, seized shut. Prior attempts to force the distorted windows closed had also bent some of the locking handles and other hardware.

Figure 4. The sash and frame were most severely corroded along lower, horizontal members. A vertical glazing bar had previously been removed from the sash above to fit a window air conditioning unit (1). A replacement "T"-shaped length of steel that will be spliced in can be seen on the right (2).

In order to repair the four windows previously altered for air conditioning at 9 Roxbury Road, it was necessary to replace missing metal sections along the lower third of the sash and frame. Lengths of replacement steel with the typical “Z” and “T”- shaped profiles were obtained from a stock of salvage material maintained by the repair company. Exact matches were easily achieved because replacement pieces came from identical Fenestra casement windows of the same period. To rebuild the sash, replacement steel bars were held to the existing sash with clamps and brazed together with an oxygen-acetylene torch (*see figure 7*). After

cooling, the brass seam was ground down with a sander so that it was flush with the existing surface. Though not necessary in this project, a similar treatment can be used when portions of the frame or sash are corroded beyond repair. In such a case, damage is usually limited to the frame, sill and lower portions of the sash, where unattended water problems lead to severe oxidization. The deteriorated section can usually be cut out and new pieces from salvaged stock brazed into place.

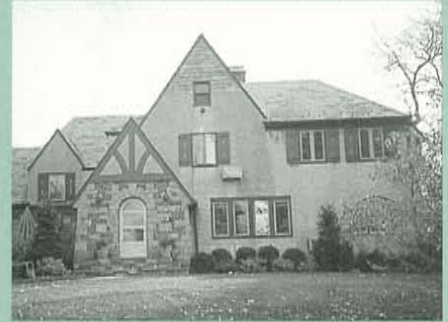
**Inappropriate replacement windows dramatically affect the appearance of a historic home that once featured steel casement windows.**

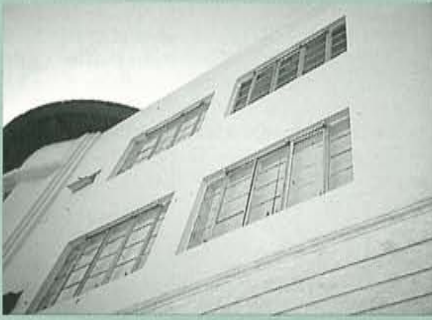
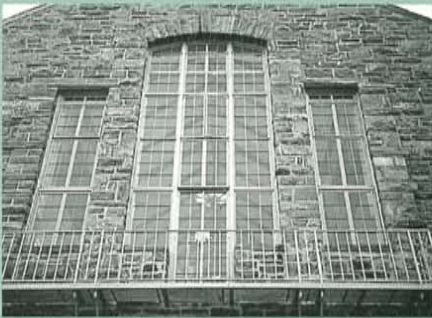
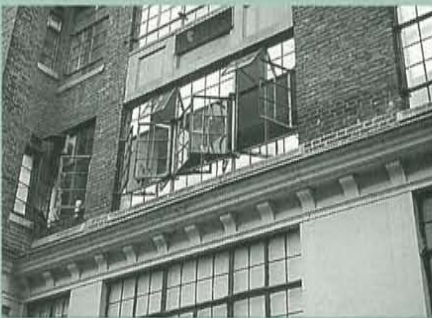
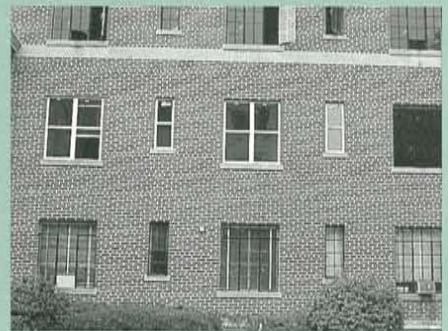
**Historic steel casement windows are in the process of being replaced with new units that compromise the character of this building facade.**

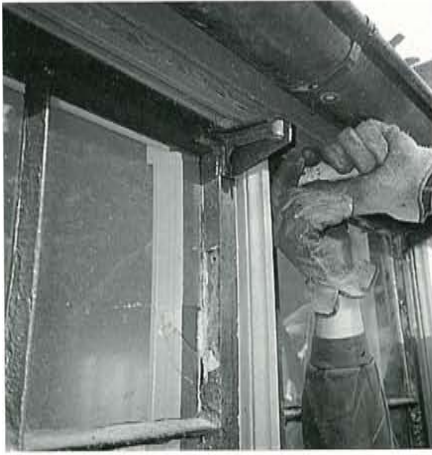
**Figure 5.** Before realigning the window, paint, caulk, weatherstripping and rust were stripped from all surfaces where the sash and frame were in contact.

After protecting the work area, layers of paint, rust, caulk and weatherstripping were scraped from all contact surfaces where the sash meets the frame and where locking pieces meet (see figure 5). Such extraneous material had to be removed before attempting to realign the window, so that the severity of distortion could be accu-

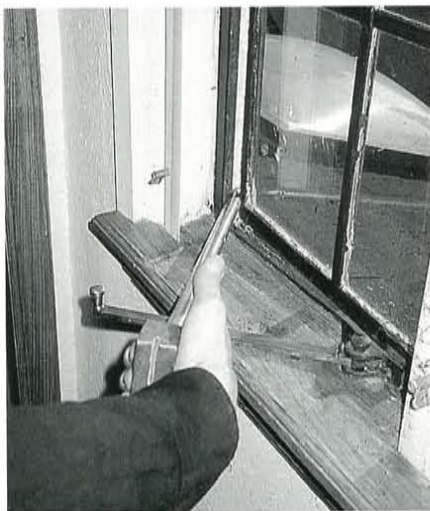
**Figure 6.** Pull bars were used to realign the sash from the inside. These custom made tools were especially useful on single sash units where the worker was unable to reach through an adjacent opening to apply pressure from the outside.

rately determined and the repairman could tell when a correct fit was achieved. Using metal shims of varying thickness placed between sash and frame, the worker then began the realignment process by gently applying pressure to the sash. With the shims acting as levers, one location was pushed in while another was pulled, to bring racked corners and warped planes back into alignment. Where the sash was bent outward on either the top or bottom, it was gently twisted back into shape. On single windows, where there was little room to reach out and manipulate the sash from the inside, various pull bars custom-made of notched aluminum rods were used (see figure 6). When the sash was aligned, bent locking pieces and other hardware were similarly returned to their original shape or, where broken, replaced with identical pieces.

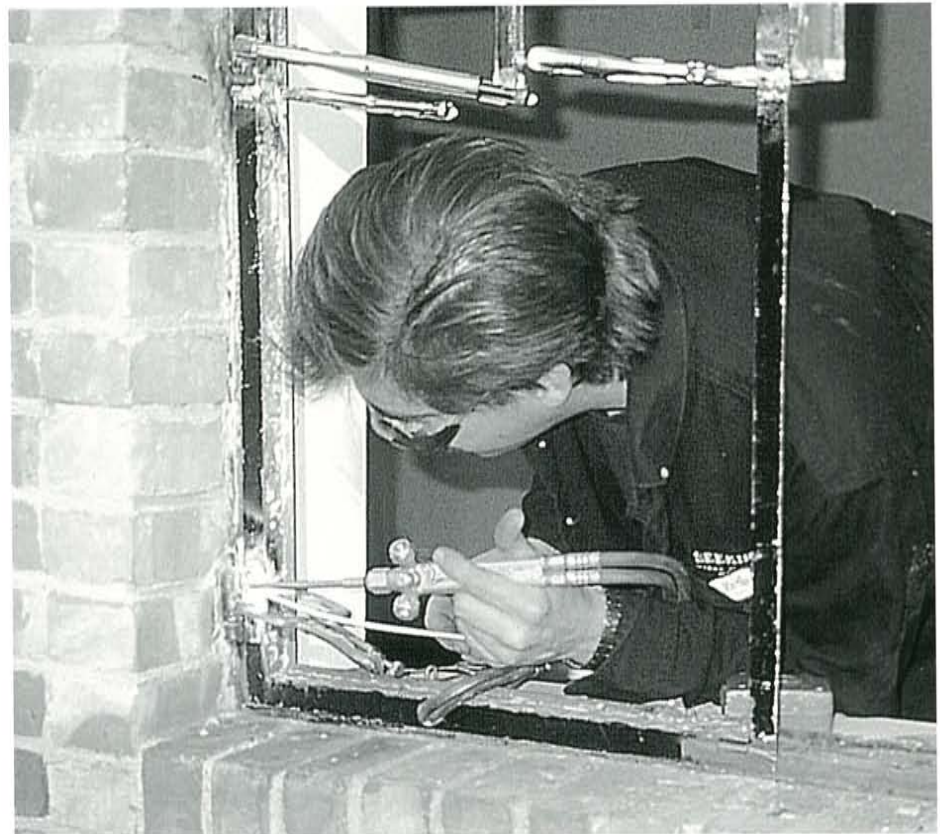
**Figure 7.** New steel sections were brazed into the historic sash and frame where the windows had previously been altered to fit air conditioning units. Because the replacement pieces came from a stock of salvaged window materials, they matched perfectly the profiles and dimensions of the missing sections.

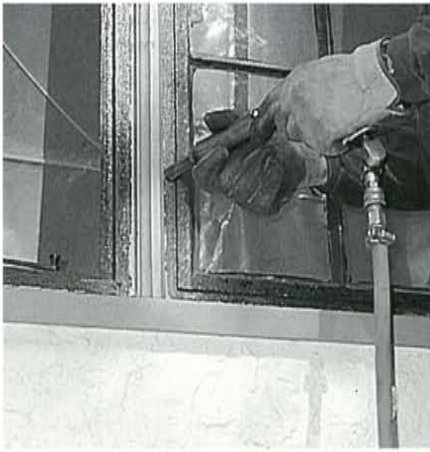
**Figure 8.** A pneumatic needle gun was used to strip much of the paint from the steel frame and sash. It was followed by wire wheel and small disk sanders and hand chisels. The blunt tipped needles did not damage the steel or adjacent glass.

Initial paint and rust removal was done with a pneumatic needlegun. When set to a standard air pressure, the needlegun neither pitted the steel, nor damaged adjacent glass (*see figure 8*). Occasionally an air hammer with a blunt end attachment was also used. The needlegun was followed by a sander with wire wheel attachments. Run the length of each steel member, this tool removed almost all of the remaining paint and most of the rust. It was especially useful in clearing pockets of rust from crevices and gently grinding down the more severely pitted surfaces. Removing rust with a sander was preferred over sandblasting because a sander is less messy, does not require shielding the glass and masonry surround, and is less likely to damage the steel. Finally, a small hand chisel and sandpaper were used in corners, on the inside edges of the hinges and in other tight locations not reachable with larger tools. Because they were used as guides for the application of the new putty bevel, it was essential that the edges of the muntins were free from nicks or bumps that would have resulted in an uneven profile.

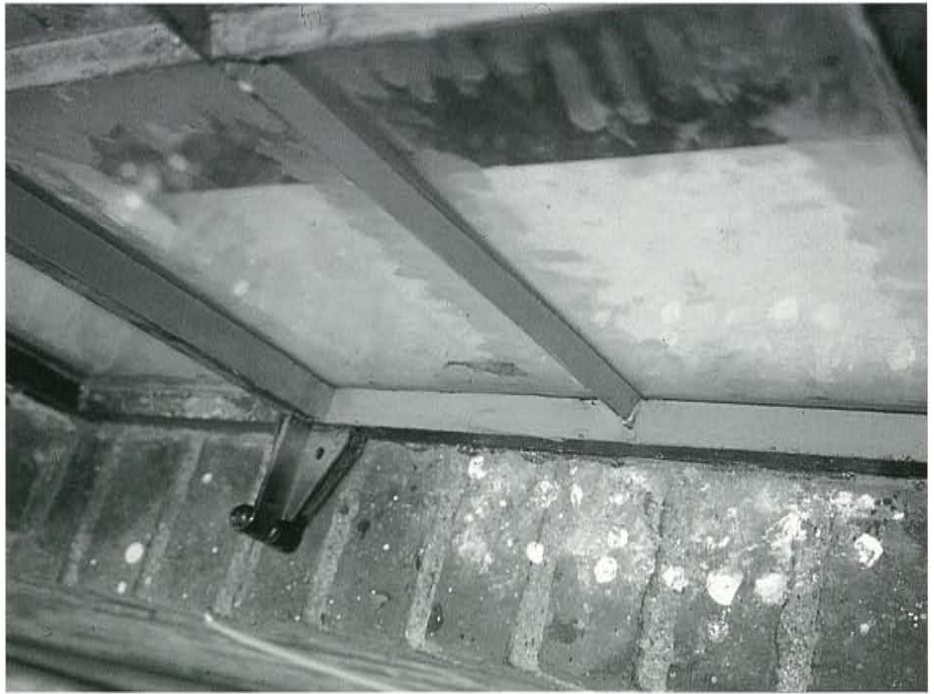
**Figure 9.** An oil-based putty was used to reglaze the historic casement windows. Painting was undertaken two weeks after reglazing.

The glazing contractor used natural, oil-based (linseed or soybean) putty that remains relatively soft. Putty was repacked along the interior face first. In keeping with the historic appearance of the windows, all putty lines on the inside were run flush with the muntin, so that no bevel profile was present. This brought sightlines back to the narrow appearance that is so characteristic of historic steel windows, while creating a watertight seal that keeps condensation from entering the joint. Putty was then applied along the exterior in a beveled profile that helps shed water (*see figure 9*). Finally, the glass was carefully cleaned with a four-inch razor blade followed by a standard glass cleaner.

Although the manufacturer states that the putty can be painted the day after application, the painting contractor preferred to allow two weeks for the putty to cure sufficiently. Two finish coats were applied to the frame, sash and glazing putty. The industrial paint, a brand commonly used on steel bridges, was custom mixed a taupe color to match the exterior wood trim. To form a moisture resistant seal, paint was extended a small amount beyond the putty and onto the glass face – a standard practice, both past and present.

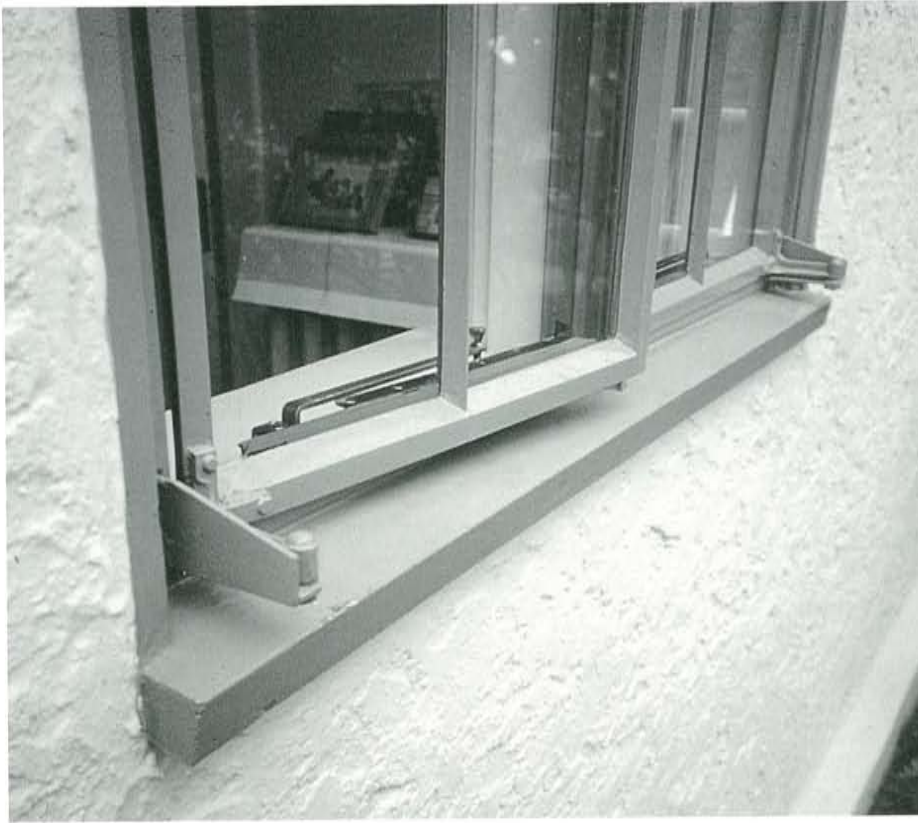
Figure 10. Detail of complete windows, repaired, serviced, reglazed and repainted.

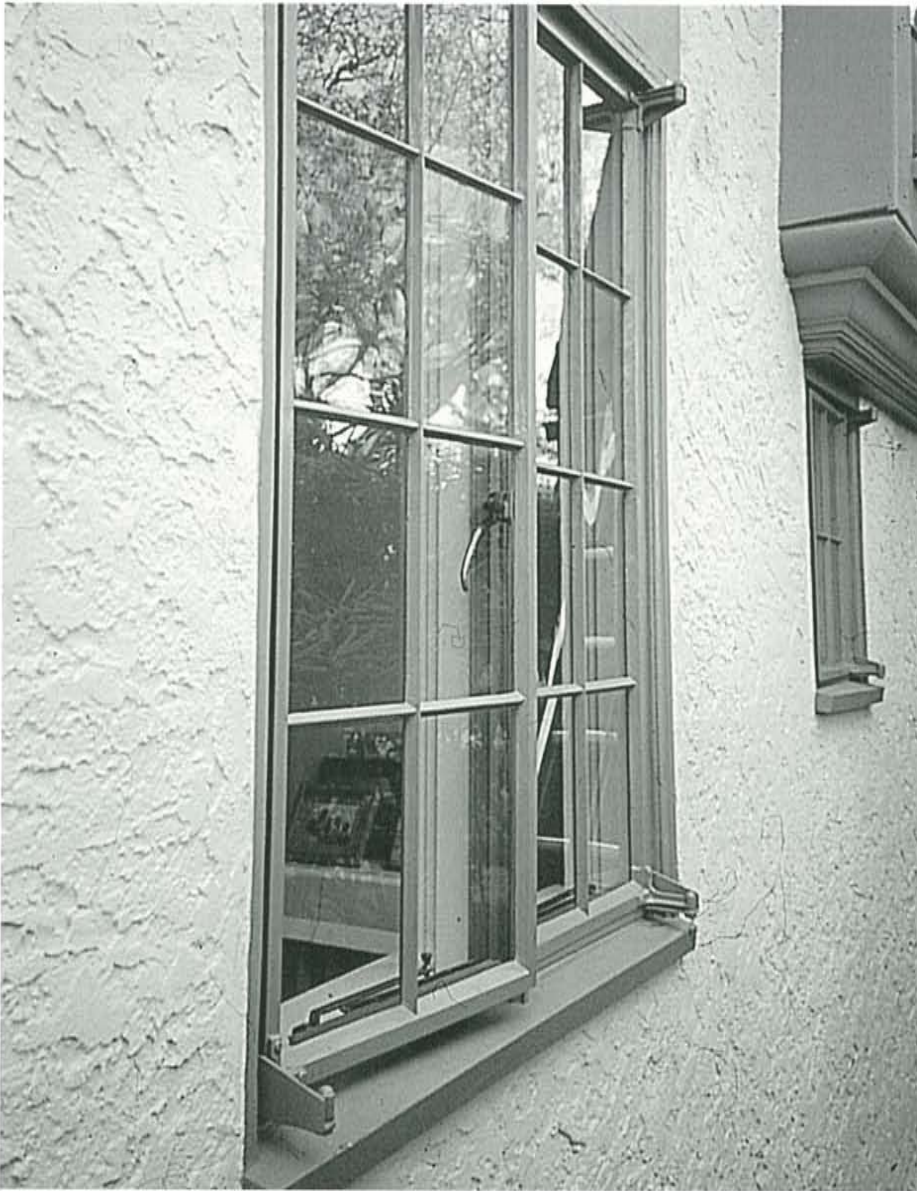
**Figure 11.** The completed work reveals the aesthetic appeal of the historic casement window – qualities appreciated both past and present.
