### NUMBER 5

# Rehabilitating a Historic Truss Bridge Using a Fiber Reinforced Plastic Deck

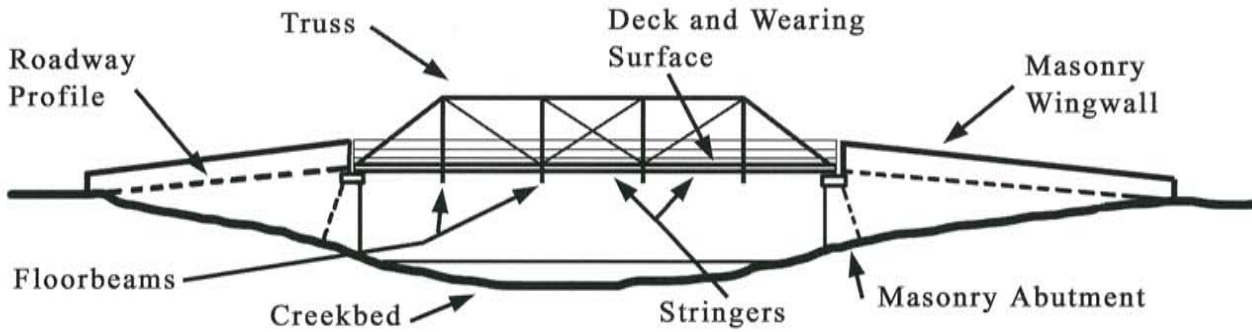
Figure 1. Drawing of Wilson's Bridge showing major structural and site components. Drawing: Chester County Engineering Department.

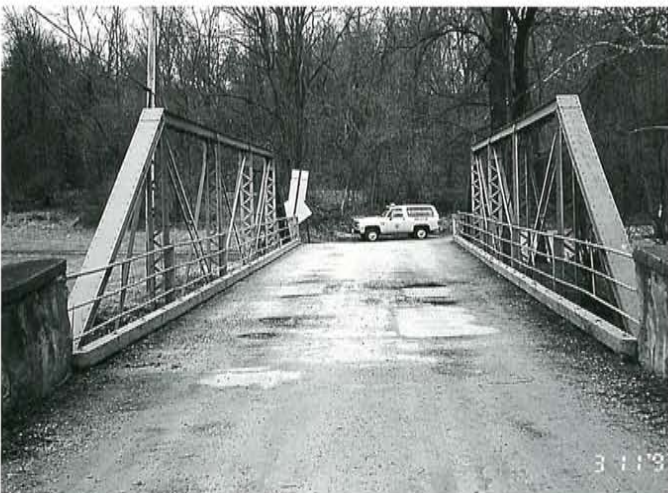
Figure 2. Before rehabilitation, Wilson's Bridge had an asphalt wearing surface that was delaminating from the deck below. Extensive cracks and numerous potholes were also present.

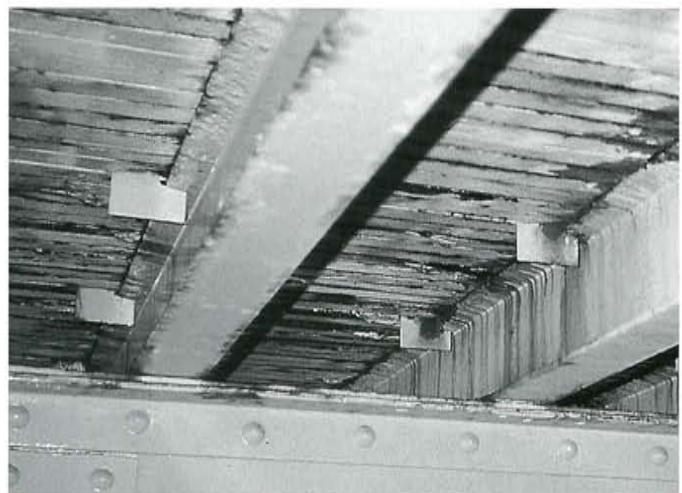
Figure 3. A view of the underside of Wilson's Bridge before rehabilitation. The timber nail laminated deck sat on steel "I-beam" stringers which, in turn, were supported by wrought iron floor beams. Failure of the wearing surface had allowed water to penetrate the laminated deck planks causing further deterioration to both the deck and the stringers below.

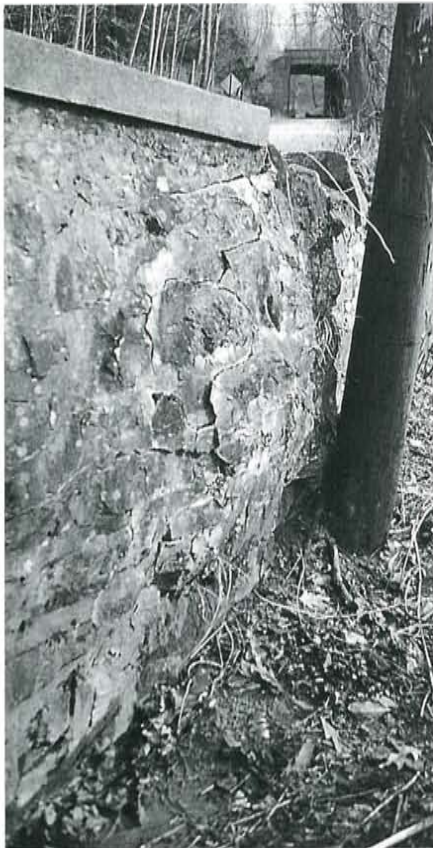
Figure 4. The Wilson Bridge wingwalls had loose and crumbling mortar joints. Much of the wall surface required removal of this deteriorated material and significant repointing.

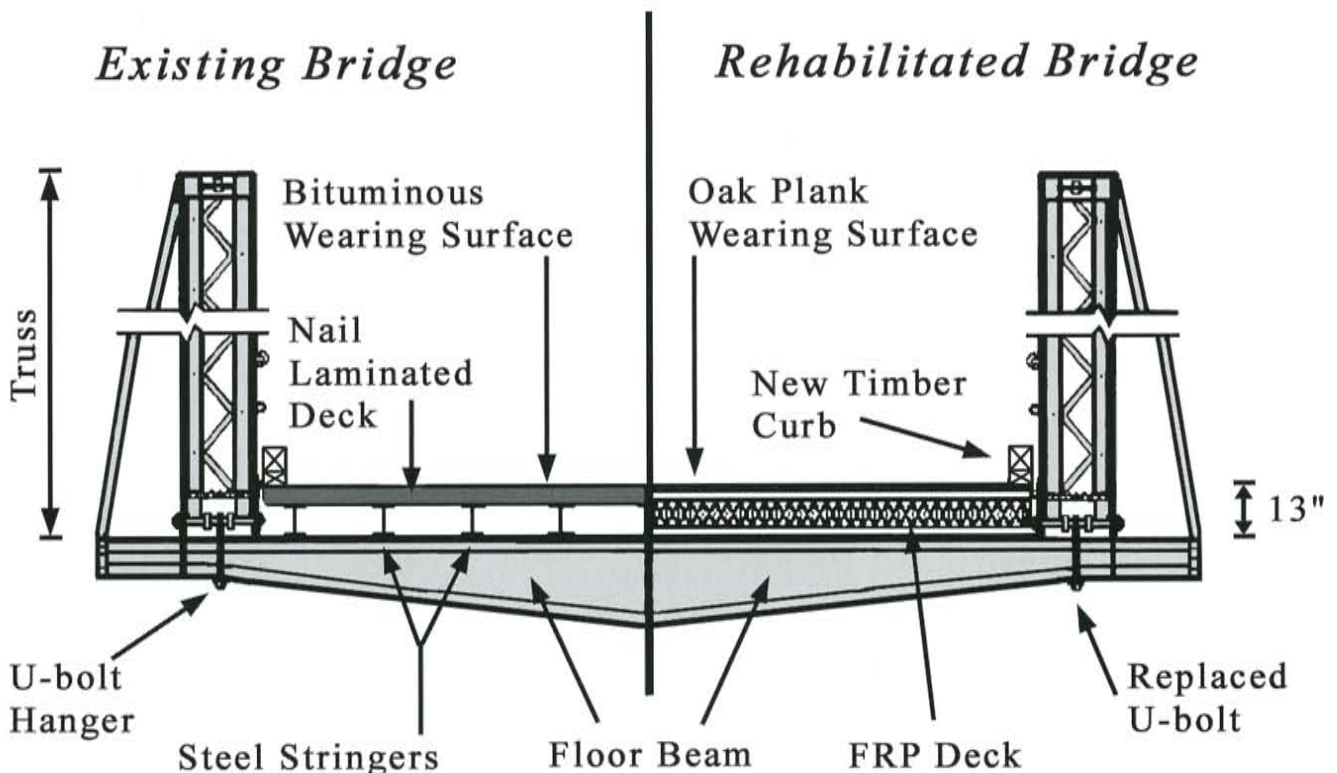
Figure 5. A section drawing of the Wilson's Bridge. The left side shows the construction of the span before rehabilitation, while the right side shows removal of the stringers and the installation of an FRP deck with a plank wearing surface. Both systems were approximately thirteen inches thick. Drawing: Chester County Engineering Department.

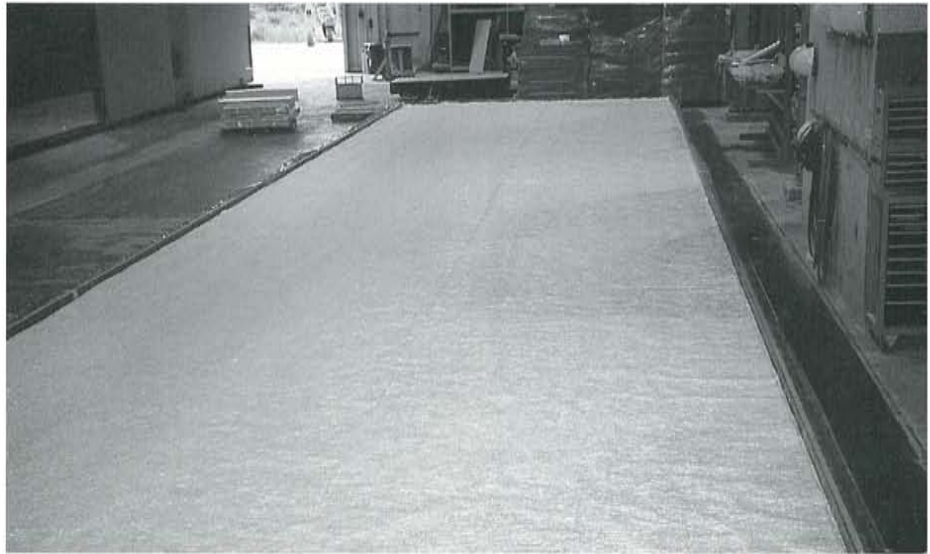
Figure 6. Taken at the composite manufacturer, this photo shows layers of fiberglass arranged around the deck core and placed in the mold. The mold was then infused with a resin that sealed the layers into a one-piece panel. Photo: Hayati Catbas, Hardcore Composites.

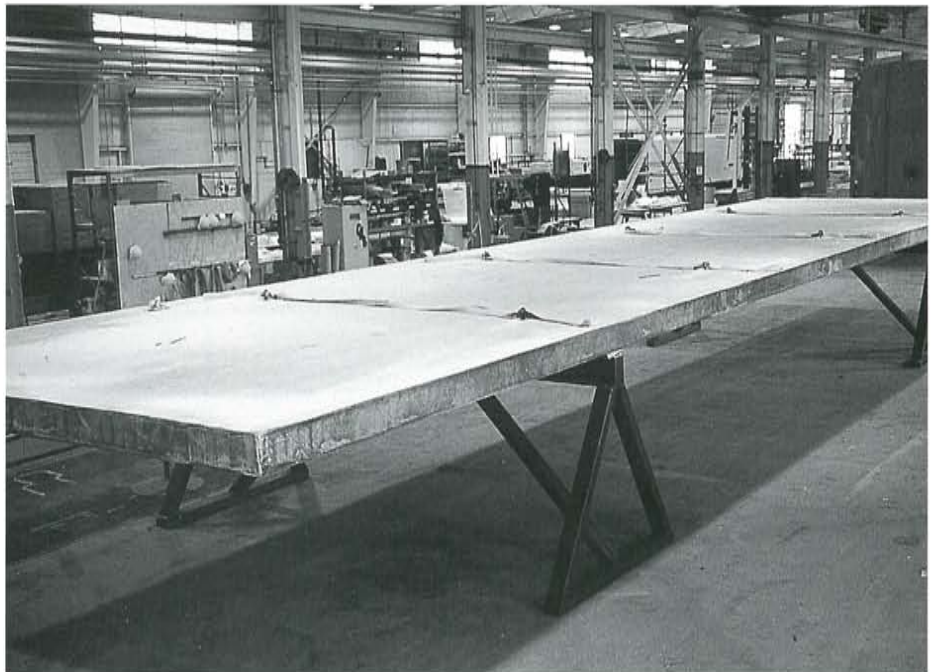
Figure 7. After the panel had set into a solid mass, workers removed it from the mold and sanded and finished all surfaces. The last steps included painting the deck and installing the oak plank wearing surface. Photo: Hayati Catbas, Hardcore Composites.

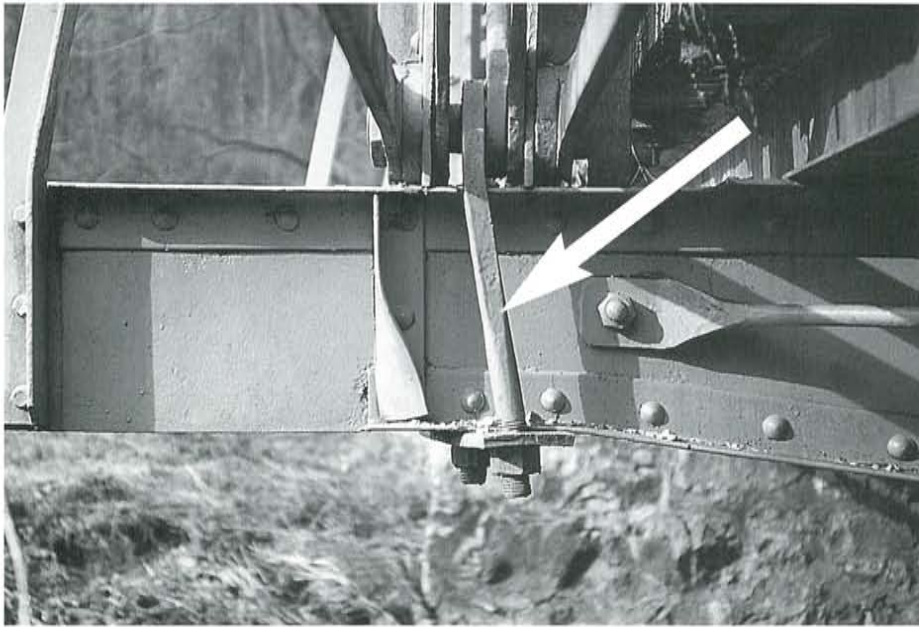
Figure 8. U-bolts connected each of the four floor beams to the superstructure above. Prior to rehabilitation, some bolts, like the one in the photo, showed signs of impact damage. The engineers determined that all of the wrought iron bolts were near the threshold of their stress level and called for replacement with high-strength steel U-bolts of the same dimensions.

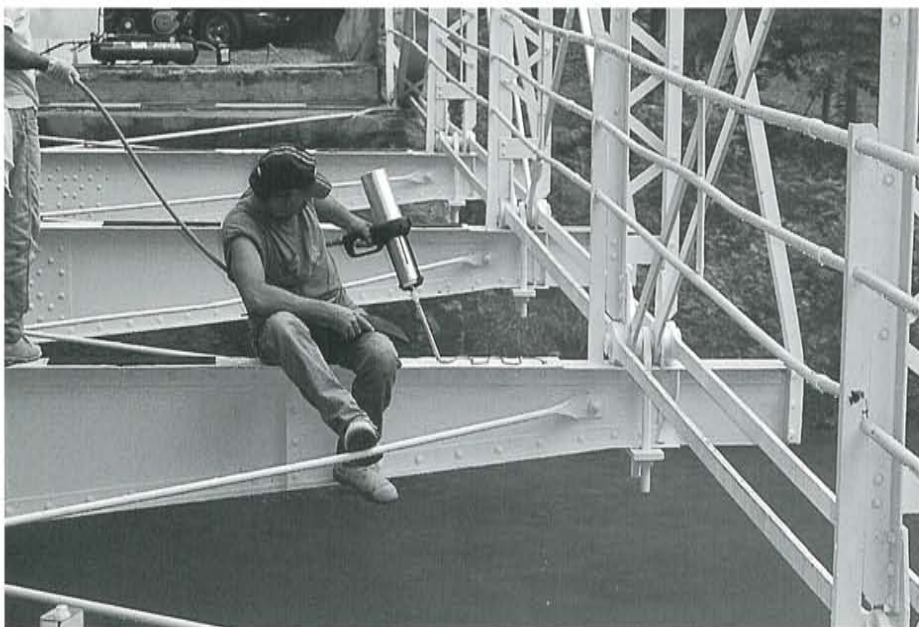
Figure 9. A worker applied adhesive to the floor beams where each of the bearing pads would be positioned. Four pads were installed on each floor beam to cushion the deck, evenly distribute loads to the floor beam and provide a secure fit between beam and deck.

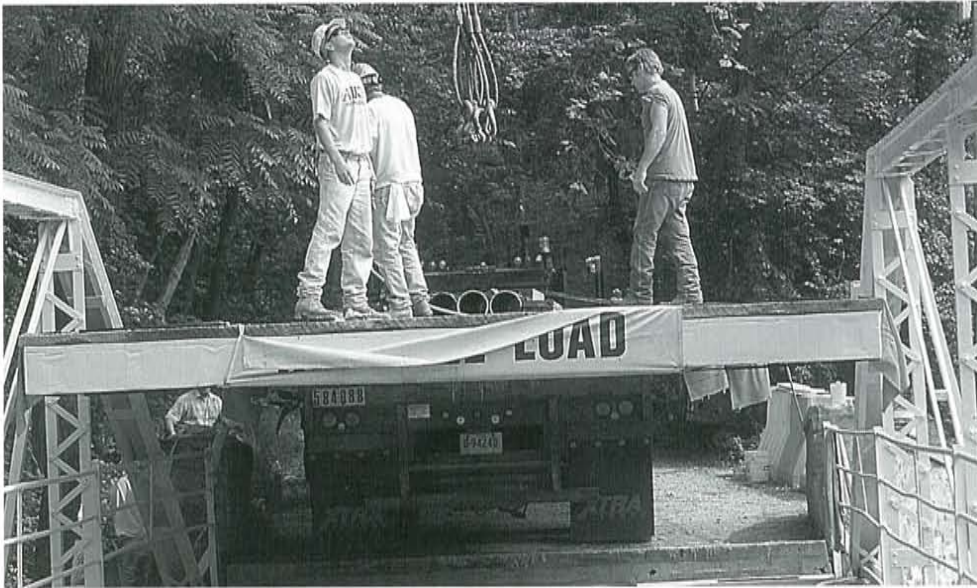
Figure 10. When the deck arrived at the site, the trailer was backed onto the bridge approach and crane cables secured to the deck. Although the road beyond that side of the bridge is a dead end, the truck driver was able to maneuver across a vacant site to get the deck on the opposite side of the creek.

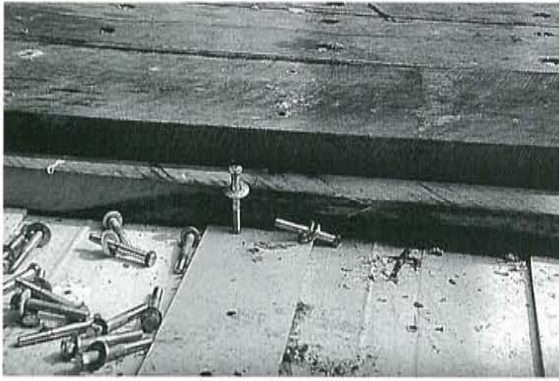
Figure 13. After the deck was locked to the floor beams and the crane cables removed, remaining oak planks that made up the wearing surface were bolted to the composite deck.

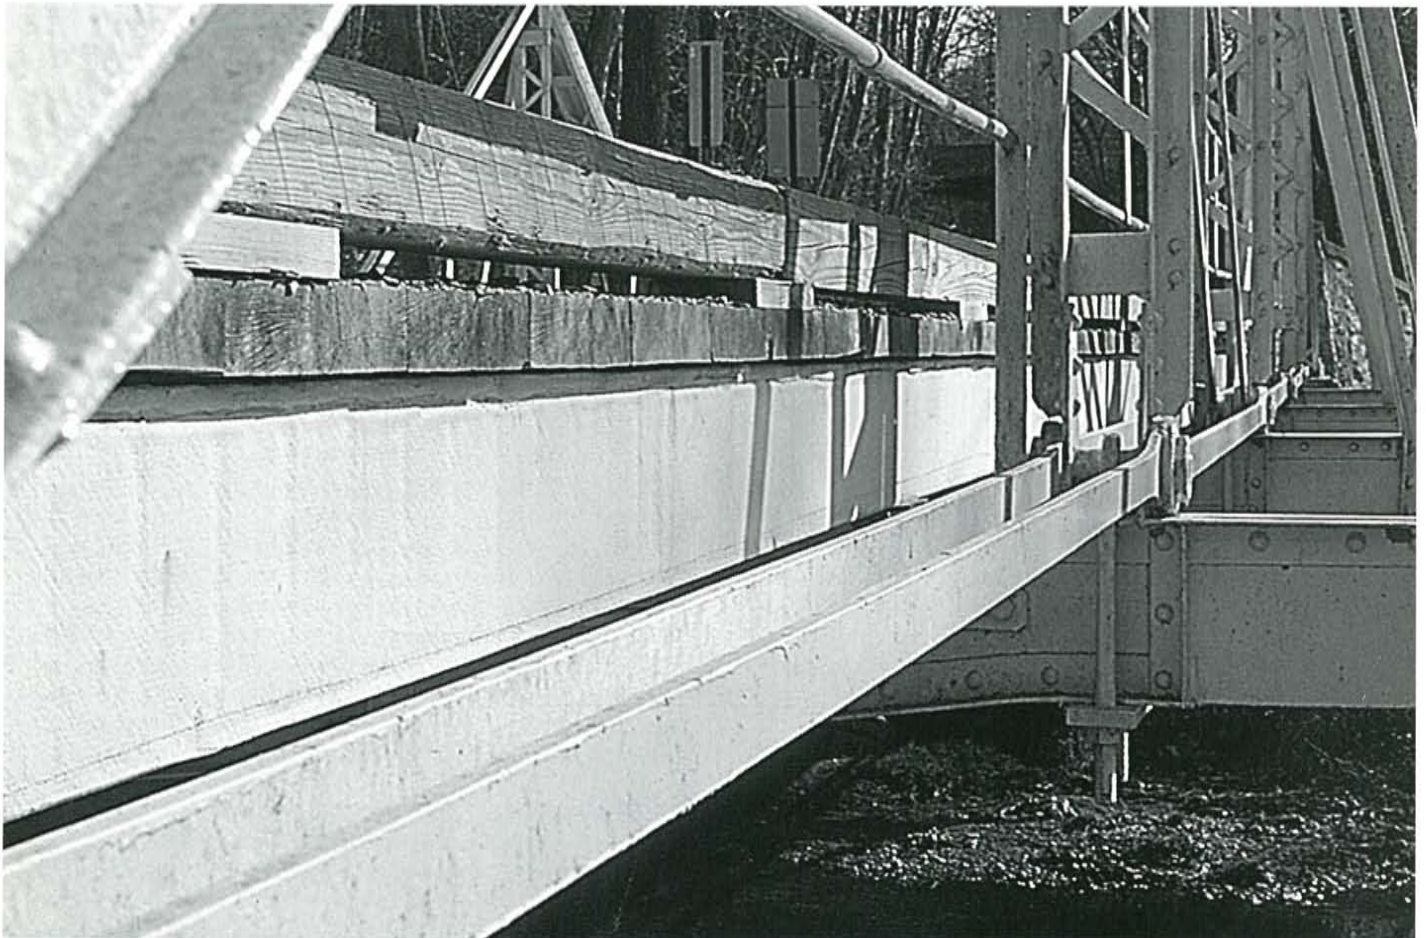
Figure 14. The composite deck, painted to match the superstructure, is visually compatible with the historic bridge as it originally appeared with timber stringers. The new deck and wearing surface are the same thickness as the previous system of steel stringers, nail-laminated deck, and bituminous surface. Photo: Chad Randl.

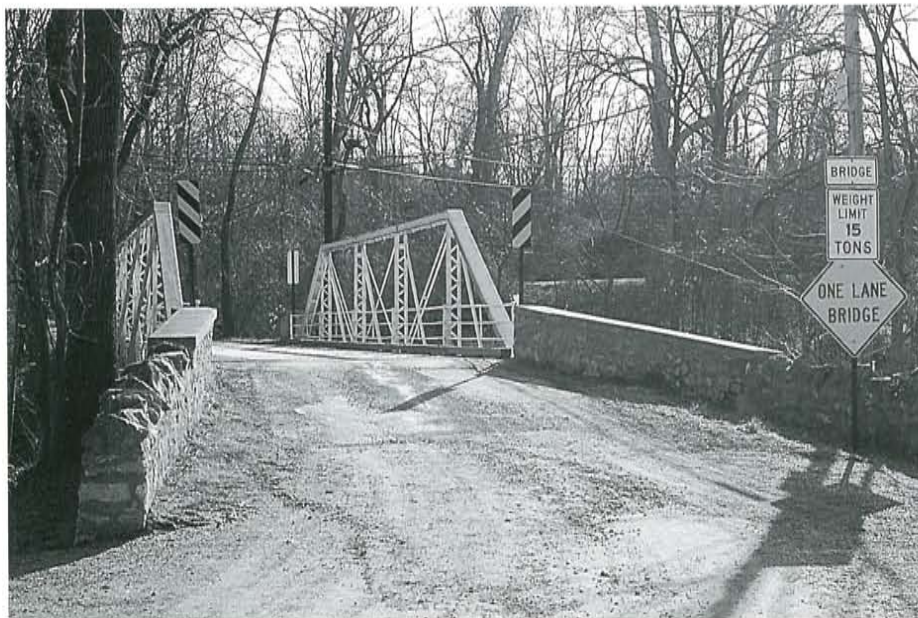
**Figure 15.** The landscape surrounding Wilson's Bridge has changed little since the span was constructed in the 1800s. The use of a composite deck and plank wearing surface in place of the deteriorated, fourth generation deck was an innovative solution that allowed the bridge to remain in place and in use with little change to its historic character. Photo: Chad Randl.
