## ALDRIDGE HOTEL Shawnee, Oklahoma

# Preservation Tech Notes

## METALS NUMBER 6

### Repair and Reproduction of Metal Canopies and Marquees with Glass Pendants

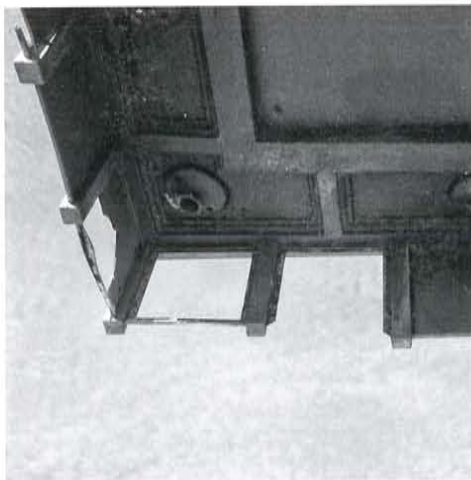
Figure 2. The underside of the main canopy's left corner, showing damage to copper pendant frames and missing glass.

By the time the rehabilitation work began, the main entrance canopy had suffered years of neglect and decay (see figure 1). The entire canopy had been painted green, masking the structure's original patina, ornate stamped ceiling, and colored glass pendants. Since the canopy was encased in copper, it was not possible to visually establish the condition of its internal structure. However, it was evident that the glass pendants located at the corners and along the sides were either missing or cracked. The pendant frames were also bent, twisted, or broken off (see figure 2).

meet code, as the existing glass was not tempered. Because of the extent of needed repairs, both the left and right corners and side sections, along with the ceiling panels, were completely dismantled and taken to the contractor's shop. Upon removal of these sections, it was discovered that the wood frame to which the copper was attached had rotted as a result of water seepage and needed to be replaced.

After transporting the dismantled canopy sections back to the shop, the sheet metal contractor took measurements of the existing pendants that were in good condition. Along with the canopy's original drawings, these measurements were used to create a pattern for the needed replacements. The design for the pendant, measuring 7 1/4" x 7 1/4" and made of 16 oz. copper, resembled a picture frame. At the bottom of the frame, a U-shaped channel provided a bottom receiver for the glass to help hold it in place. An extended U-channel was used along the top, providing extra room so the glass pane could slide up out of the bottom channel for replacement when broken. Affixed to the backside of the frame were four 1/2" copper clips, two on

In addition to creating replacement frames for the broken and missing glass pendants, repairs were made to the existing copper cladding covering the canopy frame. The contractor straightened out copper that had been bent or twisted. New copper pieces were sleeved over damaged pieces or made to span missing portions, and then were soldered in place. Copper pop rivets were used to attach pieces where sleeving was not practical. To

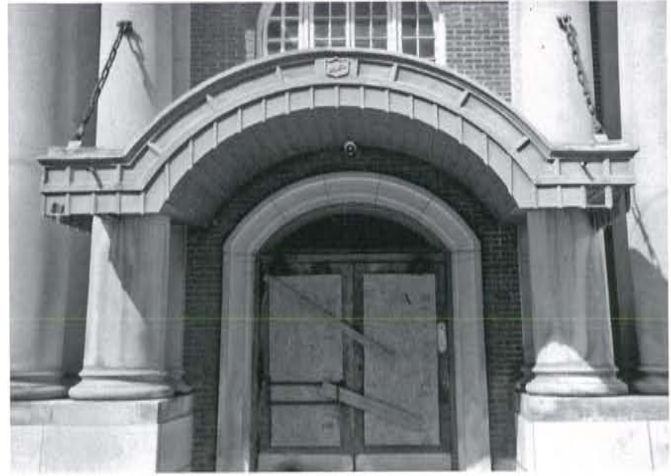
Figure 1. The Aldridge Hotel's south main entrance canopy as it existed at the start of the building's rehabilitation.

The initial task of the sheet metal contractor was to establish the condition of the canopy and determine what could be repaired and what needed to be replaced. The contractor began by surveying the copper cladding that covered the roof, sides and underside of the canopy structure. Since paint was covering the copper cladding, the decision was made to remove the non-historic paint to allow for a more thorough condition assessment.

Upon removal of the paint, it was evident that the archway and canopy roof were in sound condition. Ferrous armatures and attachments were inspected for rust since copper sheet is cathodic to iron. Approximately 40% of the glass pendant frames located along the canopy's sides required replacement and the canopy's galvanized metal ceiling needed to be repaired. It was also decided that all the glass panes would need to be replaced in order to

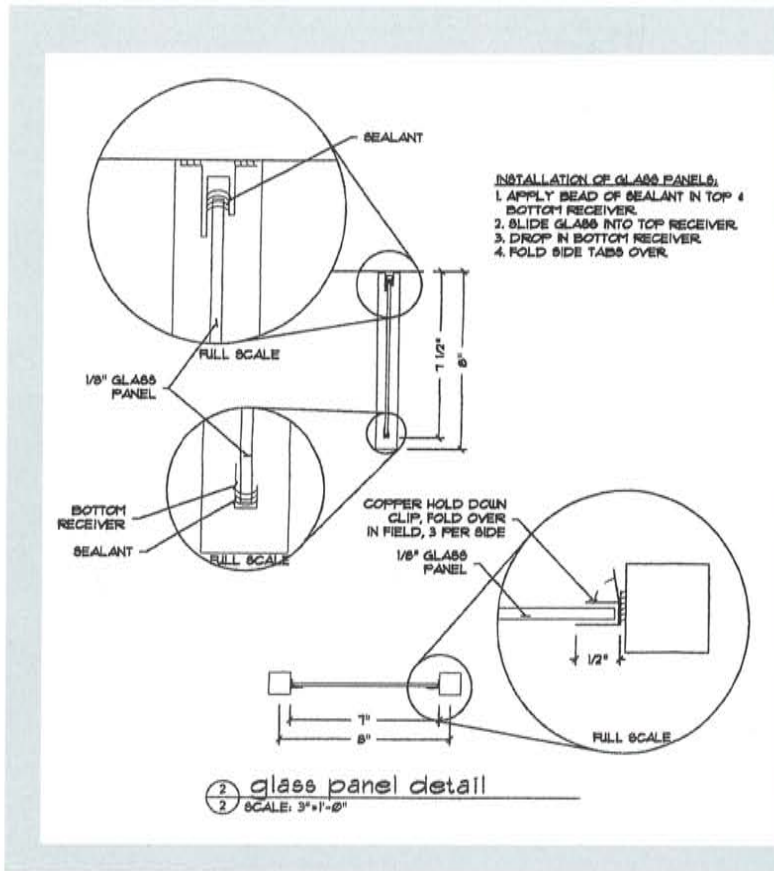
Figure 3. Details of the proposed replacement pendant frame, including how the pendant glass was to be installed. Drawing: The Hill Firm.

each vertical side, which when folded over the glass, helped secure the lights in place (see figure 3).

After cutting and shaping the metal pieces, the new pendant frame was soldered together. Each frame was then soldered to the dividing posts between each pendant. These 1" square copper posts served as the connector between each pendant and provided structural strength for the row of glass pendants. At the top of each pendant frame, the metal sides included a flange at the upper end that enabled it to be affixed with screws to the underside of the canopy. An additional section of copper panned over the flanges provided for a weather tight seal.

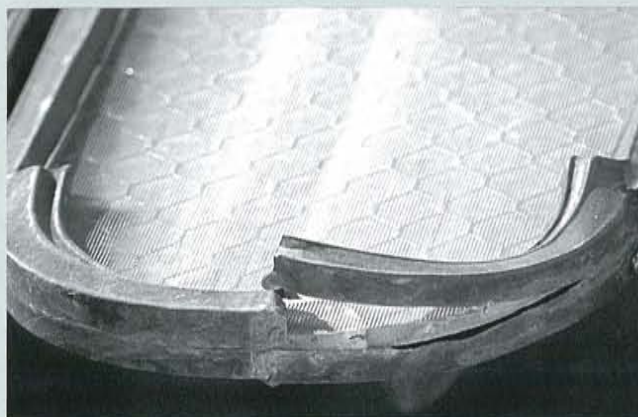
**Figure b.** In this double-faced pendant, the soldered joint on the outer face has failed where two adjacent pendant halves are connected.

**Open joints:** Metal joints connect individual pieces of the pendant frame. Where joints have opened up, water can seep inside and cause eventual rusting of the galvanized steel. In colder climates, metal deformation can occur from water freezing and expanding within the frame. Open joints should be cleaned, aligned, and re-soldered rather than simply filling voids with caulk or other sealants.

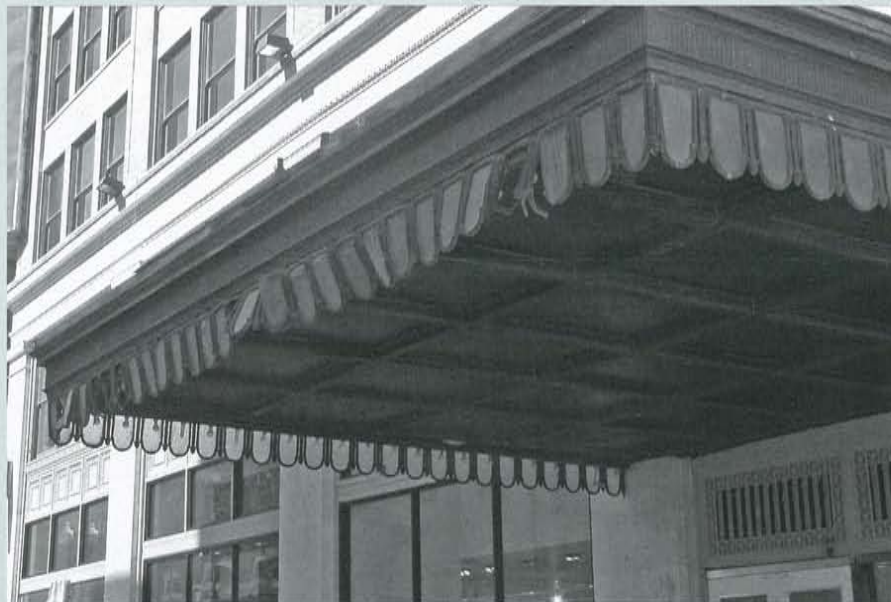
**Figure a.** Rust, paint failure, open joints, broken glass, or damaged and missing sections are indications that pendant frames are in need of repair.

Rust, paint failure, open joints, broken glass, or damaged and missing sections are indications that pendant frames are in need of repair. When the pendant frame is in reasonably good condition, it may be possible to make necessary repairs on-site. Where more extensive deterioration has occurred or where the wood substructure has deteriorated, sections of the canopy usually are removed and taken to a shop for repair or replacement work.

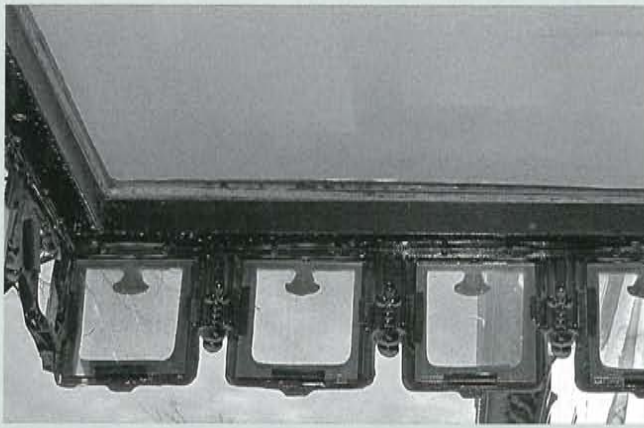
**Figure c. Broken glass in single-faced pendants can be easily replaced from the back side, where the glass is held in place by metal tabs, as shown above, or by glazing putty.**

**Broken or missing glass:** Glass breakage can result from stones and other airborne objects; deformation in the pendant frame from entrapped moisture that freezes and thaws; and impact from tall service vehicles or mechanical lifts. Glass in pendant frames that are open in the back are the easiest to replace since they are secured by exposed metal tabs. For most double-faced pendant frames, the glass originally was installed as the frame was soldered together. The recommended procedure is to detach the individual pendant frame from the canopy

and unsolder the connection with adjacent pendants. This allows for the individual pendant to be taken down, the old glass removed and measured, and new glass installed. With some pendants, the removal of individual ones is problematic and it may be possible to undertake the work in place. Alternately, it may be necessary to remove one or more pendants and replace them with new ones.

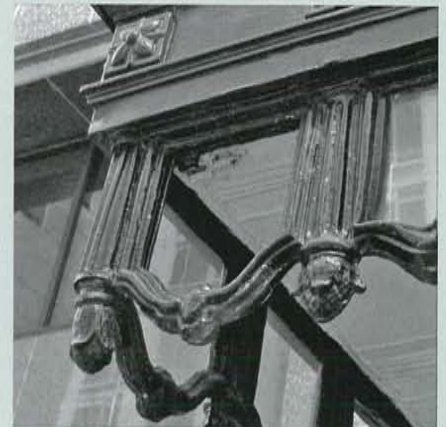
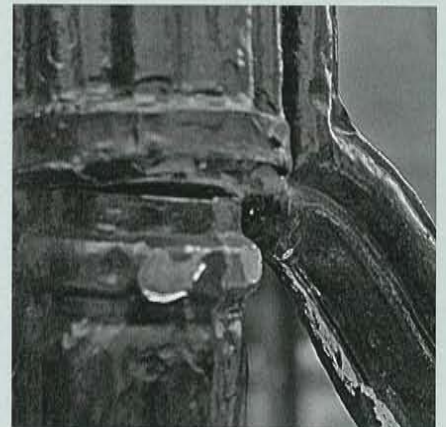
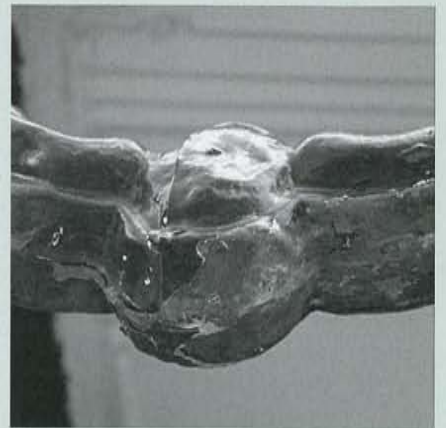
**Figure d. Typical deteriorated conditions on pressed, galvanized metal pendants can include broken or missing glass (top); broken or misaligned elements (middle); and rust along the bottom of the pendant frames where water has collected (bottom). These conditions can usually be repaired.**

**Deteriorated, damaged or missing pendant frames:** Depending upon their condition, it may be possible to remove old galvanized sheet metal elements to make repairs in the field or shop. Old stamped zinc is more difficult to repair. Long-term exposure to acid rain leads to deterioration, resulting in the zinc sheet being thinned and perforated. This tends to occur where water ponds, such as the bottom of the pendant frame. While new zinc sheet stampings may be bent or molded as needed to install, existing zinc stampings generally fatigue and fracture with a small amount of movement. As a result, when zinc pendant frames cannot be repaired in place, it usually will be necessary to replace them with new ones.

Where sections of the pendant frame are damaged or beyond repair, there are a number of possible steps that can be taken to correct this condition. Some of the old patterns of metal pendant frames are still manufactured so new matching replacement pieces may be available. Where various pendants are missing or damaged and matching new pieces are not available, it may be possible to purchase a similar pattern and group the new pieces on the sides back toward the building. Another alternative that works with some matching double-faced pendants is to scavenge needed sections by removing the backs of existing ones and using them

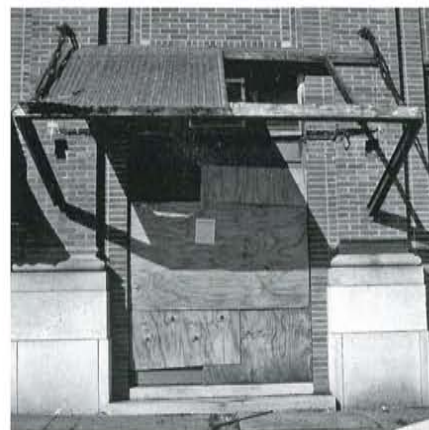
While a simple shed canopy existed at the east entrance at the start of the building rehabilitation, it was poorly constructed and in deteriorated condition (*see figure 5*). Physical evidence of the original canopy fortunately had survived. The pockets remained in the masonry wall that once carried the supporting beams and the historic overhead cables and anchors still were in use. The flat roofline of the original canopy clearly was evident against the building, cutting right below the transom over the doors. Furthermore, ghost marks on the brick wall helped to establish the height of the box canopy frame.

Figure 5. The east canopy entrance prior to the fabrication of its replacement. The original canopy had been replaced long ago with a simple covering that had deteriorated as well.

The new canopy consisted of a metal sub-frame, upon which a wood frame made of exterior grade plywood was attached. For the canopy cladding,

16 oz. copper was used along the top and sides. To match the patina of the existing canopy on the main entrance, the new canopy was chemically treated.

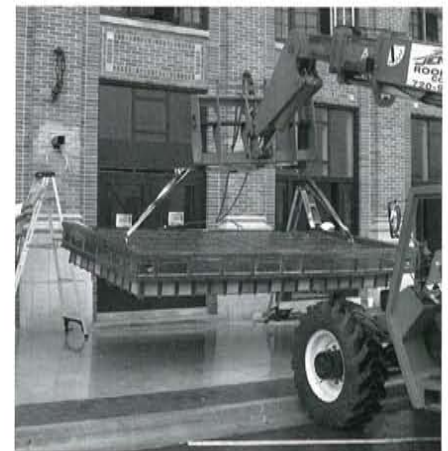
Figure 6. The installation of the new canopy required the use of a Sky Track and a special harness to ensure the protection of the copper frame. Photo courtesy of Thad Jennings, JENCO Roofing & Sheet Metal.

the structure safely to the building. The contractor then used a lift to set the canopy into place (see figure 6). The entire process had to be handled with care, given the vulnerability of the canopy's soft copper skin and the hanging pendant frames.

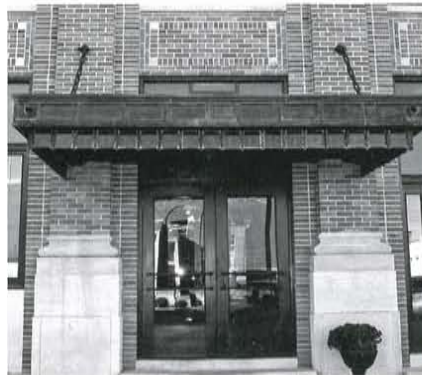
Figure 7. The new copper canopy on the east elevation of the Aldridge.
