Preservation Tech Notes

NUMBER 21

Replacement Wood Sash Utilizing True Divided Lights and An Interior Piggyback Energy Panel

BEATTY'S MILL (CORAL STREET ARTS HOUSE) Philadelphia, Pennsylvania

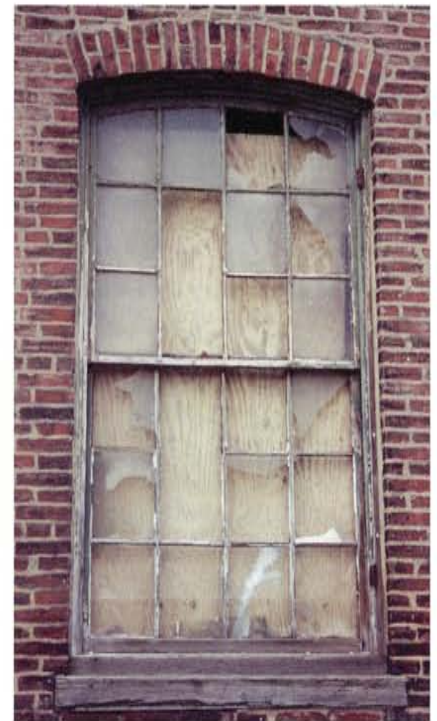
The large double-hung wood windows were one of the most prominent features of the mill. Each measured 48" by 96" with 12 lights of glass in both the upper and lower sash. Characteristic of many mill windows of the time, the sash frames were set in the masonry walls so as to minimize frame exposure on the outside. This provided for more light on the interior. It also enhanced fire safety through minimizing exposed wood on the outside, thus reducing the risk of flames spreading from an adjacent building fire (see figure 2). The outer face of the meeting rail was quite narrow.

The building had suffered many years of neglect, which was reflected in the condition of the windows. A condition survey determined that 40% of the sash were in poor condition; 45% were in fair condition; and only 15% were in good condition. Based on the window survey, the development team elected to replace the

Figure 2. The historic double-hung wood windows had narrow sash and frame members that contributed to the distinctive qualities of the windows.

existing sash with new wood sash. The initial plans included retention of the wood frames, utilizing a combination of dutchman repairs, epoxy consolidation, and epoxy repairs. Upon further investigation, it was determined that even the window frames were too deteriorated to repair.

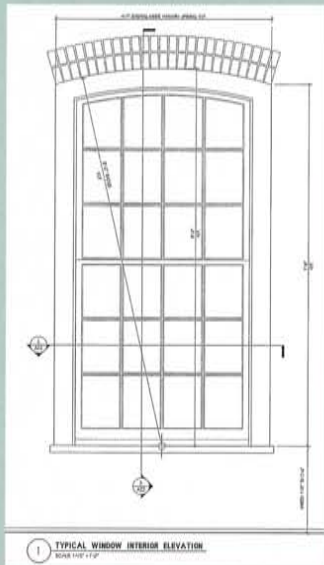
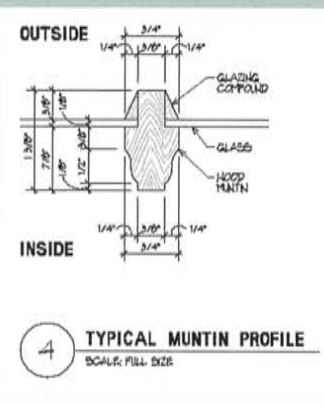
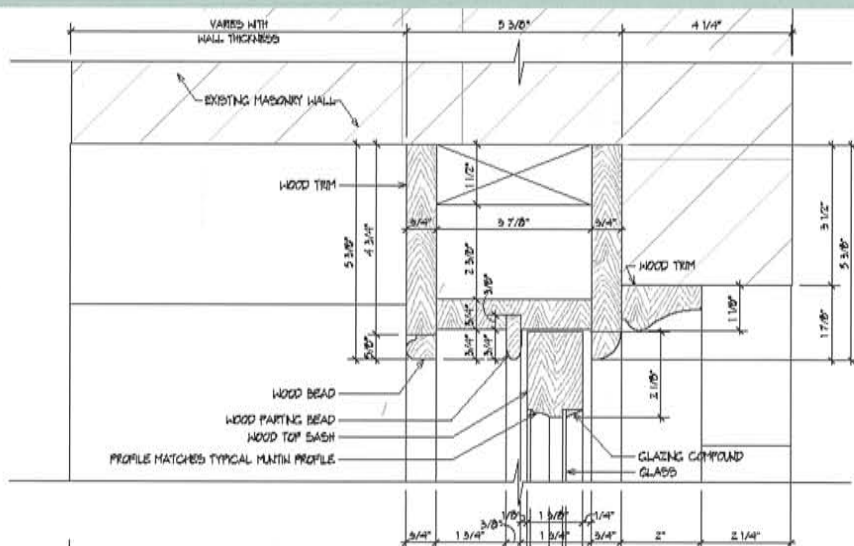
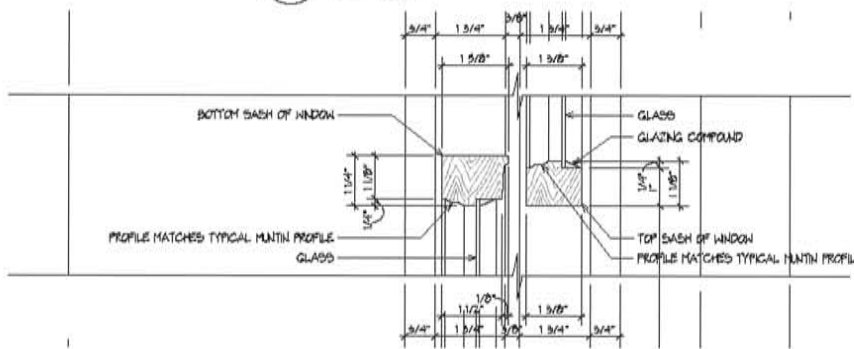
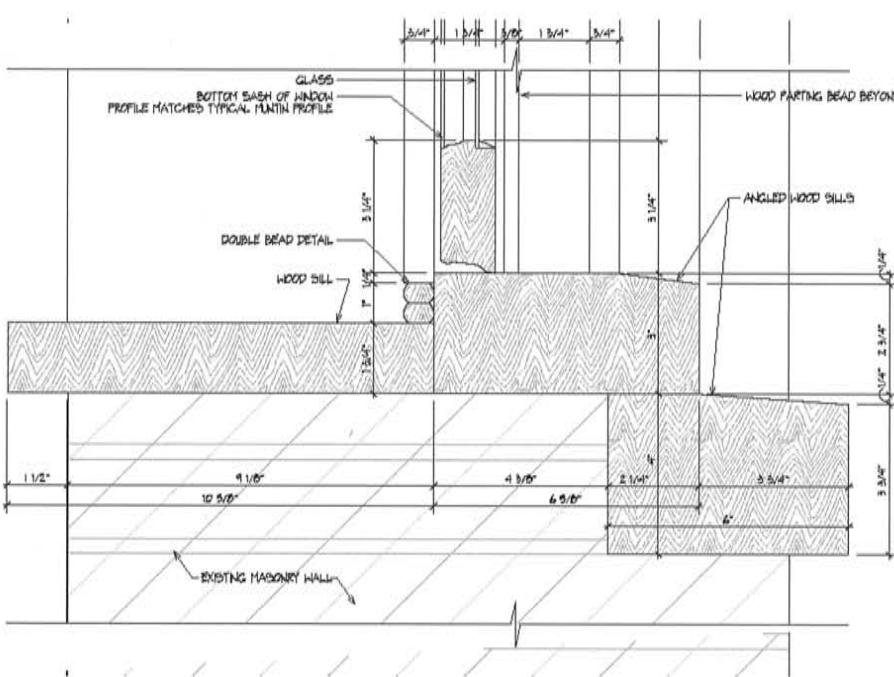
Figure 3. Drawings of the historic windows were prepared by the architectural firm based on field measurements to assist in devising an appropriate replacement window. Drawings: Courtesy of Kitchen & Associates Architectural Services.

The location of this building right on a street corner and the importance of the windows to the historic character of the building led the project team to select a window solution that closely matched both the detail and appearance of the historic windows. By selecting a new custom wood window, the narrow site lines of the historic windows could be closely replicated, the historic glass to wood ratio readily maintained, and other historic details easily reproduced (see figure 3).

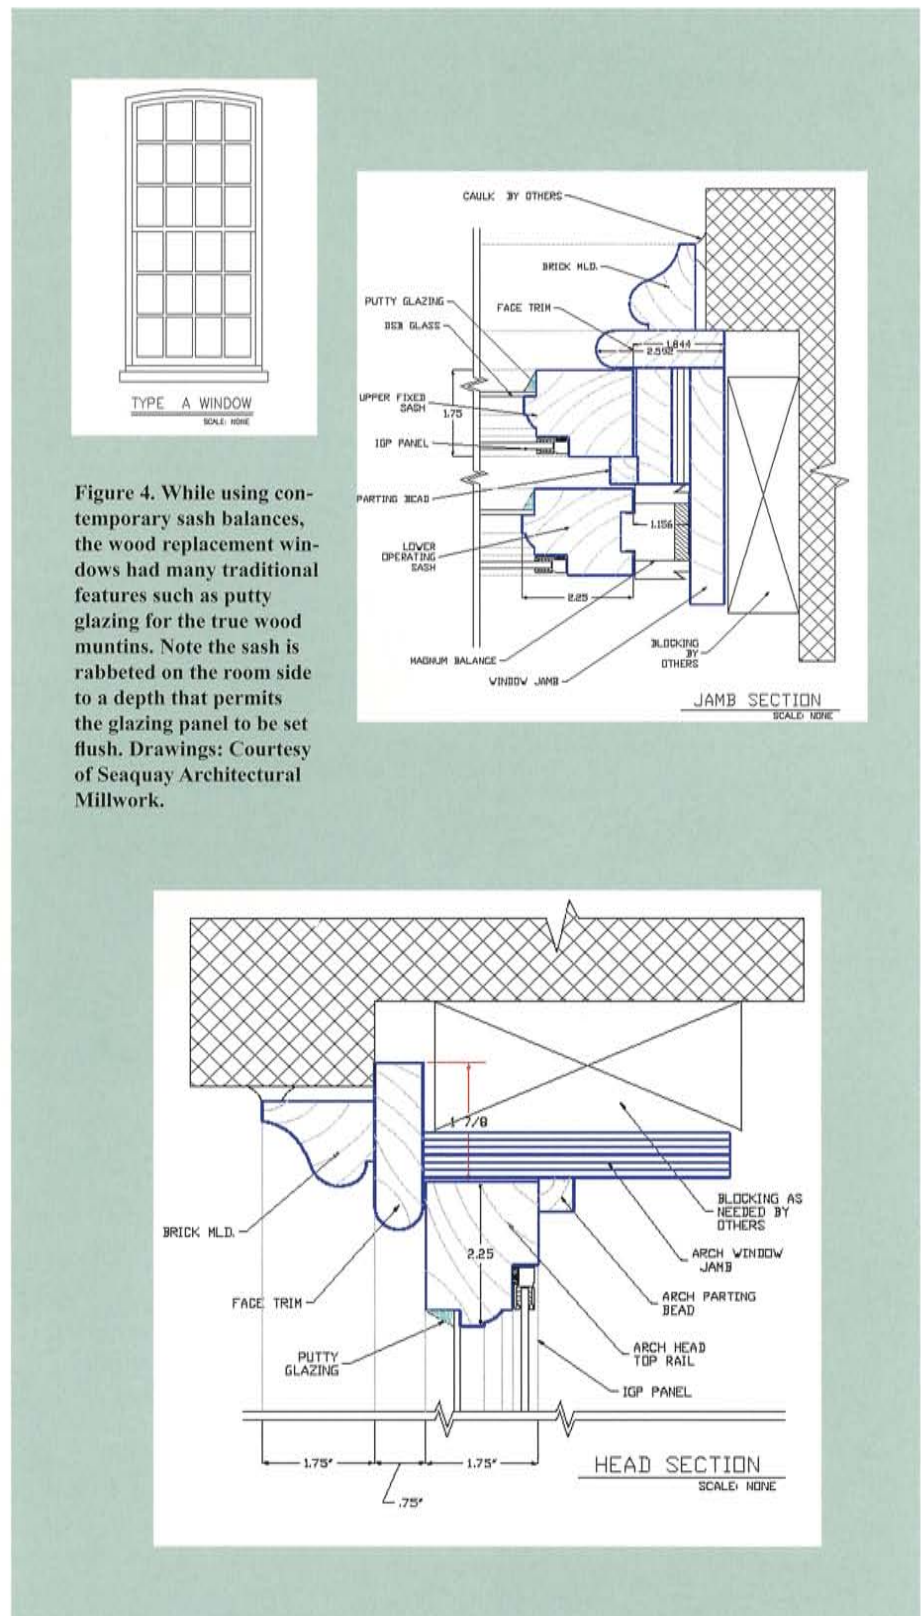
Figure 4. While using contemporary sash balances, the wood replacement windows had many traditional features such as putty glazing for the true wood muntins. Note the sash is rabbeted on the room side to a depth that permits the glazing panel to be set flush. Drawings: Courtesy of Seaquay Architectural Millwork.

To help retain the historic sightlines, the deteriorated frames were removed, permitting the new frames to be set close to the masonry (see figure 4). The alternate approach of retaining the existing frames, abutting new frames to them, and covering the outer face of the exposed portion of the older frames would have resulted in reduced glass exposure and a beefier frame appearance to the finished windows.

Several features of the new window were different than the historic windows in order to accommodate the dual glazing. The inside of the rails and stiles of the sash were rabbeted on the room side to a depth that permits the glazing panel to be set flush. To retain the depth of the original muntin and to accommodate the glazing panel on the inside, the thickness of the sash was increased to 1 3/4". In the bottom rail, weep holes were provided between the glazing panel and the outer glass, to allow water to drain from condensation that might on occasion develop between the two layers of glass.

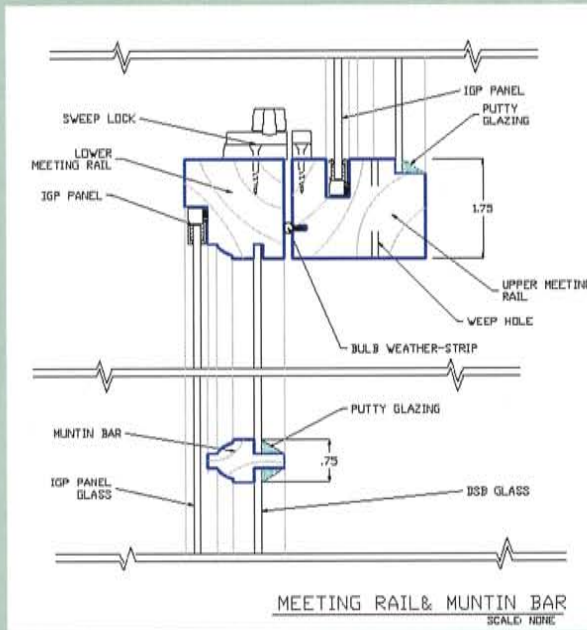
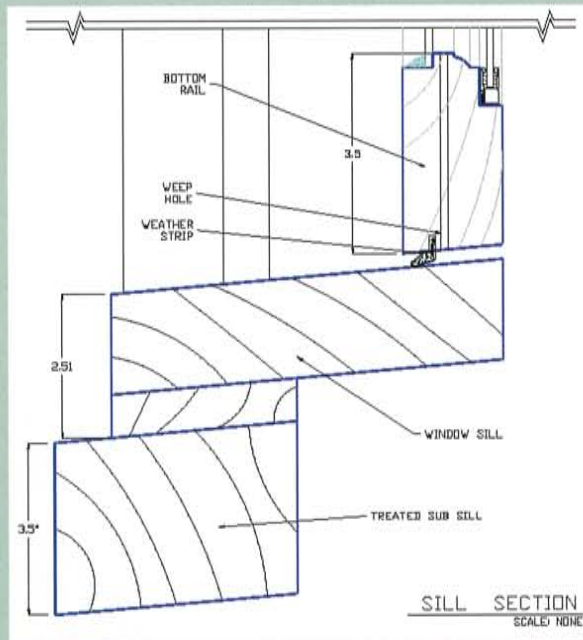
Figure 5. For the new windows to meet ASTM Standards, the face width of the meeting rail was increased 1/2 inch. To both accommodate the piggyback energy panel and match the historic muntins, the thickness of the wood sash was increased from 1 3/8" to 1 3/4". These two changes had minimal visual impact, considering the size of the windows. Drawings: Courtesy of Seaquay Architectural Millwork.

Somewhat more problematic was how close the bottom rail (meeting rail) of the new upper sash could match the narrow width of the existing window. Specifications for the project required that the replacement window meet three ASTM Standards: ASTM E283, the standard test for determining the rate of air leakage through an exterior window; ASTM E331, the test of water penetration; and ASTM E330, the standard test for structural performance of an exterior window. To meet ASTM E330 with the design pressure rating for the window set by the architect, a 1 3/4" wide meeting rail was needed (see figure 5). This was an increase of 1/2 inch over the historic sash. Fortunately because of the size of the window, this increase was considered acceptable, as the meeting rail still appeared relatively narrow even with the 1/2 inch increase.

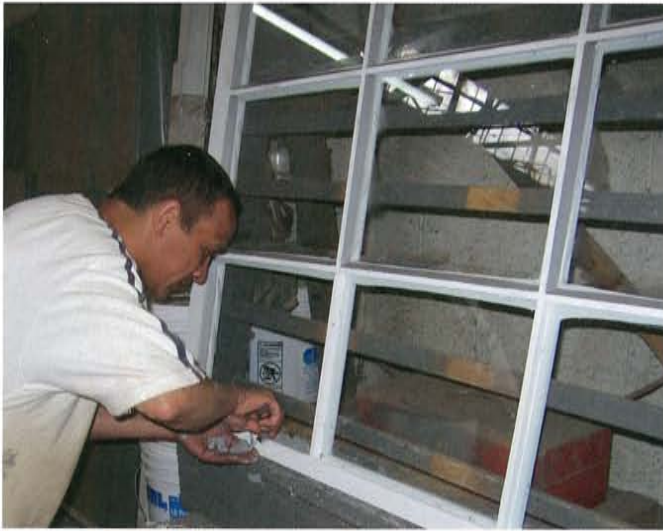
Figure 6. The outer glass was installed in the traditional manner, using exterior glazing putty. Photo: Charles Fisher.

The windows were then assembled and sanded. The outer glass was installed in the factory after the assembled sash were primed. Exterior glazing putty manufactured by C.R. Lawrence was applied in the traditional manner (see figure 6). Since the upper sash were to be fixed in the operable windows, weatherstripping and block and tackle balances were provided only for the lower sash. Each window was provided with two sweep locks and two sash lifts for the operable lower sash. Of the 188 replacement windows, 111 were single hung and 77 were fixed (see figure 7).

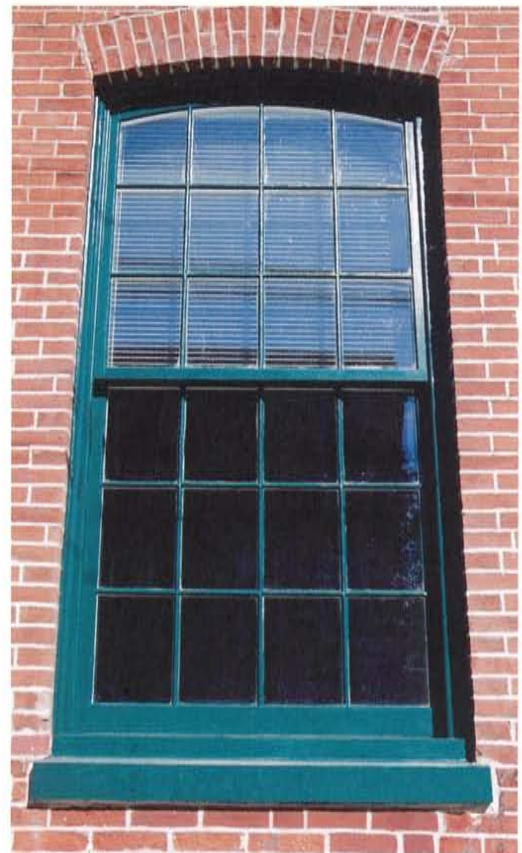
Figure 7. The new window's joinery, individual glass lights, reflective qualities, and painted wood finish all help to capture the appearance of the original units.

The new windows in Beatty's Mill successfully matched the historic units while providing enhanced energy conservation. There is little difference between the new and historic windows in terms of the characteristic features (see figures 2 and 7). The integral wood muntins, individual panes of glass, reflective qualities of the glass, glazing putty, and painted wood surfaces, along with the benefits of using a custom-wood window manufacturer that could duplicate

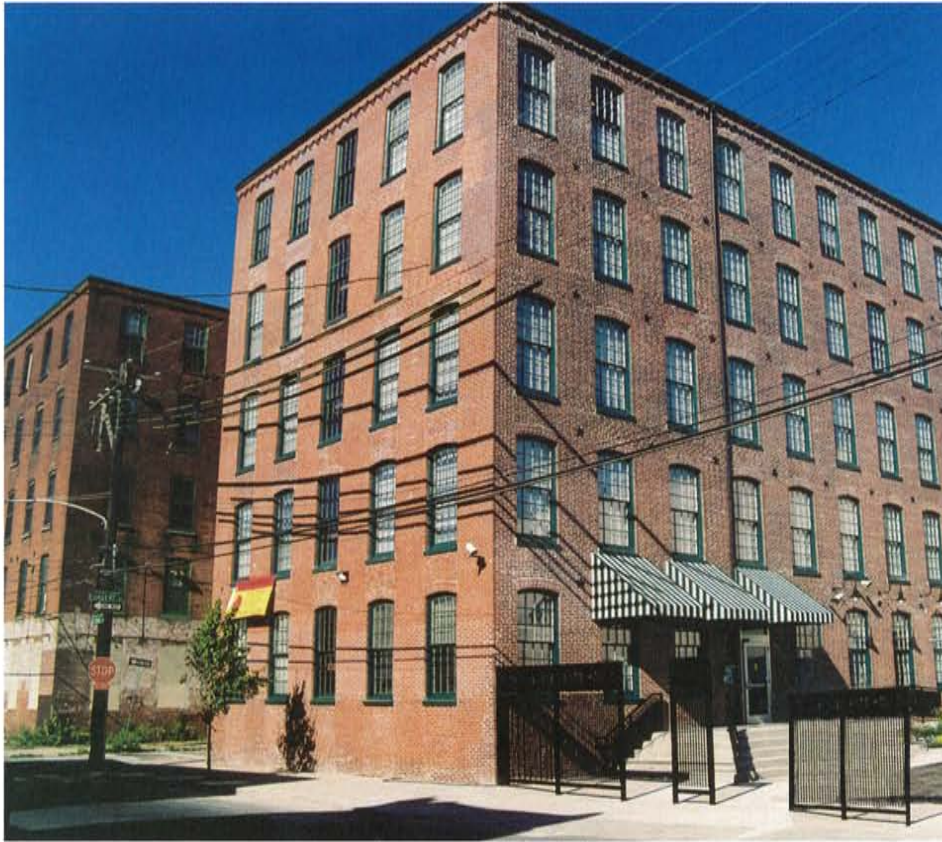
Figure 8. Upon completion of the work, the former mill now serves as low-income housing and artist live/work space. The new wood windows provide improved energy performance and enhance the visual qualities of the historic building.

the traditional true-divided light sash while incorporating dual glazing for energy conservation. Its use at Beatty's Mill and even larger buildings demonstrates that this type of a dual-glazed wood sash can be a viable window solution for projects of varying size (see figure 8).
