Preservation Tech Notes

WINDOWS NUMBER 22

Maintenance and Repair of Historic Aluminum Windows

Kaaren R. Staveteig
Technical Preservation Services
National Park Service

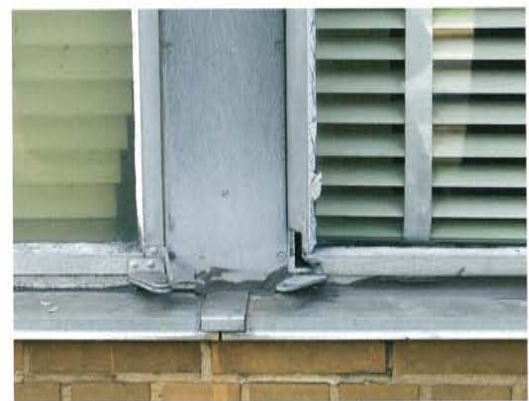
Figure 6. Deferred maintenance can result in a series of problems, such as broken hardware, cracked or missing glazing putty, and missing perimeter caulk (all shown above). All of these problems can be corrected. Note the uneven nature of the surface deposits of pollutants and grime on the mullion and sill of this window due to weathering and lack of cyclical cleaning.

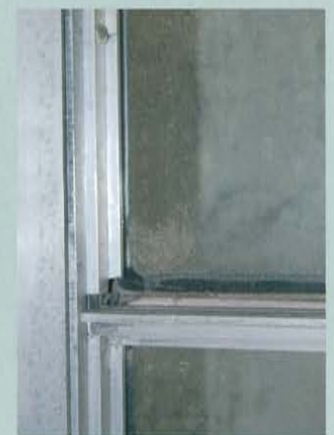
Figure b. The panes of glass were secured into the frame with aluminum glazing stops, each individually cut, drilled, and fixed in place from the inside. Here the vertical stop is in place while the horizontal is missing.

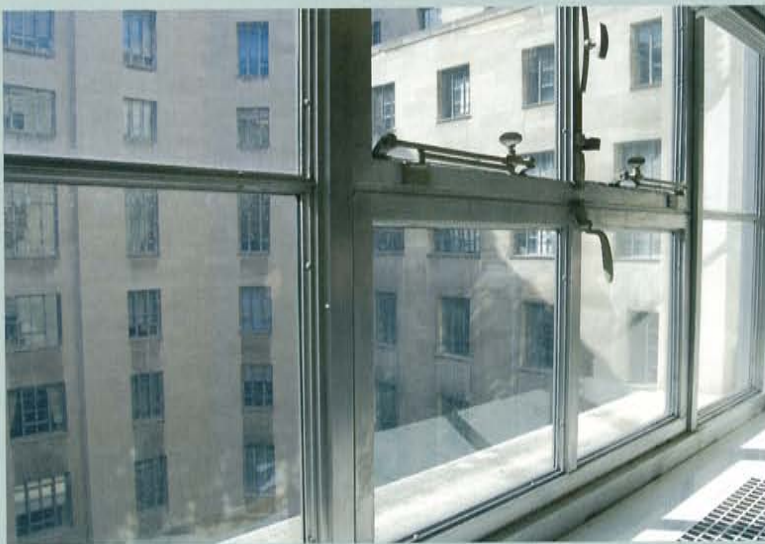
Figure c. In cleaning historic aluminum windows, the gentlest means possible should be used. More aggressive cleaners should be used only where necessary. The interior surface of this window was cleaned ten years ago with an aluminum jelly cleaner, rinsed and then dried thoroughly. The original mill finish still retains its luster.

After the glass was removed, the aluminum frames and muntins were thoroughly cleaned on the inside with an aluminum jelly cleaner, pumice, and scouring pads, when

needed. The aluminum was then rinsed to remove the cleaner residue (Figure c). For the exterior surfaces of windows that were more heavily corroded, the aluminum restoration company proposed a more aggressive chemical cleaner be used. This necessitated that the surrounding limestone surfaces around each window be well protected. During a mockup cleaning exercise, this chemical cleaner proved too acidic, difficult to control, and damaging to the adjacent stone. After testing some alternate products, the team found that a diamond abrasive pad used in combination with the Duro Aluminum Cleaner in jell form, worked the best. Special care was still necessary to protect the surrounding limestone.

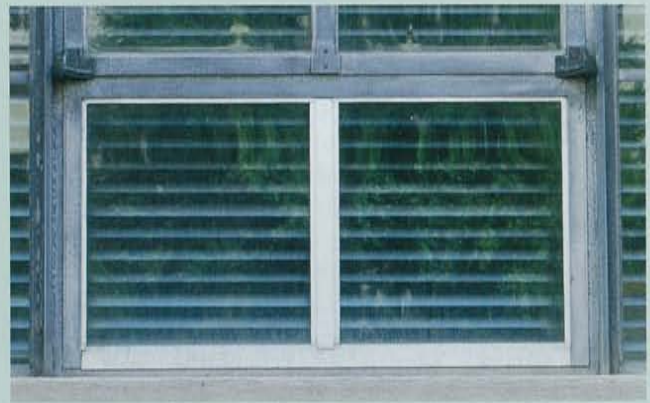
Figure d. Numerous hopper units have been removed over time to accommodate air conditioning units. Replacement hopper units were manufactured, as needed, to match the original hoppers elsewhere in the building.

An aluminum company reproduced the vertical muntin that historically existed in the hopper unit but was missing from numerous units. After the muntins were cut to size, each was slotted at the end and fitted into the hopper frame, and then welded at the tip. The same company also made custom extrusions for the rails and stiles of the hopper units for use in fabricating entire hoppers where missing (Figure d).

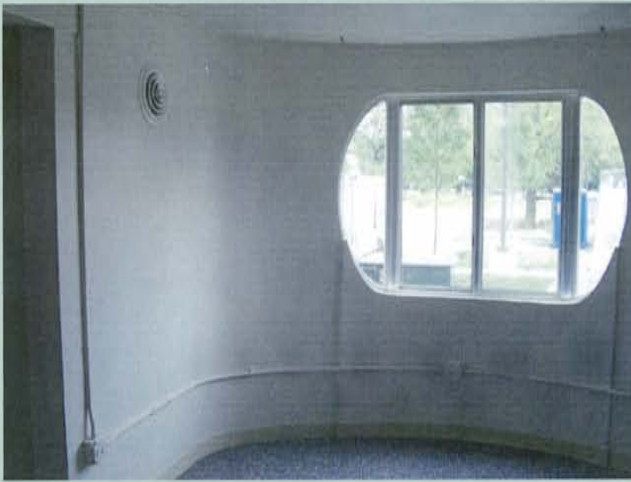
Figure e. Both interior and exterior aluminum surfaces had become dull, soiled, and oxidized as a result of traffic exhaust and air pollution. Cleaning the aluminum stabilized any further deterioration and brought back the luster of the original mill finish. (Photo: Holsten Real Estate Development Corp.)

The aluminum surfaces needed to be cleaned and taken back closer to their original appearance. Because of the effect of weathering and use, it was considered acceptable in this project to use certain cleaning techniques not normally recommended for more ornamental architectural aluminum. A common chemical cleaner and/or

denatured alcohol were used to remove the general residue on the aluminum. Wearing rubber gloves, the crew wiped on the cleaner with a damp cloth, allowed it to stand for 3-5 minutes, and then wiped it off with a clean damp cloth. Scouring pads and scrapers were sometimes used on more encrusted areas, as needed. The removable sash units were cleaned in the basement shop, while any frames that remained in situ were cleaned in place (Figure e).

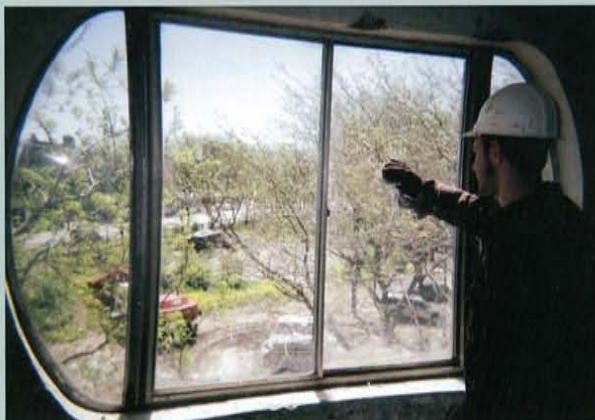
Figure f. Repair and replacement work was done from the inside to lessen the risk of damage to the outside finish. (Photo: Holsten Real Estate Development Corp.)

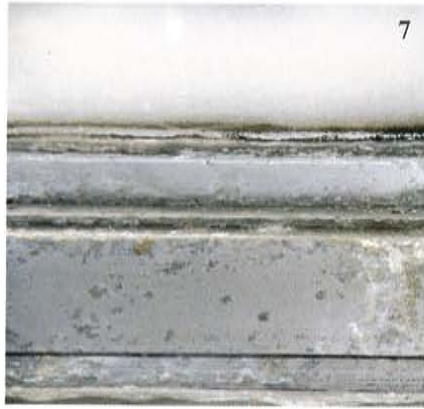
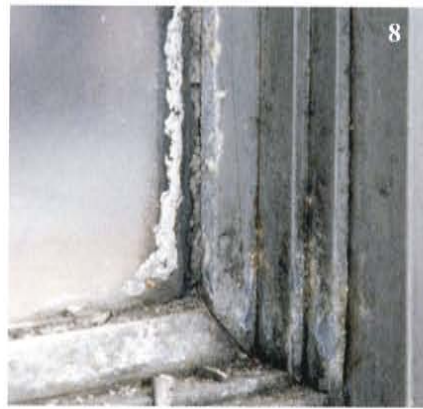
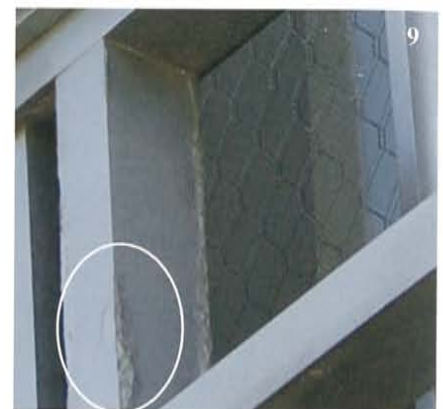
Figures 7 and 8. Aluminum corrosion can appear as a white discoloration and forms on the surface as the protective oxide film breaks down, as seen in these 60 year old windows in the PSFS Building, Philadelphia, before they were replaced. The small dark bumps are where surface dirt, grime, and pollution particles collect. Over time, pits form beneath these dark areas as the surface continues to corrode. This corrosive action is further encouraged by foreign particles, such as dirt and chlorides, which hold moisture next to the surface. (Photo: Powers & Company Inc.) Figure 9. Some aluminum alloys are less corrosion resistant than others. Delamination, as seen on this aluminum railing in front of a window at the Folger Shakespeare Library, can occur when an aluminum-copper alloy is introduced and used in an outdoor setting. The original specifications called for aluminum and chromium, but were not followed.
