**Tech Notes**

**LYNDHURST GATEHOUSE**

NUMBER 3

**Exterior Storm  
Windows:  
Casement Design  
Wooden Storm Sash**

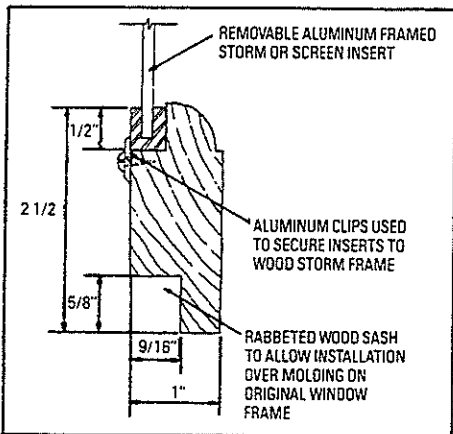
Figure 1. The single casement, wooden storm window had two removable panels for screen and glass inserts. This custom design fulfilled a variety of requirements established for the project with minimum physical damage and visual changes to the historic windows. Drawing: Martha L. Werenfels

dows and attached to the existing frame (see figure 1). The arched-headed wooden storm window with one-over-one glass panes matched the size of the original double-hung sash. Molding details similar to the original were incorporated in the new storm sash. Each of the two panes in the storm sash was set in thin aluminum frames and secured in the wood storm window with standard clips. This installation technique enables the storm panels to be easily removed by a person on the inside of the house and replaced during the summer with screens (see figure 2).

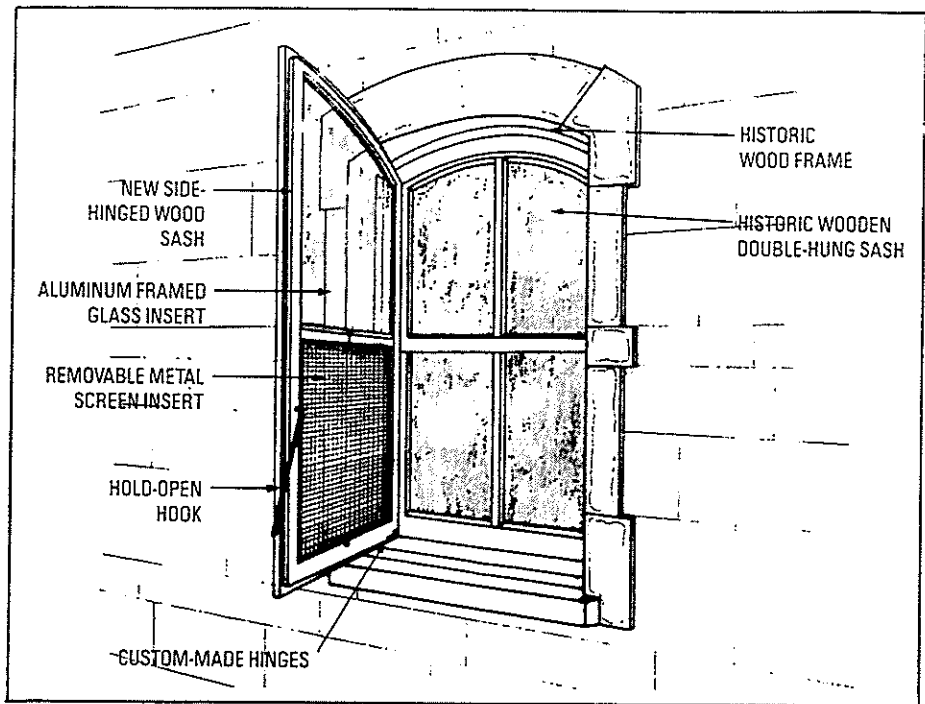
Figure 2. Section of the wood stile shows how the removable screen and storm panels are secured by use of aluminum clips. Also note that the storm sash was rabbeted along the inside edge to allow retention of original window molding. Drawing: Martha L. Werenfels

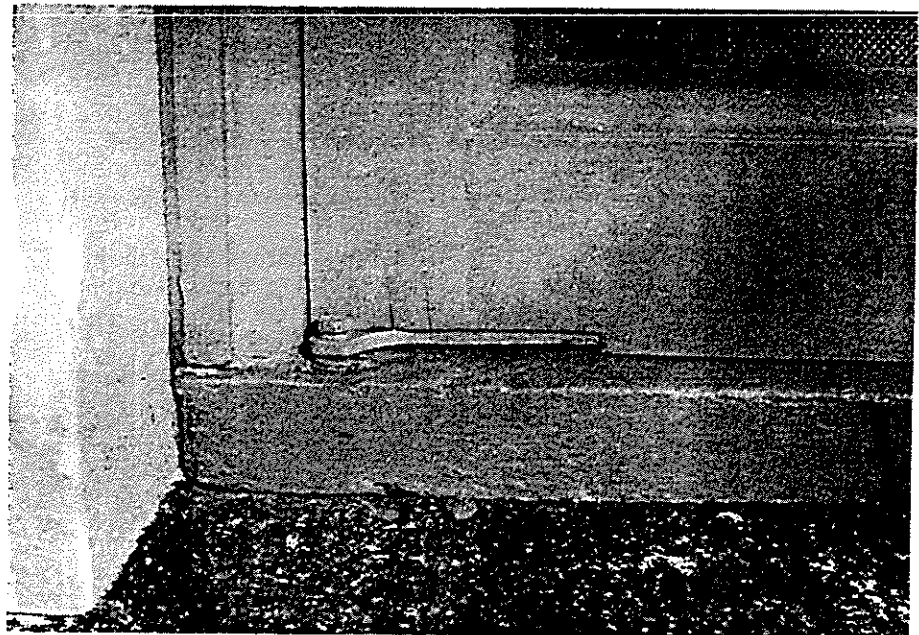
Figure 3. The only feature of the storm window that required expensive custom work was the pin-in-socket hinges (bottom one shown in photograph). Commercially available hardware could have been used; however this project sought to minimize physical damage to historic woodwork and thus tested a prototype design. Stainless steel was used for reduced maintenance costs. Photo: Richard Bierce, AIA

Mounting hardware consisted of pin-in-socket hinges which required the drilling of only two holes in the existing frame (see figure 3). The hinges allow the window to open casement-style for egress and ventilation purposes.

Custom-made stainless steel hinges of a pin-in-socket design were attached to the left side, top and bottom, of each window. The windows were then sanded, treated with a non-toxic preservative, and primed with an oil-alkyd paint.

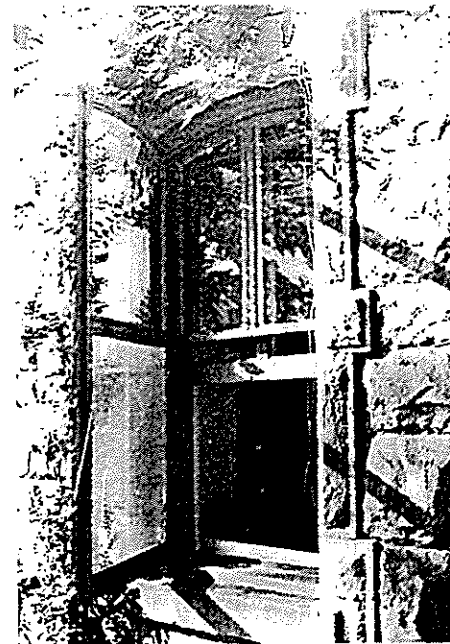
Figure 5. The new wooden storm sash was installed in the historic frame; the edge of the storm frame was rabbeted to accommodate the historic molding on the old wood frame. Photo: Richard Bierce, AIA

wood preservative used on the sash, then filled with a polysulfide caulk before the anchor was inserted. After the windows were installed, 1 inch hook-eyes were attached to secure the windows shut while a second hook-eye, 1 foot long, was installed on each window to hold it in a fixed position when opened (see figure 5).
