## FLORIDA STATE CAPITOL

## WINDOWS

NUMBER 7

### Window Awnings

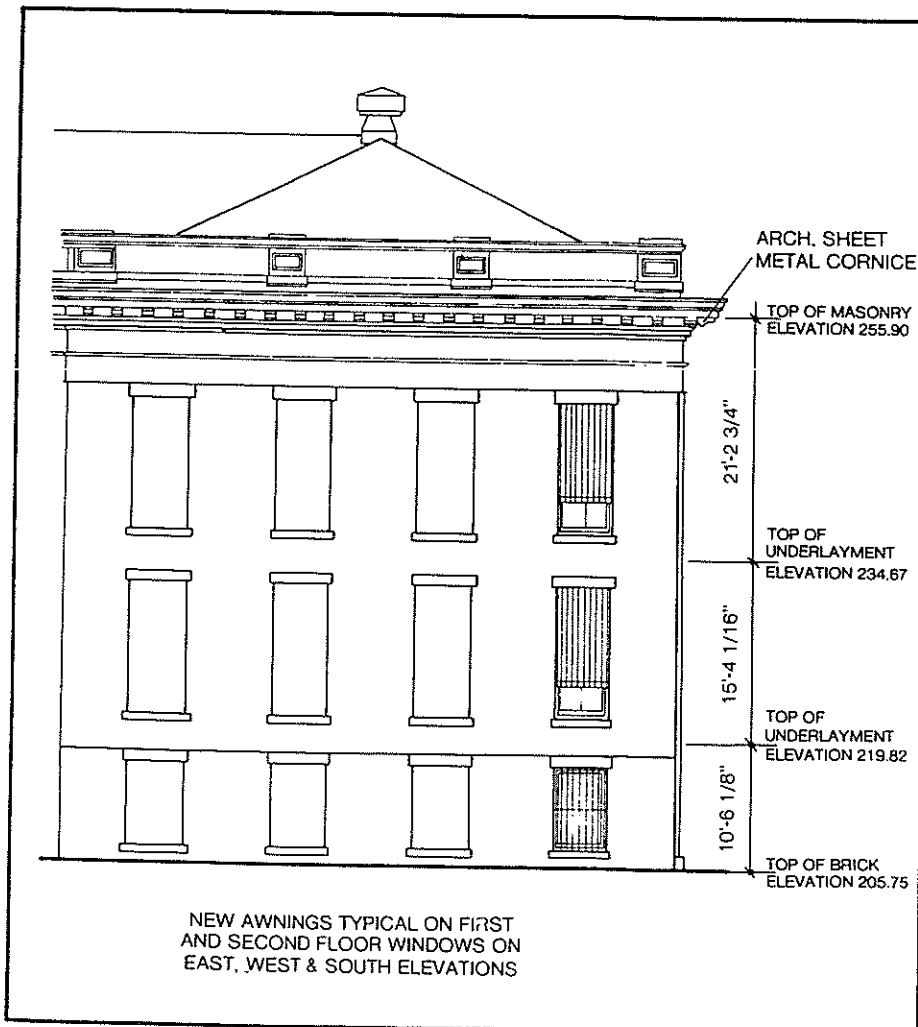
Figure 1. Large awnings were specified for all but the north elevation in order to reduce solar gain. Drawing: Courtesy, Shepard Associates, Architects and Planners, Inc.

Since the primary facades of the Capitol faced east and west, awnings were needed on the two main floors on all but the north side (see figure 1). Solar heat gain, which originally would have consumed 54% of the required cooling load, was now estimated to be 31.5% of the equipment load, and allowed a downsizing of the HVAC system by 25 tons. In typical first floor offices, the exposed glass surface would now only account for 46% of the required cooling load down from 72%. On the second floor, there was a similar change from 56% down to 30%.

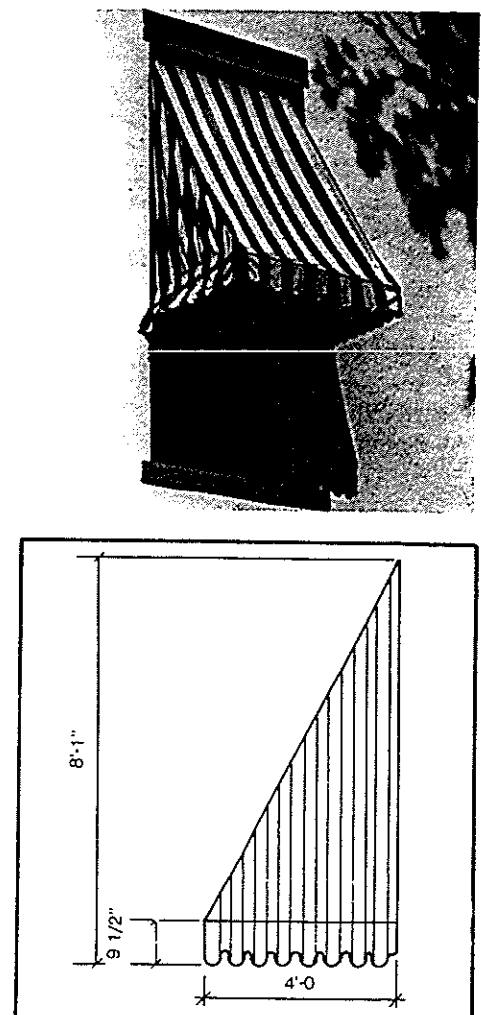
The awnings were fabricated to the architect's design of 4' wide by 4' deep with a height of 8'-1" and a 9 1/2" scalloped valance (see figure 2). The 100% acrylic fabric has vertical stripes four inches apart. Regrettably the production of the acrylic weave did not allow for pure color separation, and as a result the striping is in reality red and a very light pink; still the impression of red and white is maintained.

Figure 2. Early photographs were used in determining the appropriate design and size of the new awnings shown in the photograph. Drawing: Courtesy, Shepard Associates, Architects and Planners, Inc.; Photo: Courtesy, Florida Bureau of Historic Preservation.

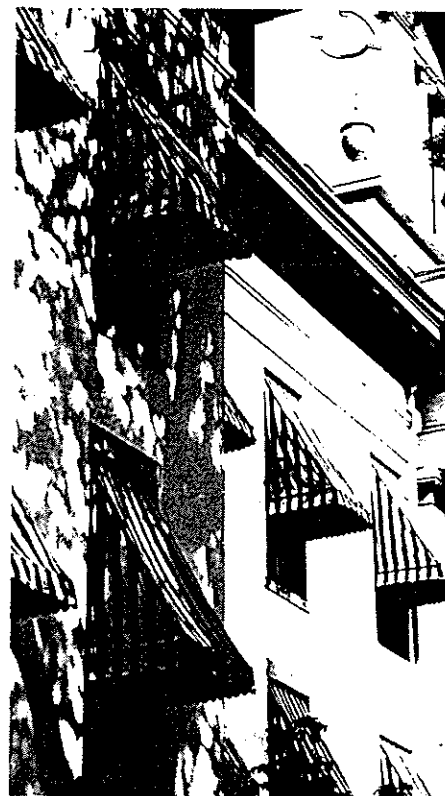
**Figure 3.** By reducing the glare and solar gain, the awnings have eliminated the need to purchase and maintain interior shades and draperies in various offices. Photo: Courtesy, Florida Bureau of Historic Preservation.

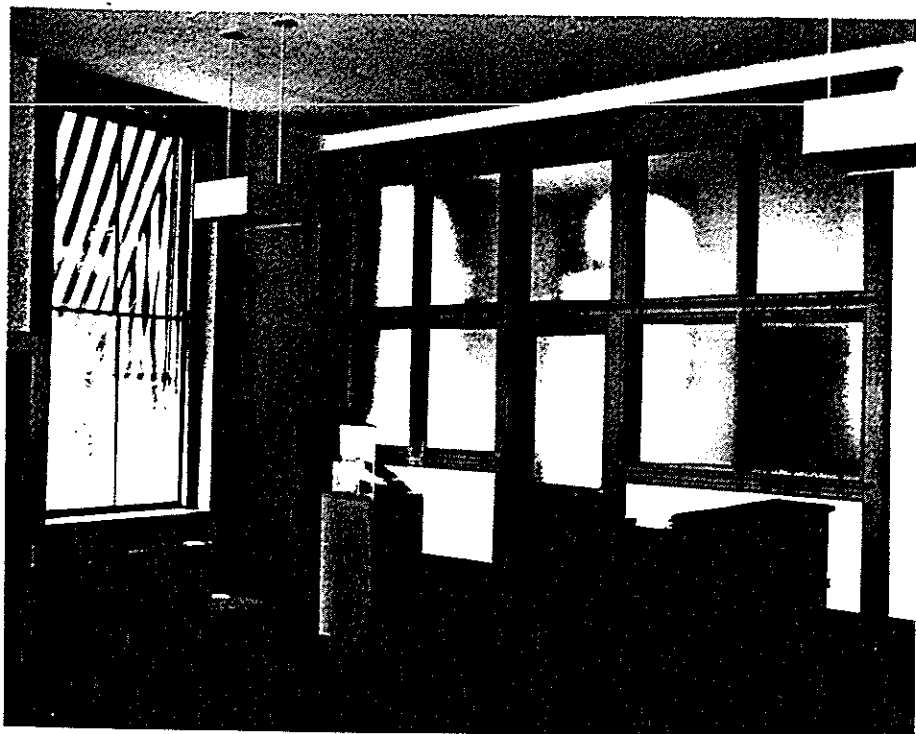
The decision to make the frames rigid to prevent retraction of the awnings on the Florida State Capitol did prove to be unwise, since seasonal high winds, exacerbated by large adjacent new construction, caused greater damage than had been anticipated. To correct this condition, the windows, which had been screwed shut and sealed, were easily reopened; the awnings were rigged so that they can be drawn back in high winds; and various sleeves and pins were removed from the frames, returning them to their original operable condition. Now whenever inclement weather is anticipated or more sunlight is required in certain rooms, maintenance personnel can

**Figure 4.** While the awnings were installed in order to save on energy costs, the restoration of this highly decorative and colorful feature enhances the historic appearance of the building. Photo: Courtesy, Florida Bureau of Historic Preservation.
