COLORADO STATE REGISTER OF HISTORIC PROPERTIES NOMINATION FORM

Historic Name Conrad Borgens House

Street Address 415 13th Street

City Greeley

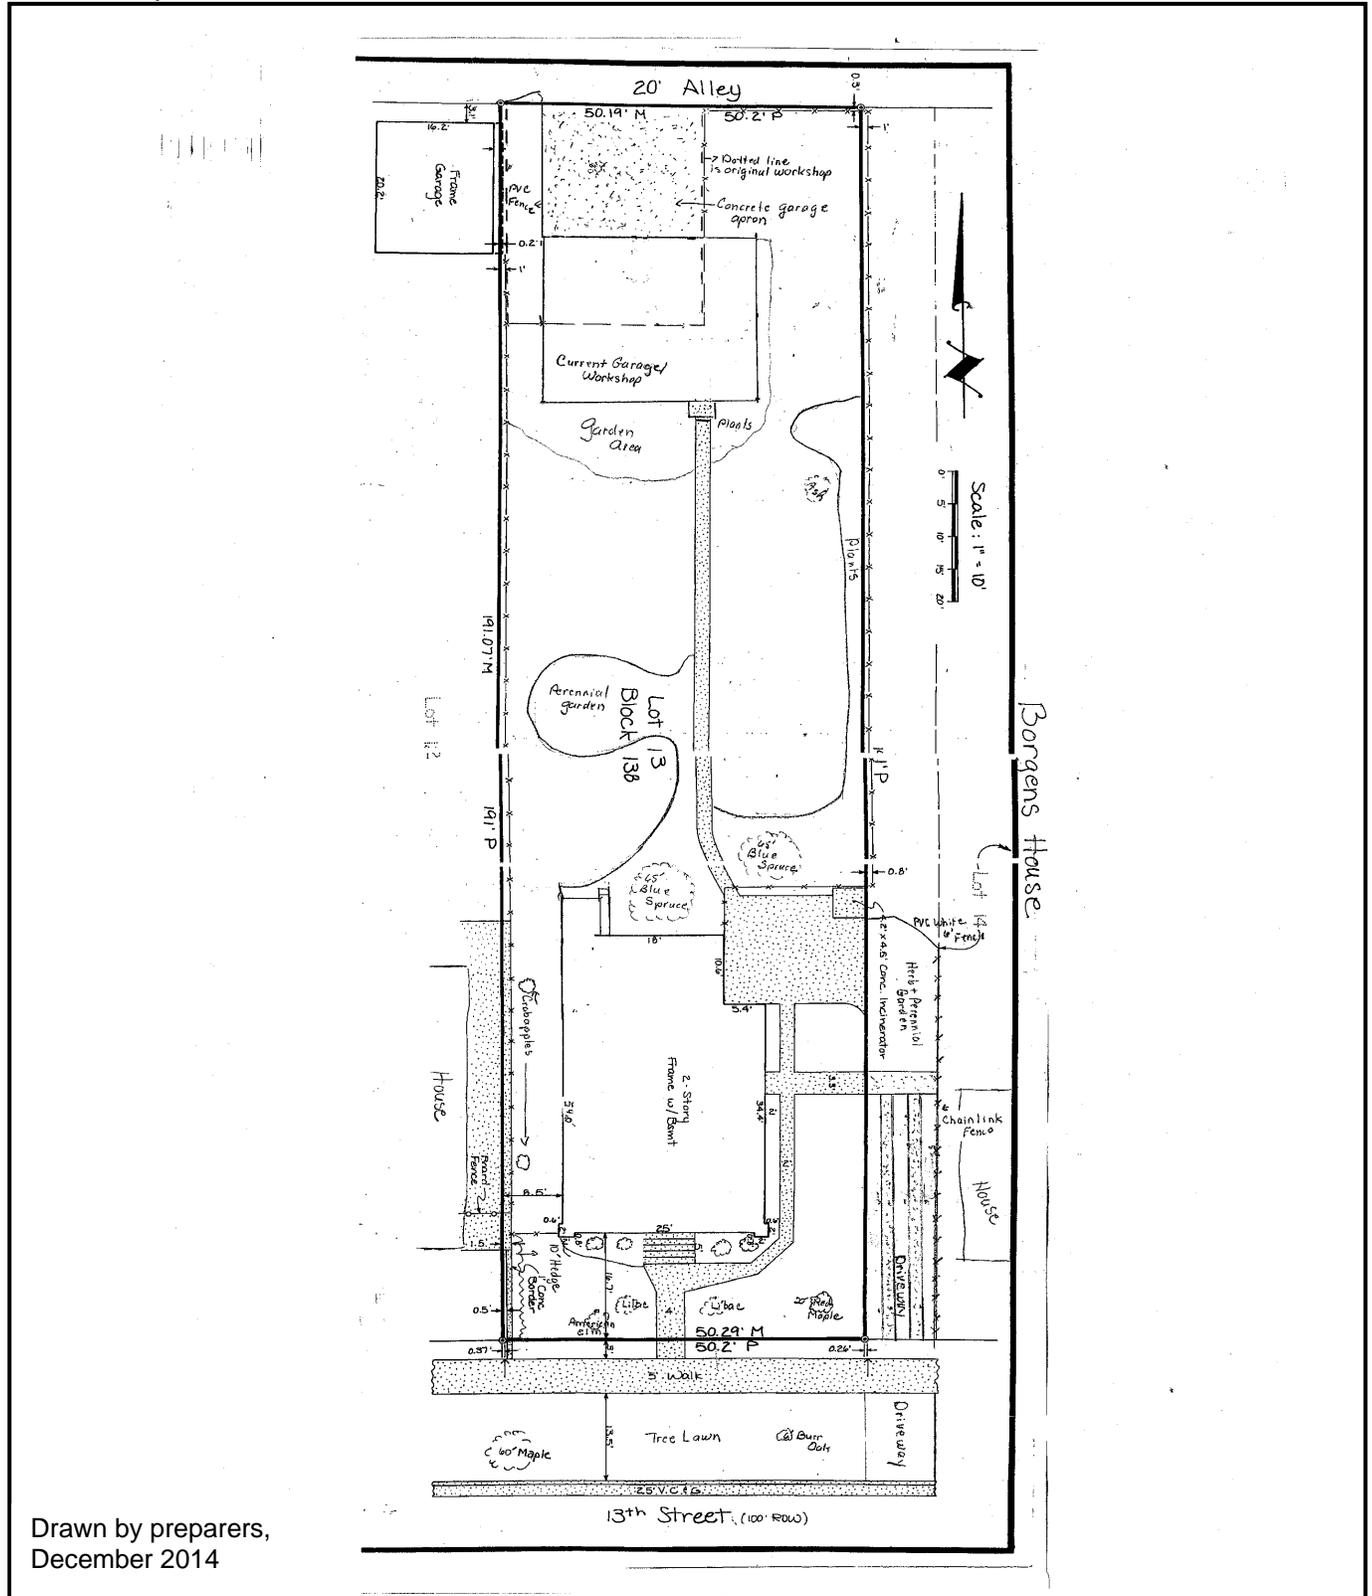
Sketch Map

Drawn by preparers,
December 2014
