# Using Old Farm Buildings

**Dexter W. Johnson**  
Agricultural Engineering  
North Dakota State University, Fargo, ND

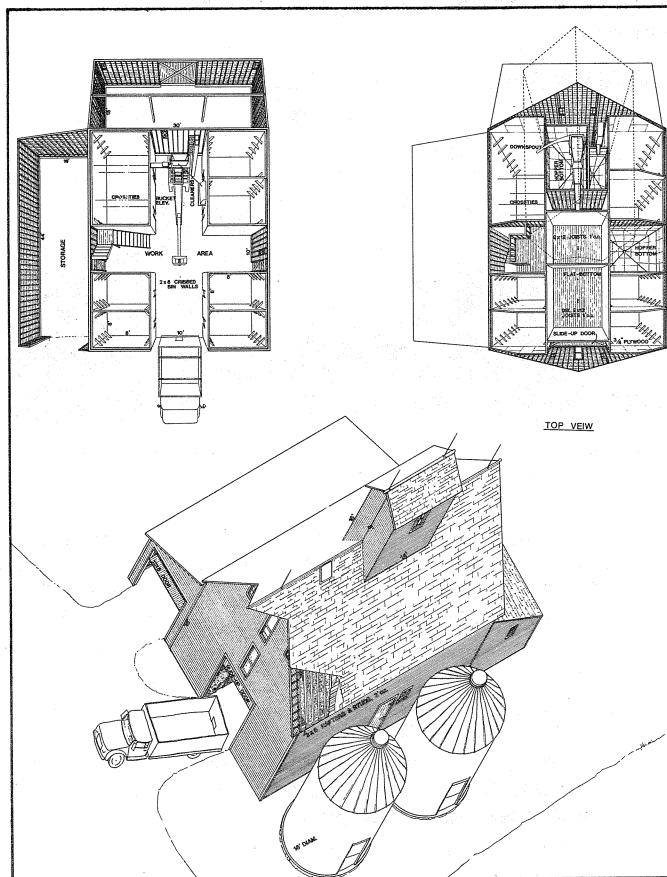
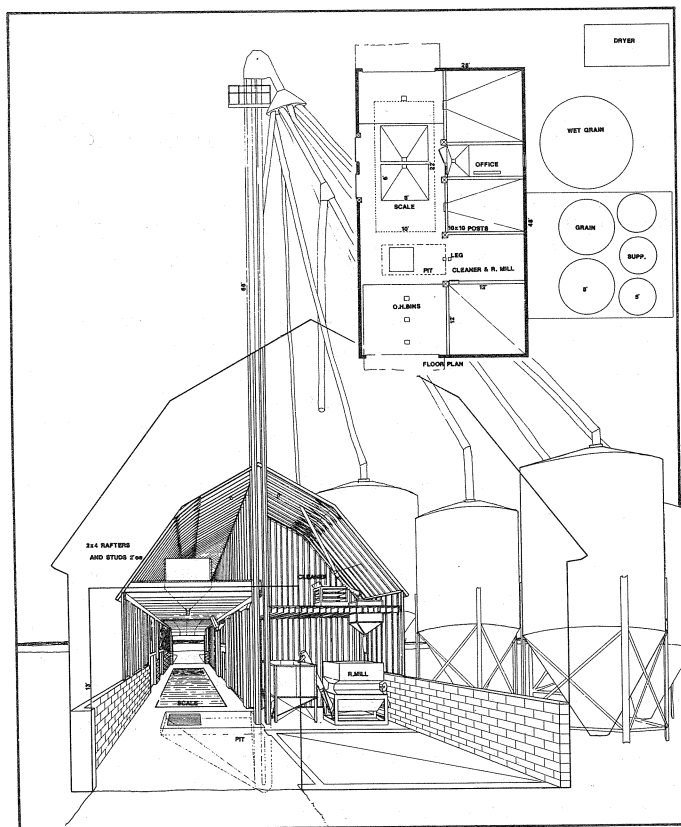
## SEED CLEANING AND GRAIN STORAGE

This operator wanted to preserve and yet make practical use of his 30'x44' two-story gamblerooft barn originally constructed for dairy in 1890. Nearly 10,000 bushels of storage (plus the two 2500-bushel round steel bins) and work space for sieve-type, rotary-disc and movable, gravity-table seed cleaning machines were provided in the 1957 remodeling. Rehabilitated, it now permits one person to clean and treat seed, utilizing off-season winter labor. The 16' wide side lean provides storage for bags and equipment--the end lean collects screenings from the cleaning equipment. A 40' high, 1200 bu/hr bucket elevator moves grain up from trucks (which are backed in and unloaded into a 7' long, movable, 8" auger to the bucket elevator) to storage bins or cleaners, and drops it through a hand-moved, overhead downspout into storage. Uncleaned grain is stored in the eight 1/4'x8' full-height, flat-floor bins of 2"x6" cribbed-wall construction. Cleaned grain is stored in five metal-lined, hoppers, overhead bins that are supported by 6"x6" joists on 2' centers. The flat-bottom bin above the alley is supported with 2"x12" joists on 1' centers. The original rock foundation was replaced with reinforced concrete, new sills were installed and the building was lowered back into place at a cost of \$12,000 materials plus owner and neighbor labor. Equipment costs for cleaners, conveyors, etc. were extra.

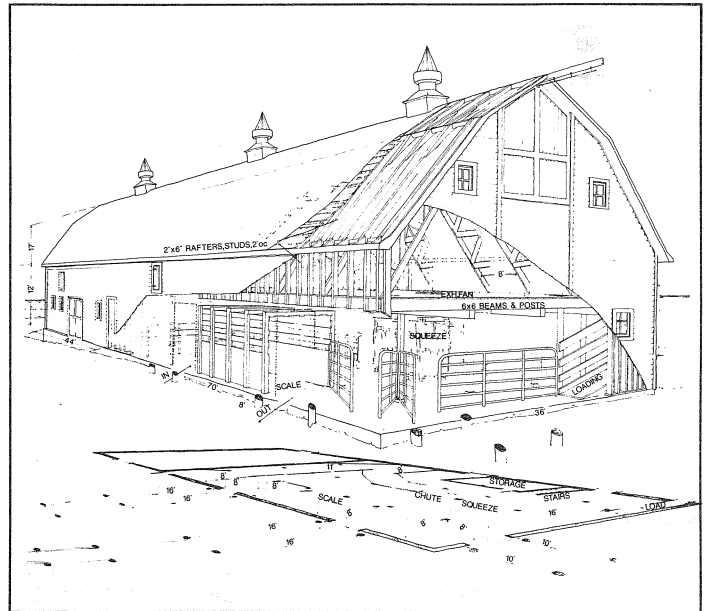
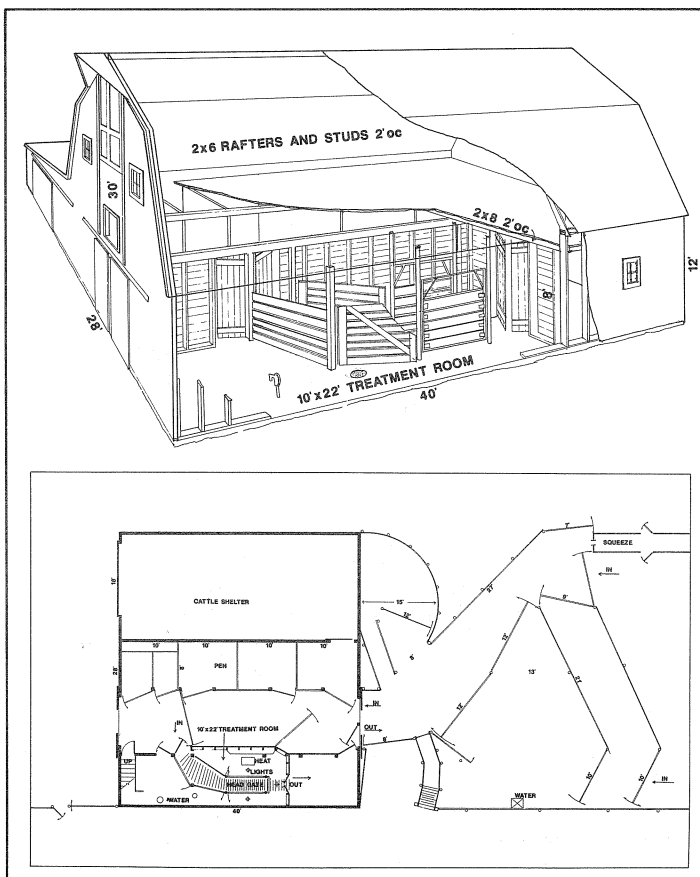
## LIVESTOCK HOUSING AND HANDLING

In 1912, lumber was hauled by wagon team to construct an original 36'x70' horse and cattle barn. A 44' long addition was added later for more livestock. A farmstead landmark and often used for benefit dances during WWI, it was unused for about 10 years until the owners recognized a potential use for it in their family cattle feedlot operation.

Knowing the weights of livestock purchased, to be sold or being fed in the feedyard is essential for efficiency. Treating sick cattle or processing new cattle needs to be done on time. Farming along with feeding means limited operator time is available during daylight and/or good weather. To cope with this situation, a 20,000 lb capacity, 7'x16' platform scale for weighing was installed in 1975. This scale, sorting pens, chute and loading system were planned and installed indoors so one person could, day or night and regardless of weather, "handle" cattle with the family 1200 head feedyard system. Since this is the only scale and handling system in the area, neighbors now often use this facility to weigh and sort their hogs, sheep and cattle. The second-floor mow space is used for miscellaneous storage and aids temperature and moisture control in the 8' high main barn space. An exhaust fan in the ceiling over the headgate quickly moves out branding smoke and odor. The interior mow-support posts see double use for gate and pen partition support. The indoor loading ramp stays dry and clean. The alternate, groundlevel chute is convenient for stock trailers. Cost was about \$7,500 for new concrete floor and equipment plus owner labor. A new, comparable-size barn would have cost twice this and an area historic feature probably torn down. A practical use for an old building helps to justify the necessary maintenance and insurance costs.

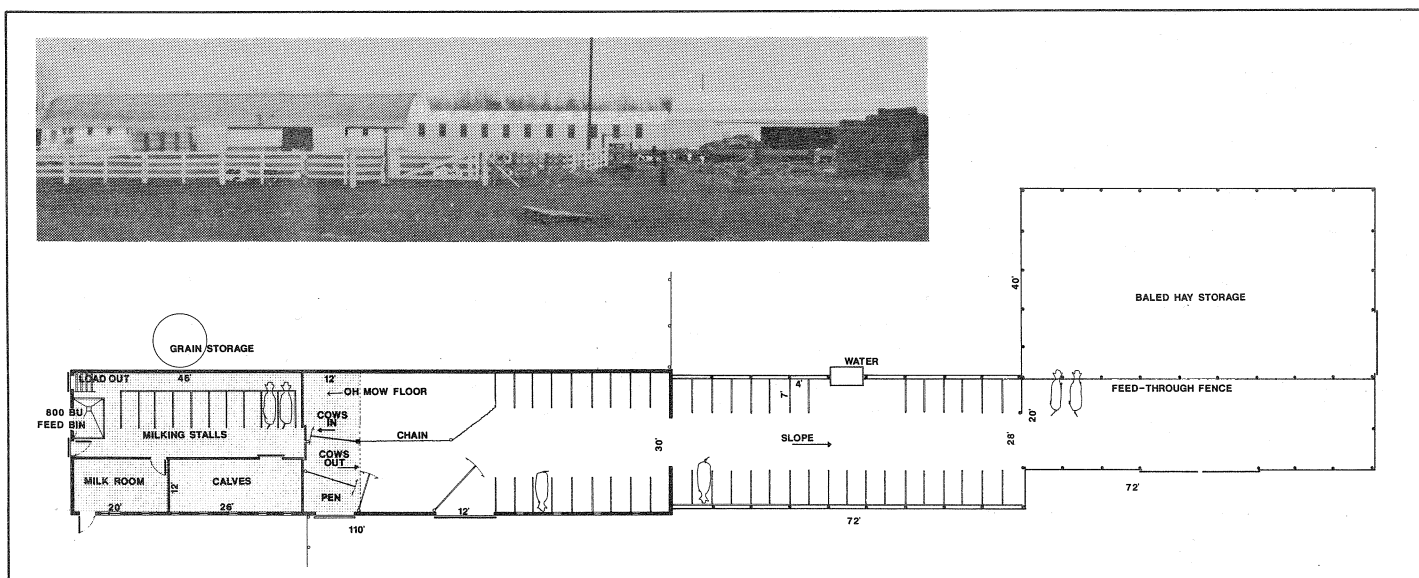
## DAIRY MILKING, HOUSING AND FEEDING

Loose or freestall dairy housing systems permit low-labor group handling, feeding and tractor-powered manure cleaning. Although management is critical, investment is less per cow than with conventional stanchion housing. A loan of \$5000 along with owner and neighbor labor was used in 1955 to construct this 30'x110' wood archroof barn with ten floor-level milking stanchions, milk pipeline and milkroom at one end along with overhead bedding storage. Open, loose housing for 28 cows was provided at the other end of the barn. Youngstock were housed in another barn

and most feeding then was done outdoors. In 1965 a 40'x72' clearspan, pole frame hay storage with 20' wide lean for self-feeding was erected 72' away from the archroof barn for \$3500 cost plus owner labor. This allowed indoor storage and feeding of rectangular hay bales to reduce waste and labor. In 1968 a 28'x72' truss-rafter, poleframe building with natural ventilation system was fitted into the space between the archroof barn and the hay storage/feeding building. Indoor/outdoor watering and freestalls were included in this part and in the original loose housing area for 40 cows. Over 13 years, a complete dairy milking, housing and feeding system was developed with minimal investment.

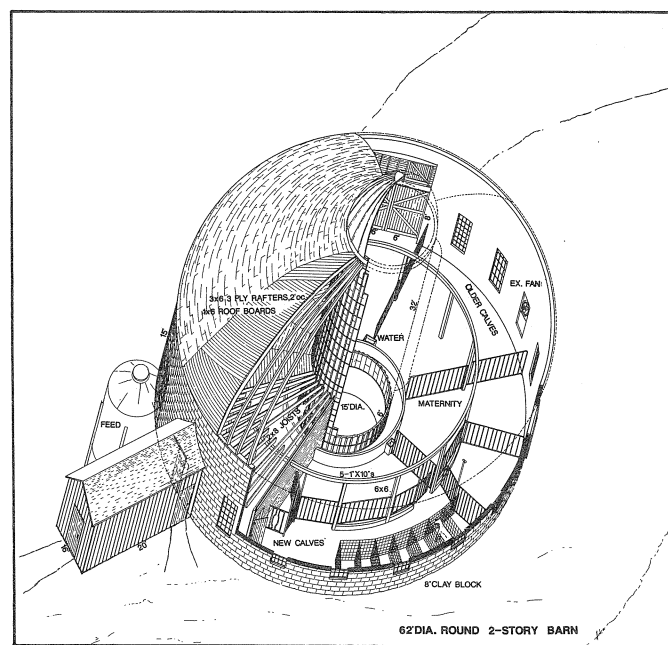
## DAIRY CALF HOUSING

Several dairy operations, when expanding, have used the old stanchion barn for housing calves to be grown up for herd replacements. The overhead mow provides hay and bedding storage plus insulation for animal air-temperature control. Mow-floor posts also support the numerous pen partitions. Few operators, however, have a round barn with its special floorplan layout arrangement problems. An area historic feature, this 62' diameter clay block wall barn was converted in 1972 for under \$1000 when the milking herd was moved into a new, larger, freestall housing, indoor feeding and elevated milking parlor setup. Calf barn investment was thus held to a minimum and an old farm building preserved for practical use.

Originally constructed in 1926, cowstalls faced in toward the feedmanger/alley that surrounded a central wood silo. A gutter and work alley next to the exterior wall had an overhead track-litter carrier system for hand-cleaning manure. Moisture deteriorated the original hemispherical-shaped roof. It was replaced with a lower-profile, arch-roof in 1950. The 15'x32' concrete-stave silo replaced the wood silo in 1948. The windows were replaced with higher insulating-value glass block in 1960. An exhaust fan ventilation system is used for cold weather. Door openings are adjusted for air movement in moderate weather. Straw bedding and indoor hay/grain feeding is done by hand. Pens are cleaned periodically with a skid-steer loader through the 12' wide rear door. The maternity pen permits cows to calve indoors with close supervision. Newborn calves are placed in individual, floor-level, bedded pens for six weeks to control sucking on each other. After getting onto a hay/grain ration, calves are moved over to larger and larger group pens with adjoining outdoor pen space.

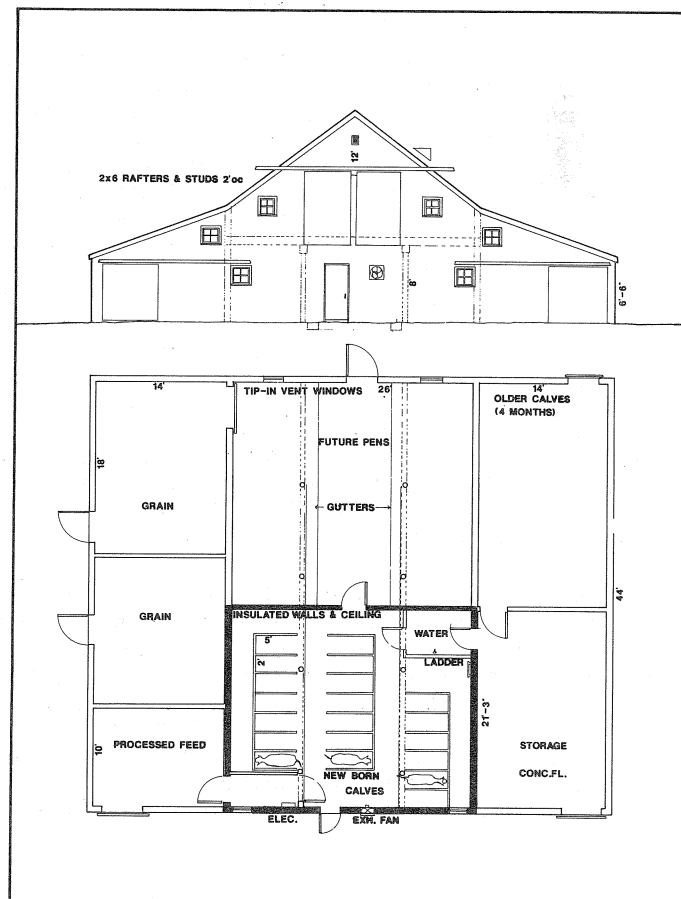
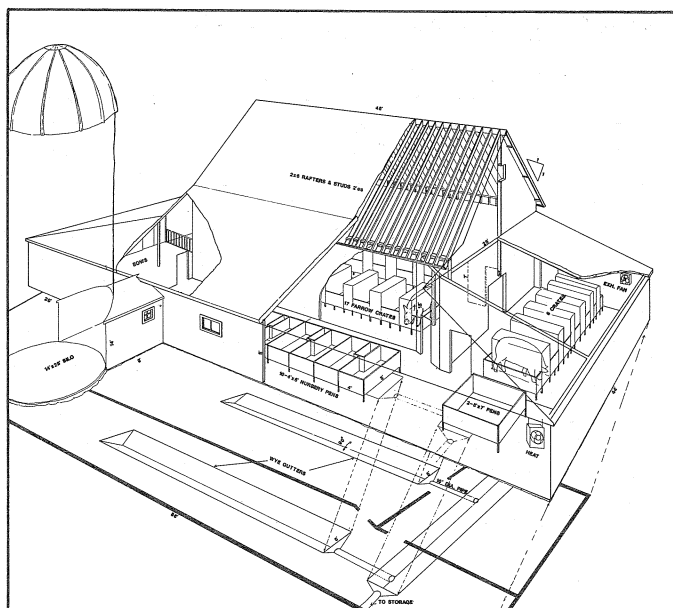
## CALF HOUSING AND GRAIN STORAGE

For less than \$1000 sheathing and insulation cost plus mostly owner labor, a 1957 gabled roof, drop-sided, 26'x44' dairy barn with 14' wide leans was adapted to calf-youngstock-grain storage when a new, separate, housing system was constructed in 1984 for an expanding dairy operation. Twenty individual, bedded, floor-level stalls for the newborn calves were home-built from ½" exterior grade plywood and located in the main barn space.

Feeding and manure cleaning is done by hand for the small calves. Heated water is available for mixing dry milk replacer feed. A tractor loader is used for periodic cleaning group pens in the 14' wide lean. The overhead mow provides baled straw and hay storage plus insulation to prevent indoor condensation. A continuous-running, variable-capacity, exhaust ventilation fan along with a portable, oil-fired, hot-air heater and movable heat lamps maintain a 40°F winter temperature for the small calves. Fresh air enters the barn through manually adjusted, small openings in the ceiling near the crosswall.

Older, grouped calves have access to outdoor pens and their barn space temperature fluctuates with outdoor conditions. About 2,000 bu of grain can be stored in the one, 14' wide, concrete floored lean. The 10'x14' feed storage bin is filled with a tractor-powered grinder-mixer and used for convenient hand feeding calves.

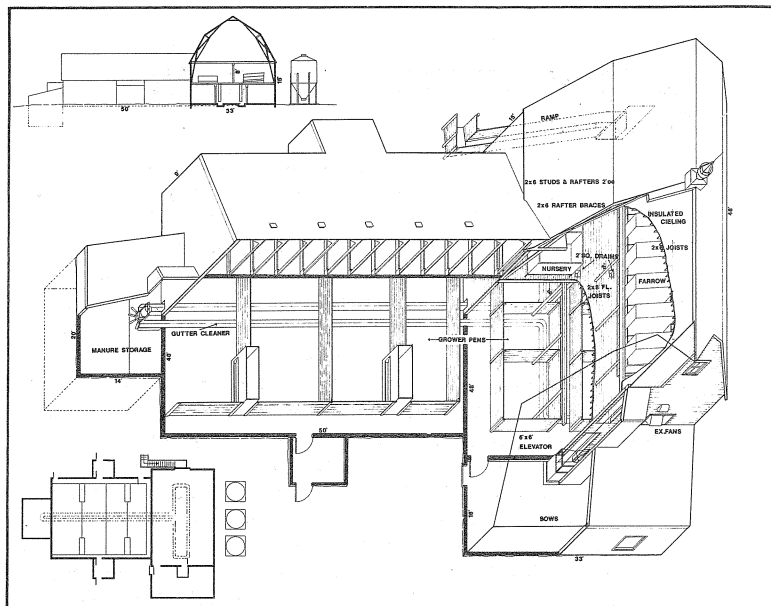
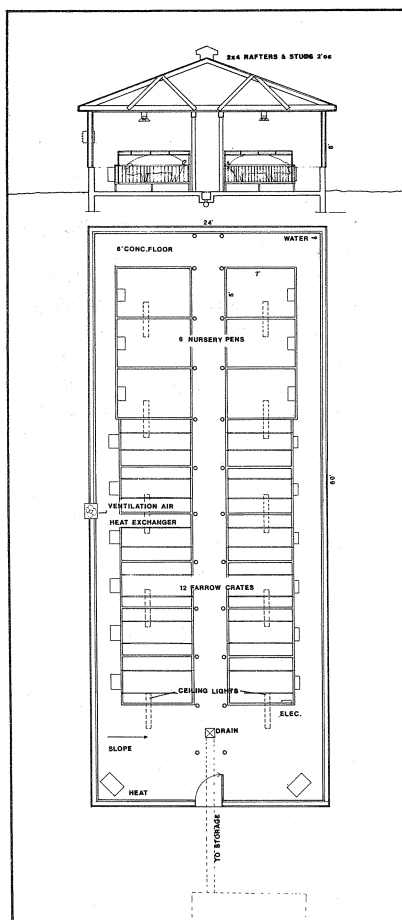
## TWO-STORY SWINE BARN

Many owners of large, two-story barns have pondered utilizing the second floor of their barn for livestock space. Animal access and manure handling are special problems. In 1978, this operator obtained at no cost a 33'x48' two story barn, moved it and installed an 8' high, post-beam supported ceiling with insulation above it over the mow floor. The walls were also insulated and sheathed inside. This insulated second-floor space is heated with an 80,000 BTU heater and exhaust-fan ventilated to provide controlled environment space for four homebuilt wood farrow crates, six farrow pens and a nursery pen located on the old mow floor. Smooth 4'x8' fiberglass sheets were glued together and installed over a sloped framework to seal the mow floor and direct manure to two 2'-square drains located near the center of the room. The drains convey manure down to the gutter cleaner in the ground floor below. The gutter cleaner conveys all manure to the 14'x20' manure storage at the end of the 40'x50' one-story insulated pen barn addition constructed new for growing out pigs.

Operator access to the upper farrowing room is by the outdoor ramp at the one end or the electric motor-powered, cable winch-operated 6'x6' home built platform "elevator" at the other end, designed mainly to move up pregnant sows and move weaned pigs down to grower pens directly below the farrow room. Commercial feed stored in the hoppers feed bins was separately conveyed by 4" diameter electric motor powered augers to feeders in the barn. This was later changed to on-farm feed processing to reduce costs. Moving the barn, installing a new foundation, concrete floor and upstairs fiberglass floor, insulation, interior sheathing, ceiling, pen equipment and heating-ventilation system for the two-story barn cost \$10,000 with owner labor extra. The 40'x50' addition cost \$22,000 when constructed new with the manure storage.

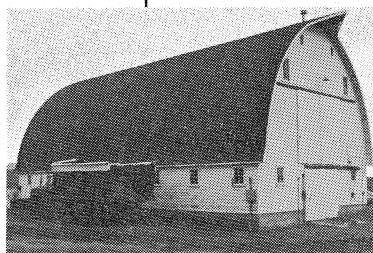
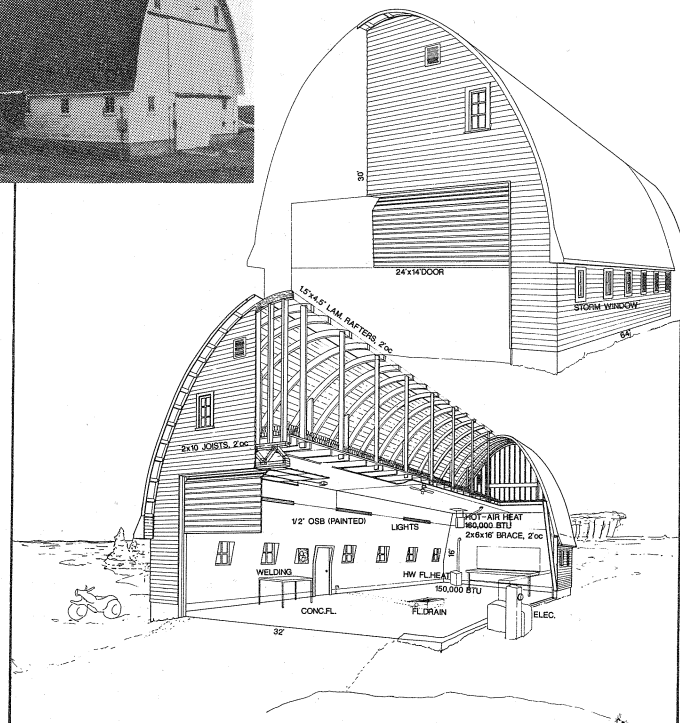
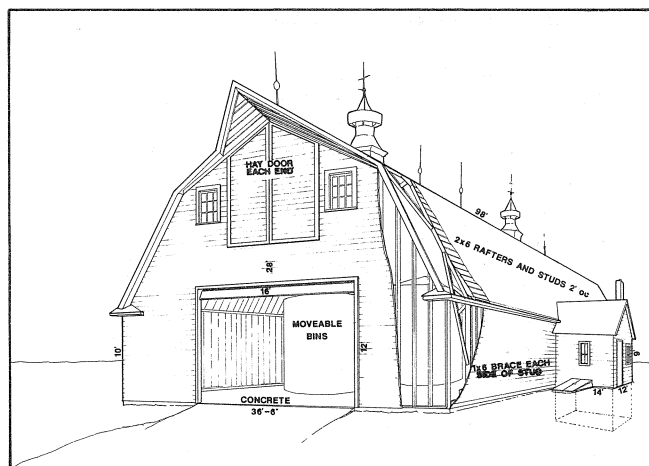
## FARM REPAIR SHOP

Owners of this unused 1951 two-story archroof 32'x64' barn rebuilt it in 1982 to an insulated-heated shop now used year-round. Walls were insulated with 6" batt insulation and sheeted inside with 1/2" oriented strand board (OSB) and painted with white enamel for brightness and cleanability. The mow floor was cut loose and raised by jacking to provide the 16' high interior space needed for modern machinery. The large 24'x14' insulated overhead door (shown) is on the backwall, preserving the barn's historic appearance (see photo) from the farmyard. This door arrangement also removes the usual farm shop doorway machinery, spare parts, etc. clutter out of view from the farmyard. To maintain strength, the lower walls were reinforced with a 2"x6"x16' brace gusseted over with 1/2" plywood on each 1.5"x4.5" glued laminated rafter located every 2'. Insulation was blown in the upper walls and 14" thick over the ceiling. The new 5" thick concrete floor was sloped to a 2' square grated central floor drain that siphons water out through a 4" PVC drainpipe to an outside belowground 4'x6' seepage pit. Oil floats and must periodically be skimmed out of the floor drain while sediment is handcleaned out to avoid plugging the disposal system. The building is warmed by about 90°F propane-heated water circulated through four 200' circuits of 3/4" diam. polybutylene pipe placed in the concrete floor—one circuit in each quarter of the floor. The foundation exterior must be insulated to conserve floor heat. Double 80-watt bulb fluorescent light fixtures are located on 10' spacings around the edge of the ceiling. About \$15,000 was spent for concrete, insulation, bracing, sheeting, heating, electric wiring and lighting. Labor was extra.

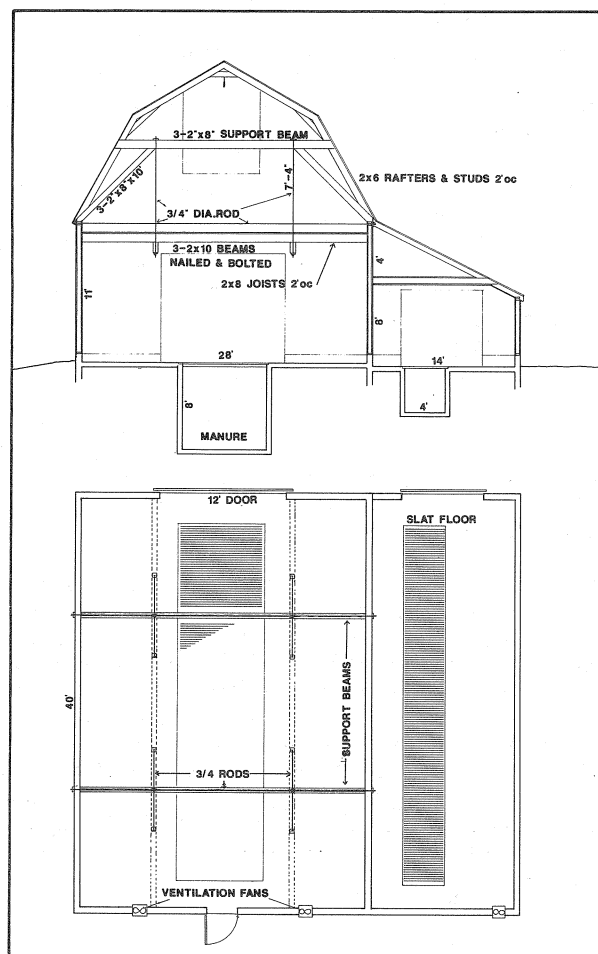
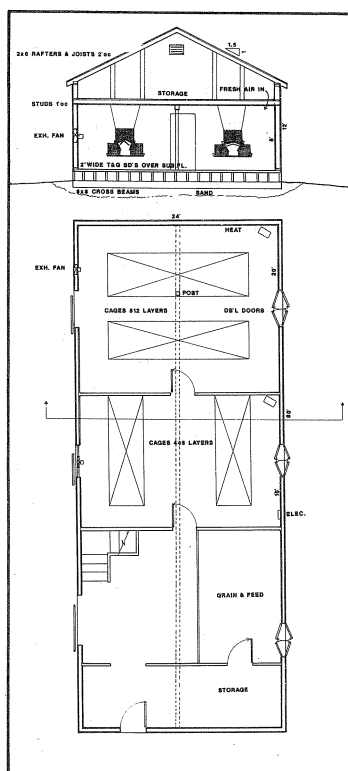
## CLEARSPAN SUPPORT FOR HAYMOW FLOOR

Most two-story barns are constructed with close-spaced posts and beams to support the overhead mow floor load. These posts plus low (usually about 8') ceiling clearance interfere with flexibility. This is especially troublesome if the building is to be adapted to modern tractor machinery. The scheme illustrated shows the use of simple, built-up beams of 2" lumber which support  $\frac{3}{4}$ " diameter rods angling down each way and firmly anchored under the two mow-floor main support beams. The mow support beams were reconstructed using 3-2"x10"s nailed and bolted together with 28 ga. metal sandwiched between them. The mow floor was jacked up 4' higher and refastened to the studs just below the top wall plate to provide 11' clearance on the ground floor.

New lumber, used rods, carpenter and owner labor altogether cost \$2500 in 1968 when the 1913 original 28'x40' dairy barn with 14' lean was converted to machinery storage. In 1977 it was further remodeled for feeder pig production. This remodeling included installation of the below-slatfloor liquid manure storages, insulation, sheeting, lighting and a supplemental heat and ventilation system for 14 farrow crates in the main barn and four nursery pens in the lean. Plans are now underway to readapt the barn to a repair shop.

In other situations, especially for larger buildings, larger and heavier truss rafter/beams have been similarly installed to support the mow floor. Added bracing is important to secure the support beams and concentrated wall loads. Careful design and installation is essential for this type of support post removal and use of clearspan support for a haymow floor. The building size and construction greatly affects the clearspan construction. Construction plans for old (and new) farm buildings are available through county extension offices or extension agricultural engineers at state Land Grant universities.

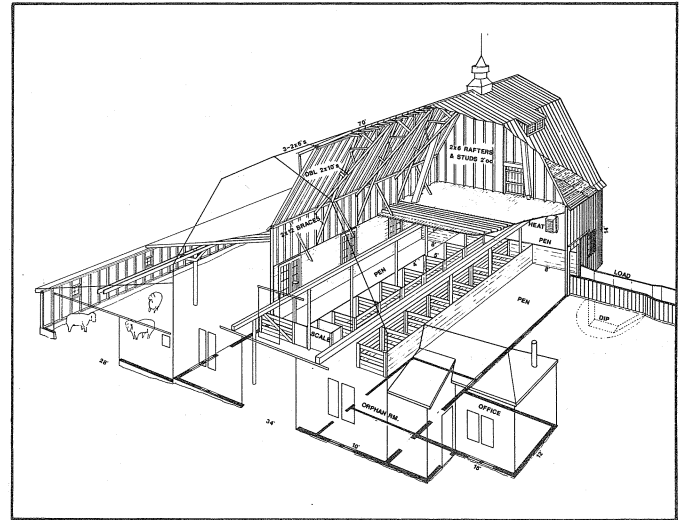
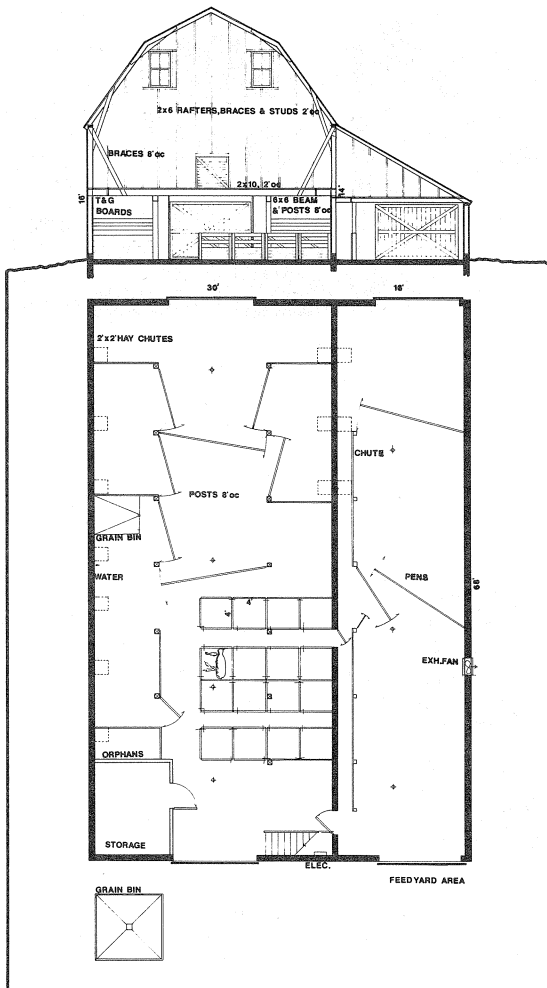
## EWELAMBING - NURSERY

Redesigned for practical sheep research in 1968, this 34'x70' doublewalled barn was originally constructed for 32 cows in stanchions with four 8'x12' maternity and calf pens. To preserve appearance, minimize maintenance and assist the insulation, the barn exterior was sheeted with white painted metal in 1979. Ewes, wintered outdoors, have access to the 28' wide lean which was constructed in 1970 for \$8,000. Lambing in early January, shorn close-up ewes are penned overnight in one of the 8' wide pens in the main barn. Ewes with newborn lambs are penned in 4'x5' jugs for two to three days until lambs are mothered up. Straw and hay bale storage in the overhead mow provides temperature and moisture control in the heated, exhaust-fan ventilated lambing barn and reduces troublesome pneumonia problems. Orphan and bum lambs are penned in a separate room near the office to provide special care. Ewes with lambs are accumulated together from the jugs into eight-head ewe-lamb groups and then to 32-head ewe groups in two adjustable-size pens in the lean. From there the groups are moved to another barn and pen spaces to grow until weaned. Indoor pens are manually bedded with straw. Manure cleaning is done with a skid-steer loader. A 2'x6'x5' deep concrete tank was constructed in the old upright silo pit to dip sheep for convenient, effective tick control. The chute is also used for loading out sheep.

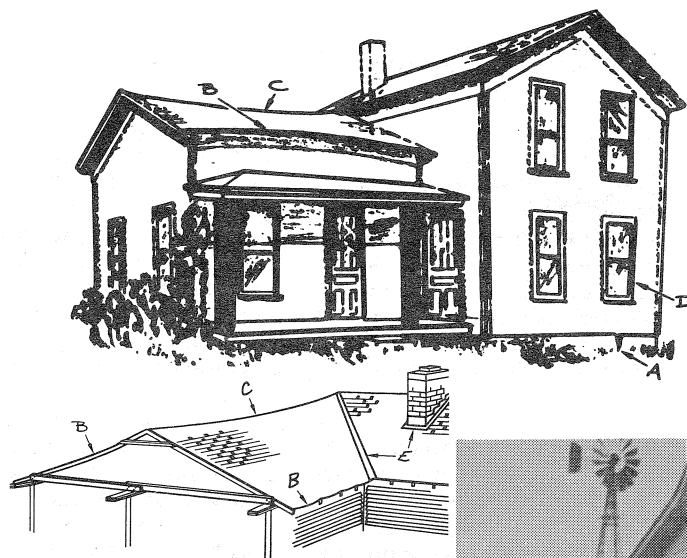
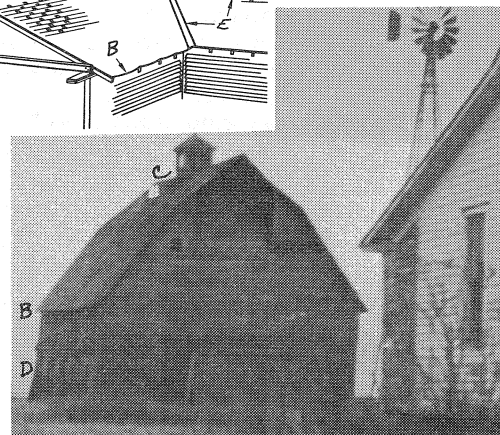
Foundations settle or heave because of concentrated overloads, freezing/thawing differences around the building and degeneration of the foundation material. This results in a building badly out-of-square as evidenced in the drawings by (A) large cracks, (B) eaveline distortions, (C) sagging roof ridges and (D) loose-fitting or stuck windows and doors. Most houses have several interior crosswalls which aid wall and roof strength. Few such interior walls are in large, open farm service buildings. Inadequate bracing and/or deteriorated framing and fasteners, too, cause sagging and unevenness at eaves, roof ridges and rafters. A strong cross-tie or floor and ceiling joists are needed to prevent walls from spreading outward. Flashing (E) is needed at roof intersections to prevent leaks yet allow for contraction and expansion.

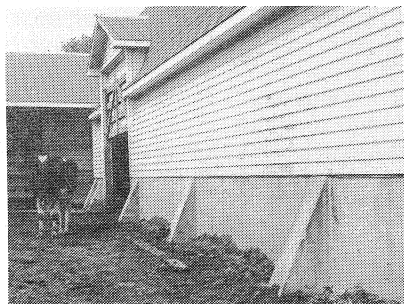
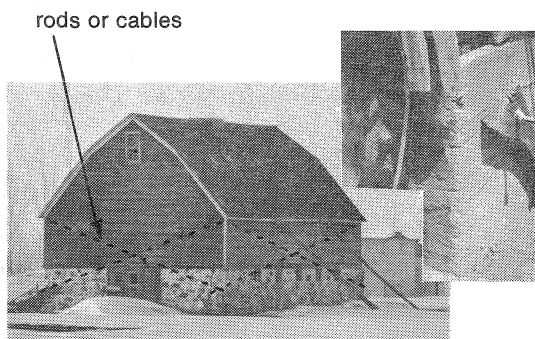
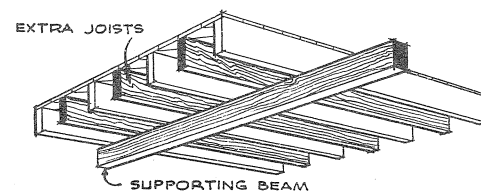
*A beam or extra joists can strengthen weak floors.*

Sagging buildings can sometimes be repaired rather simply. Cracked and sagging foundations can be reinforced in place with foundation buttresses (left photo). In addition to, or in place of, brace posts (right photo) use 1/2" diameter or larger rods or cables from corner to corner (note dashed lines) on walls to straighten buildings. Long threads at ends or with turnbuckles near the center permits a gradually 'drawing' the building back into a vertical, square shape. These can be left in place (photo inset) or corner braces installed.

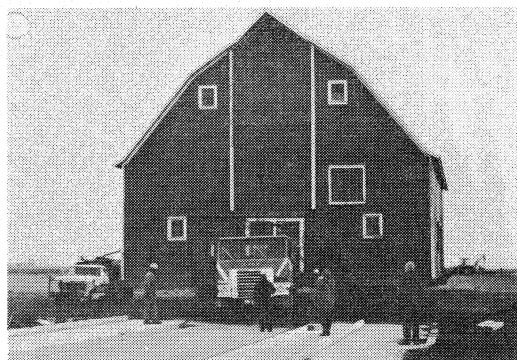
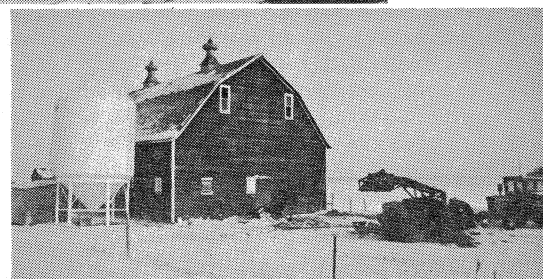
## MOVING OLD FARM BUILDINGS

Moving an old farm building to a new site is sometimes a practical alternative compared to new construction—although it is better to use an old building “as is” and where it is. Often there are used buildings in the community which the owner wants to get rid of. Usually a single-wall farm service building weighs much less than a plastered, double-wall house and moving damage is tolerable. Their larger size sometimes presents overhead and highway width clearance problems. This requires special permits and preparation. Farm buildings can be moved on skids or timbers overland short distances—especially on frozen ground with little snow. Heavy duty wheels to carry long, thick building support beams are needed for moving a building over several miles.

A new dairyman expanding on very limited capital in 1983 advertised for and located this unused 38'x64', two-story, tie-stall barn. Although over 22 miles away, and across two railroad crossings plus a large overhead electric powerline, the moving costs were held to \$7000 because of a skilled, well-equipped mover. A new concrete foundation, floor, gutter cleaner, waterline installation, electric wiring, milking equipment and labor brought the total cost to \$30,000. This provided space for 30 cows, a 16'x20' milkroom addition and overhead hay storage.
