National Register of Historic Places Registration Form

historic name Montrose Fruit & Produce Association Building

other names/site number Montrose Potato Growers Association Building (5MN.5270)

street & number 39 W Main St

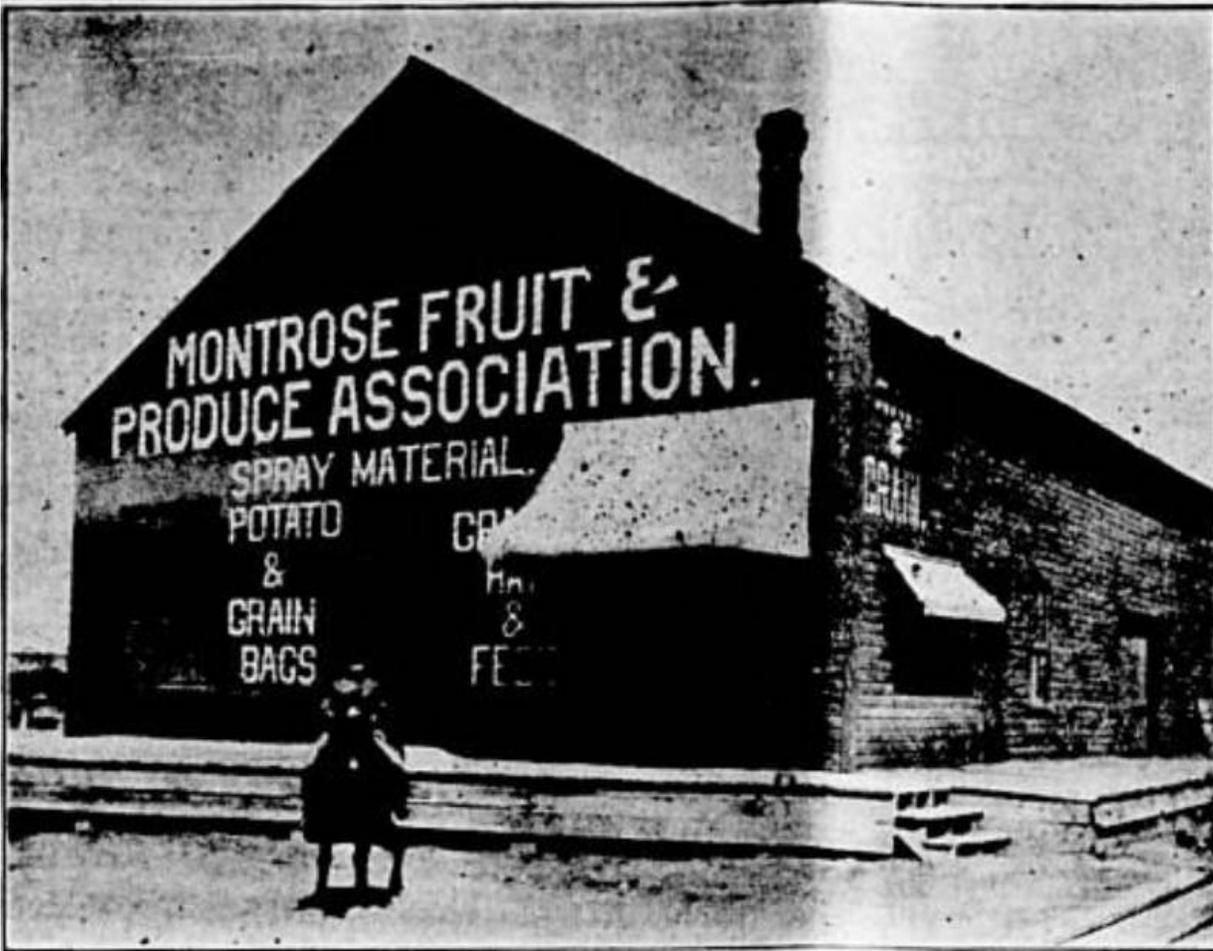
Figure 1: Historic photo of the first Montrose Fruit & Produce Association warehouse building, prior to 1908 fire, south façade, camera looking northwest, ca. 1908. (Source: "Montrose Fruit Growers Association." *Montrose Press*, 5 June 1908.)

Sometime after the association’s creation in 1907, the first building to serve as the Montrose Fruit & Produce Association’s warehouse and offices was built (Figure 1). The gable-roof wood-frame building stood on the site until it was destroyed by fire on June 22, 1908.¹⁶ Losses were put at \$10,000 with \$5,000 covered by insurance.¹⁷ The Montrose Fruit & Produce Association members decided to rebuild on the same site a “building of brick and stone” that would cost approximately \$6,000 and be “modern in every respect”.¹⁸ The new building was designed by architect John H. Antrobus and was to be a one-story brick building measuring 45’ wide at the front, 116’ long, and 67’ wide at the back with a stone basement, with excavation beginning in July 1908.¹⁹ The Montrose construction firm of White & Okey (William L. White and Homer O. Okey) were chosen to construct the building.²⁰ By September 1908 the brick walls had begun to be built and it was not long before the project was completed.²¹ The new building was completed by October 23, 1908, when it was reported that the Montrose Fruit & Produce Association had moved into the new building; they reportedly had only been without a building for three months, suggesting that the new building may have been completed earlier.²²

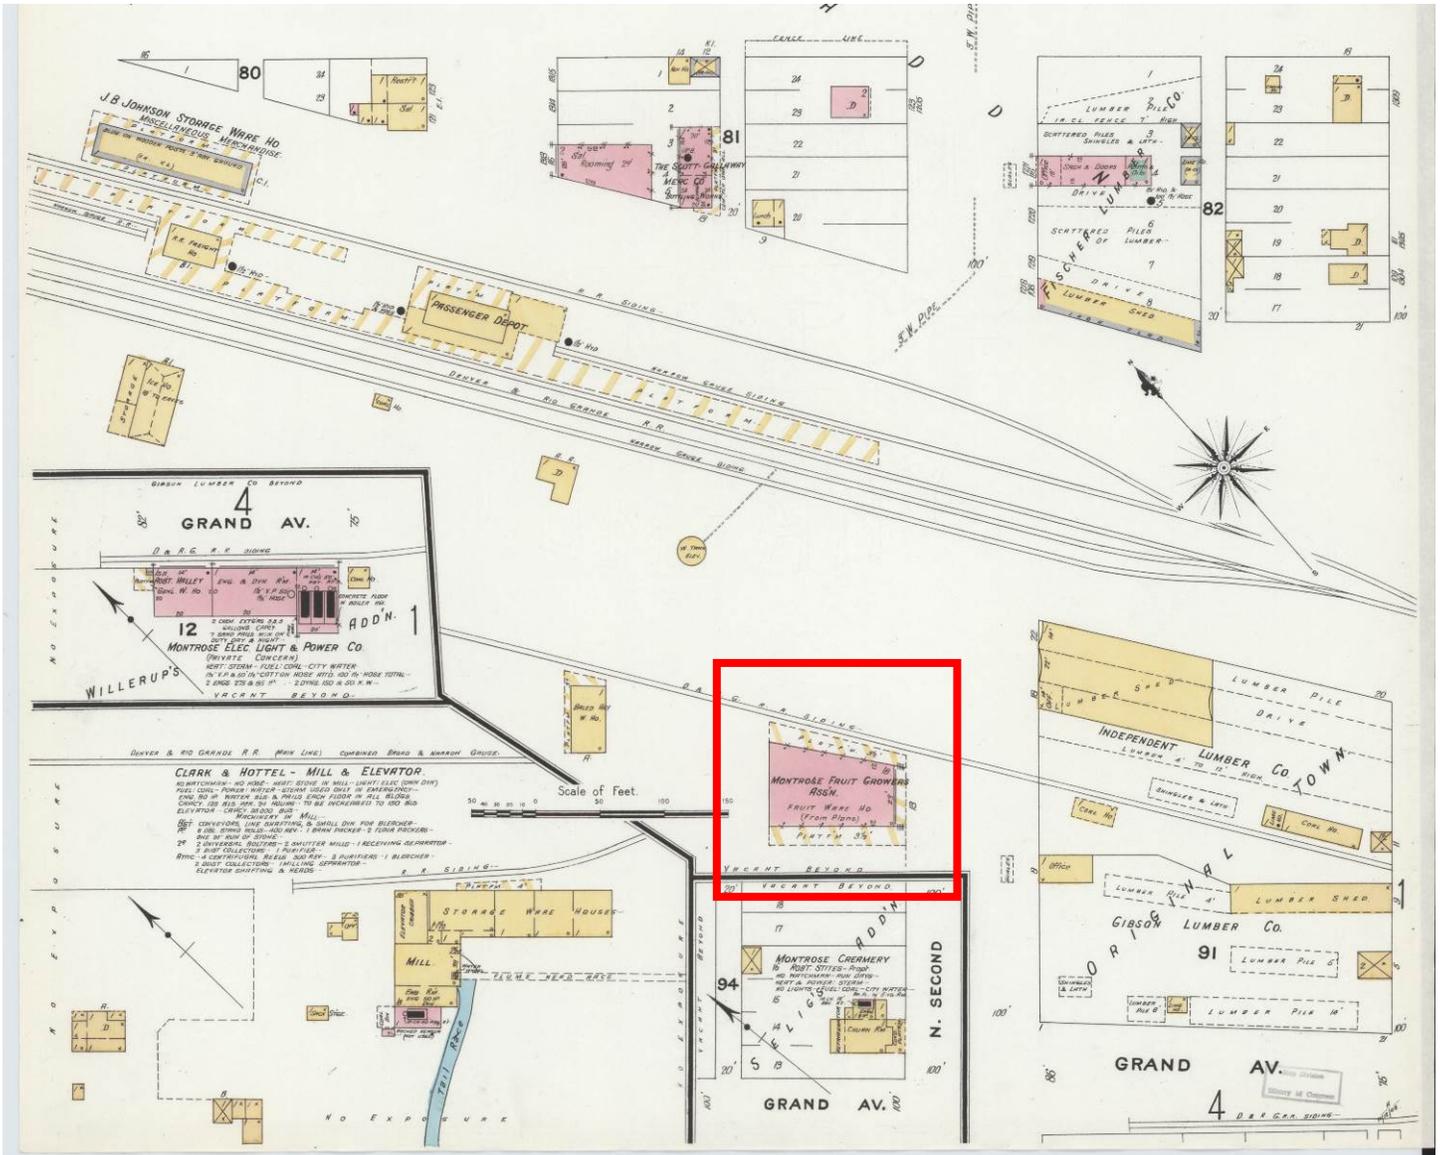
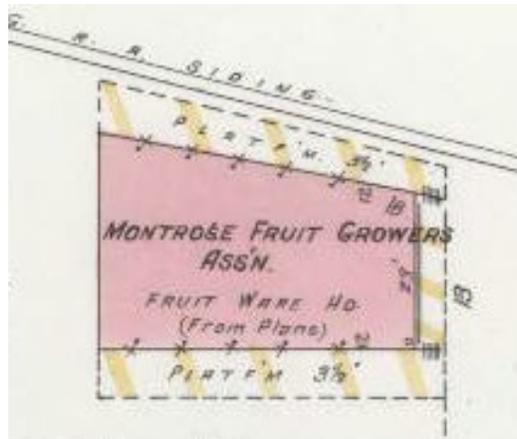
Figure 1: Details from 1908 Sanborn Fire Insurance Map documenting the Montrose Fruit Growers Assn. Building from plans. Note Denver and Rio Grande Railroad siding along the northeast side of the building. (Source: Library of Congress)

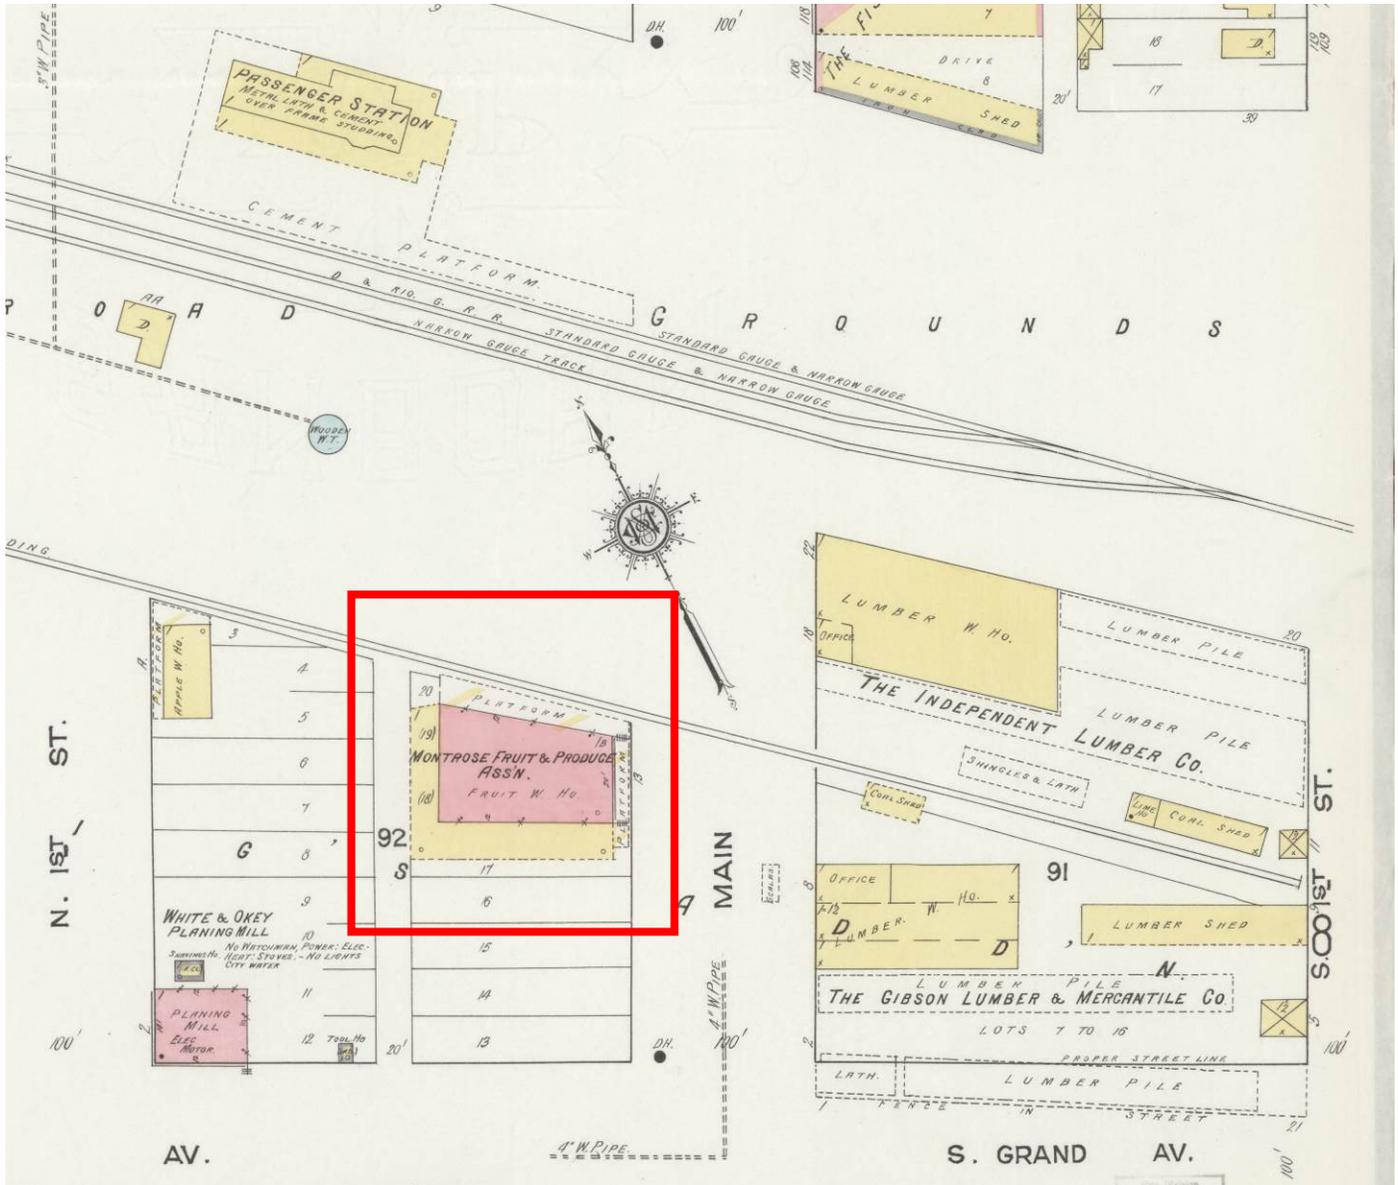
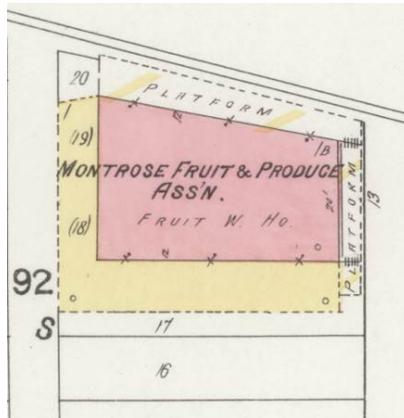
Figure 2: Details from 1912 Sanborn Fire Insurance Map. Note the changes to the platform on the west and north sides, indicating a wood frame with metal roof. (Source: Library of Congress)

The west wall mimics the east with a stepped parapet wall, now capped with bonderized steel. The southwest segment of roofline has a brick chimney for a stove that was historically located in the interior office space (no longer extant). Below the roof line are four square openings used for venting/climate control of the main interior space. Dominating the west wall is a historic shed-roofed wood loading dock with a "lattice" of boards forming its walls (Photos 5 and 8, Figure 4). The platform is documented in the 1912 Sanborn Map (Figure 2) and a 1912 photo (Figure 4). The north end of the dock is

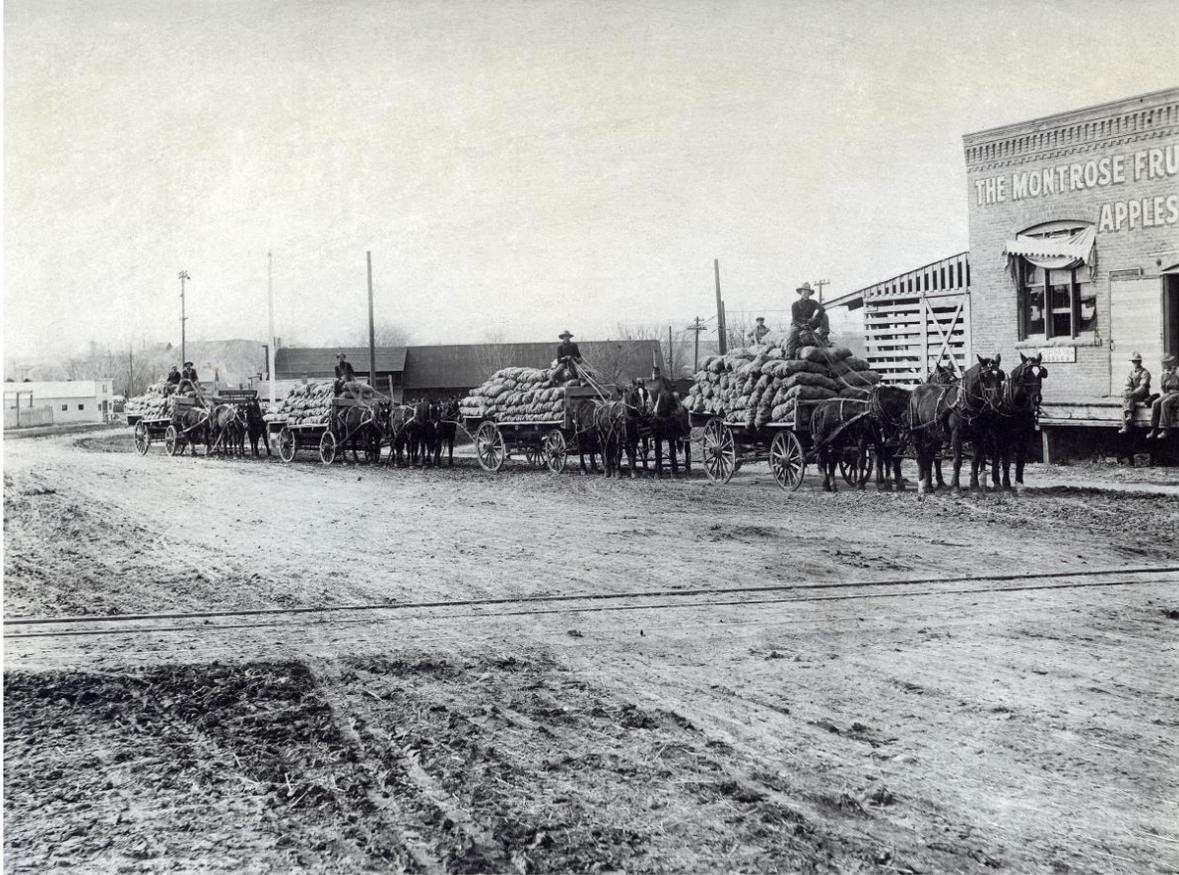
Figure 4: Historical photo, south façade and dock, camera looking west, ca. 1912. (Source: Montrose Historical Society)

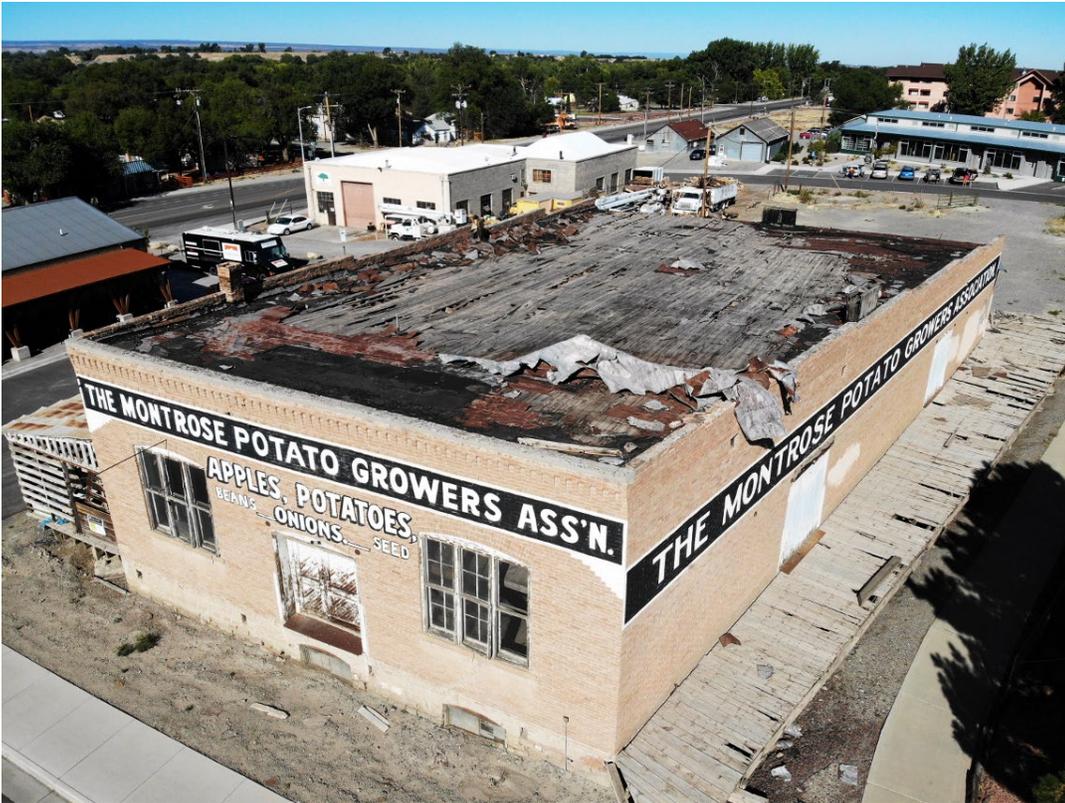
Figure 8: Aerial photo taken (25 September 2019) prior to 2019 rehabilitation, camera facing northwest. (Source: William Woody)

All other known alterations have been part of 2019 rehabilitation project to save the building from further degradation (Figures 8 and 9). This work was reviewed and approved by the Montrose Historic Preservation Commission and followed the Secretary of the Interior's Standards for Rehabilitation. The remaining parts of the roof were removed, and a new synthetic roof was installed with skylights that cannot be seen from the main vantage points along the south, west and

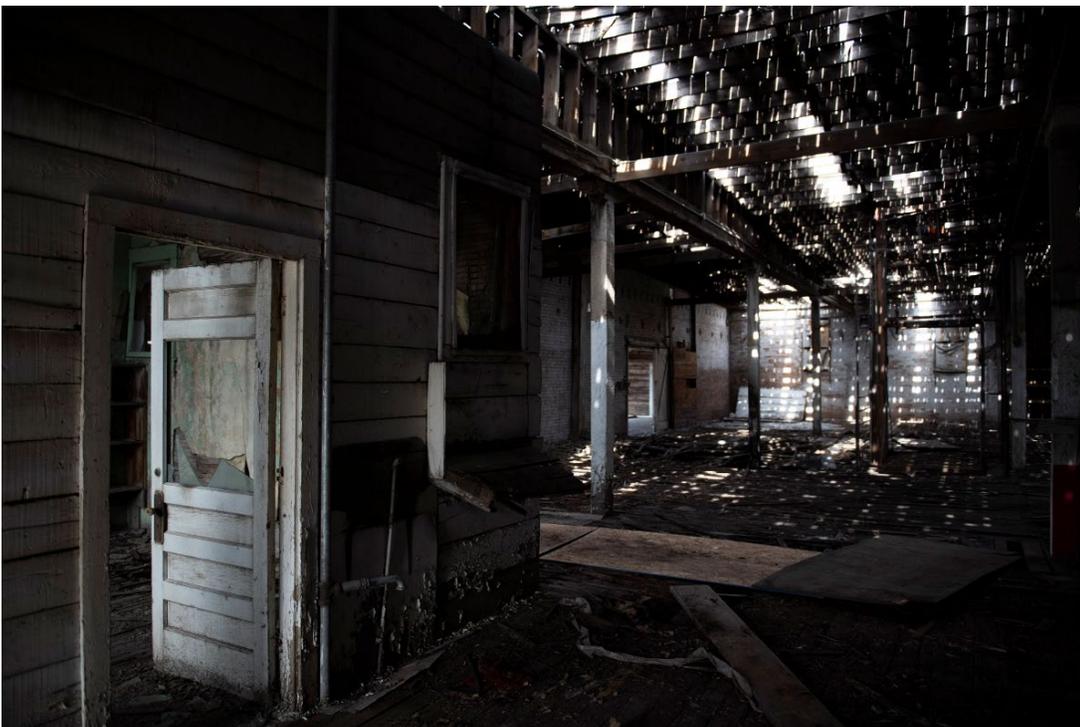
Figure 9: Photo of interior taken (10 October 2019) prior to 2019 rehabilitation. Office to the left (no longer extant). (Source: David Fishing)
