COLORADO STATE REGISTER OF HISTORIC PROPERTIES NOMINATION FORM

Historic Name Wilson & Hersperger House

Street Address 2254 West 34th Avenue

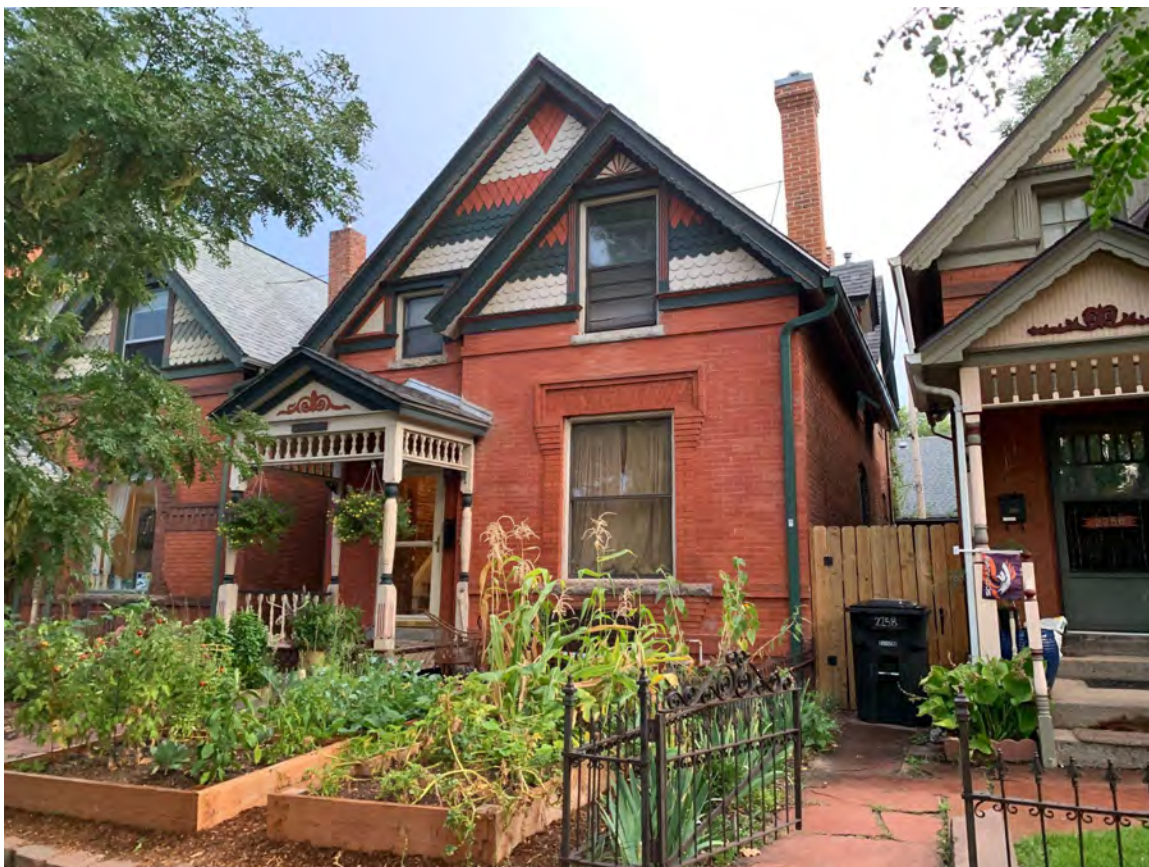
1. North (front) facade, camera facing southeast. Note the scalloped and shaped shingles, turned spindles, multiple gables, and decorative entry porch. Photo taken September 14, 2022.

On the first floor, no significant modern exterior alterations are apparent. The red brick facade is in good condition, with the most recent tuckpointing, repointing, and brick restoration occurring in ca. 2015.

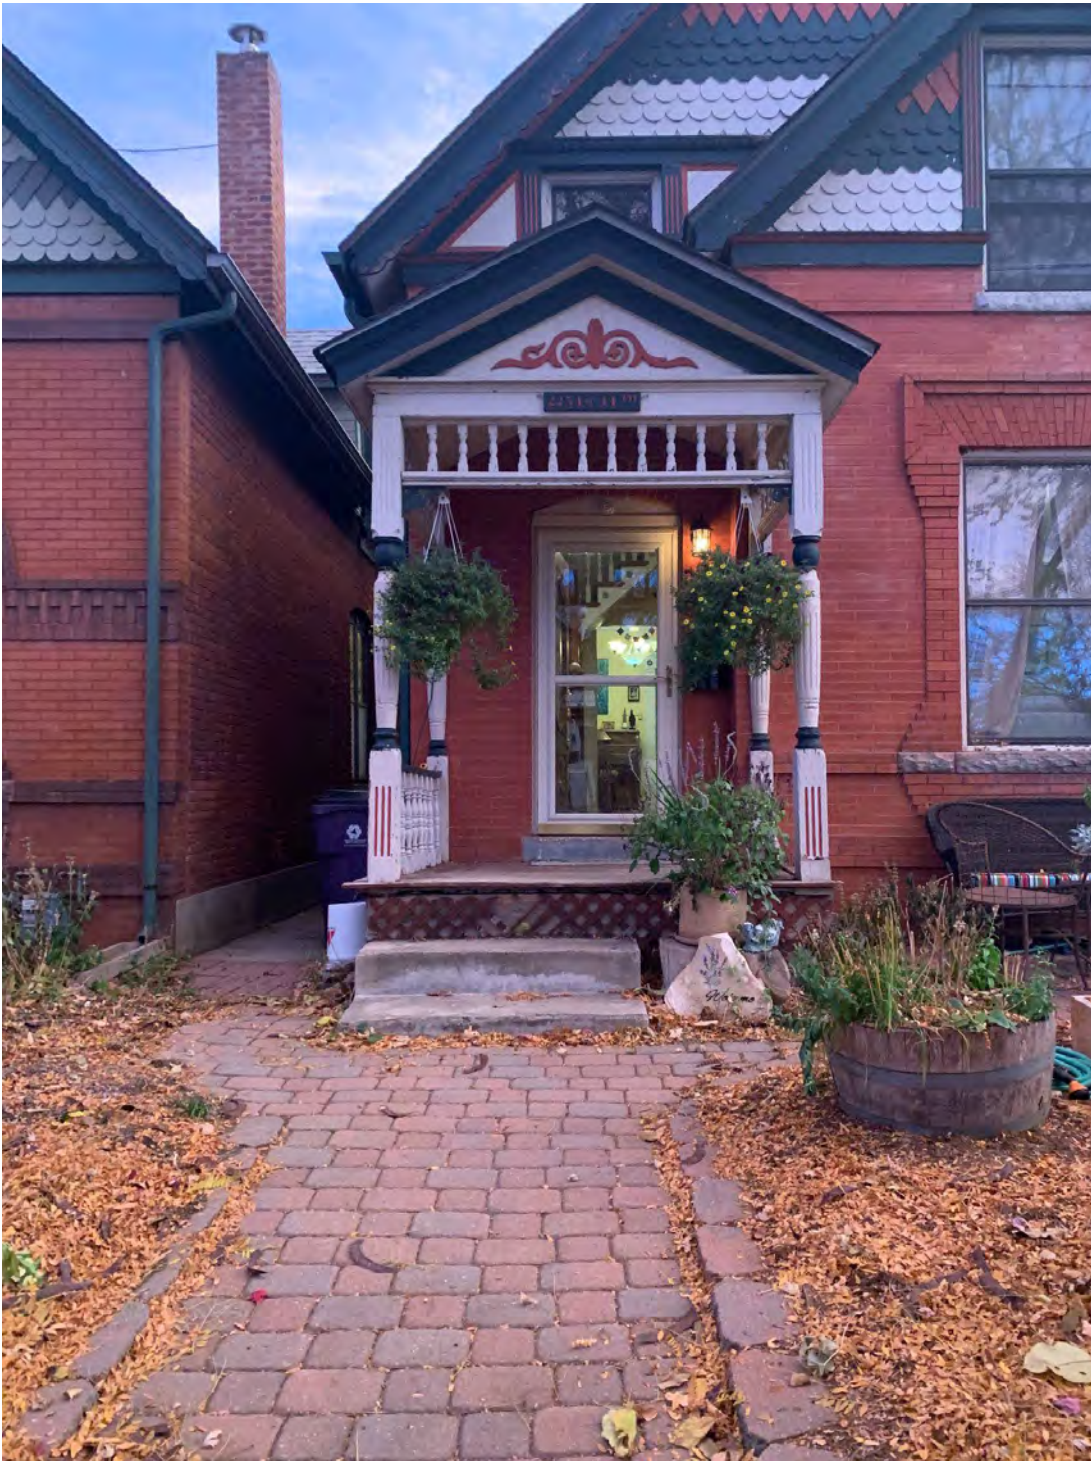
2. View of covered porch entry with turned spindles, carved-wood address placard, and ornamental fascia design. Photo taken November 5, 2022.

Two poured concrete steps lead from the cobble walk to the porch floor which consists of narrow, once-painted wood boards. The concrete steps are part of a front foundation slab which also supports the porch decking. The decking is skirted by stapled wood trellis pieces. Within the porch, there is a 24in. railing with turned spindles. The entry consists of a modern metal storm door with a sliding window screen, and a modern wood door with a decorative oval privacy window with ornamental metal-work. The door is framed with a brick semi-arched top and decorative medallion molding, with a contemporary mailbox and single contemporary porch light located to the right.

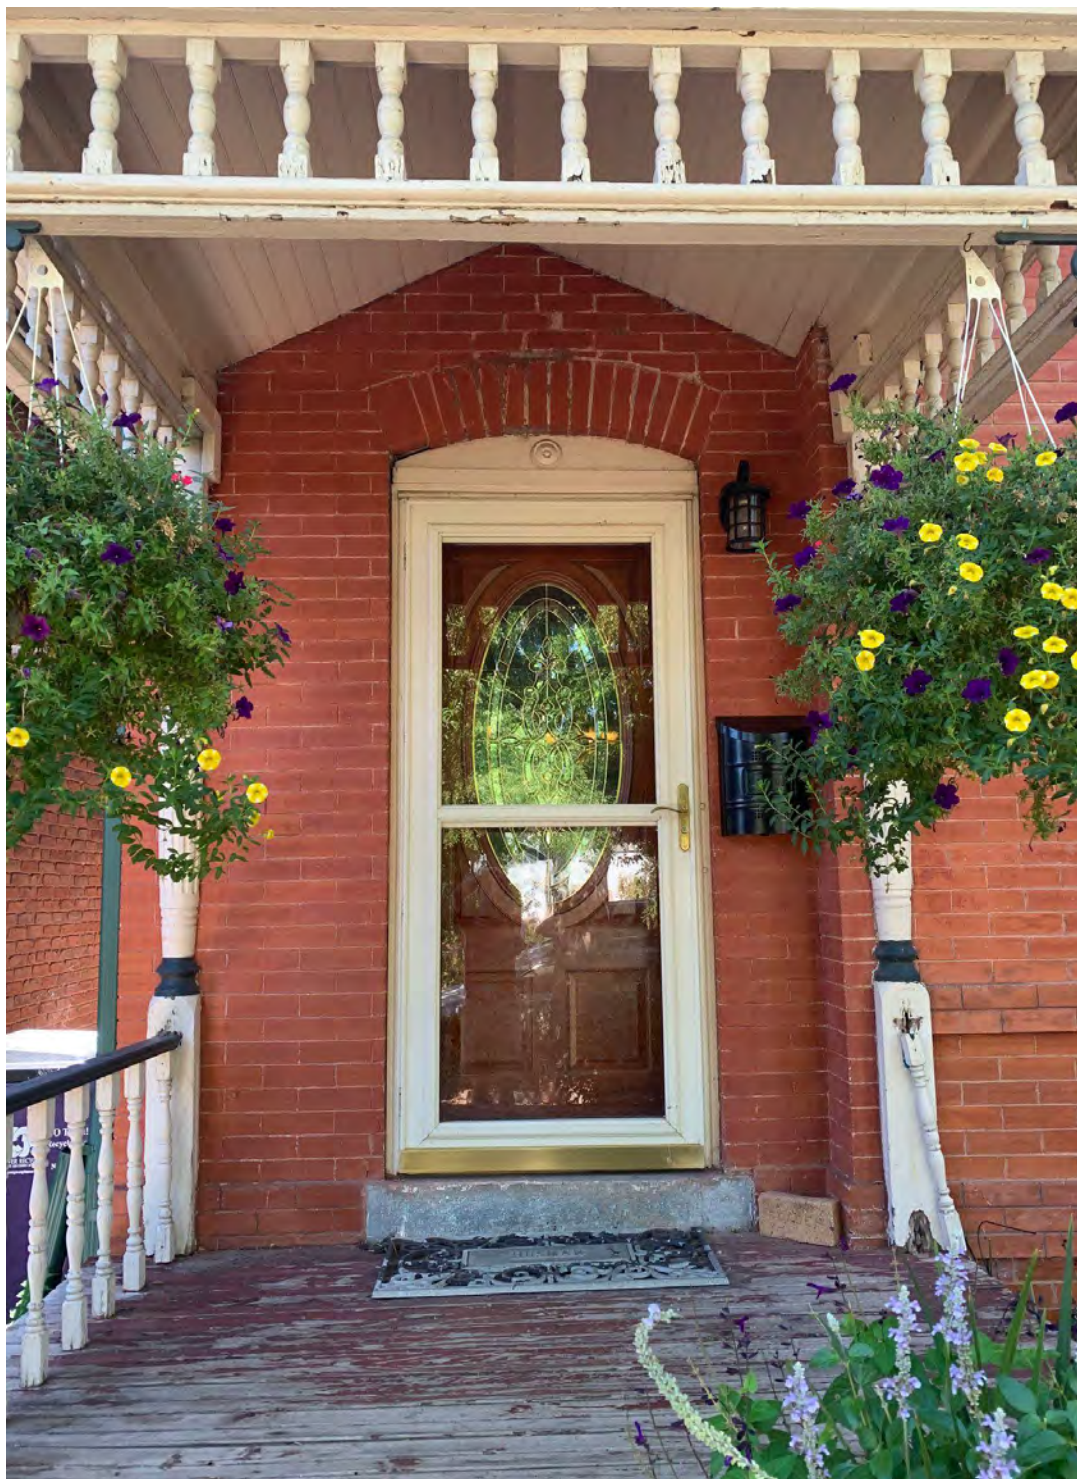
3. View of the front porch entry and door. Note the brick semi-arch above the door frame. Photo taken September 26, 2022.

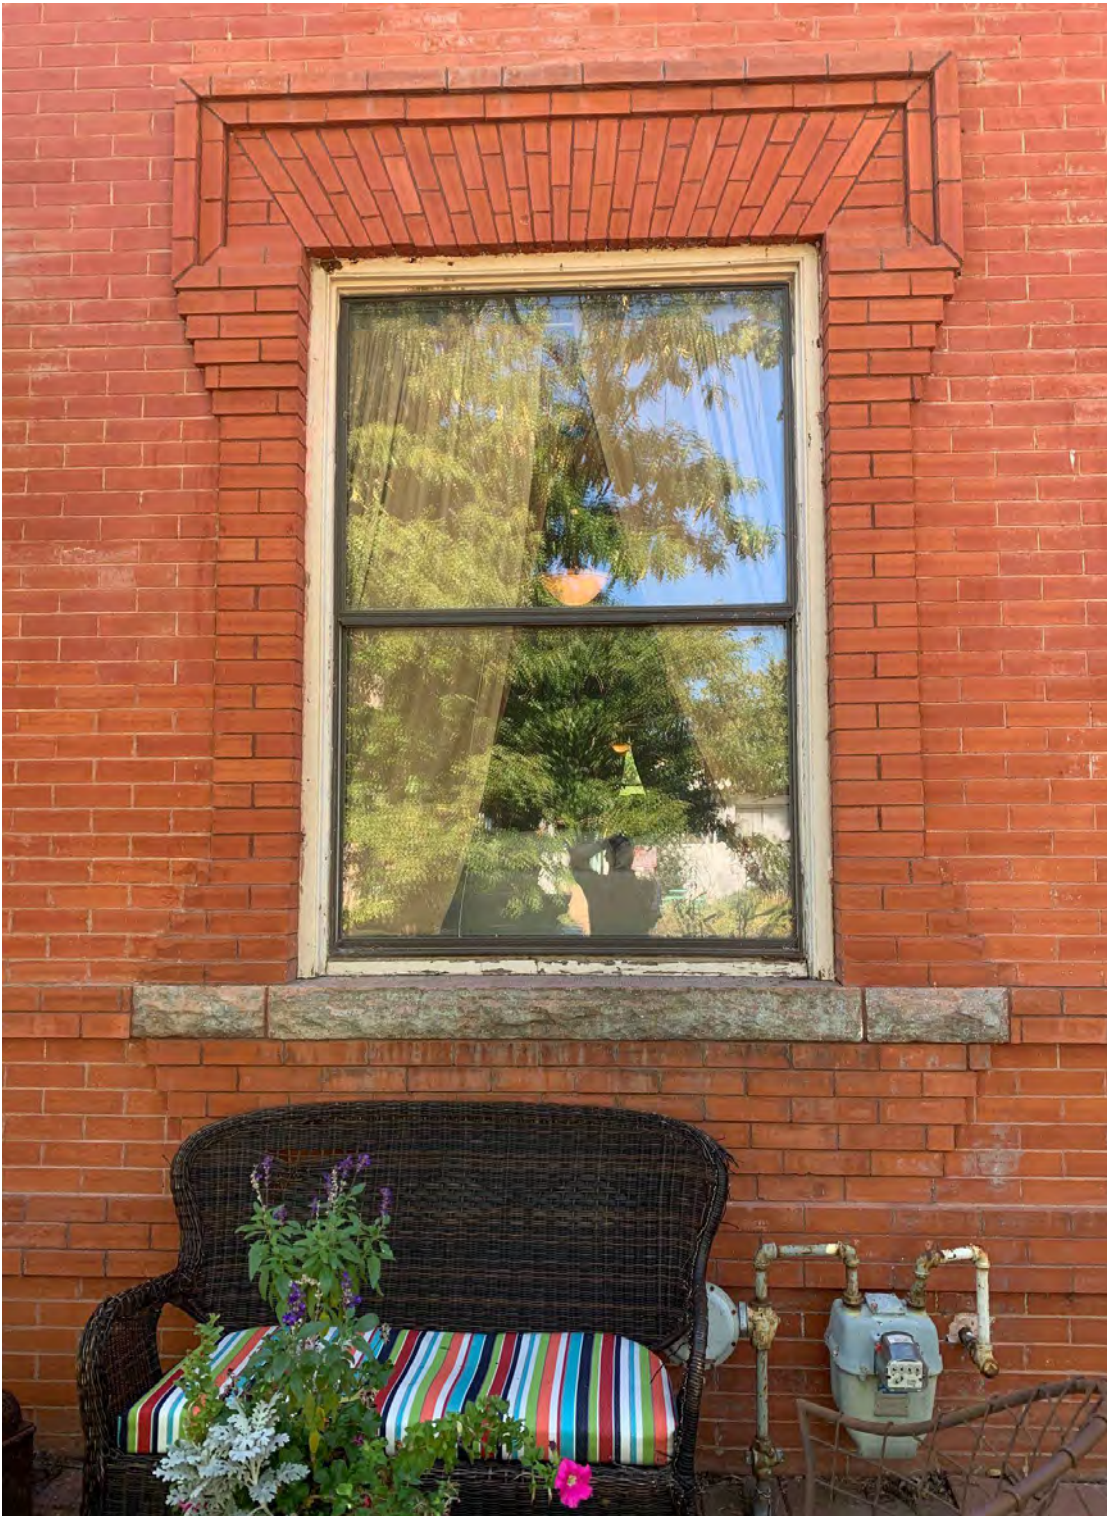
4. Photo of decorative brick framing the front window. Photo taken September 26, 2022.

On the first floor, a large window with the original stone sill is framed by red brick in an ornamental sunburst pattern. The stone sill has been power-washed to its natural red/pink color, but remaining paint flecks suggest it may have been painted red, blue, and gray at separate times in the past. The vibrant red brick facade is in excellent condition, with the

On the first floor, the large window's stone sill has been power washed to its natural color, but remaining paint flecks suggest it may have been painted red, blue, and gray at separate times in the past. The vibrant red brick facade is in excellent condition, with the most recent tuckpointing, repointing, and brick restoration occurring in ca. 2015. The two poured concrete steps leading to the porch entry are of modern construction (Est. ca. 1984-1985), and supported a ramp as seen in the property photo from *A Guide to Colorado's Historic Architecture and Engineering Second Ed.*

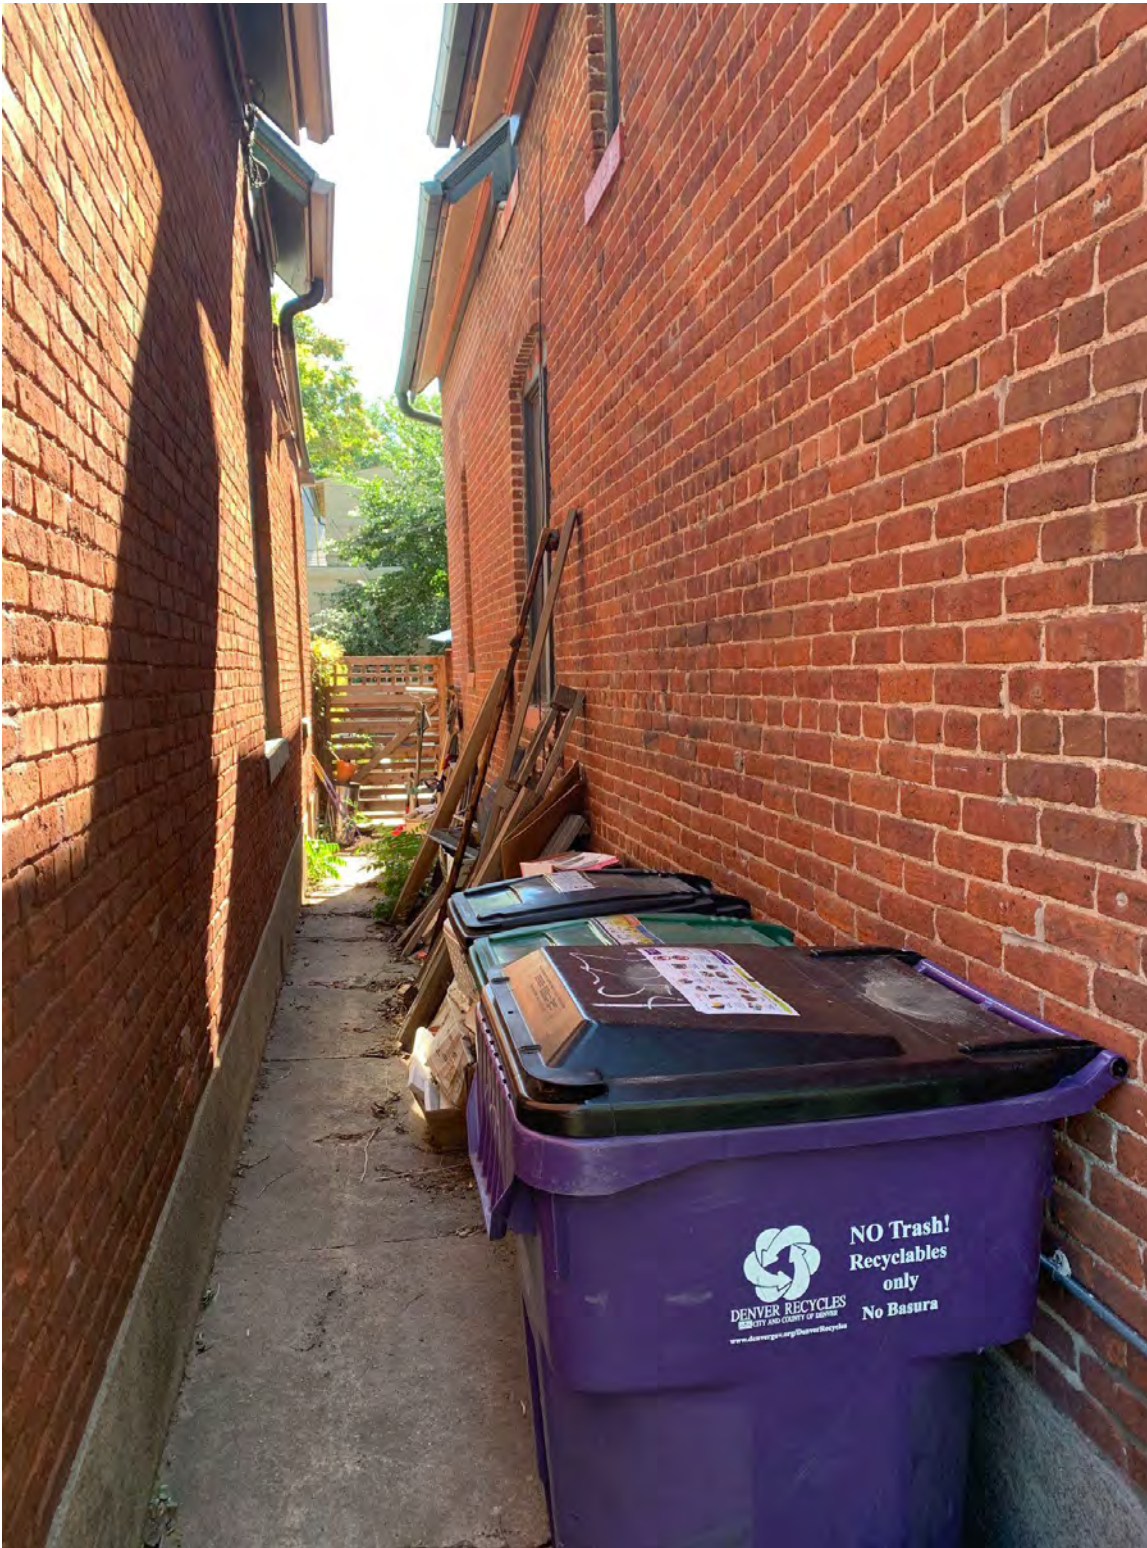
5. East-facing exterior brick wall with associated alley leading to backyard gate. Photo taken September 26, 2022.

On the first floor, a 5ft.-wide alley separating homes is the property of the Wilson & Hersperger House. The alley provides for some storage, and access to the backyard including a locking gate. The straight-face red brick has gray mortar, and includes a parge coat layer on the lower 18in. to protect the brick foundation. The first floor includes one large window (dining room) with a wood frame and wood beam sill, and includes decorative medallion molding, and a brick semi-arch atop. Toward the rear, there is one tall, narrow privacy window (first floor bath) with a new wood frame and original wood beam sill, with a brick semi-arch top.

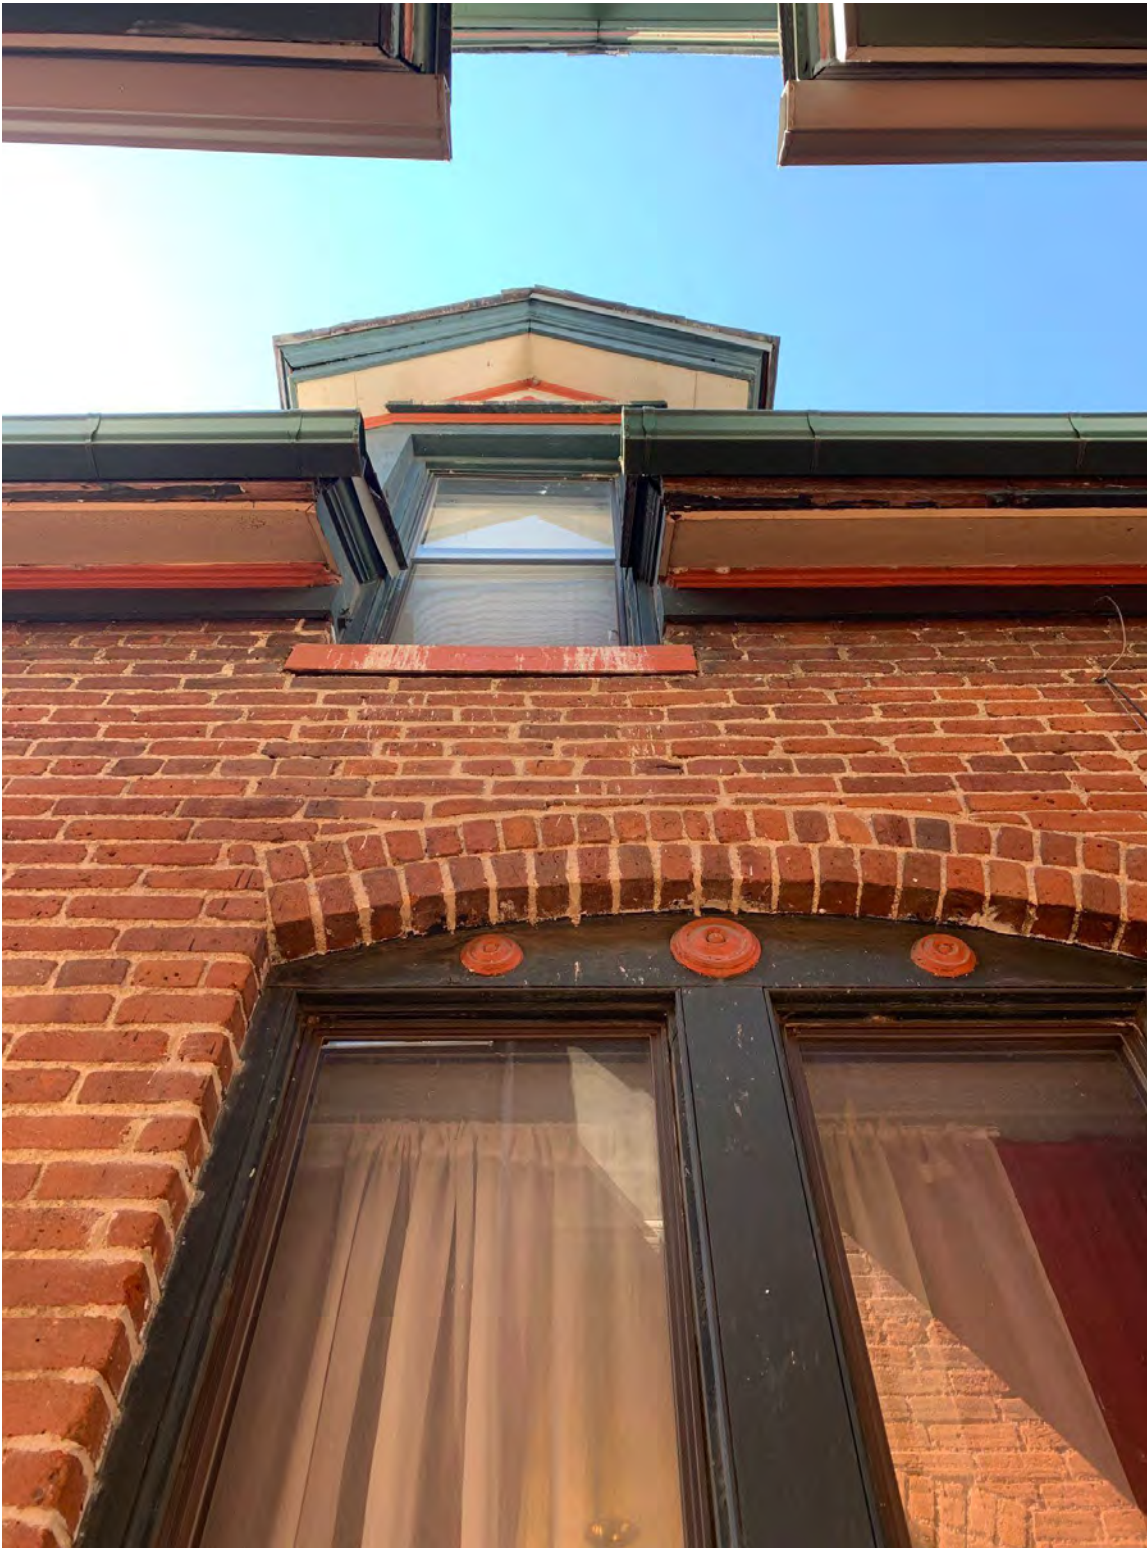
6. Photo of the first floor east-facing dining room window with decorative molding, and brick semi-arch. Above, is the second floor east-facing dormer window with decorative trim and molding. Photo taken September 26, 2022.

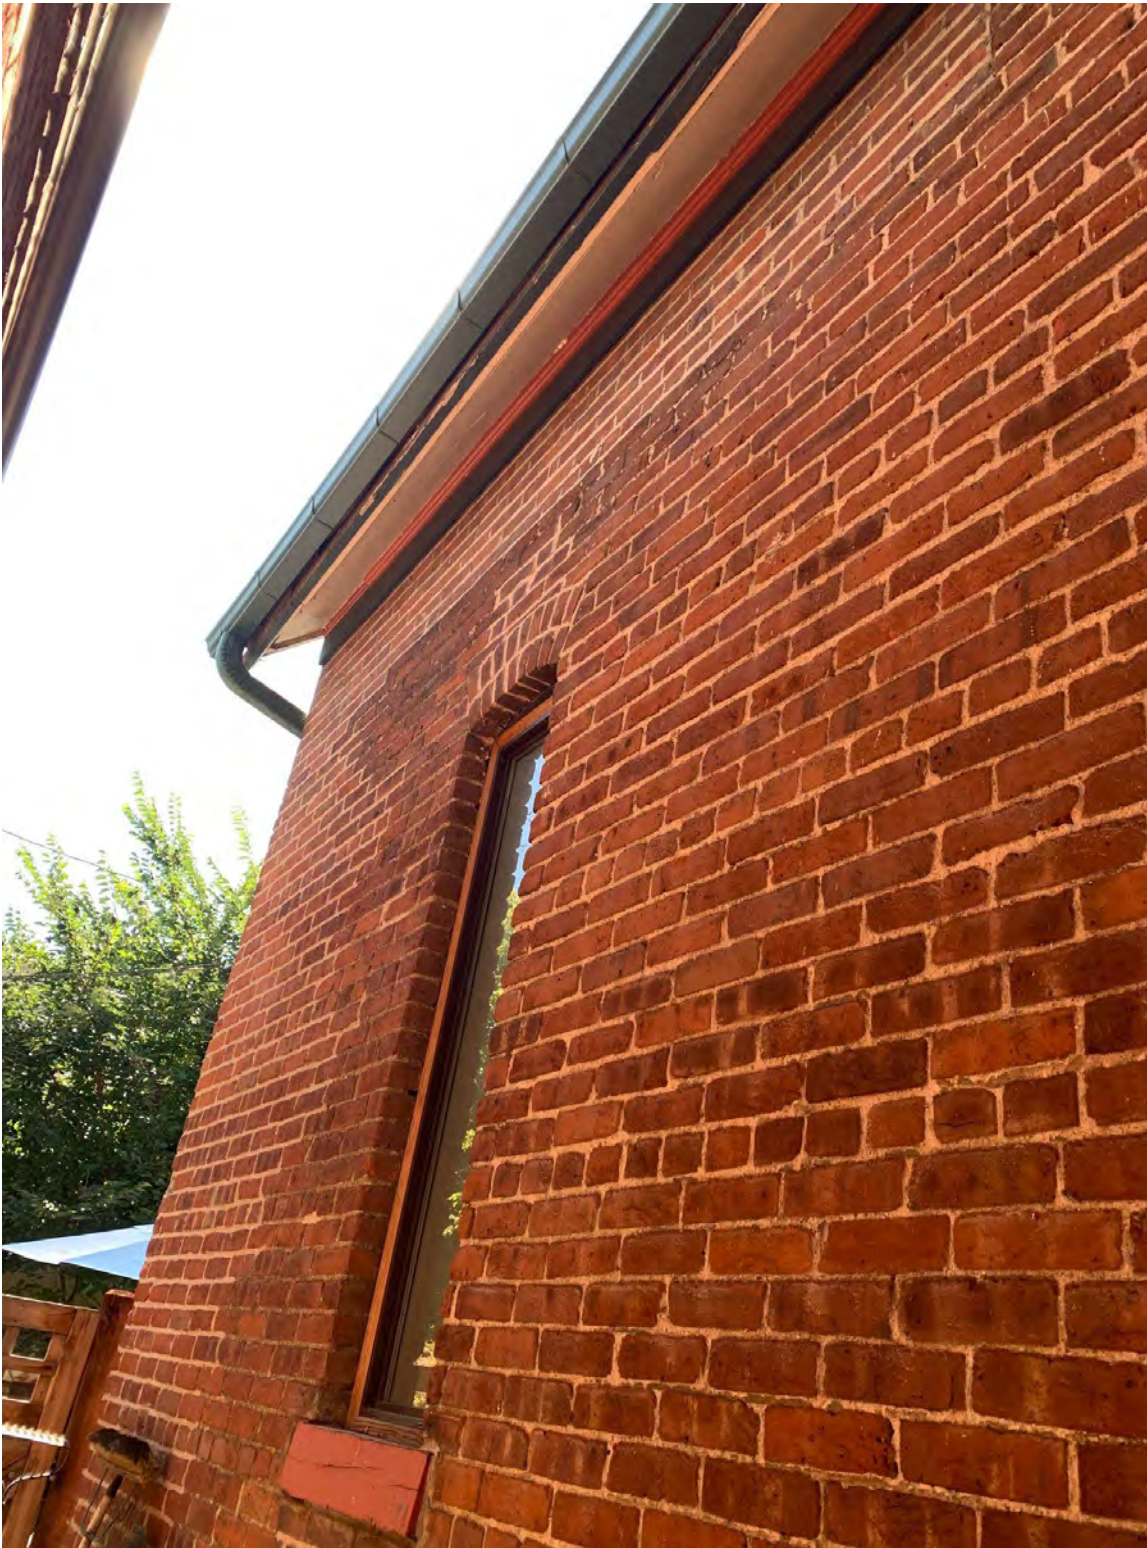
7. Photo noting layer of new brick delineating the second floor main bedroom addition. Includes first floor bathroom east-facing privacy window with new wood frame (ca. 2017). Photo taken September 26, 2022.

On the first floor, the straight-face red brick includes gray mortar, and is in good condition. On the right, there is one tall, narrow privacy window (first floor bath) with a new wood frame (installed ca. 2017), original wood beam sill, and brick semi-arch top. Below and to the left, there is one small, broken horizontal window (cellar) with a wood frame that was covered at an earlier time with wood board and insulation. The breaker panel and city meter are located midway, with a red plaster stucco "patch" of unknown origin/purpose, is located to the left. One tall, medium window (over the kitchen sink) includes its original wood frame and wood beam sill. This window was reframed and shortened, possibly when the kitchen was refurbished at an earlier time.

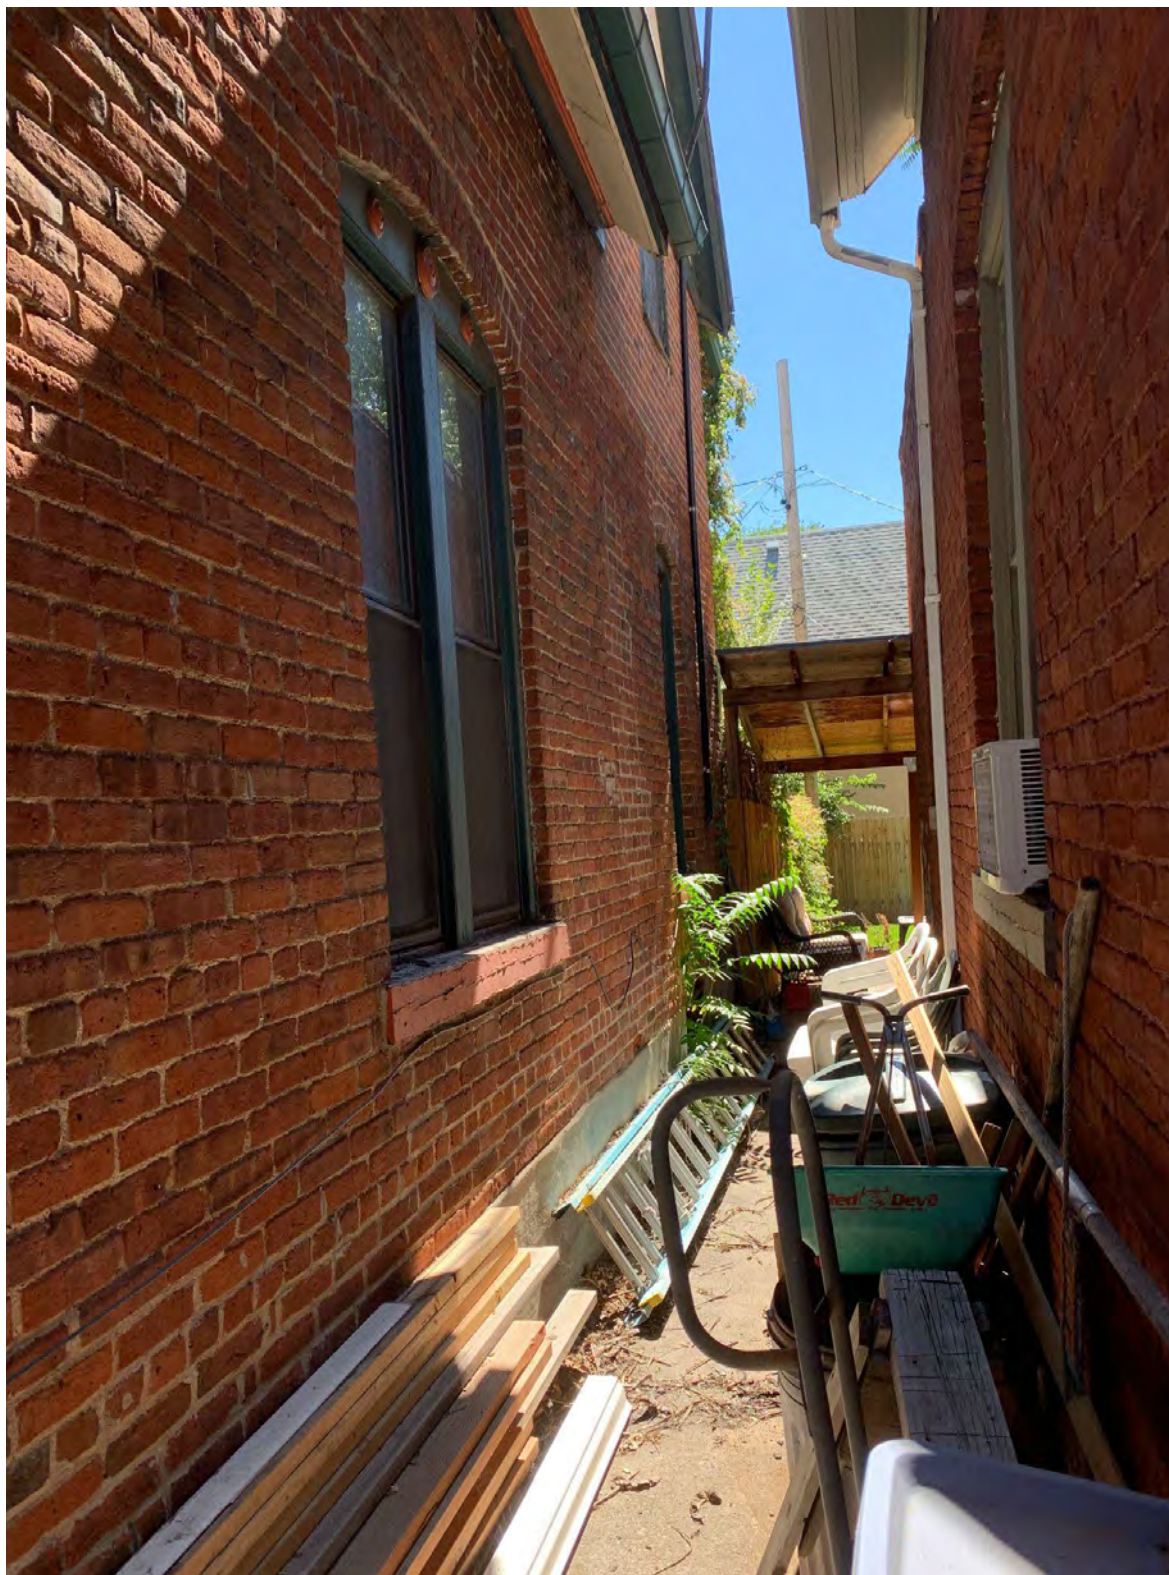
8. Photo of west-facing exterior, and first floor sitting room's west-facing window with decorative molding. The alley is property of 2258 W. 34th Ave. Photo taken September 19, 2022.

On the first floor, a 5ft.-wide alley separating homes is the neighbor's property ('2258'). The straight-faced red brick has gray mortar, and includes a parge coat layer on the lower 18in. to protect the brick foundation. The first floor includes one large window (sitting room) with a wood frame and wood beam sill with decorative medallion molding, and a brick semi-arch top (identical to the east side). Near the rear of the house, there is one tall, narrow double-paned window (kitchen) with a wood frame, wood beam sill, and brick semi-arch top. Located below, is one small, broken, horizontal window (cellar) with a wood frame. The window was covered at an earlier time with chicken wire and a wood panel, and includes a brick semi-arch top.

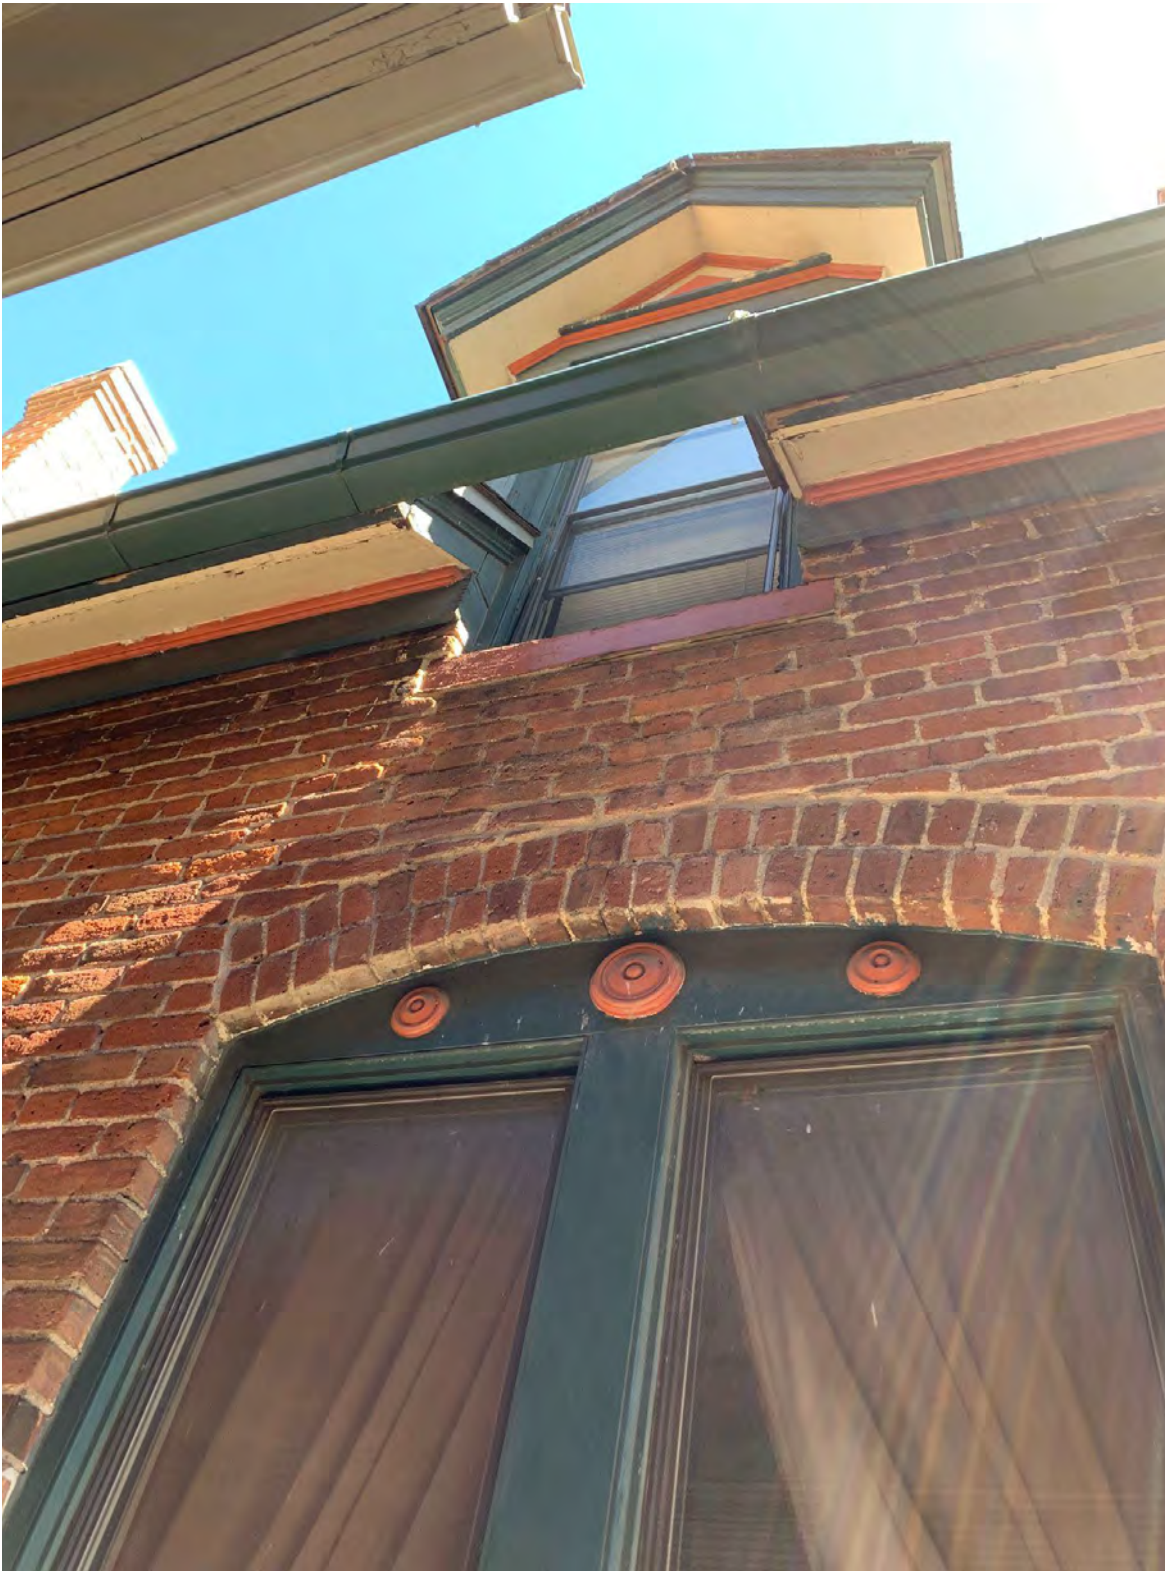
9. Photo of the first floor west-facing sitting room window with decorative molding, and brick semi-arch. Above, is the second floor west-facing dormer window with decorative trim and molding. Photo taken September 19, 2022.

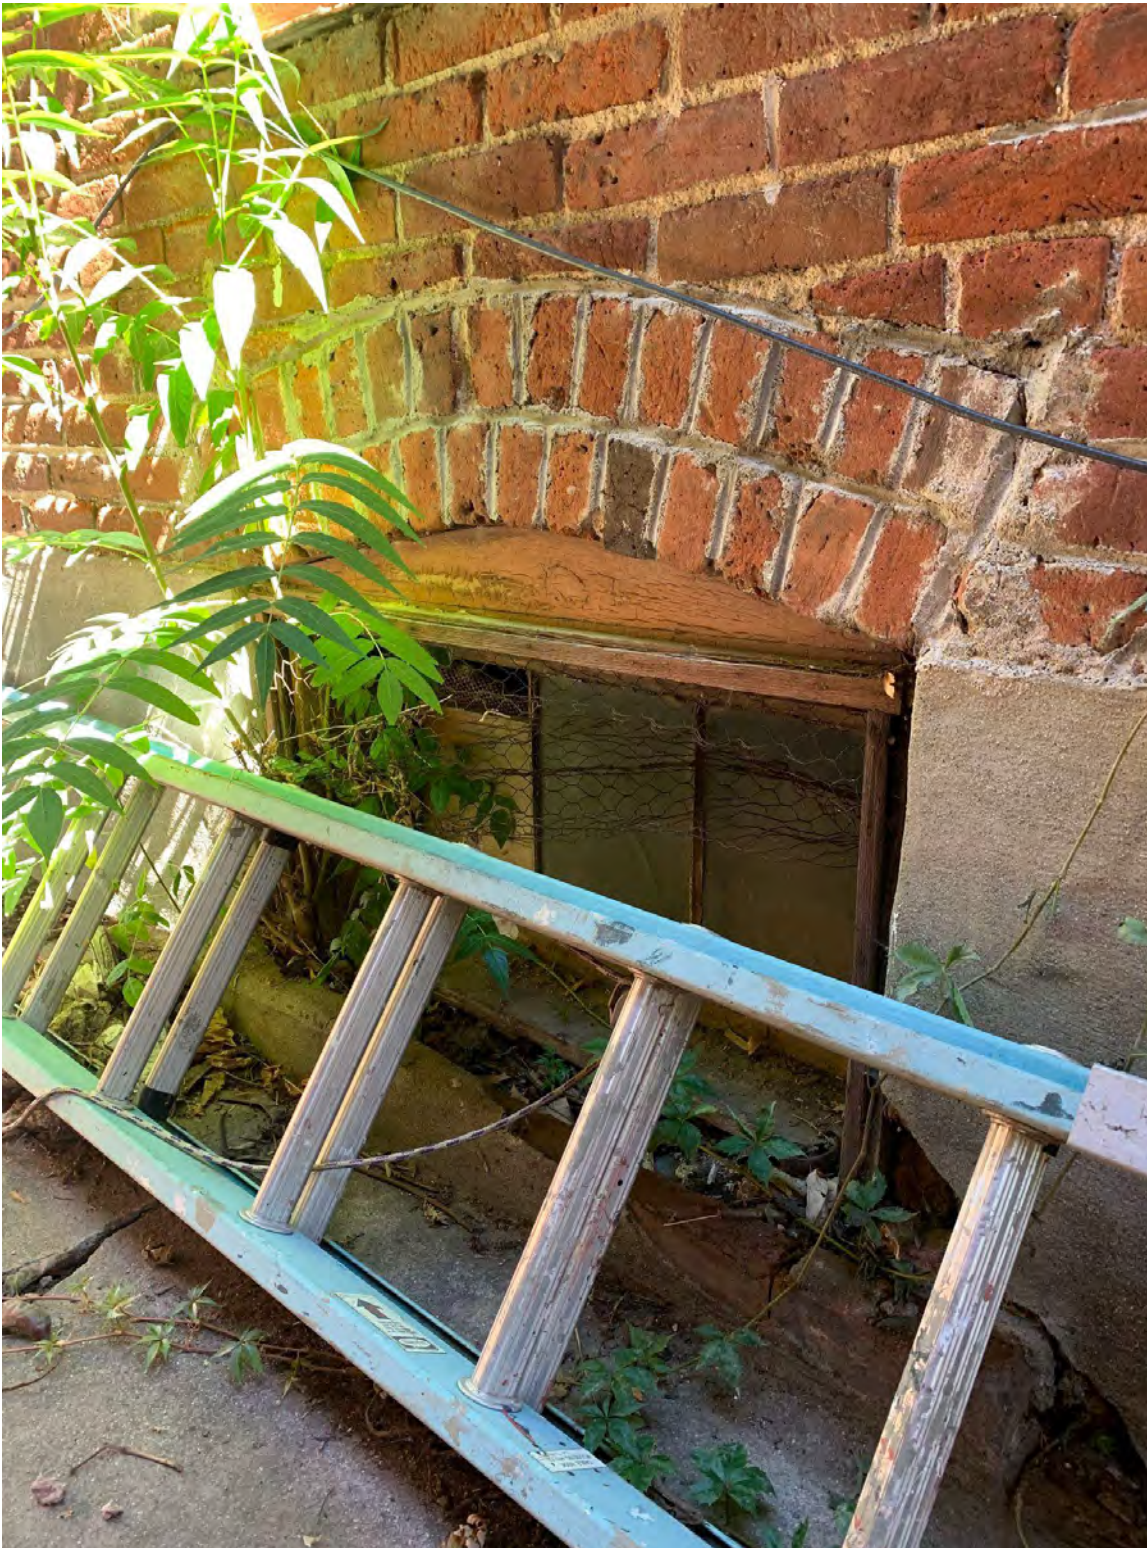
10. Original west-facing cellar window. Photo taken September 19, 2022.

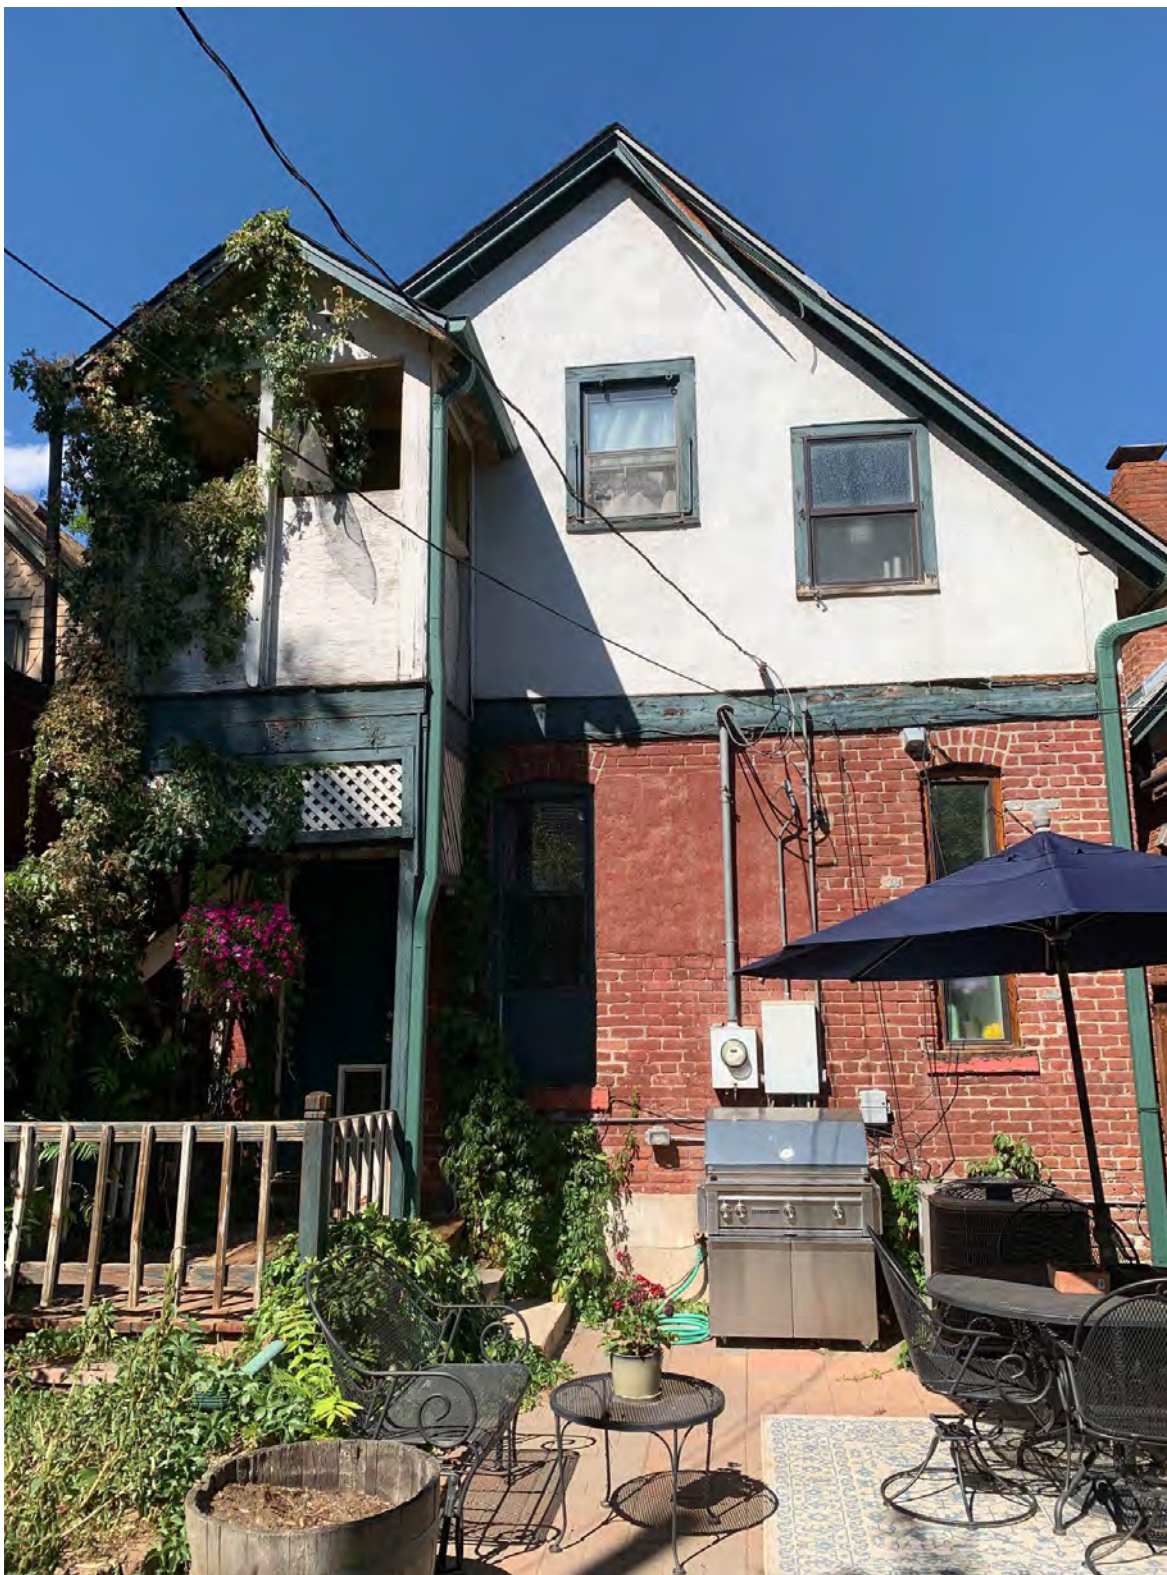
11. South-facing facade (backyard) with red brick first floor and kitchen entry porch and railing formed by the above main bedroom balcony. Note the second floor plaster/stucco facade of the main bedroom addition in the mid- to late-1930s. Photo taken September 19, 2022.

On the second floor, a horizontal section of non-decorative bargeboard separates the first level from the second level main bedroom addition (Lario ca. mid-late 1930's). The facade is white plaster stucco over brick and wood, with its main gable and secondary balcony gable. Straight fascia and trim lack the Queen Anne "gingerbread" ornamentation found on the north facade, and are in need of repair. To the right, a small privacy window (main bath) with dual pane sliding construction was installed ca. 2019, while maintaining the integrity of the original wood frame and its awning hooks and

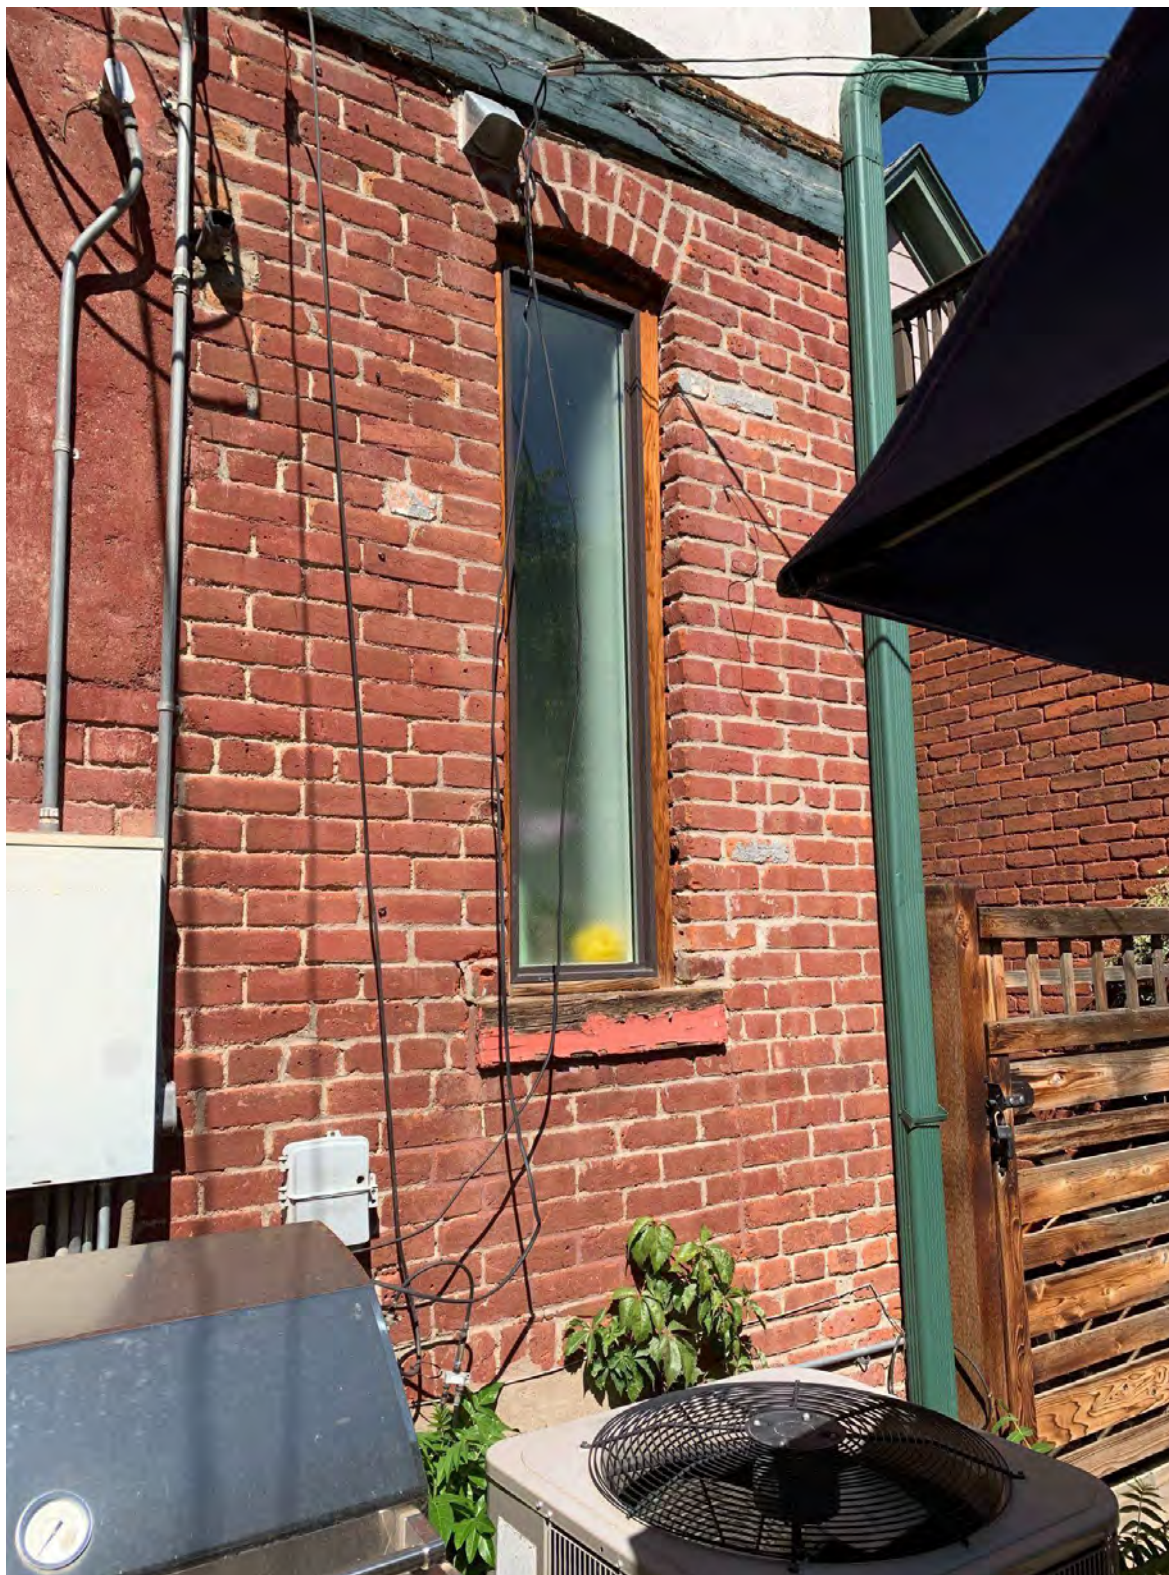
12. South-facing first floor bathroom privacy window with new wood frame (ca. 2017). Photo taken September 19, 2022.

On the first floor, toward the rear of the home one tall, narrow privacy window (first floor bath) with a new wood frame was installed ca. 2017, while maintaining the original dimensions and wood beam sill. The red brick facade is in good condition, with the most recent tuckpointing, repointing, and brick restoration occurring in ca. 2015.
