COLORADO STATE REGISTER OF HISTORIC PROPERTIES NOMINATION FORM

Historic Name Wilson & Hersperger House

Street Address 2254 West 34th Avenue

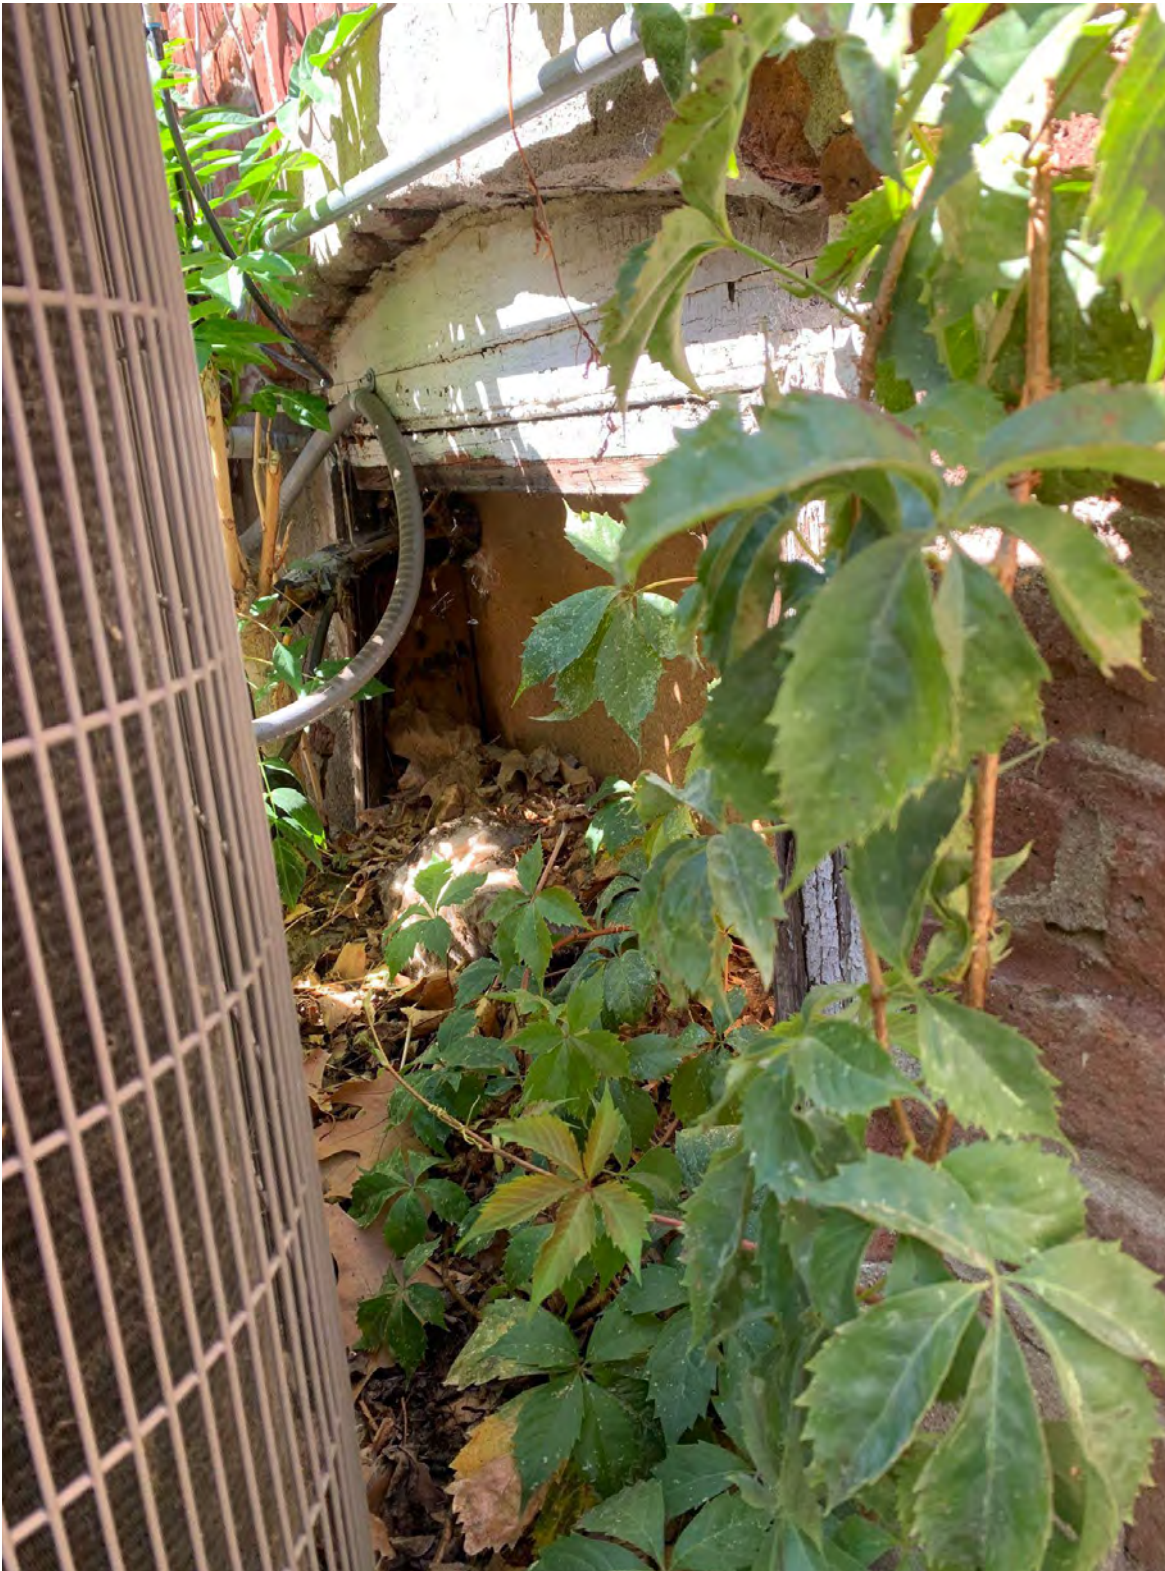
13. South-facing cellar window covered with interior wood board. Photo taken September 19, 2022.

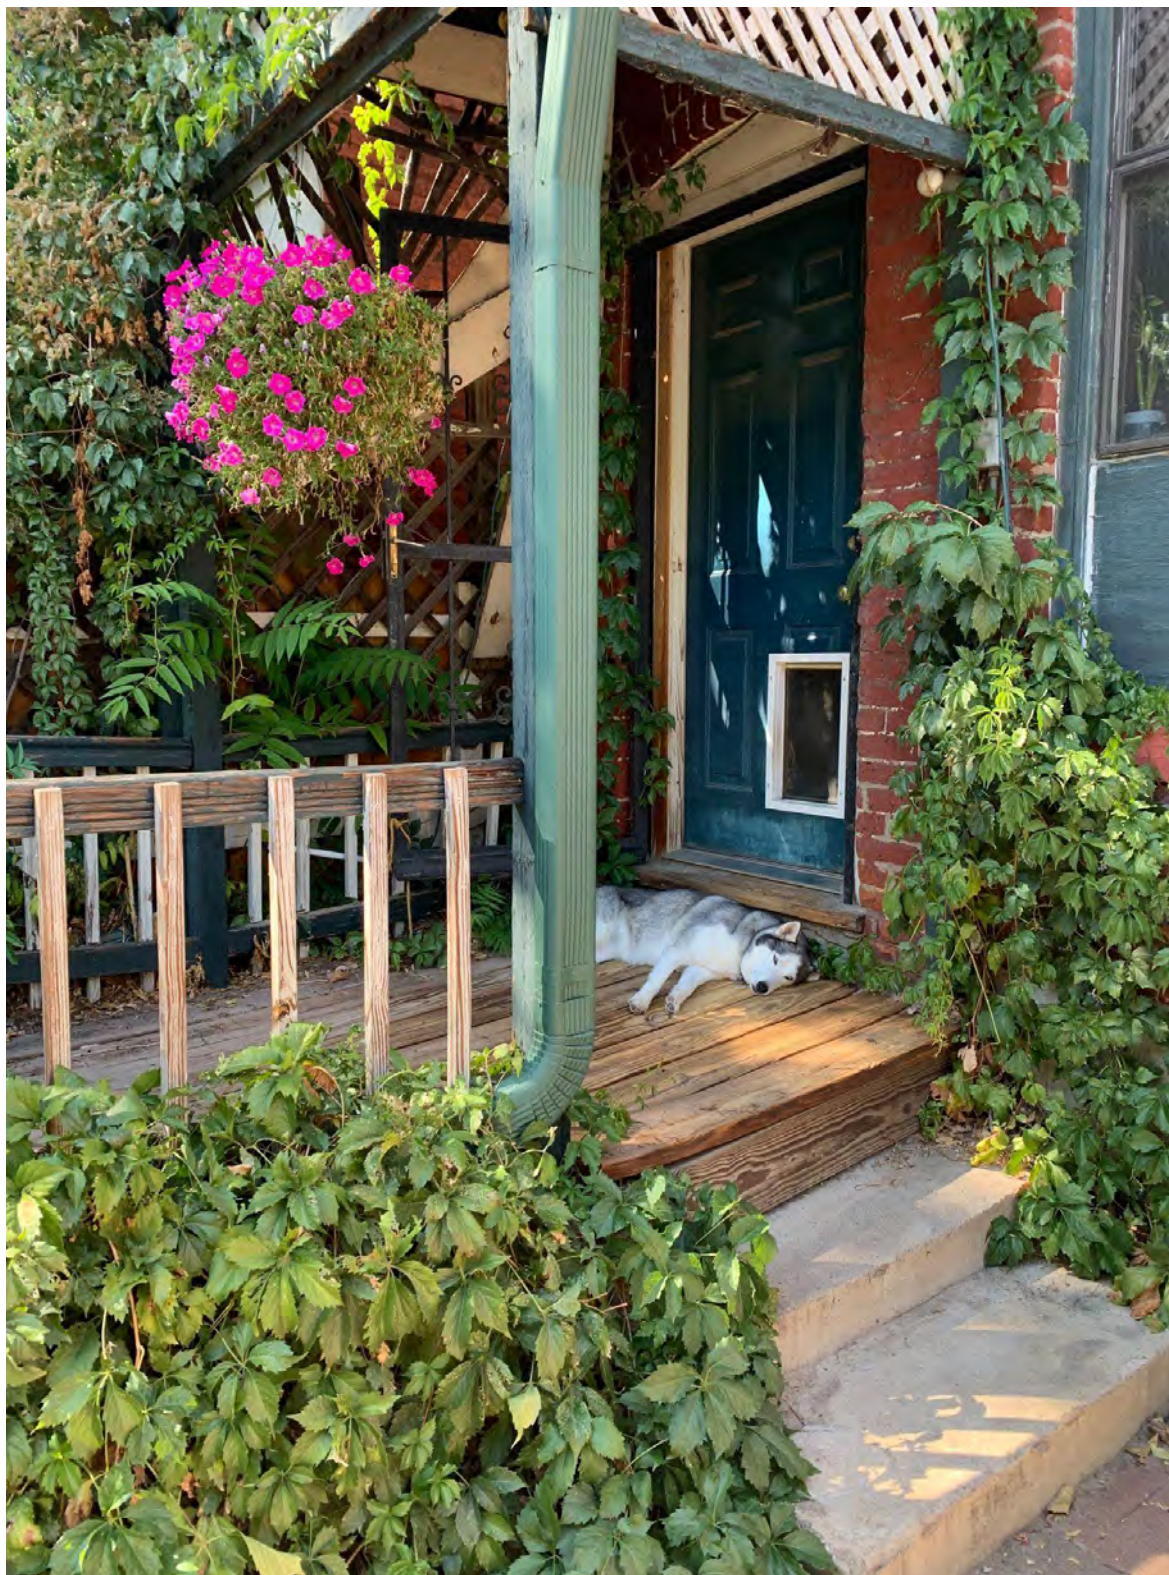
15. Rear porch with kitchen entry. Photo taken September 26, 2022.

At the rear porch entry, two poured concrete steps lead from a paver patio to a wood deck porch that is partly covered by the main bedroom Juliet balcony and its lattice skirt. The porch rests on a wood and concrete foundation, partly formed by the concrete steps, and is constructed of 2in. x 8in. decking, and includes a 34in. wood railing, and a security light. The entry consists of a wood and metal frame with a brick semi-arch top, and includes a metal security door, and a modern foam-core aluminum door with a dog door insert.

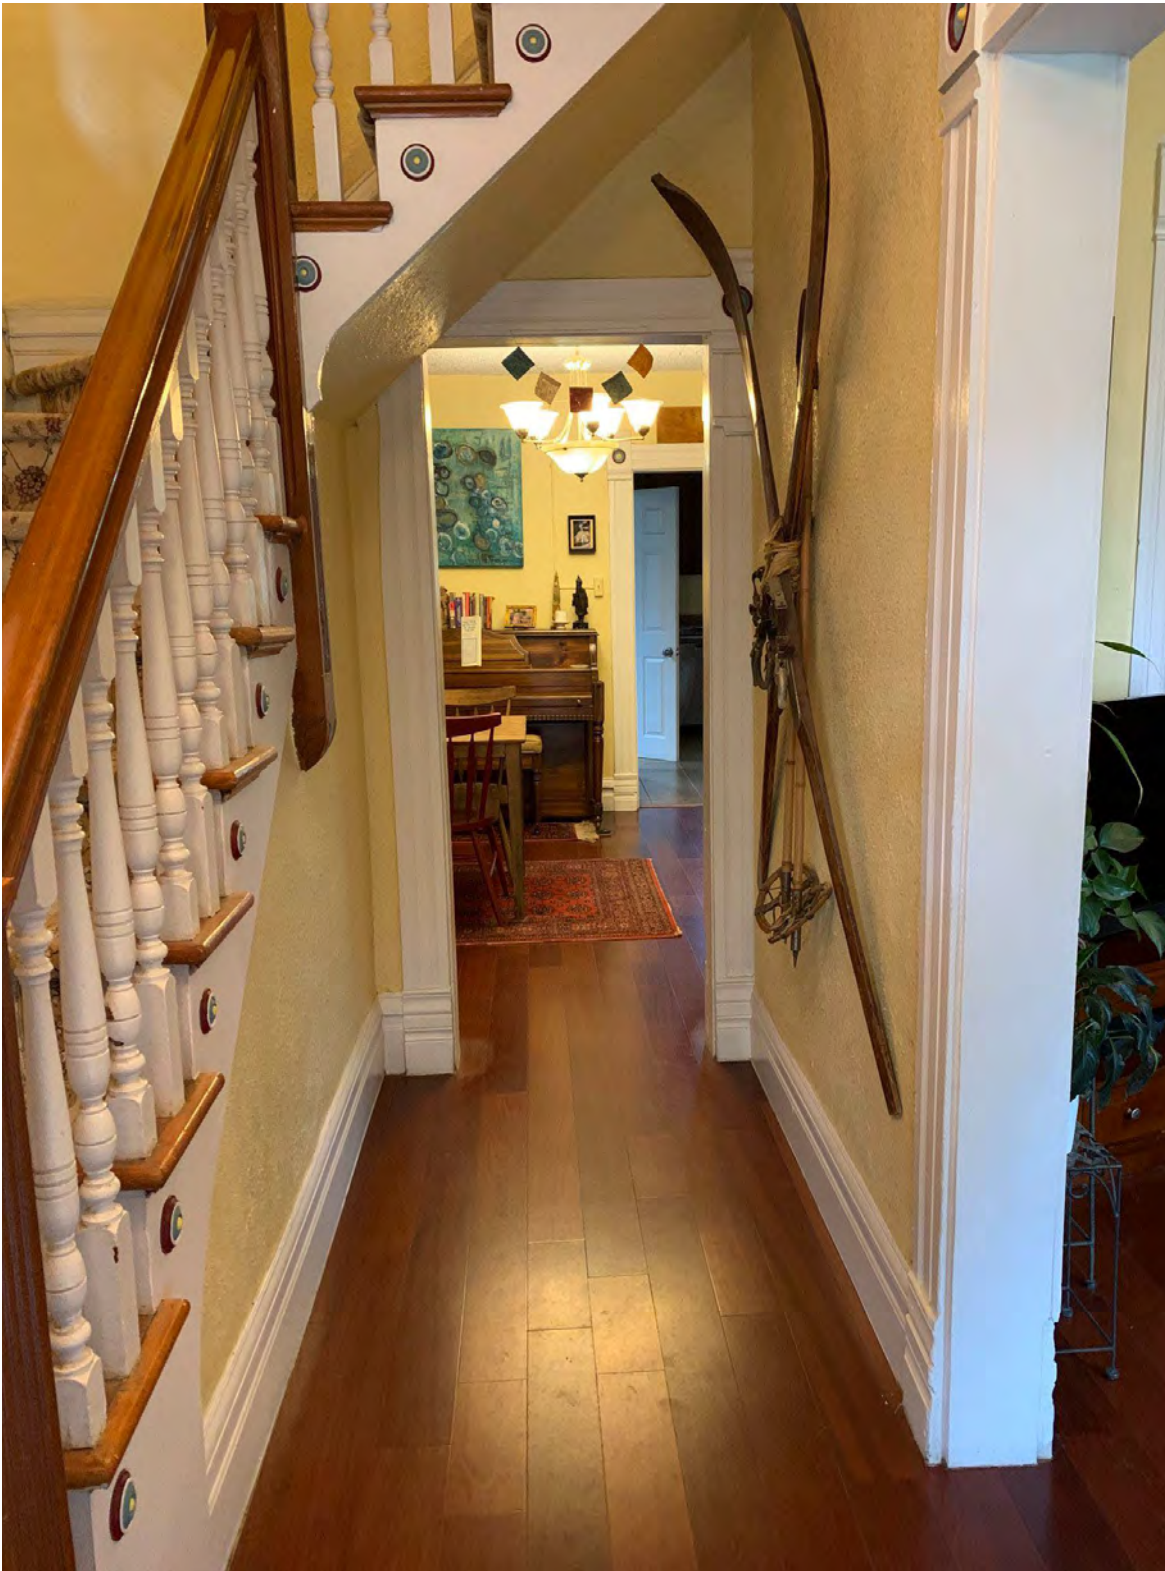
16. Foyer hallway looking south into the dining room, including the stairwell to second level with its original wood steps, handcrafted newels and railing, and decorative molding (painted ca. 2021). Photo taken September 14, 2022.

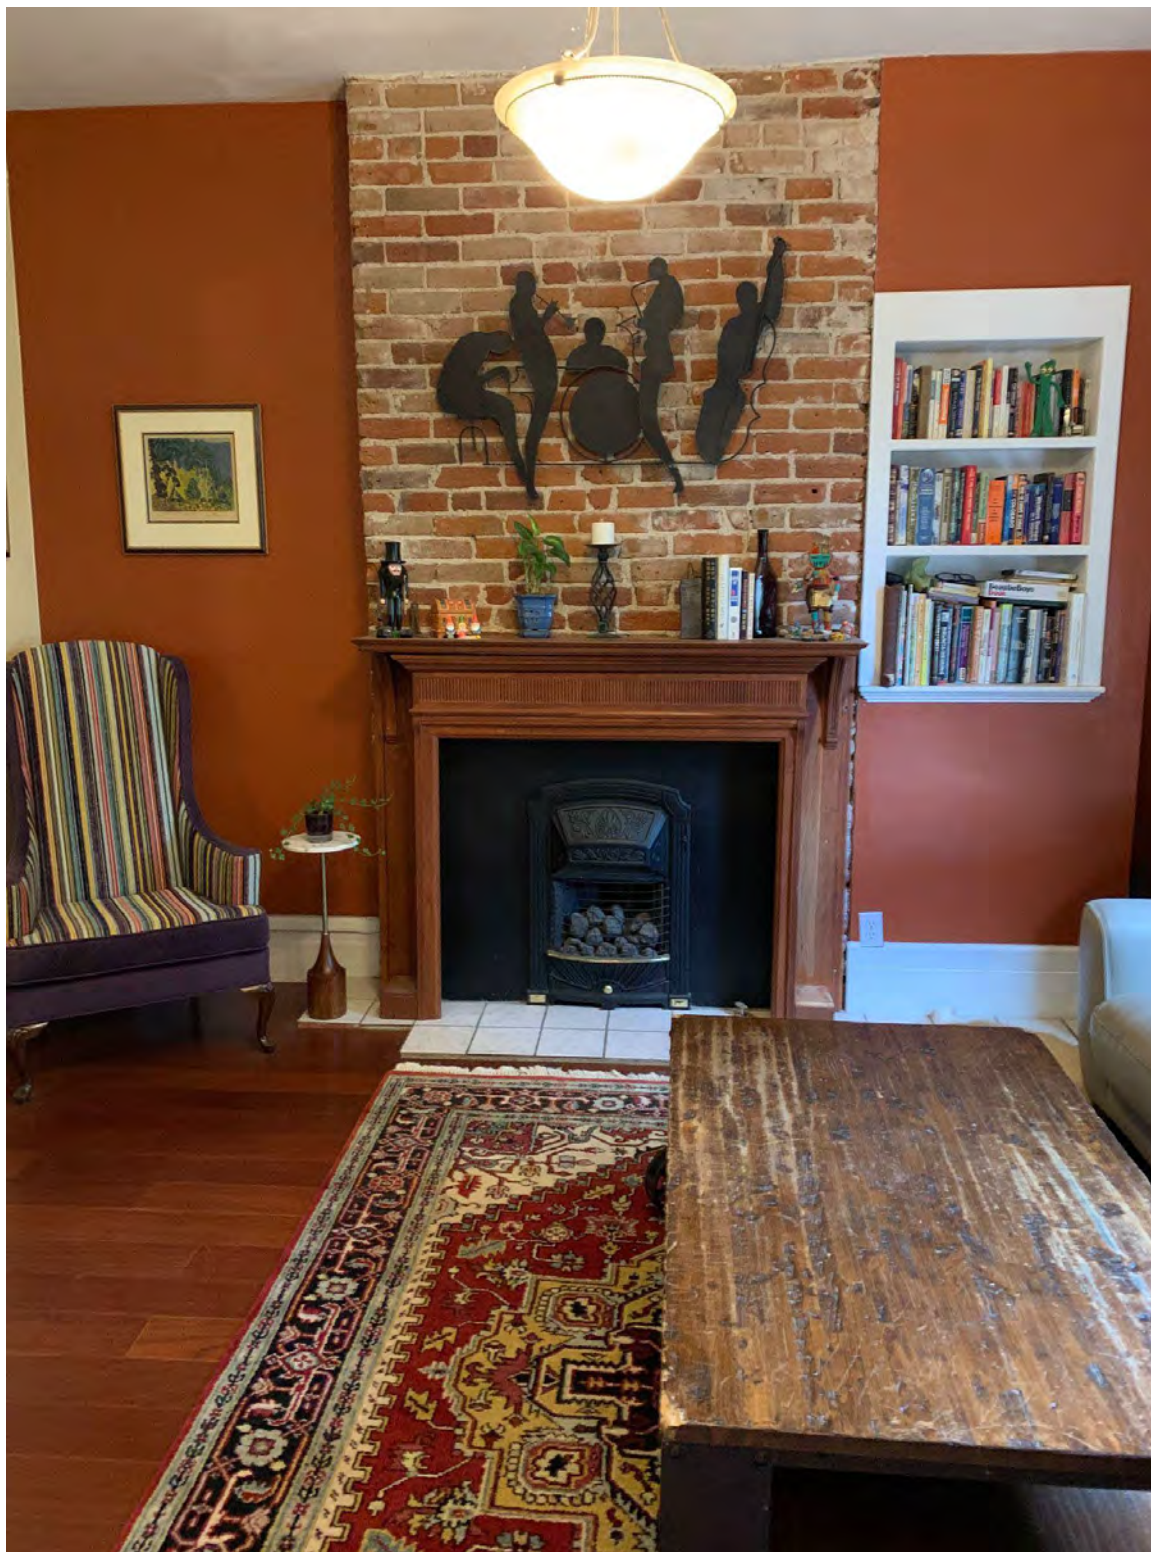
18. Living room (front room/original parlor) with fireplace mantle, built-in bookshelves, and original baseboards. Photo taken September 14, 2022.

To the right is the living room, historically known as the "parlor," which includes a high ceiling and Red Oak hardwood floors, and exposed brick above the fireplace. The room includes most of the original decorative baseboards, molding and trim, most prominent around the large north-facing front window, and pass-through. The historic fireplace has been updated with a gas fixture and front (date of alteration unknown). The hand-made wood mantle was likely built in the late 1930s-1940's due to wear patterns. White ceramic tile is used as decorative floor trim. A recessed bookcase was built into the vent build-out in 2017.

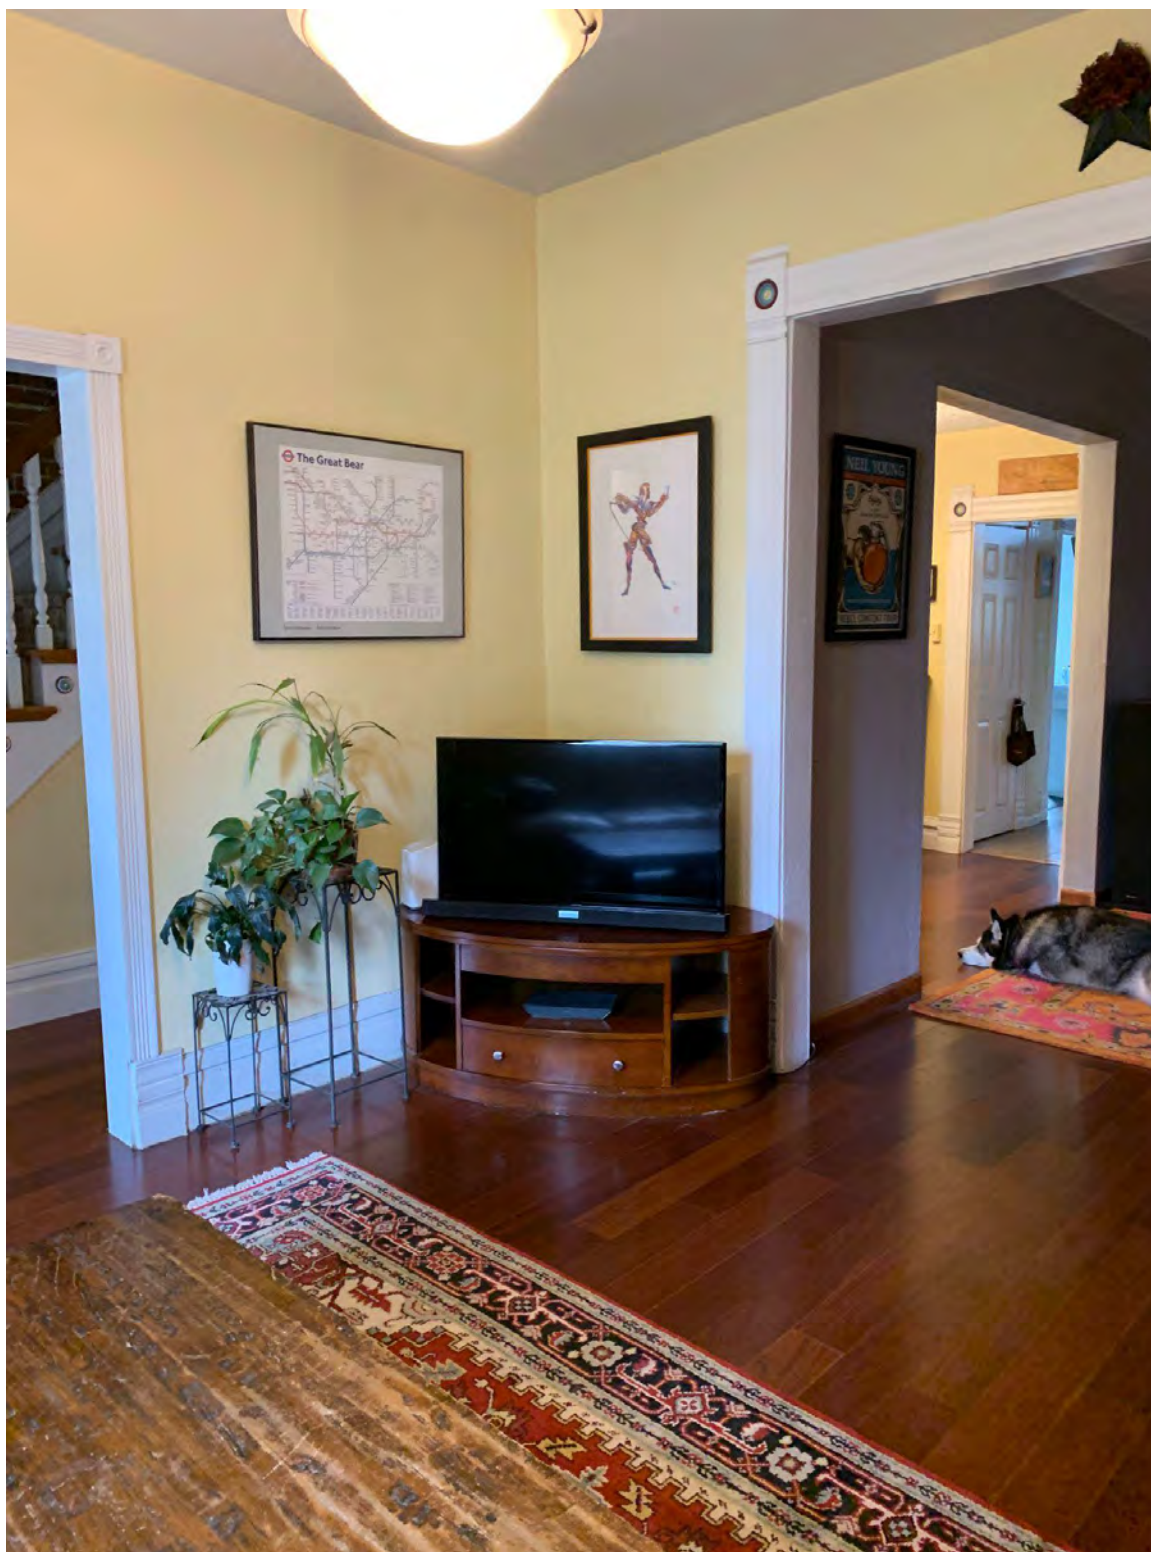
20. Living room. To the left is the foyer, to the right is the sitting room. Note the original decorative trim and molding. Photo taken September 14, 2022.

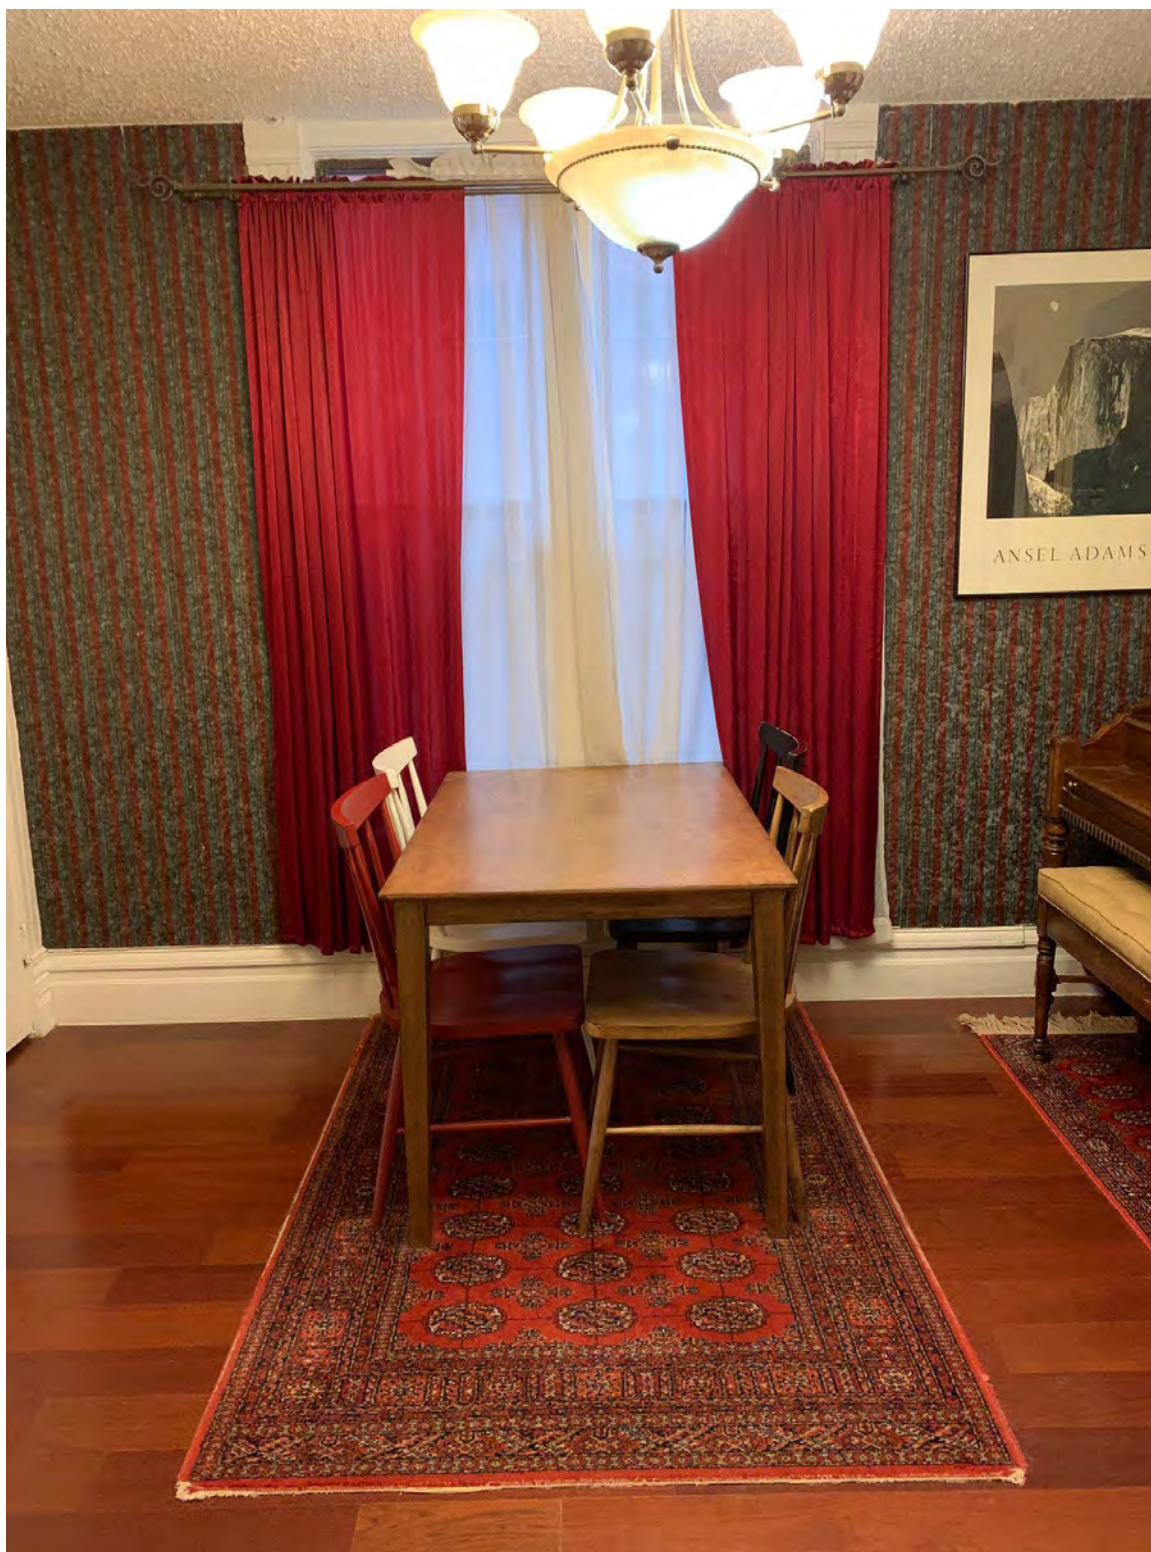
23. Photo of dining room and its east-facing window. Note the drop ceiling. Photo taken September 14, 2022.

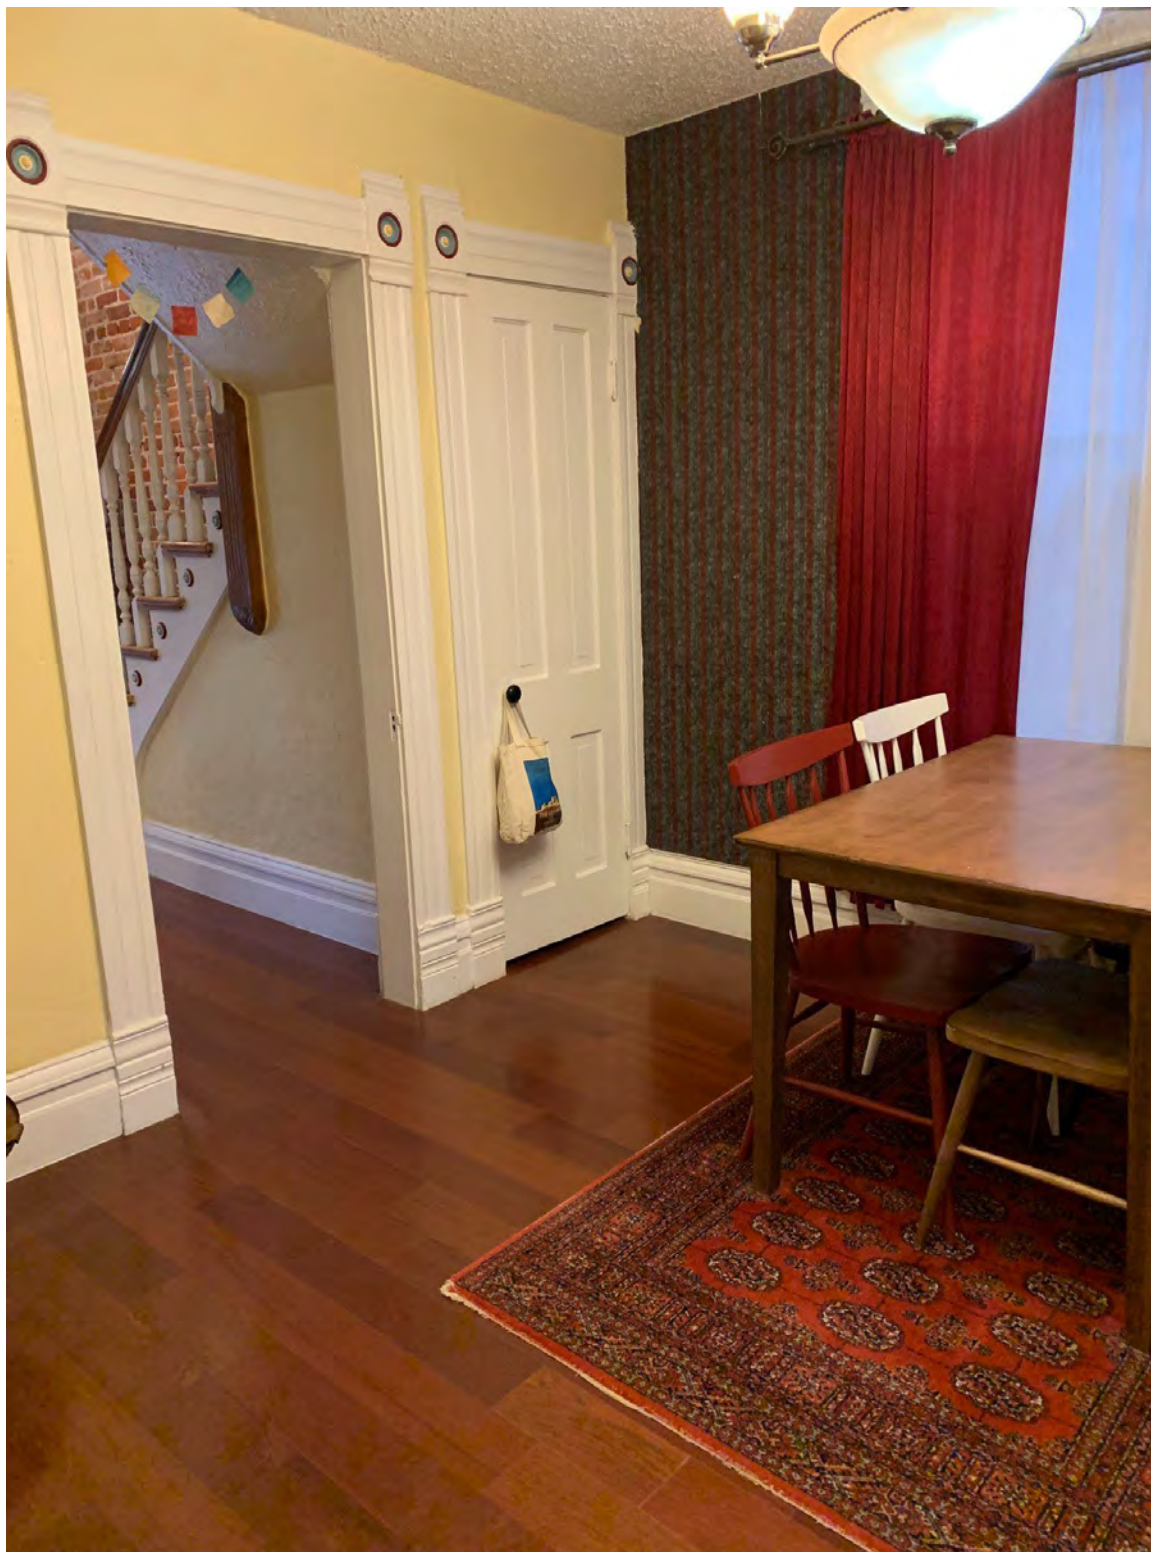
25. Dining room with the closet located below the stairwell. Note the pass-through from the foyer into the dining room had a locking door in the past, most likely when the home was utilized as a boarding house. Photo taken September 14, 2022.

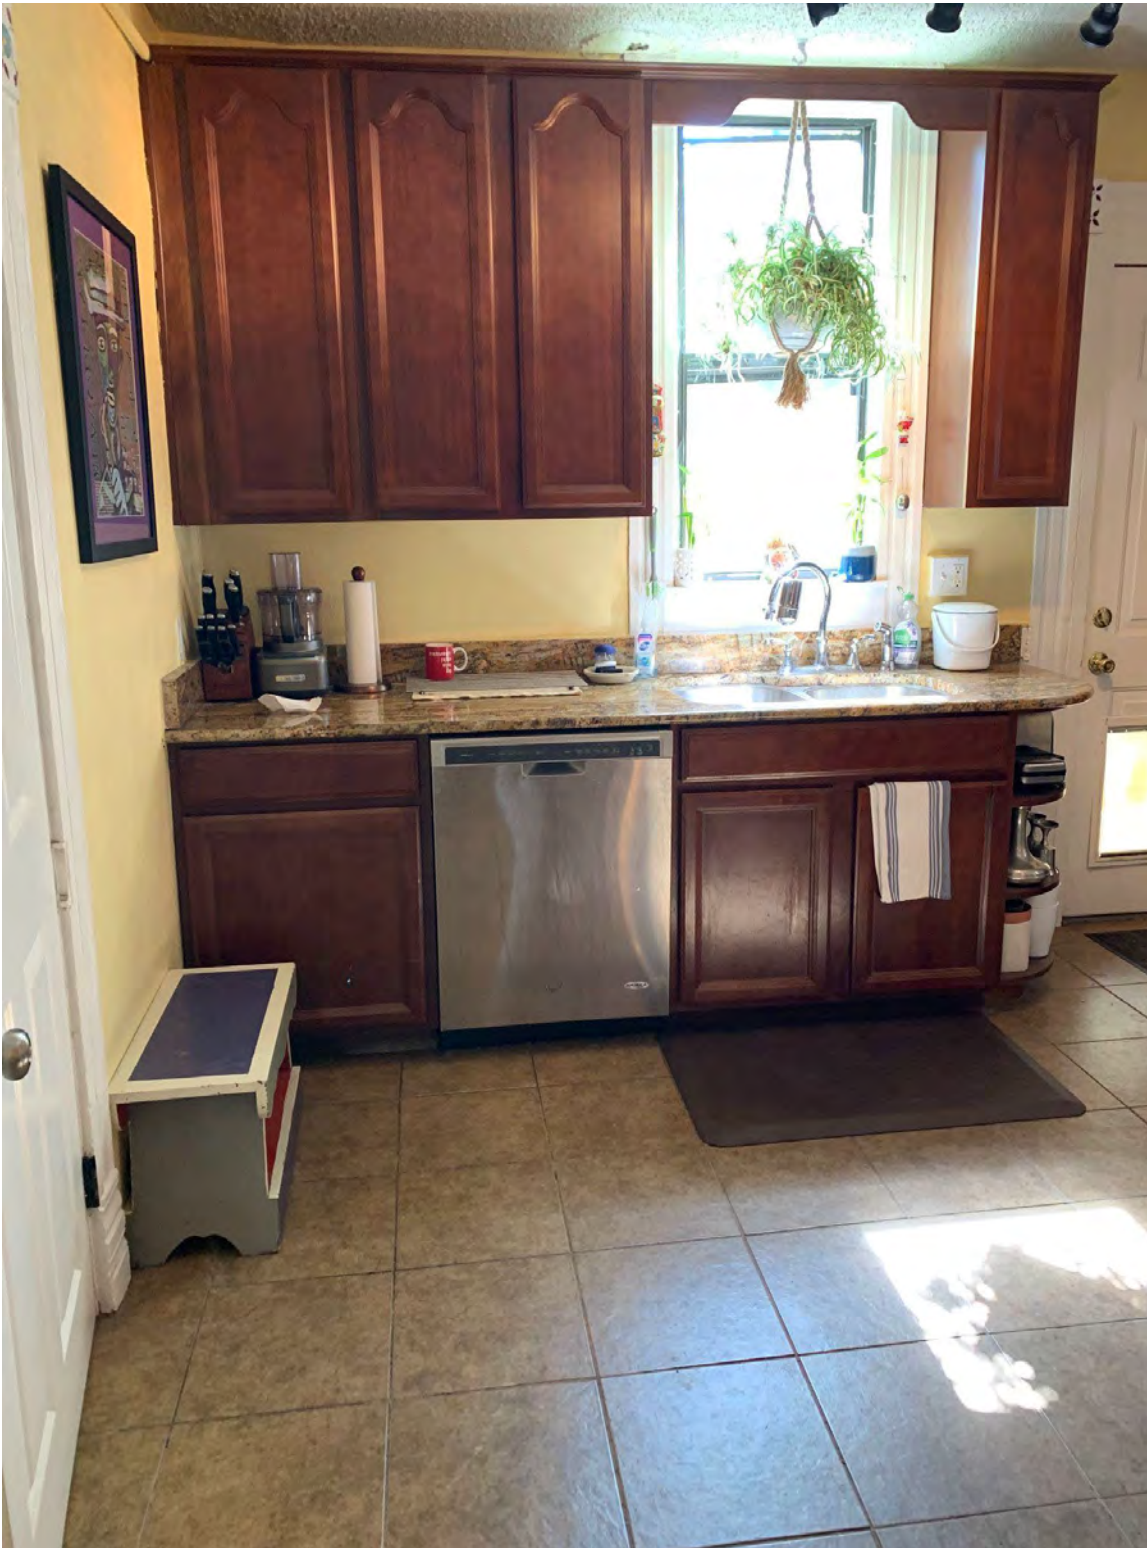
27. View from the dining room into the kitchen with its south-facing window. The cellar and bathroom doors are to the left, the door to the backyard is to the right of the counter. Photo taken September 26, 2022.

Off the dining room is the kitchen entry. The kitchen includes a drop ceiling with popcorn finish and ceramic tile floor. The room features the home's distinctive decorative molding and trim, but lacks the original baseboards. The entire kitchen was renovated by the previous homeowner in ca. 2013-2014, including the floor, marble counters, wood cabinets and drawers, wood pantry, ceiling light fixtures, and new appliances. A rectangular build-out is found on the west wall which conceals the original kitchen stove chimney, and continues through the above main bedroom. One tall, narrow mid-wall window faces west, and one south-facing window is located above the sink. A door to the backyard is located to the right of the sink counter. To the left, there is a door to the bathroom, and a door to the cellar.

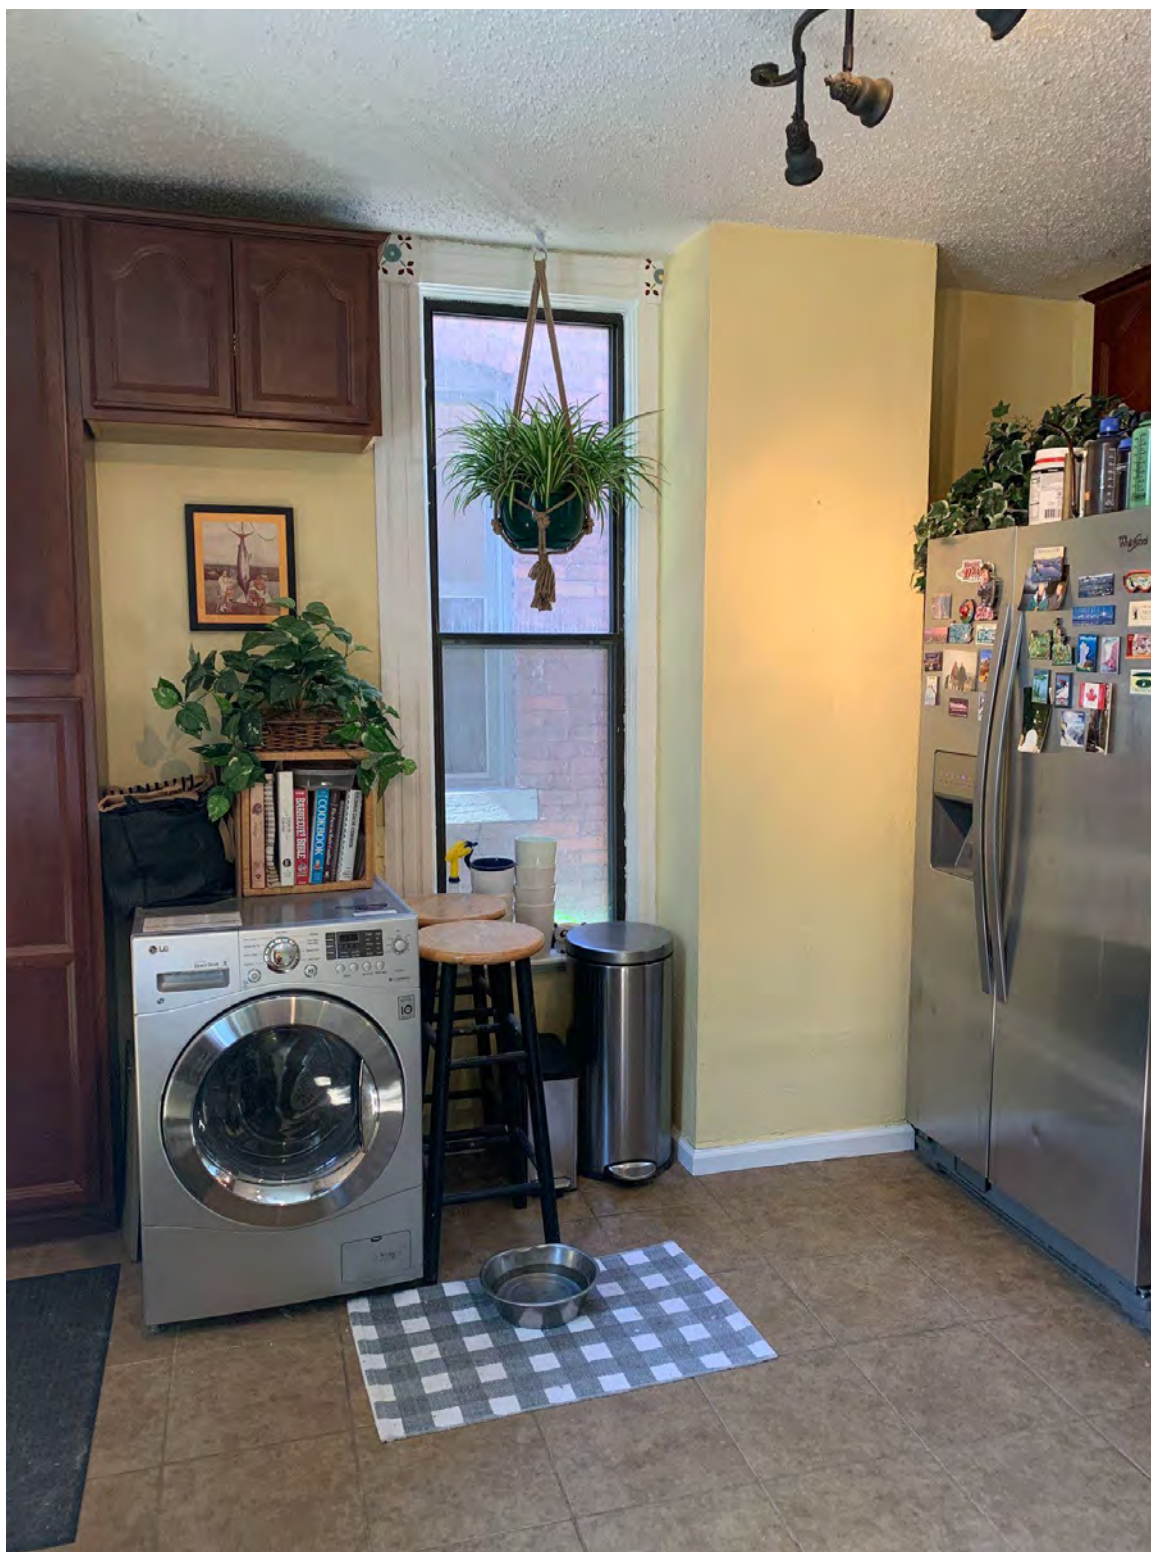
28. Kitchen with its west-facing window. Note the build-out next to the fridge which conceals the chimney flue for the historic kitchen stove. Photo taken September 26, 2022.

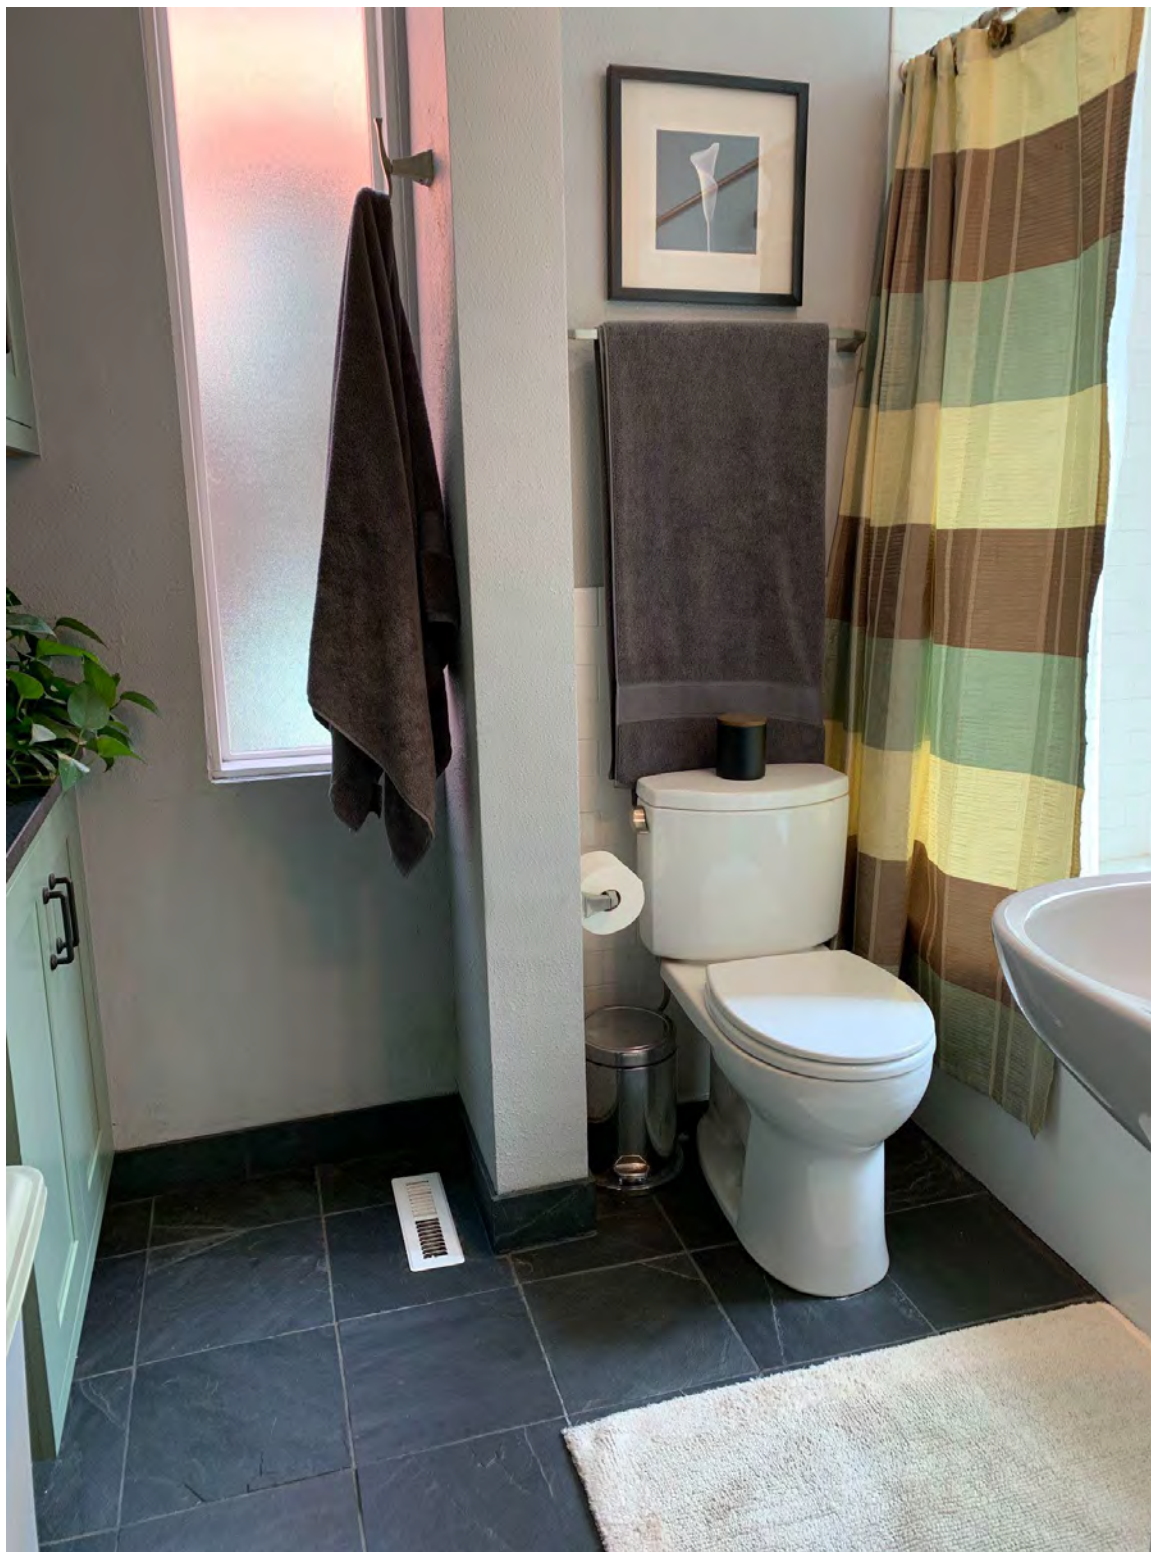
31. First floor bathroom renovated ca. 2017. Photo taken September 14, 2022.

The bathroom adjacent to the kitchen was entirely rebuilt in 2017. Due to extensive water damage and mold, the entire floor, subfloor, and plumbing were replaced, as well as much of the standard-height ceiling. The floors are black slate tile,

and the walls are predominantly white subway tile. The custom-built black marble vanity and wood cabinets mirror the orientation of the previous (non-historic) design. The bathtub, toilet, sink, and light fixtures are also contemporary. Two tall, narrow sliding windows were replaced with static privacy windows, and set in rebuilt wood frames in 2017.

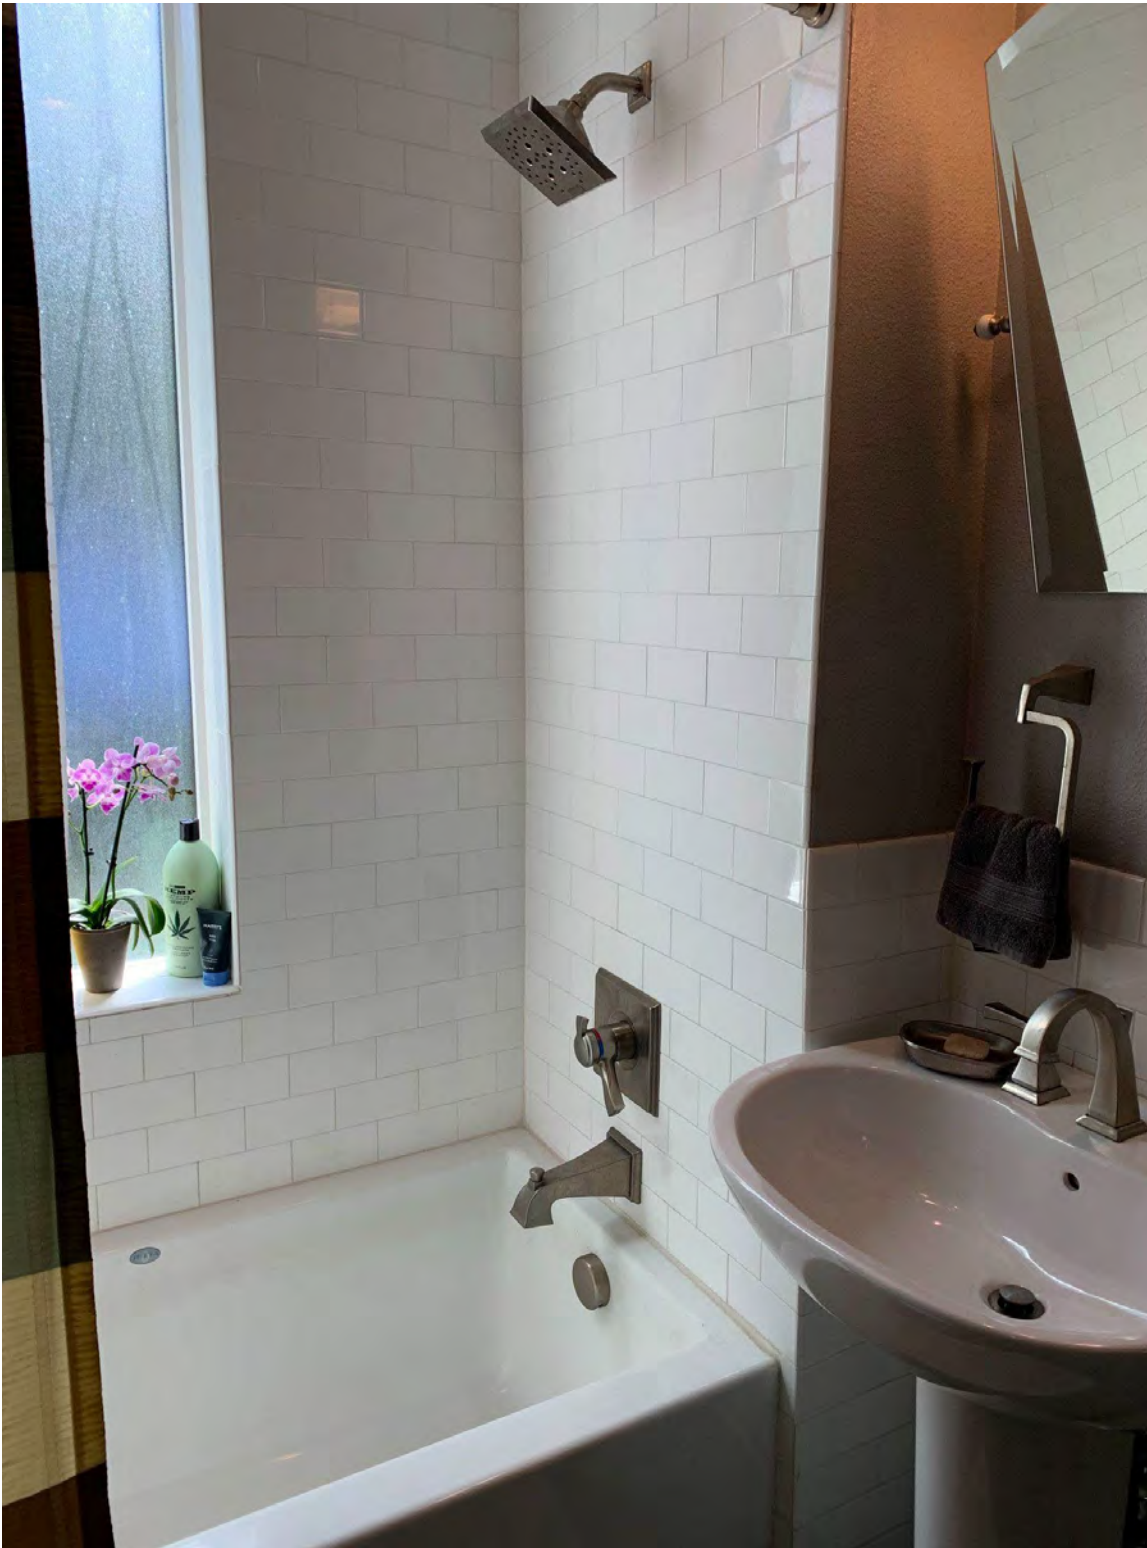
33. First floor bathroom with south-facing privacy window and subway tile shower and tub. Photo taken September 14, 2022.

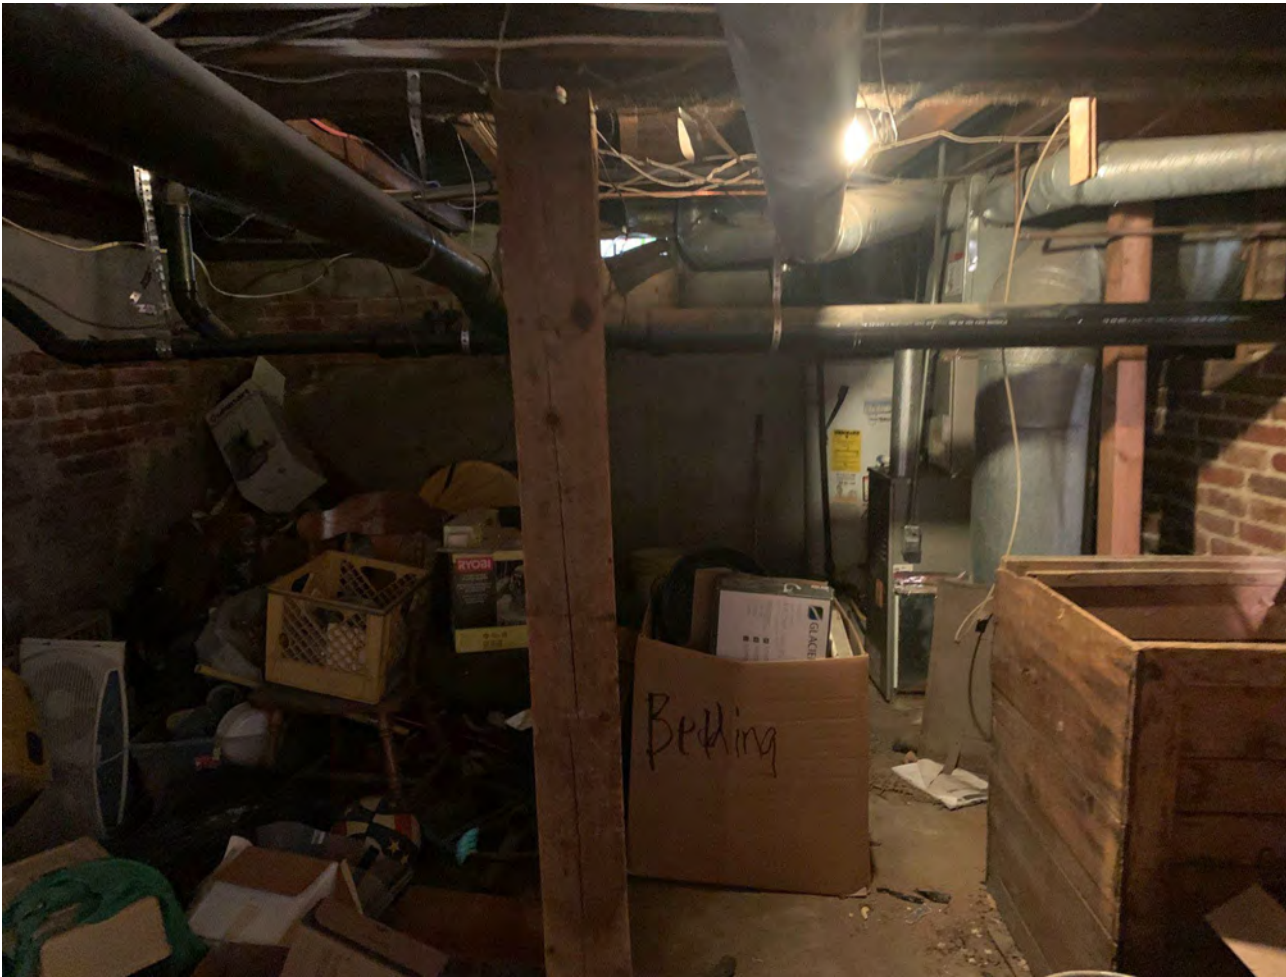
35. Cellar view from the bottom of the stairwell. Photo taken September 26, 2022.

Next to the bathroom is the cellar door. A stairwell leads to the basement with a very low ceiling of exposed beams and a concrete floor. The usable space is fairly small, and comprises the space below the kitchen and adjoining bathroom. An east-west brick wall separates the usable space, and the dirt and rubble crawlspace which comprises two-thirds of the space below the first floor. Much of the brick foundation is exposed with some plaster and concrete patching. The water heater and furnace were replaced in 2015, and air conditioning was retrofitted. The walls below the bathroom were covered with a layer of white mold-remediation paint. It is possible that when the home was used as a boarding house in leaner times, someone may have rented this space and slept below the stairs.
