COLORADO STATE REGISTER OF HISTORIC PROPERTIES NOMINATION FORM

Historic Name Wilson & Hersperger House

Street Address 2254 West 34th Avenue

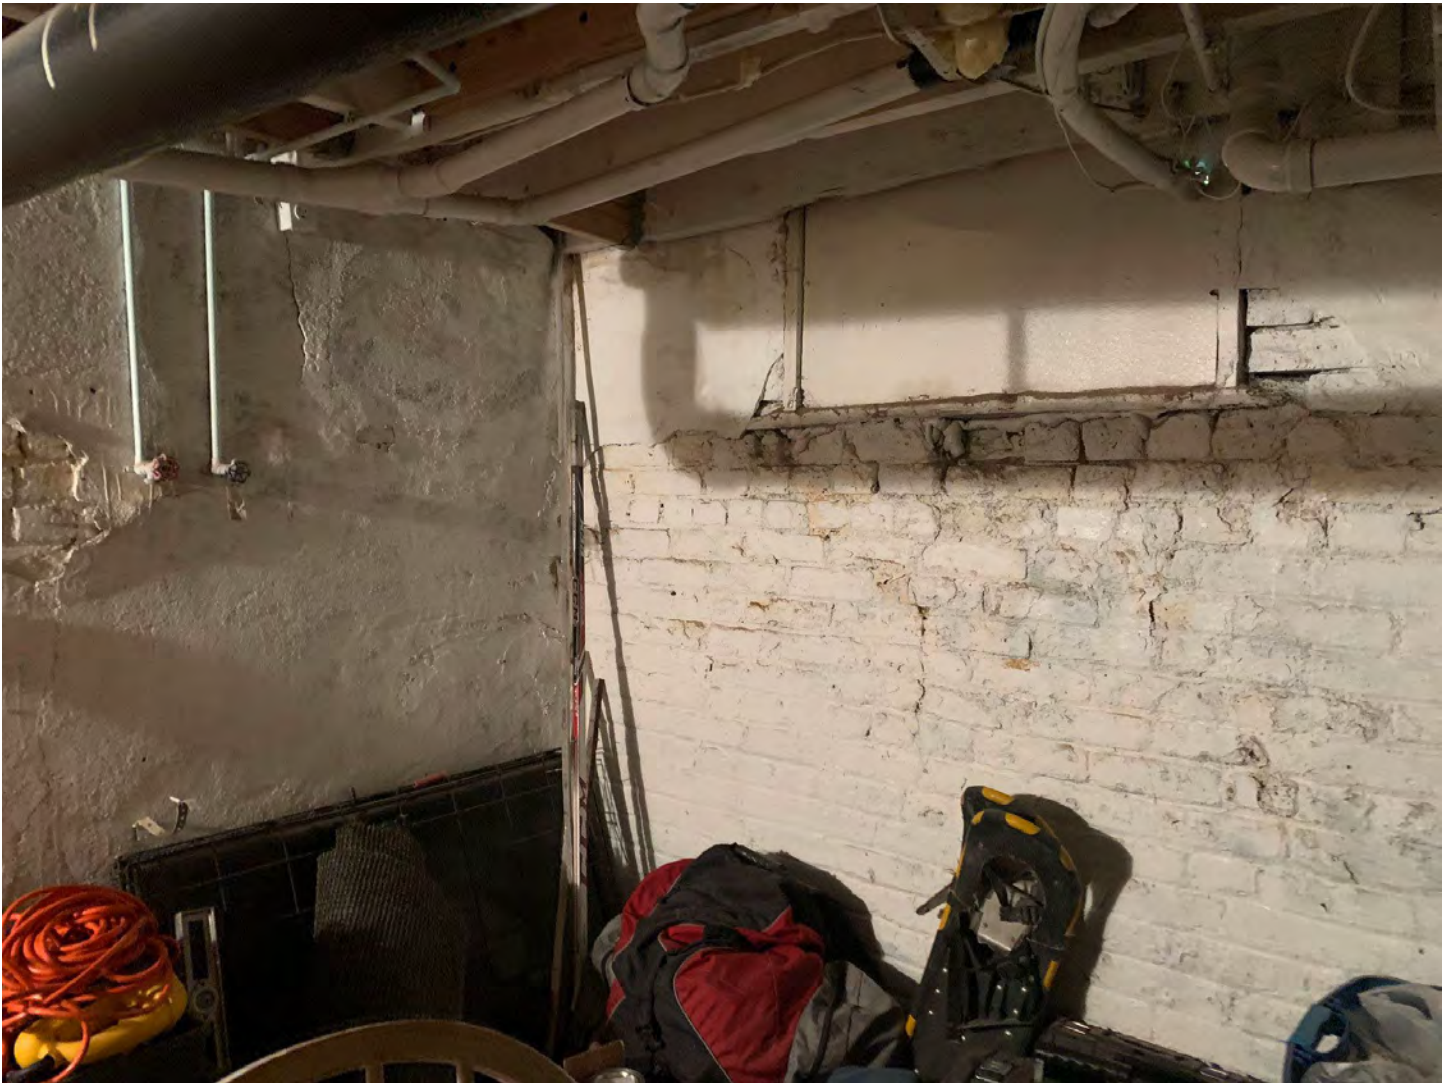
37. Cellar brick wall with some plaster repair. The boarded window faces south into the backyard. The white finish is mold remediation paint. Photo taken September 26, 2022.

Next to the bathroom is the cellar door. A stairwell leads to the basement with a very low ceiling of exposed beams and a concrete floor. The usable space is fairly small, and comprises the space below the kitchen and adjoining bathroom. An east-west brick wall separates the usable space, and the dirt and rubble crawlspace which comprises two-thirds of the space below the first floor. Much of the brick foundation is exposed with some plaster and concrete patching. The water heater and furnace were replaced in 2015, and air conditioning was retrofitted. The walls below the bathroom were covered with a layer of white mold-remediation paint. It is possible that when the home was used as a boarding house in leaner times, someone may have rented this space and slept below the stairs.

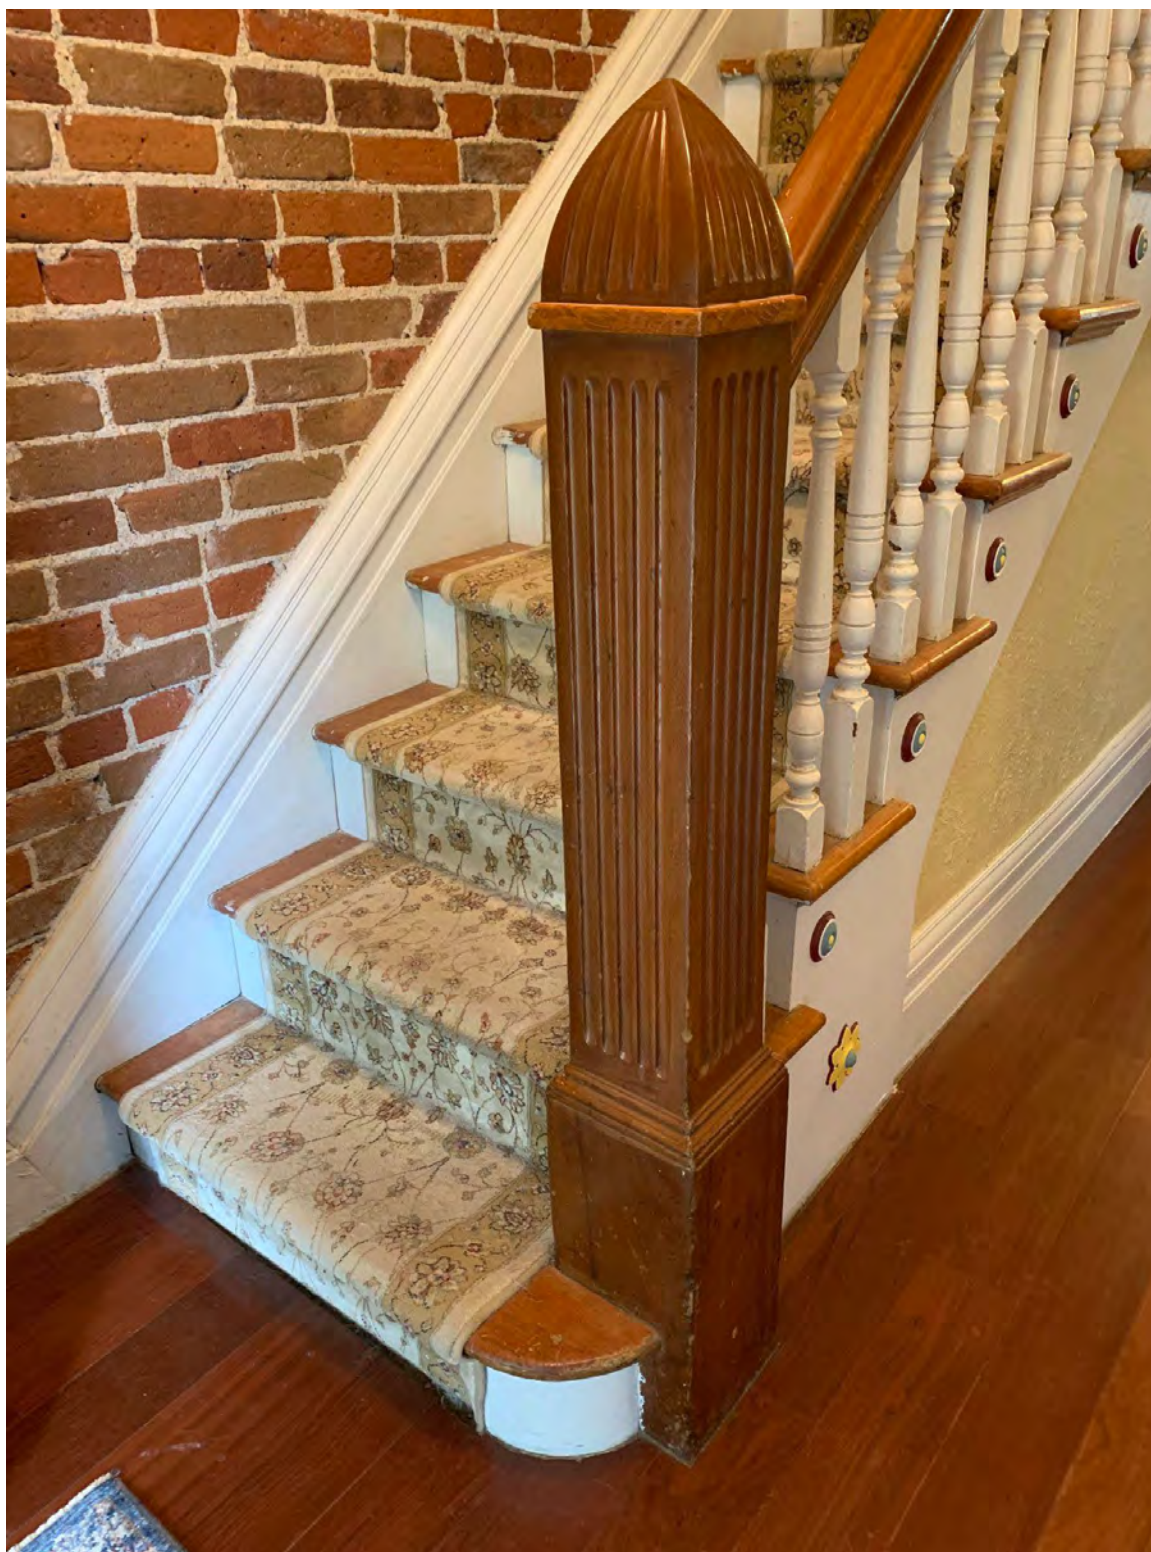
38. Stairwell in foyer leading to second floor. Note the handcrafted newel. Photo taken September 14, 2022.

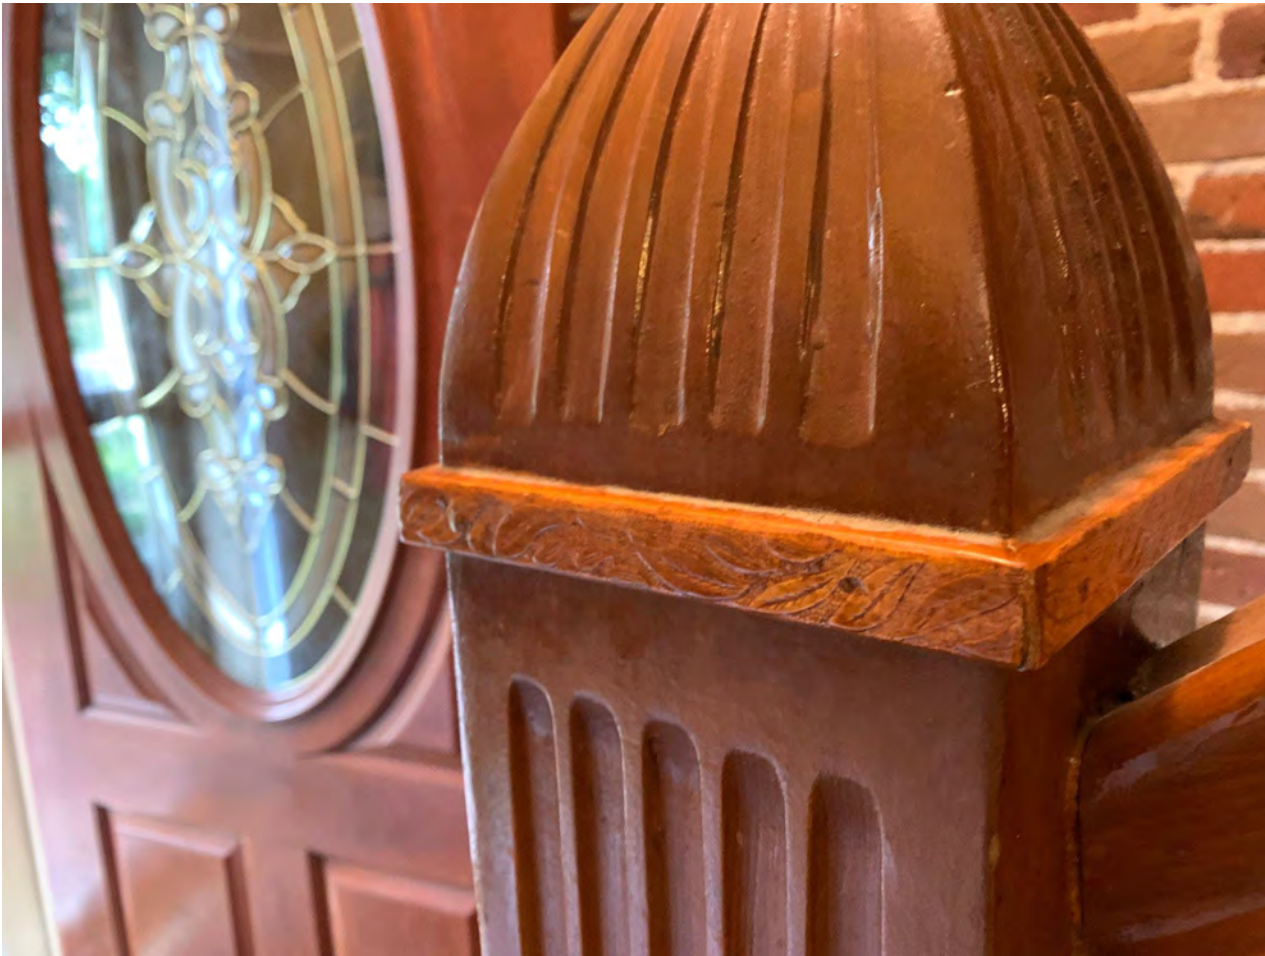
39. Leaf detailing on the lower newel. Photo taken September 14, 2022

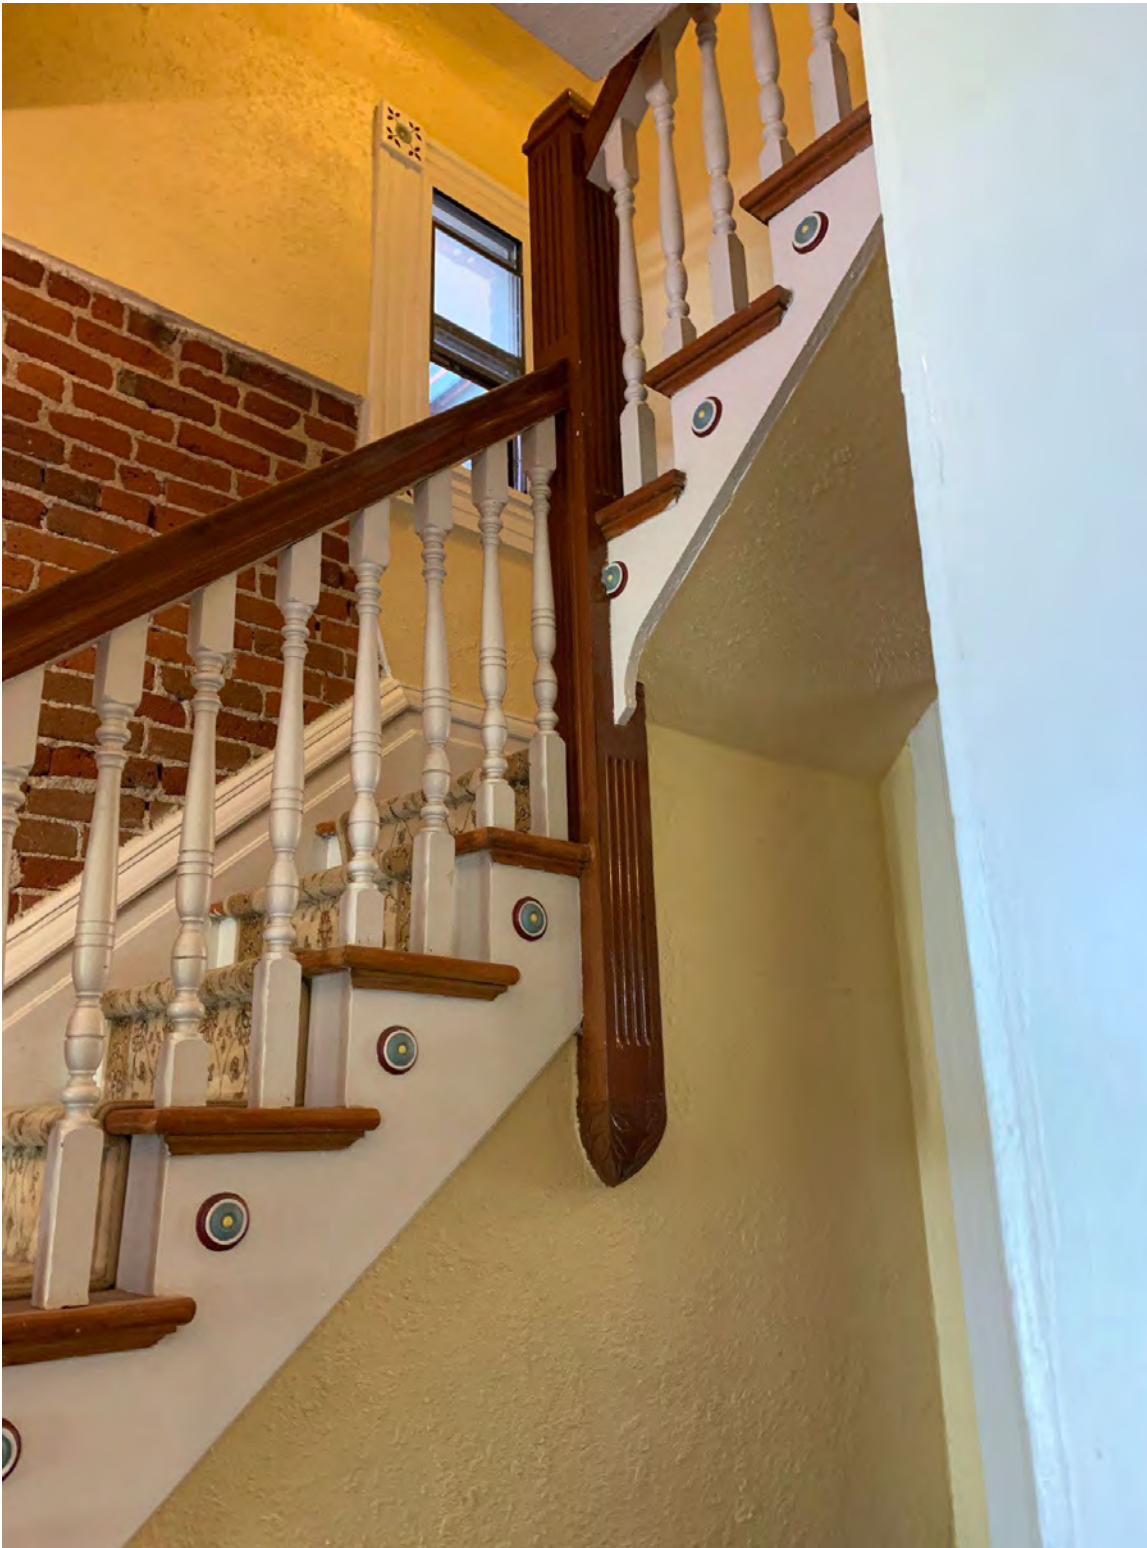
40. Stairwell detail and handcrafted landing newel. Photo taken September 26, 2022.

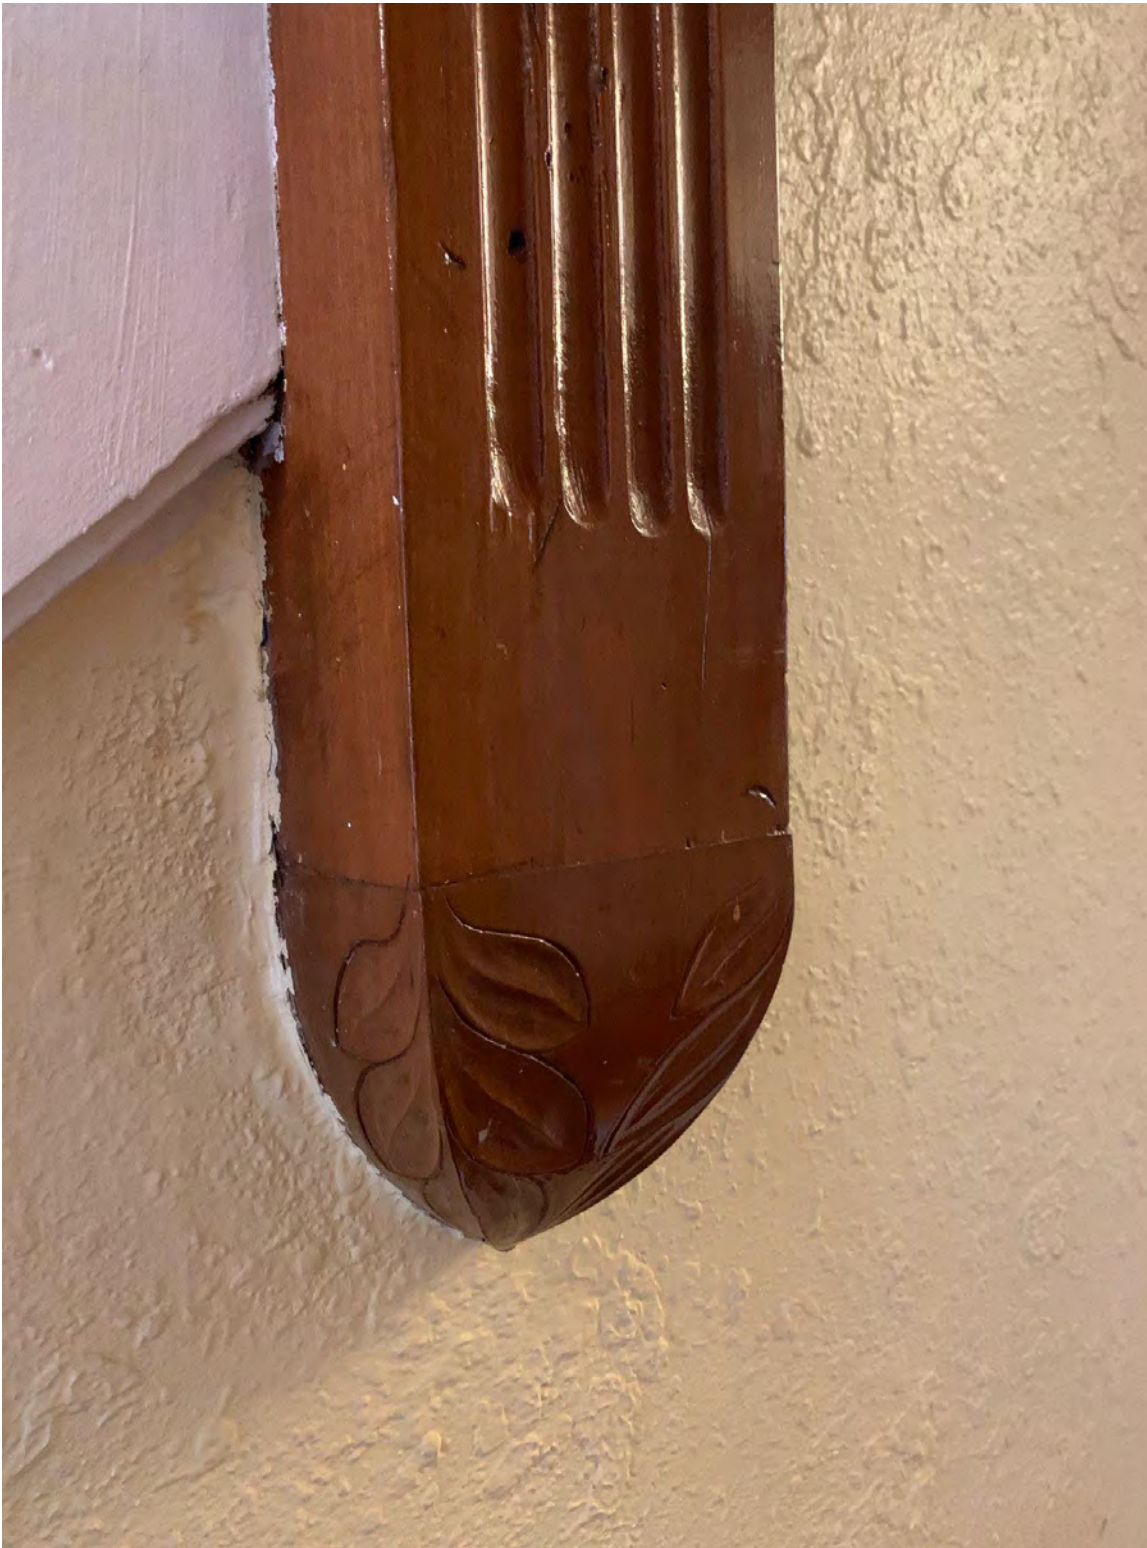
41. Leaf detailing on lower end of landing newel. Photo taken September 26, 2022.

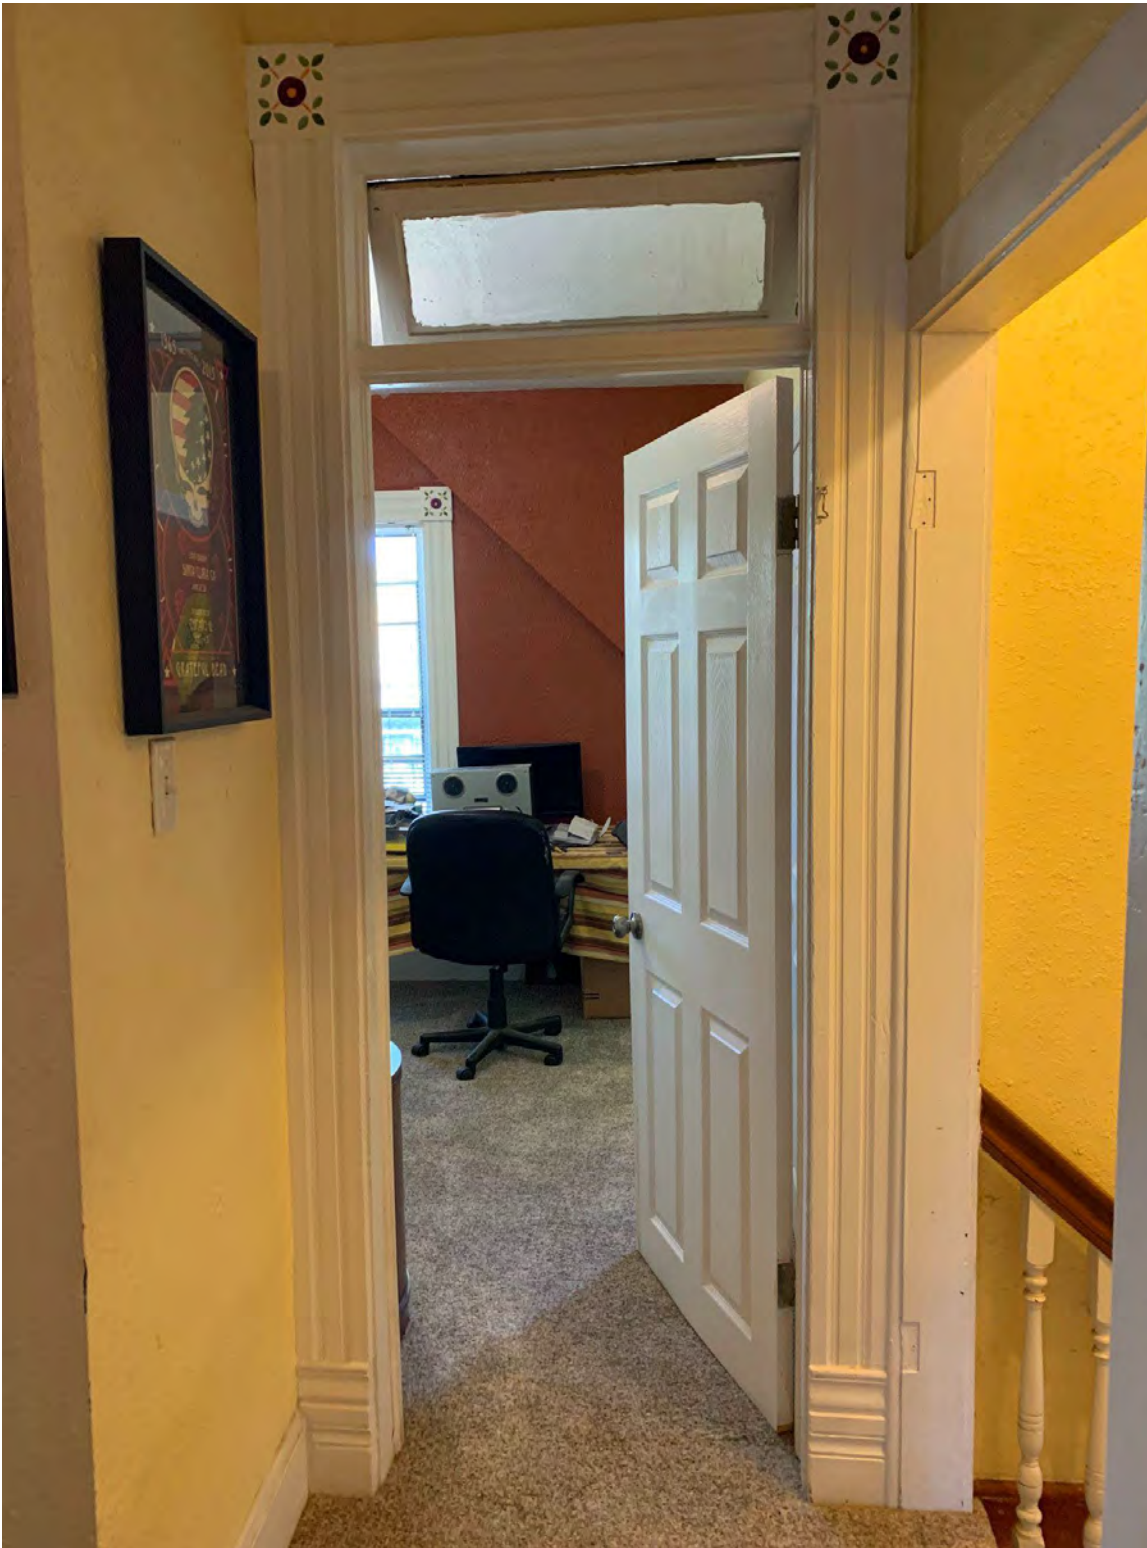
45. View from sitting room toward guest bedroom doorway with glass-paned transom. Note the spaces where hinge plates used to support a locking door at the top of the stairs. Photo taken September 26, 2022.

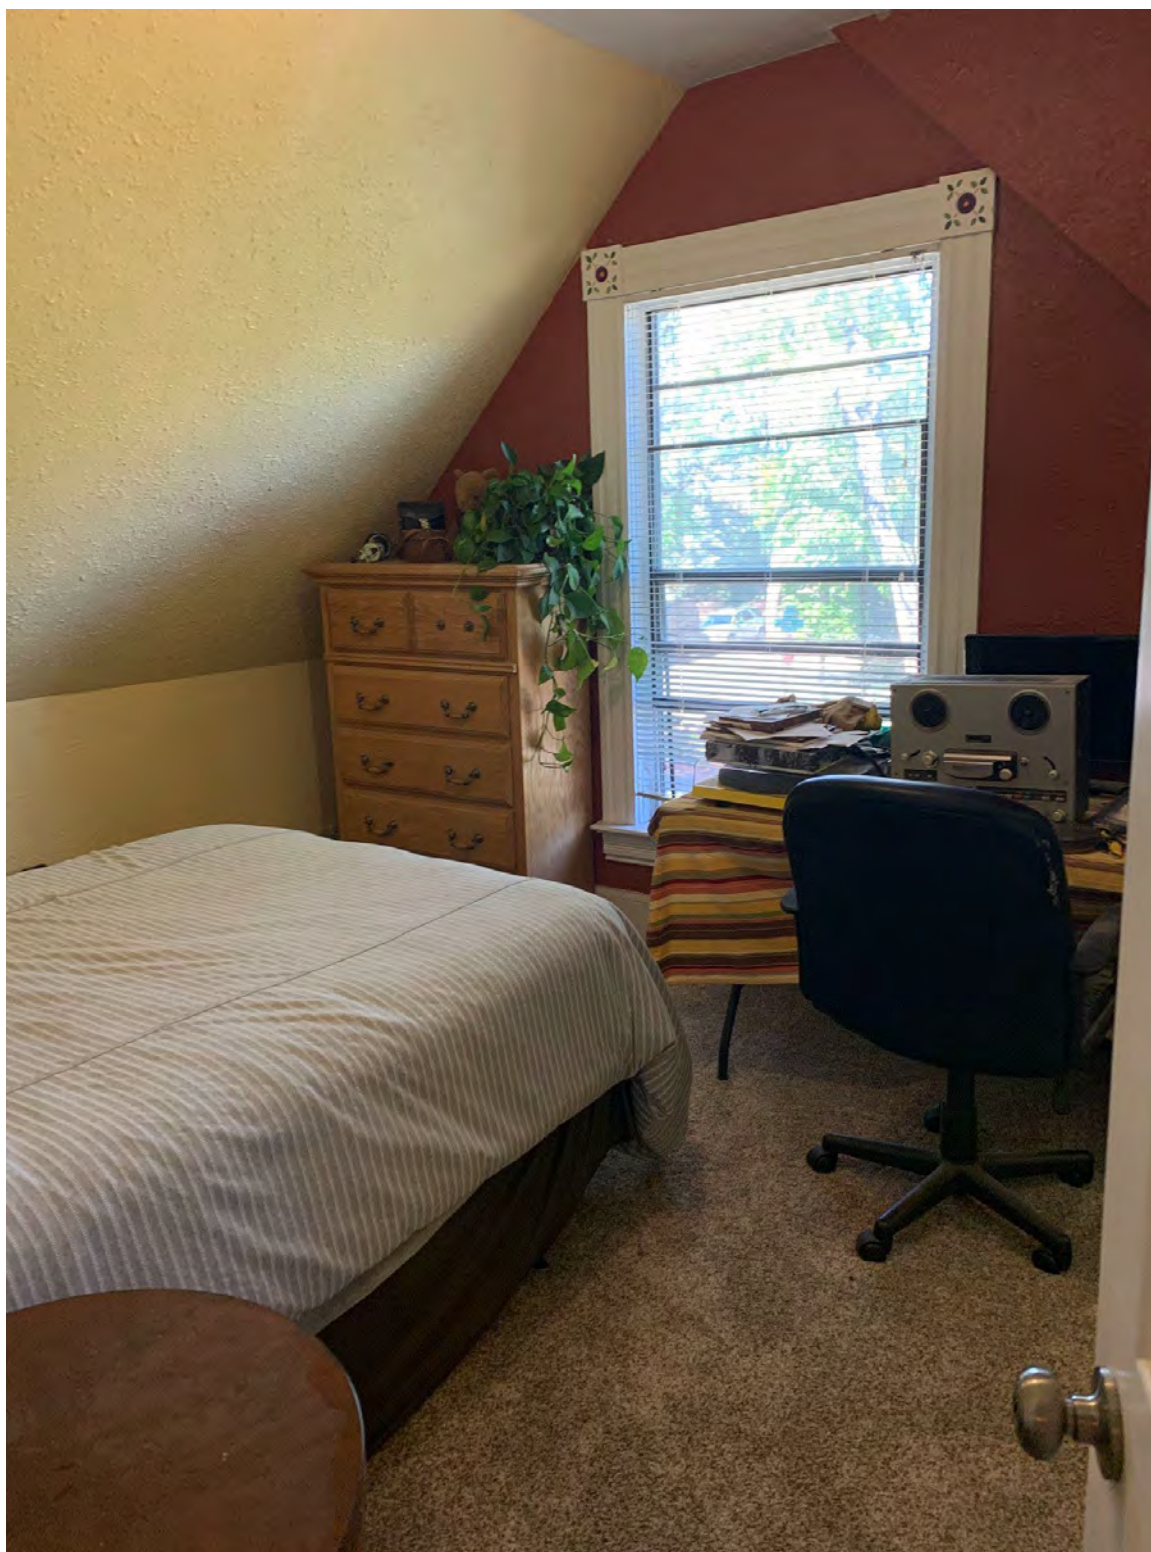
46. Guest bedroom with its large north-facing window with ornamental trim and molding. Note the impact of the sloped roofline. Photo taken September 26, 2022.

The spare bedroom features sloping ceilings resulting from the front facing gabled roofline. The room includes an entry door with its original glass transom window, one small closet, one small north-facing box-window, and one medium north-facing window. The original decorative trim and molding found on the first floor is present in this room, as well as the original baseboards. A rectangular build-out on the west wall runs floor to ceiling, concealing the original chimney flue.

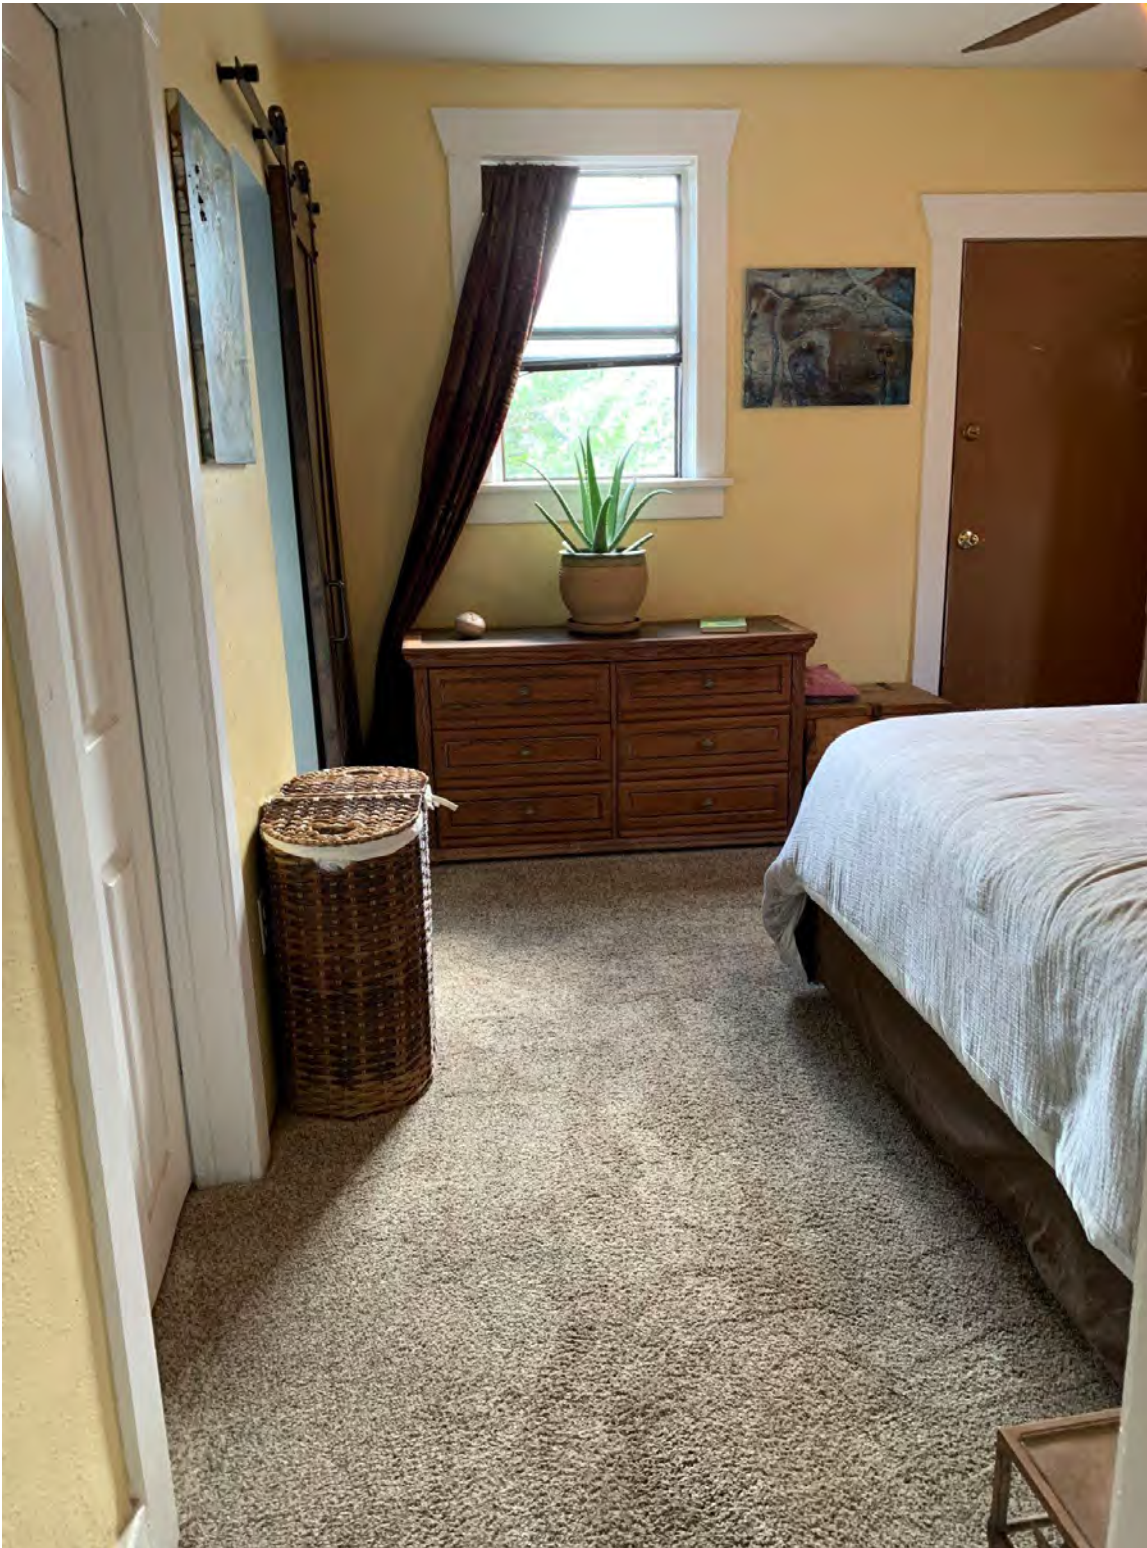
49. View from the doorway into the main bedroom with its south-facing window. The wood door to the right leads to the balcony. To the left is the closet door and the bathroom barn door. Note the very clean trim work, compared to the ornamentation found in other rooms of the house. Photo taken September 14, 2022.

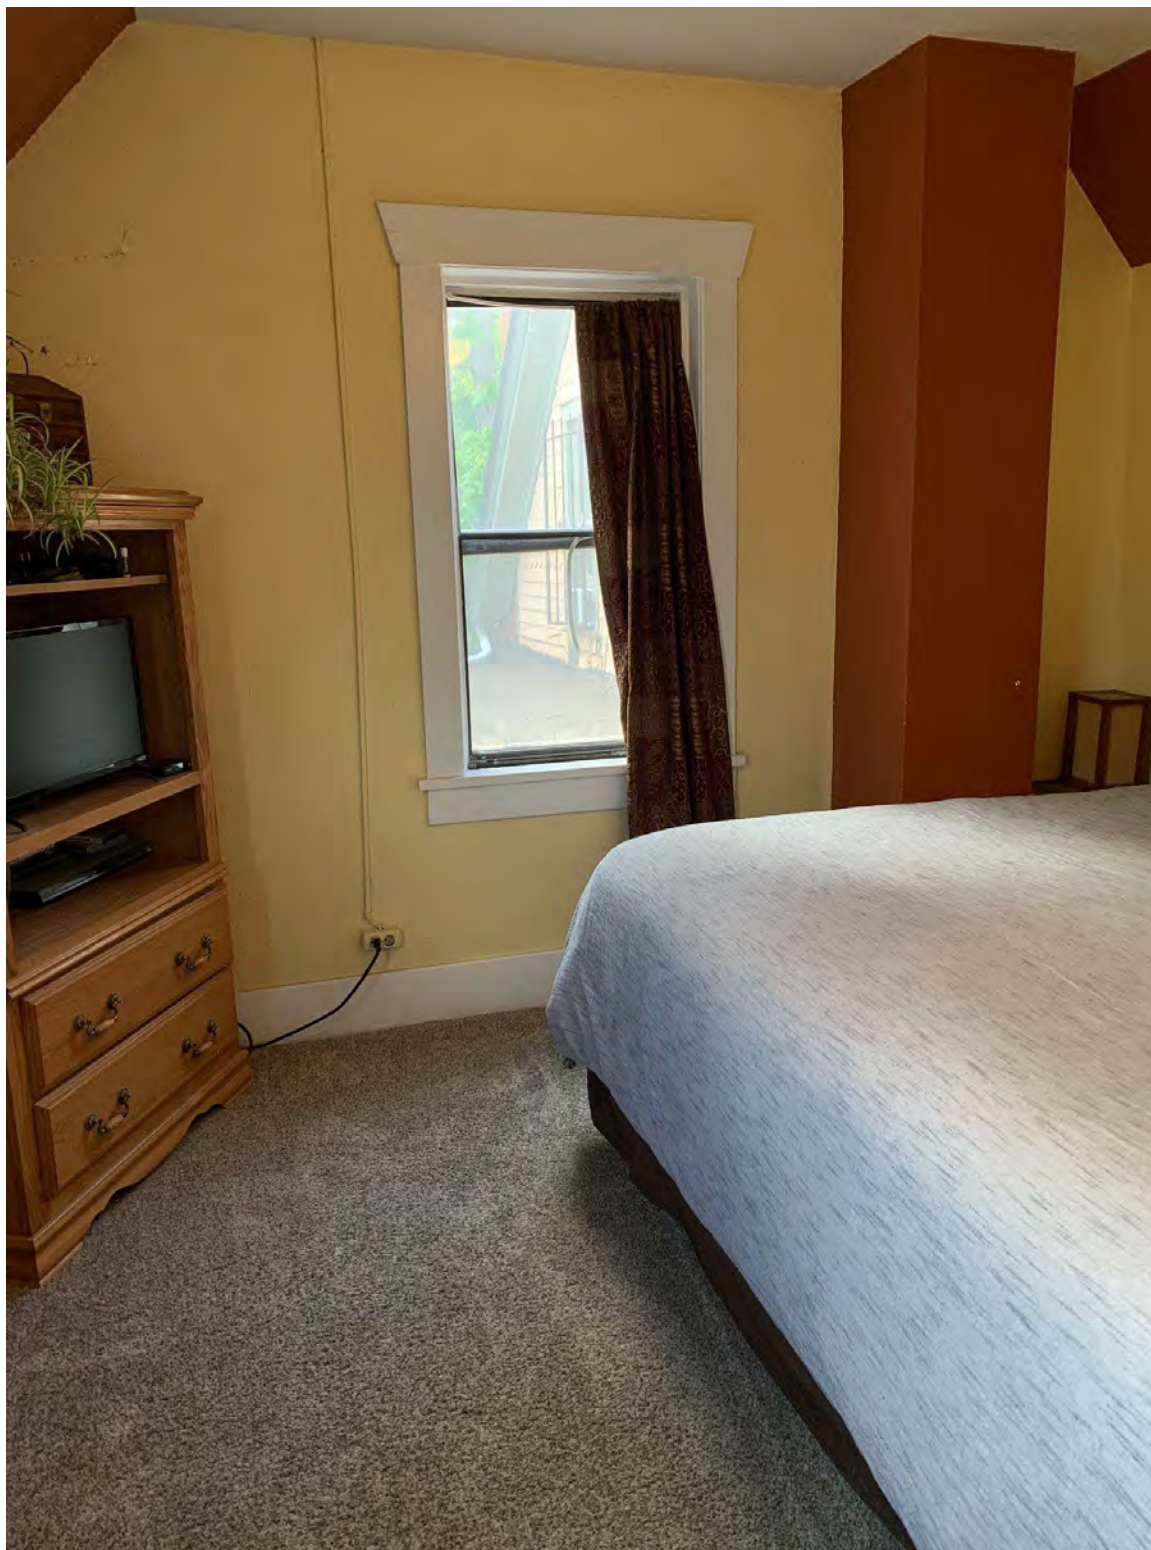
50. Main bedroom west-facing window. Note the sloping roofline of the cross-gable in the upper corners, and the vertical kitchen stove chimney flue buildout continued from the first floor. Photo taken September 14, 2022.

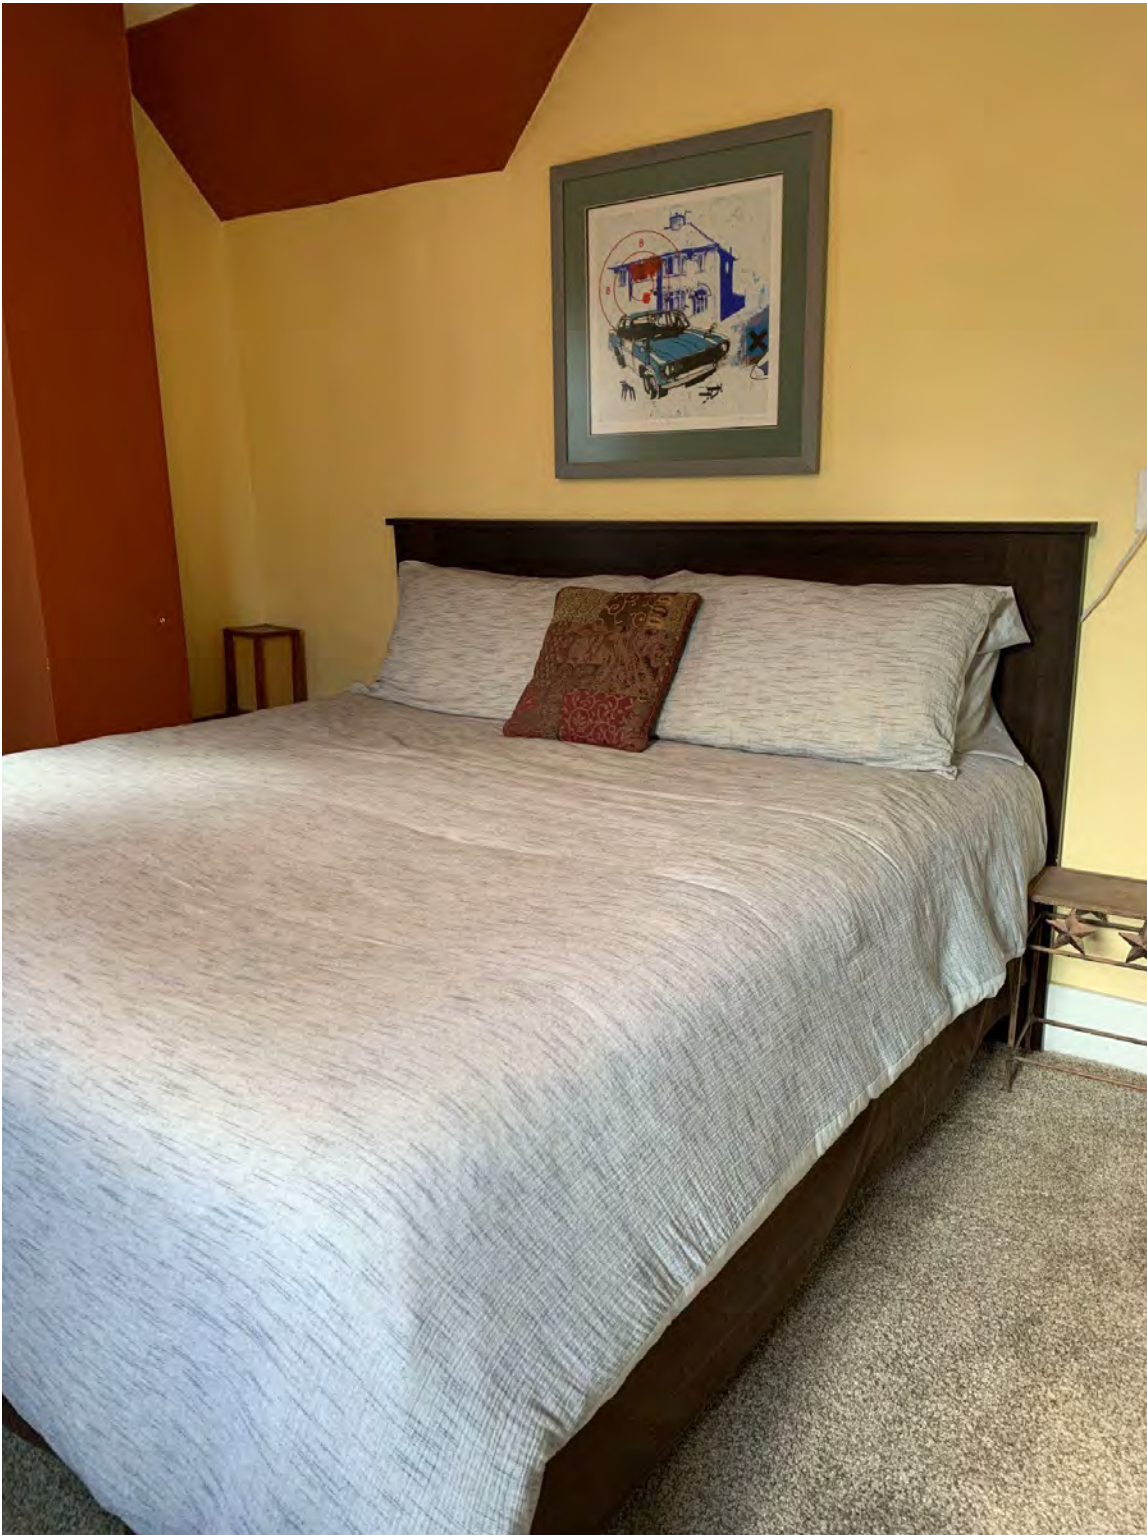
51. Main bedroom with chimney buildout and sloping roofline. Photo taken September 14, 2022.

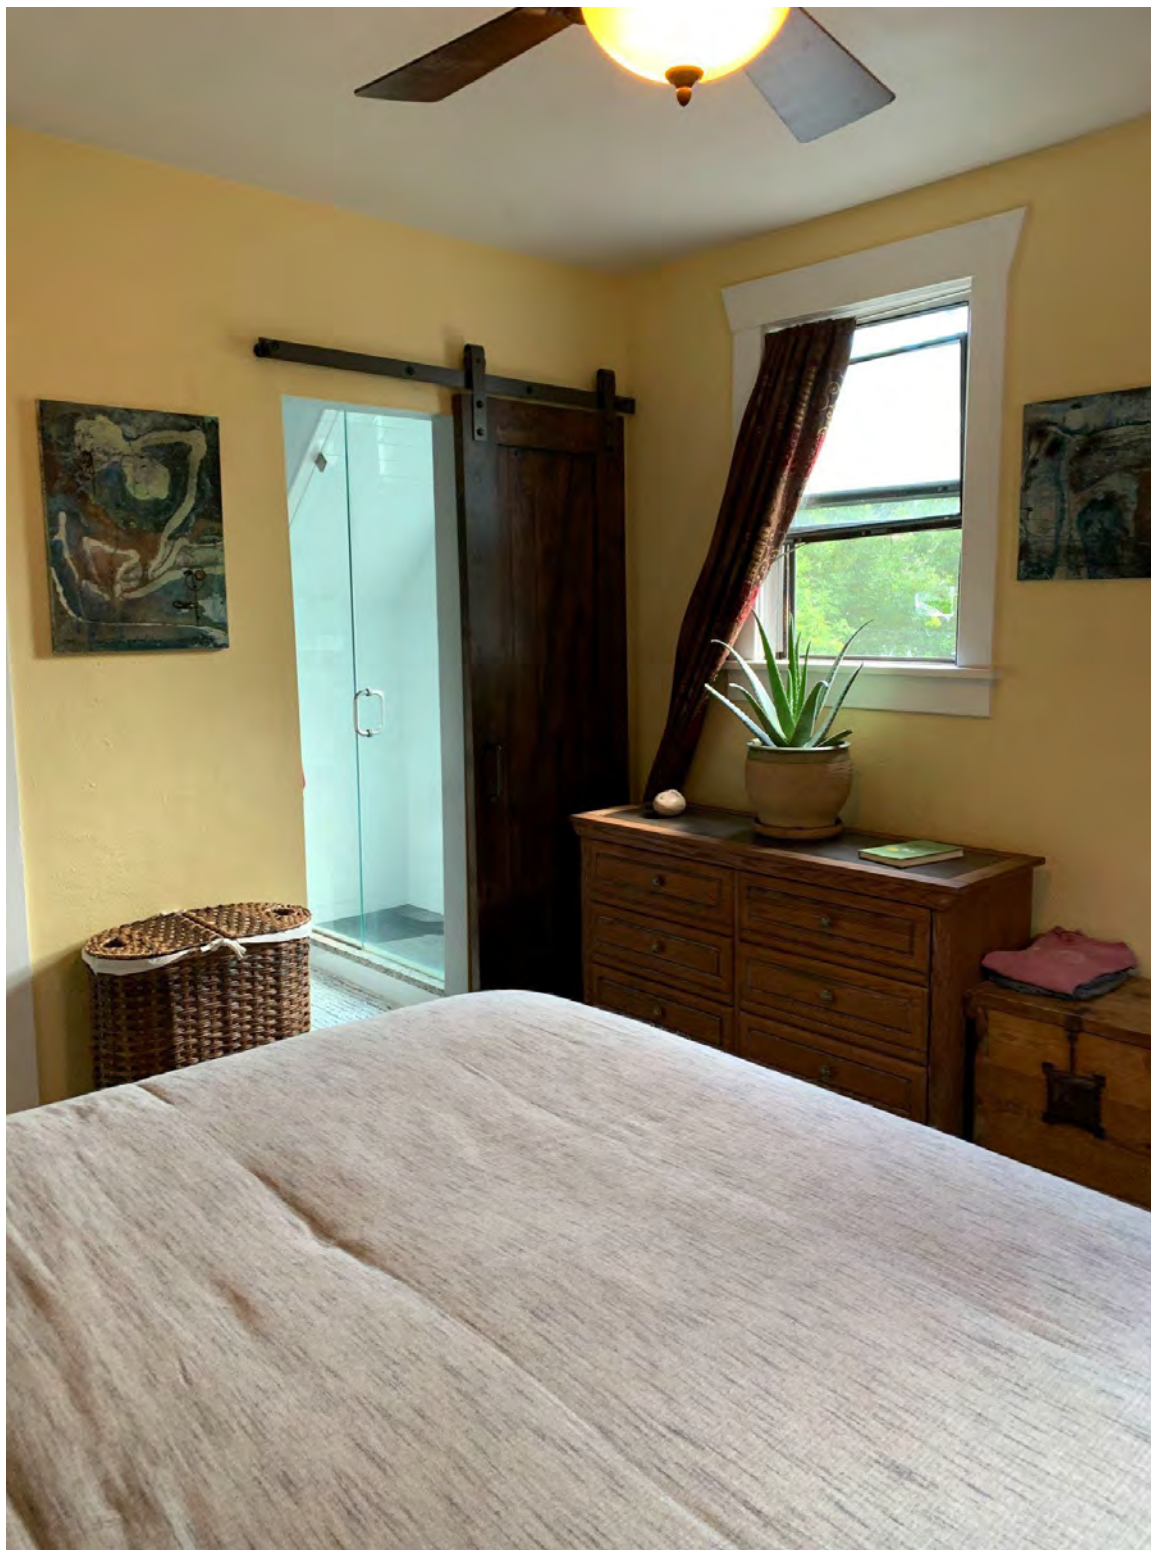
53. Main bedroom south-facing window and barn door leading to the bathroom. Photo taken September 14, 2022.

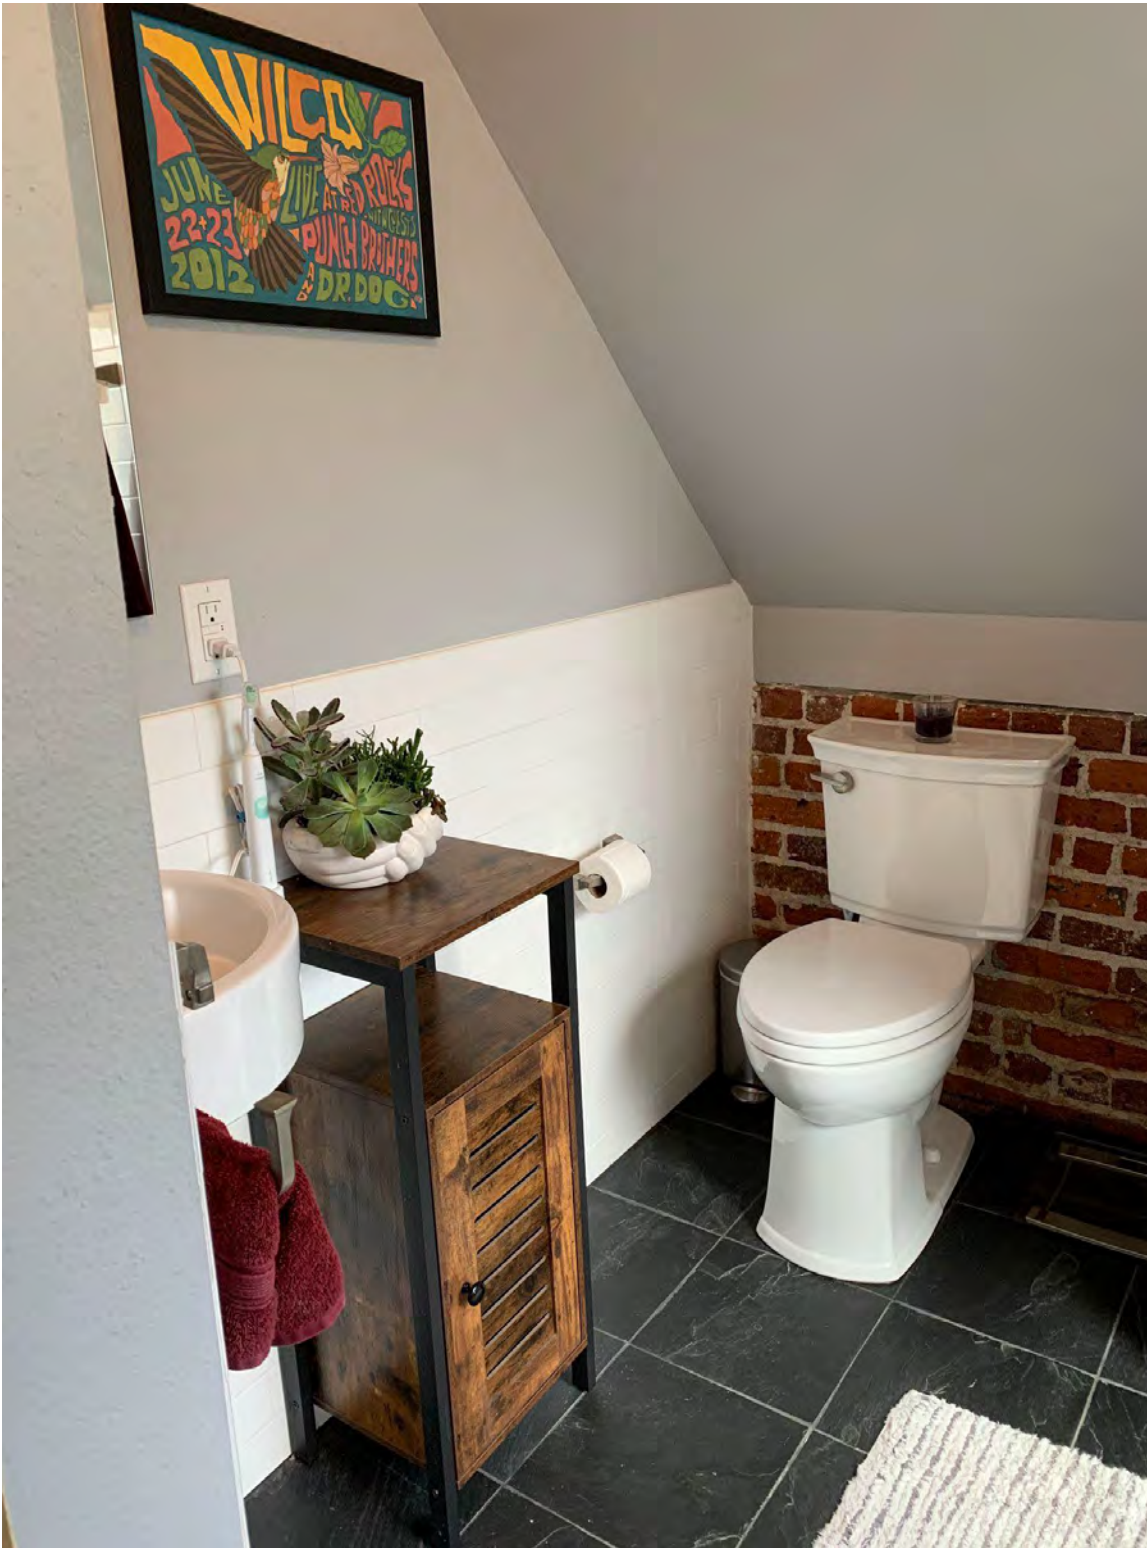
54. Main bathroom renovated in ca. 2019. Note the red brick exposed during construction. Photo taken September 14, 2022.

The main bathroom was entirely rebuilt in 2019. Due to terminal water damage and mold, the entire floor, subfloor, and plumbing were replaced. Some water damaged drywall facing was removed behind the toilet, exposing the historic red brick wall backing. The ceiling is standard height, and slopes with the roofline. The floors are black slate tile, and the walls are predominantly white subway tile, with a custom cut-glass shower partition. The toilet, sink, shower, and light fixtures are all contemporary. One sliding, double-paned privacy box window was installed with a rebuilt wood frame in 2019.
