COLORADO STATE REGISTER OF HISTORIC PROPERTIES NOMINATION FORM

Historic Name Wilson & Hersperger House

Street Address 2254 West 34th Avenue

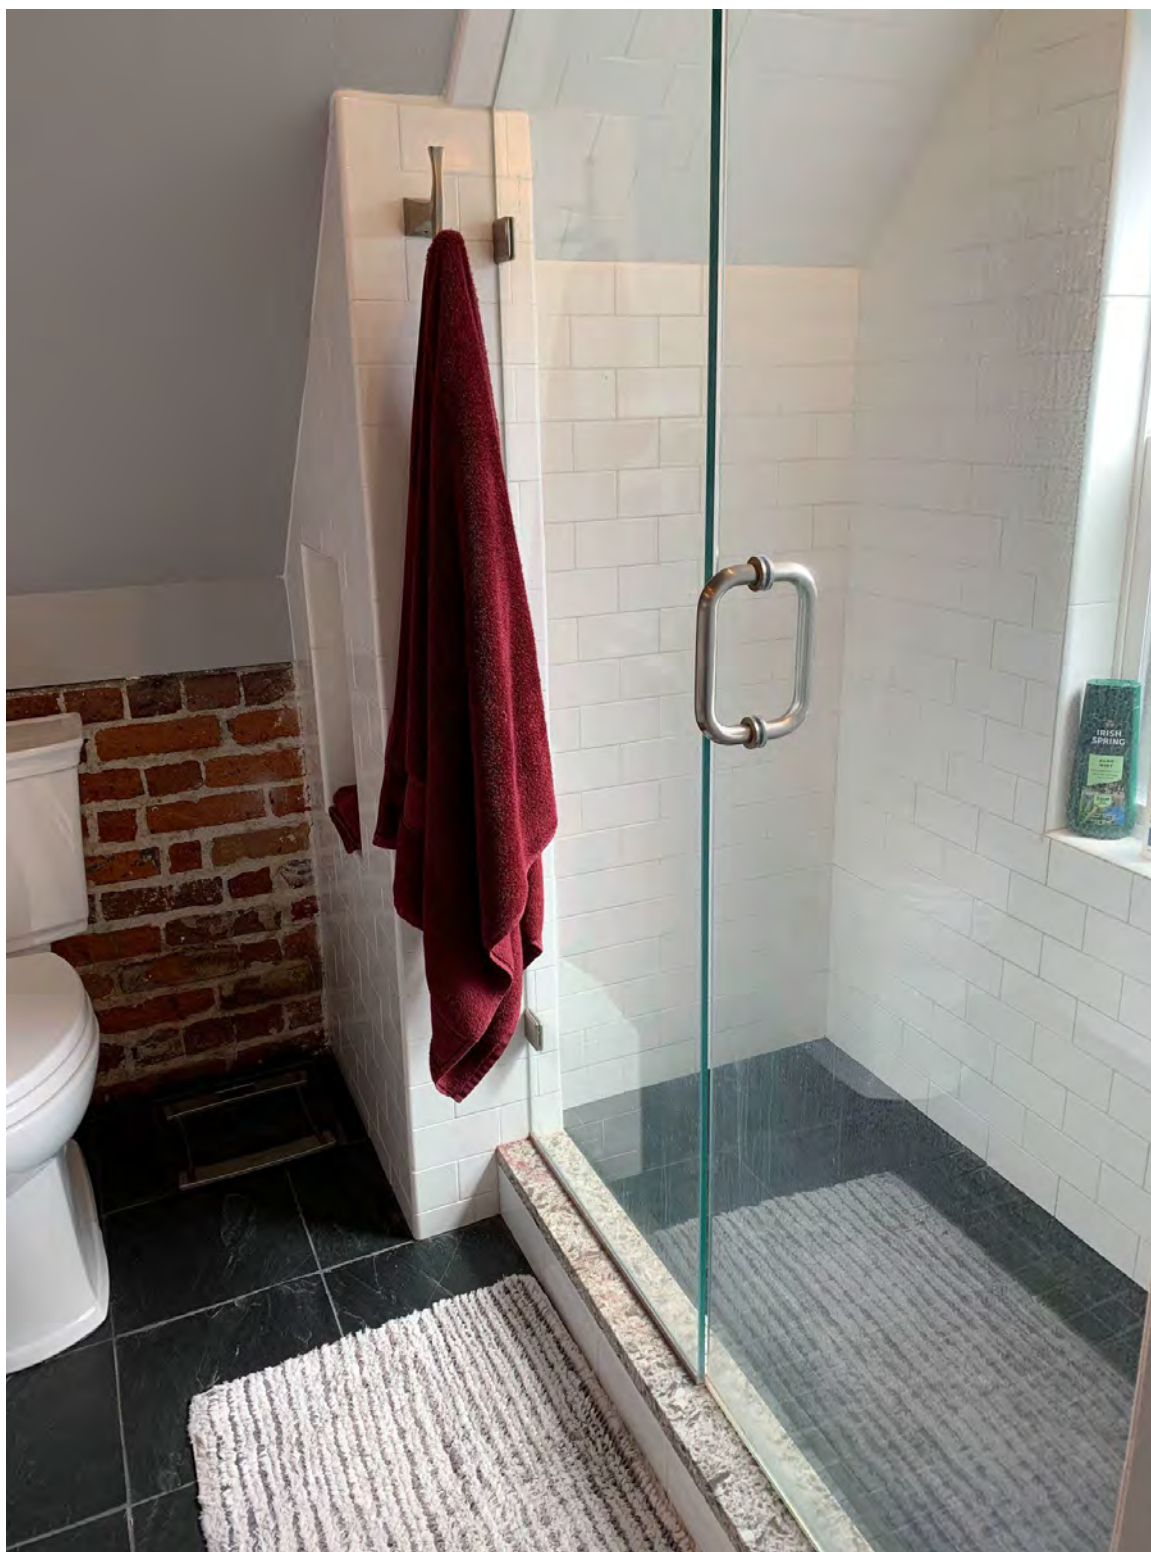
55. Main bathroom renovated in ca. 2019 with west-facing privacy window to the right. Photo taken September 14, 2022.

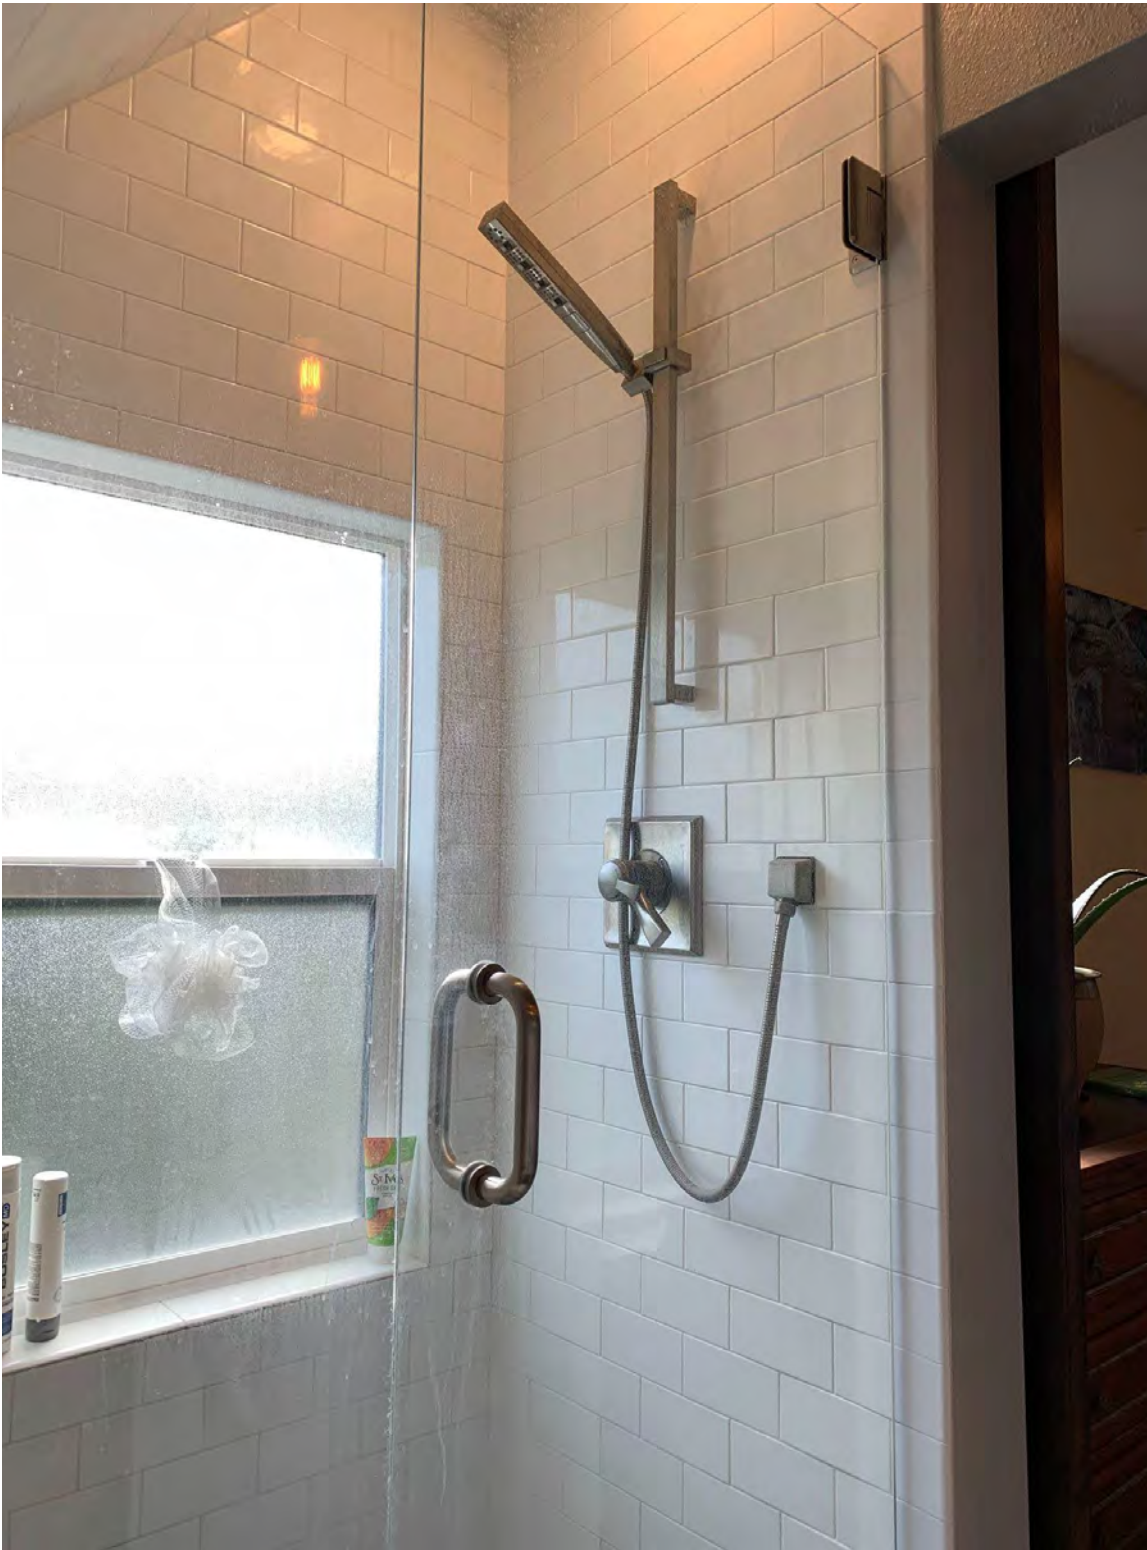
56. Main bathroom west-facing privacy window and subway tile. Photo taken September 14, 2022.

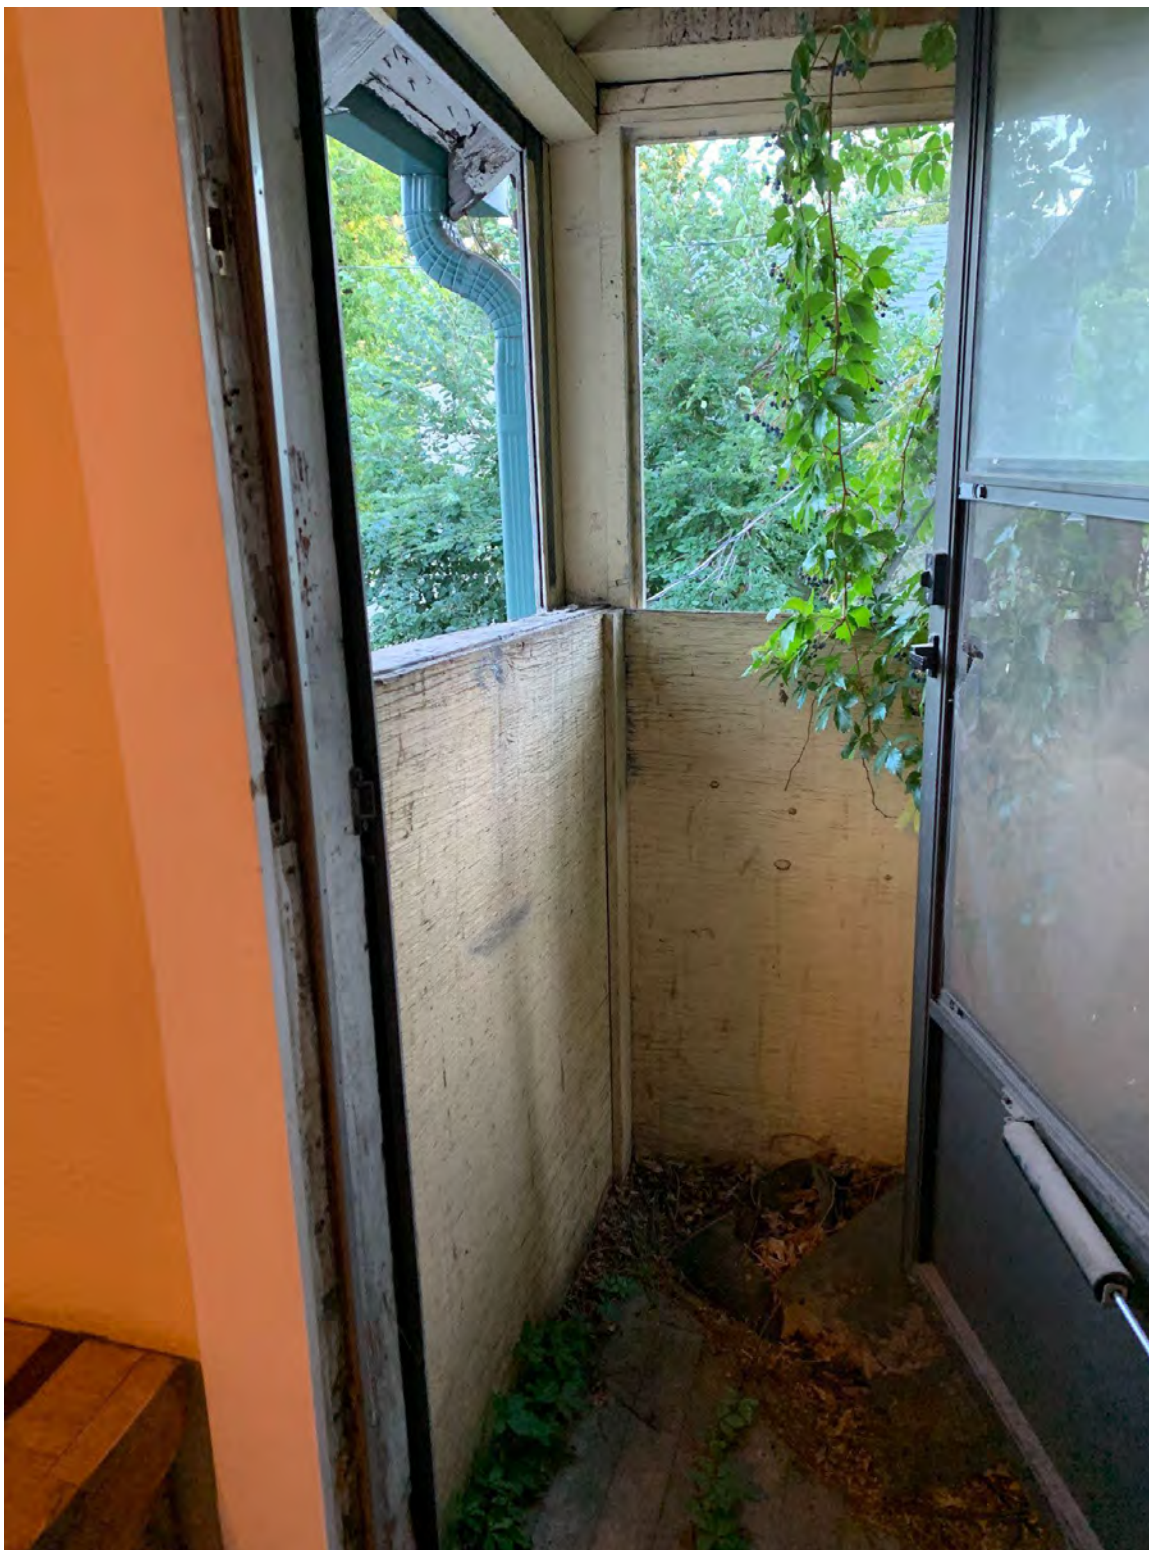
57. View of the covered 4' x 6' balcony porch from the main bedroom. Note the once screened-in windows. The balcony is currently unsafe for use. Photo taken September 26, 2022.

An attached Juliet balcony features a gabled dormer with asphalt roof and an exterior light attached. Screened windows open on each side of the 2in. x 4in. wood construction with painted particle board walls. The balcony can support weight, but is beginning to slouch and separate from the main house, thus deeming it unsafe for daily use.
