History Colorado State Historical Fund Grant Application

Grant Type: **Mini**
Repeat Application? **No**
Project Type: **Acquisition and Development**
Project Title: **Exterior Rehabilitation and Construction Documents**

Property Historic Name: **Star Hook & Ladder Co.-Georgetown City Hall**
Historic Designation: **National Register of Historic Places**
Designation Area: **Historic District**
Historic District: **Georgetown Silver Plume National Historic Landmark District**
Property Address: **404 6th Street**
Georgetown, CO
80444

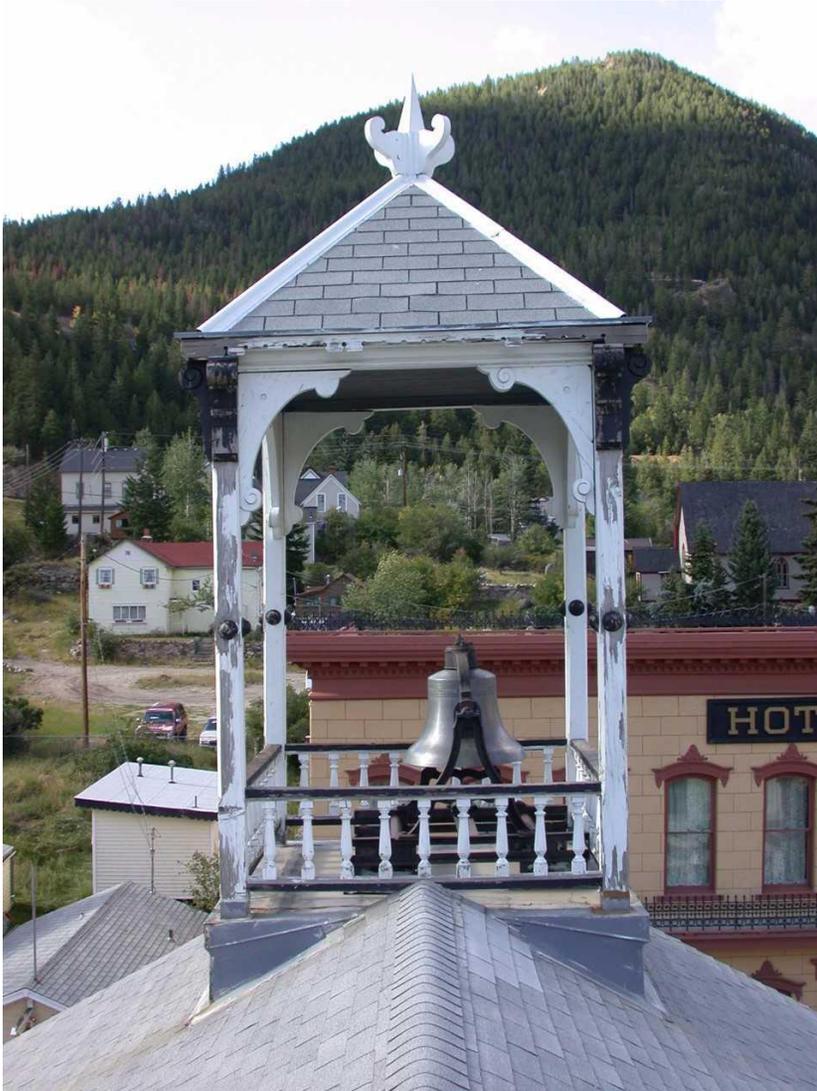
The Star Hook and Ladder's Bell Tower is in poor condition, consisting of a flat platform with no slope and poorly installed sheet metal flashing with open joints at the outside corners of the tower's base

The bell tower has two issues. First the platform on which the bell is placed is flat: no slope. The covering is a single ply membrane roofing which leaks. This is the source of the water damage in the meeting room below. As reported in the HSA "Although the single-ply membrane roofing has been patched to stop the leaks, the platform requires major repair." The HSA further describes that both sheet metal and base flashing was improperly installed. The architects will be providing construction documents to restructure the platform so it slopes, replace the membrane surface and properly complete the flashing. The scope of work anticipates that the bell will be lifted, the existing roof

edging and platform roofing removed, a new sloped deck constructed according to specifications developed by the architects and the bell replaced in position.

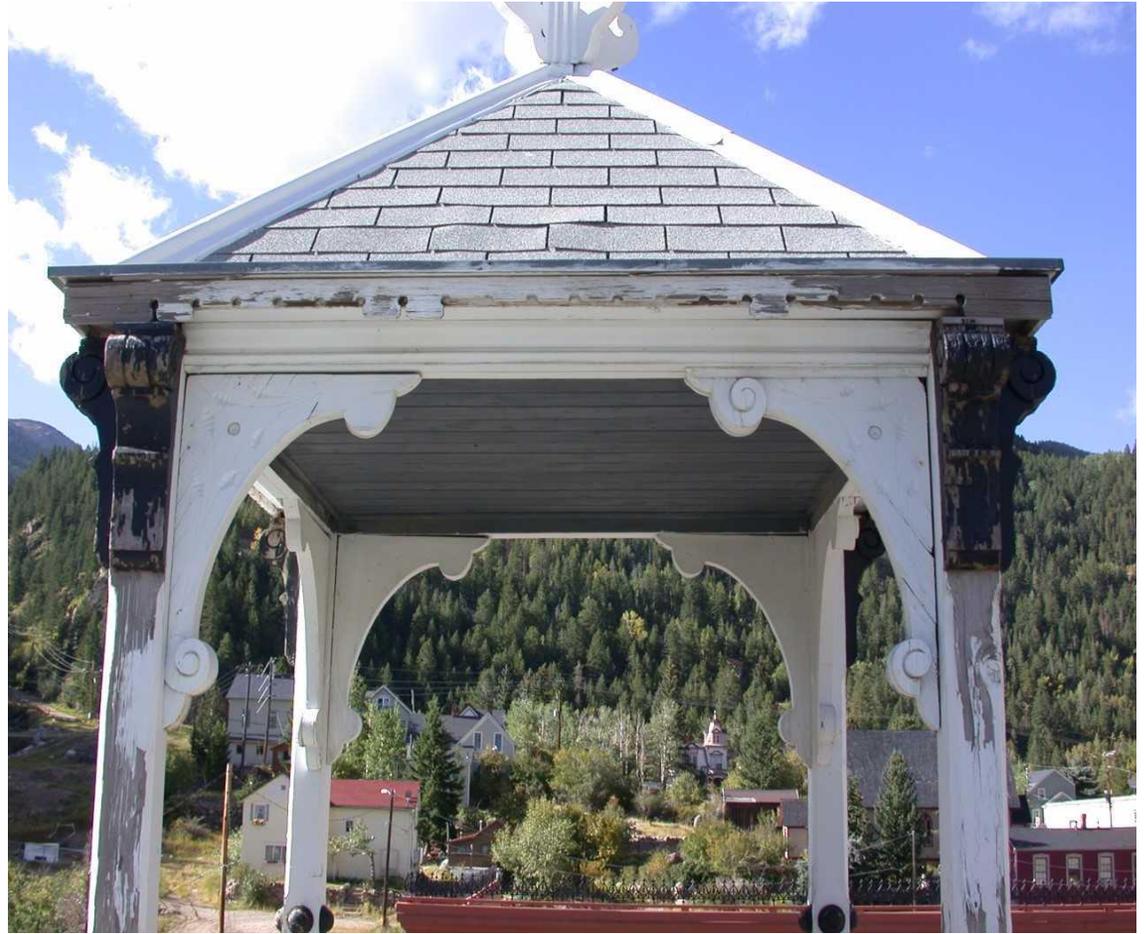
The Bell Tower has many wood components that are deteriorated and need to be repaired or replaced.

Secondly, the tower itself, while structurally sound, has deteriorating wooden elements. Portions of the decorative wood fascia are missing, the balusters and balustrades are deteriorating, and the bead board finish is missing on the vertical sides around the platform. The recommendations of the HSA to remove loose paint from the bell tower, epoxy-repair the wood, clean and apply a clear sealer to the bell yoke, replace the beadboard on the base of the tower and repaint the tower with an historical color scheme will be followed. The general contractor has significant experience with wood restoration of this type. The roof cap of the tower will be re-shingled with laminated asphalt shingles of the type to be used for a later reroofing of the entire building.

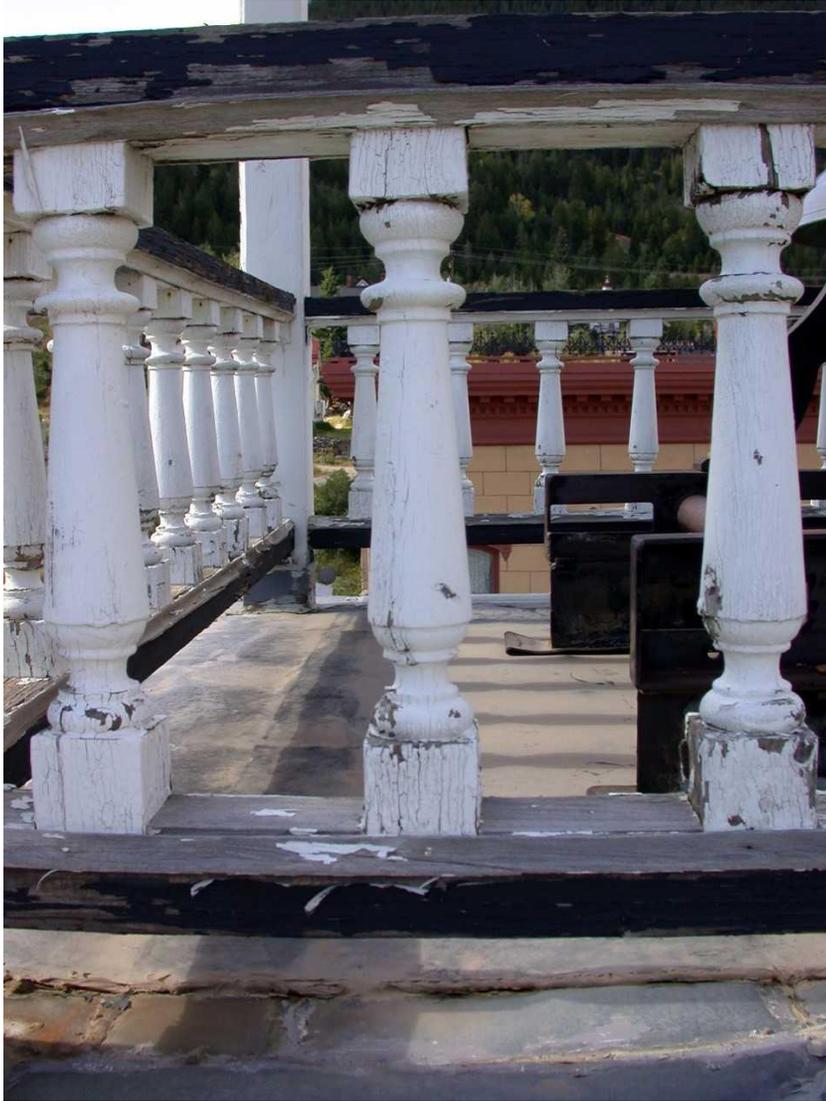
The Tower's balustrade rails are cracked and deteriorated due to water and wind damage.

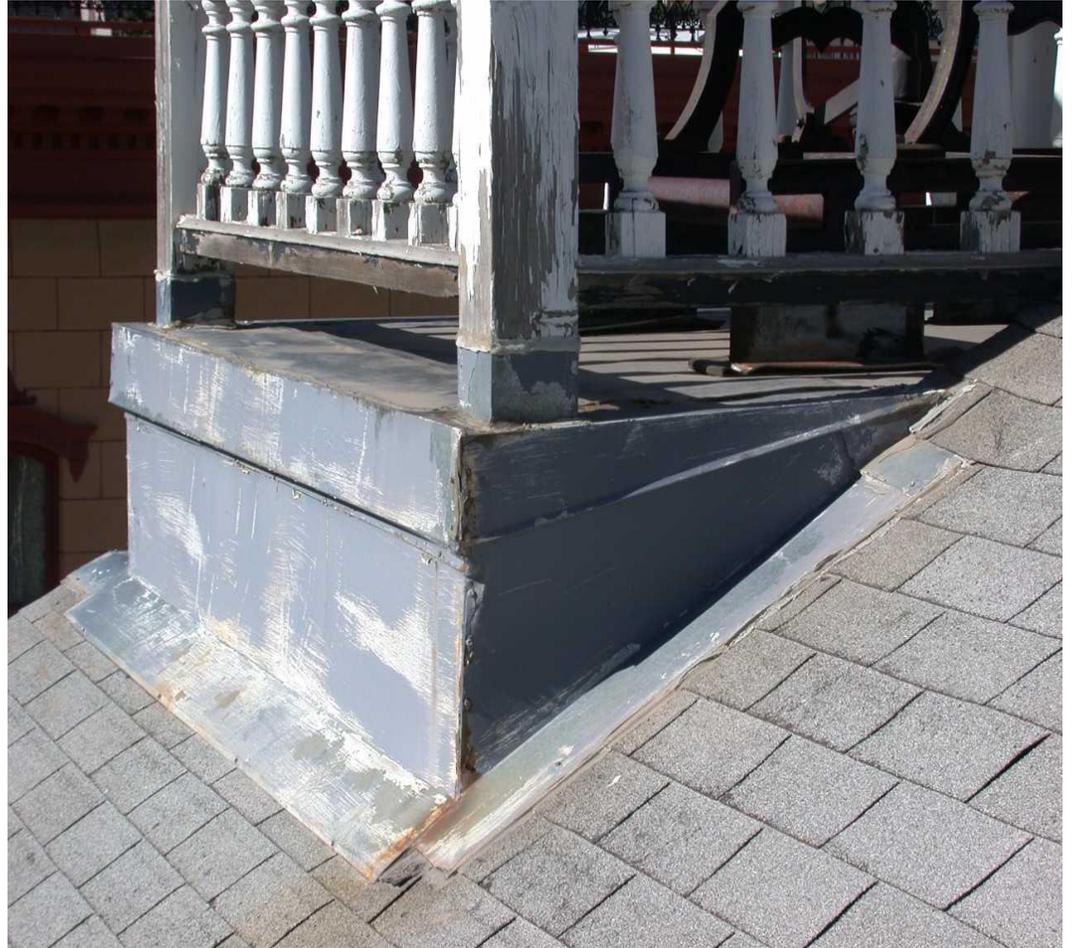
The Tower's platform is failing, due to its single-ply membrane roofing that allows moisture to enter inside.

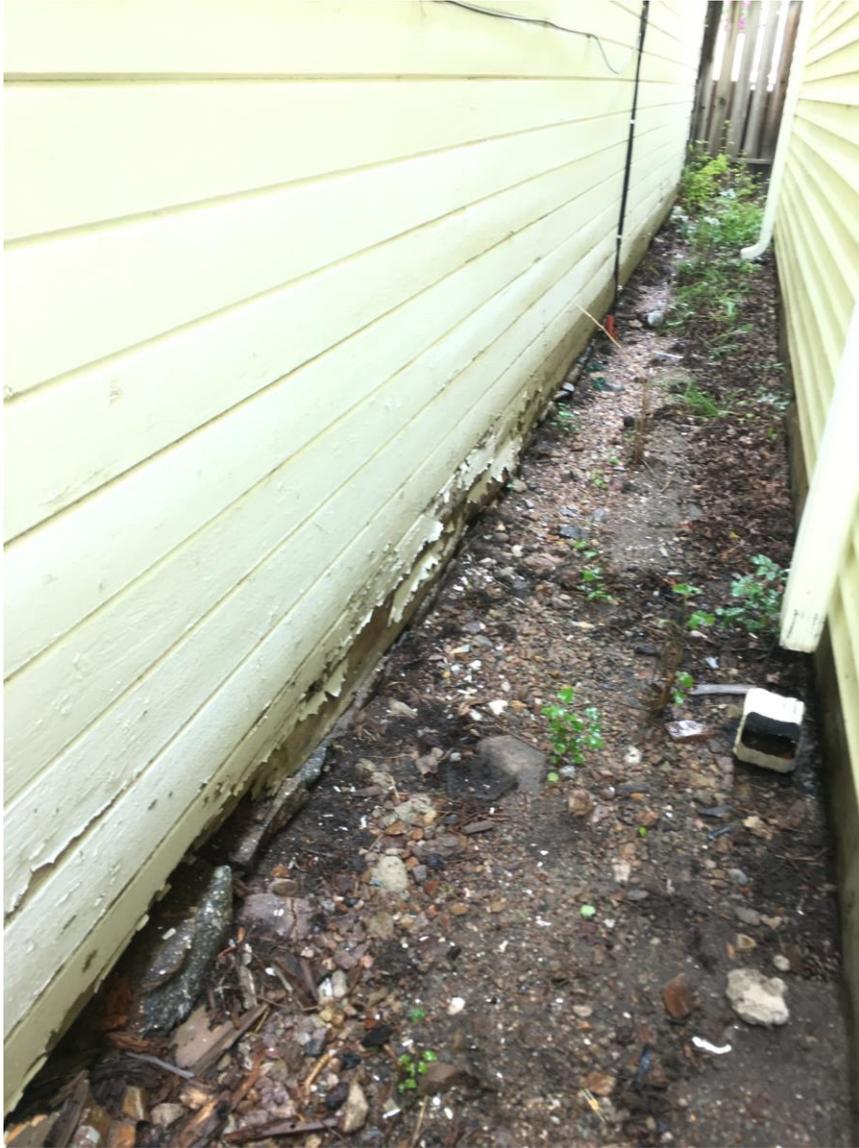
The further construction documents will address the major critical deficiency of the structure: the condition of its foundation and first floor framing. The present foundation is composed of 8 inch square wood grade beams resting on stacked stones. Some of these beams are rotting and, although the building is not in imminent danger, without attention it will be. The stacked stone foundation is not visible from the exterior as it is covered by a skirtboard. The recommendation is that the building foundation be rehabilitated by constructing a new reinforced cast-in-place concrete foundation including mid-span support of the lower level framing system. The new concrete foundation would be also be covered by a skirtboard and not visible from the exterior.

Decay along the foundation beams requiring construction documents.

Construction drawings will also address the drainage issues by designing a perimeter foundation draining system. The CDs will be submitted to SHF for review in draft form and prior to final completion.

The engineering reports and architectural construction documents for the foundation phase will permit the town to adequately prepare to undertake that project . The town offices will need to be relocated and the structure will be lifted. It is both a financial and logistical challenge. The construction documents will allow the Town to estimate and plan.

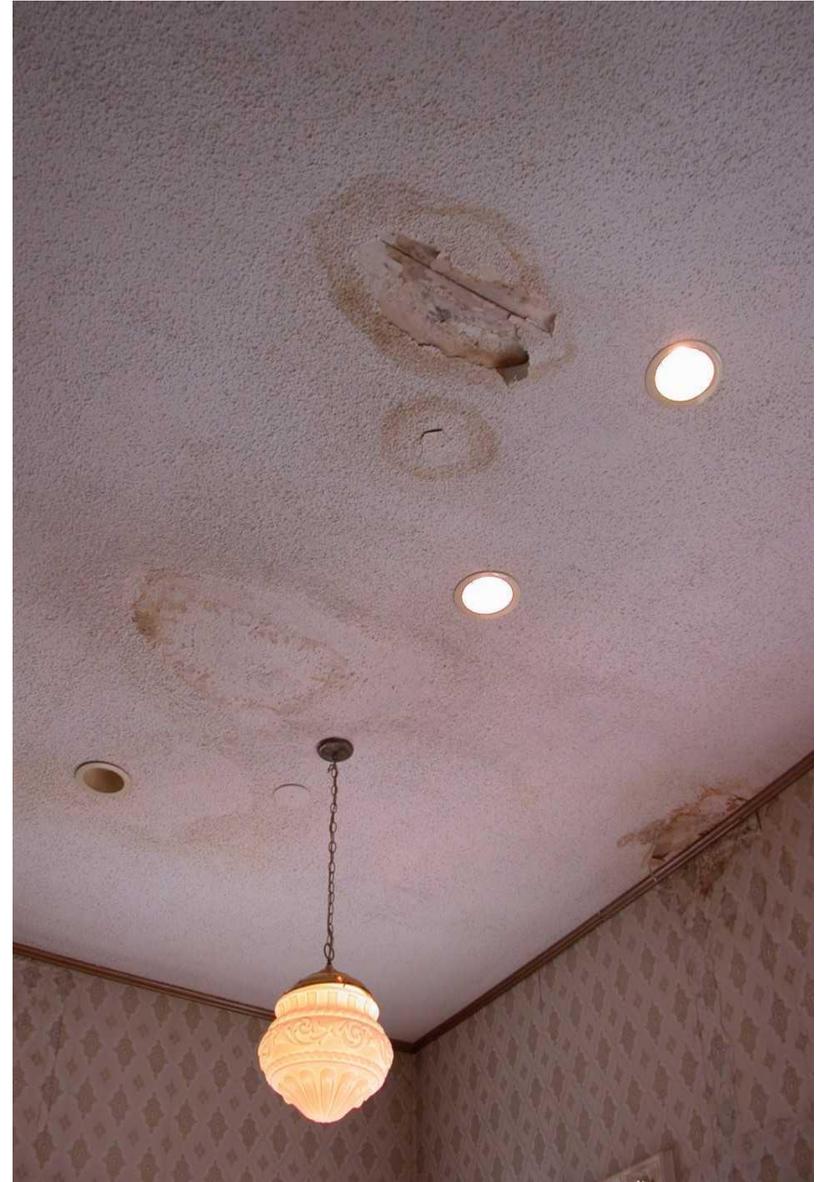
Interior roof deterioration beneath the Bell Tower continues despite patchwork repairs.

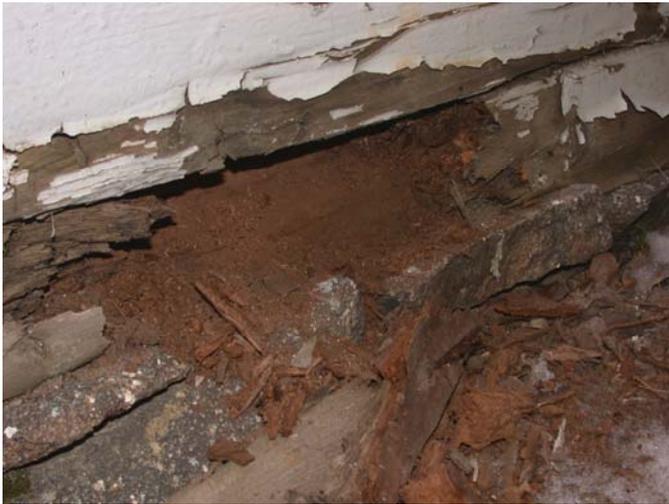
The perimeter foundation consists of wood grade beams, which are approximately 8" square, placed upon stacked stones. The condition of the ground did not allow a complete investigation of the depth of the stacked stones. However, experience suggests that the base of the stones is relatively shallow and not more than 12" below grade. The foundation stones appear to be relatively undisturbed around the entire perimeter of the building and are currently visible only along a portion of the west exterior wall. Along the north and east exterior walls, the bottom of the wood grade beam is approximately level with existing grade and is concealed behind the bottom two rows of wood siding. On the south side of the building, the stone sidewalk slabs prohibit access to the wood grade beam. However, an accessible location on the west side of the building reveals that the wood grade beam is almost completely rotted (Refer to Figure III-4).

Figure III-4. The deteriorated grade beam and wood siding can be seen in this view of the bottom of the west exterior wall.

- Rehabilitate the building foundation by constructing a new reinforced cast-in-place concrete foundation and basement, including mid-span support of the lower level floor framing system. Design the basement to be waterproof, incorporating a perimeter foundation drainage system, a waterproofing membrane, and a sump pit with dual fail-safe pumps. Repair or replace deteriorated main floor and wall framing members. This is a *critical deficiency*.

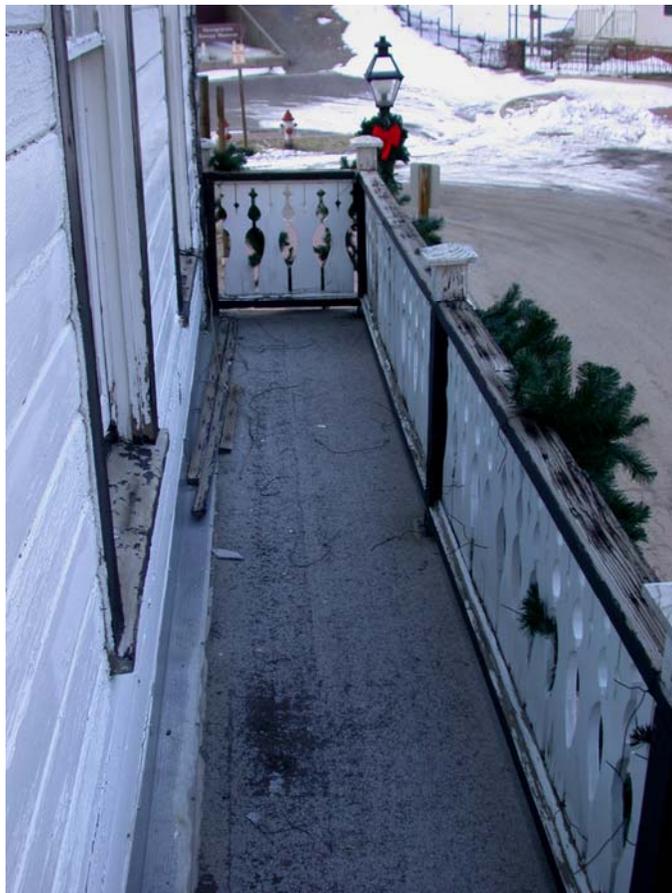
reconstructed balcony is not an exact replica of the original, but its design is in keeping with that of the original. The balcony railing is constructed of wood and its wood-framed floor is covered with bituminous sheet roofing; the reconstruction has four posts across the front, supporting the balustrade, while the original only had three. (Refer to Figure II-3 and II-7.) The balcony is in fair condition: The top and bottom rail of the balustrade are deteriorated and the plywood balusters and balcony floor are showing signs of wear, but the balcony is performing its intended decorative purpose. (Refer to Figure III-9.) The supporting brackets are in good condition, given their location under the balcony and protection from the weather. (Refer to Figure III-10.) *The balcony should be rehabilitated: The balustrade should be reconstructed with three posts across the front, if structurally feasible based upon current building code requirements, and the bituminous sheet roofing on the balcony floor replaced. The supporting brackets should be retained and rehabilitated by removing loose paint, sanding them smooth, and then repainting them in a historical paint scheme.*

Figure III-9. The top and bottom rail of the balustrade are deteriorated. The bituminous sheet roofing is showing early signs of wear.

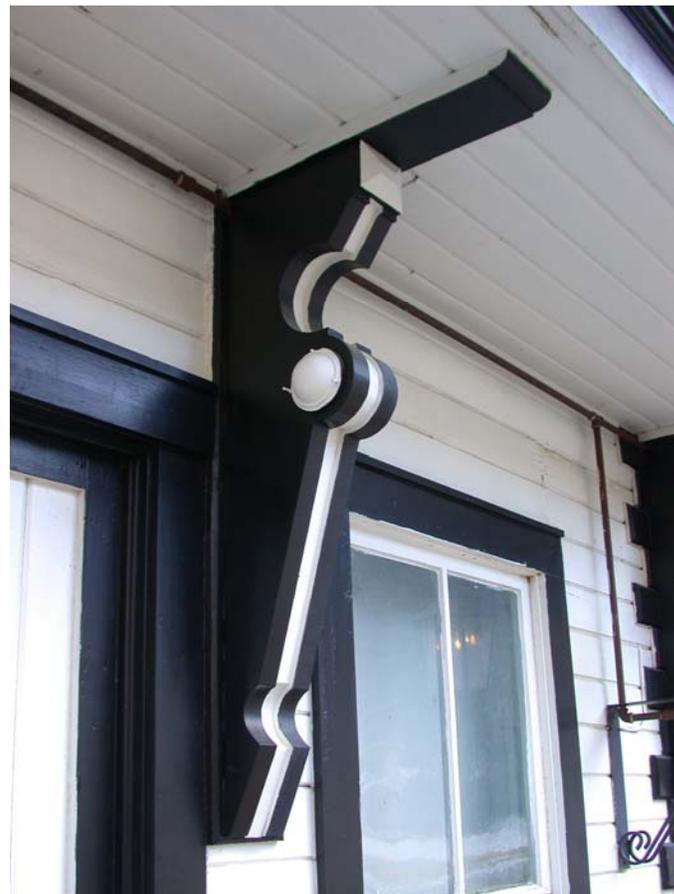
Figure III-10. This wood bracket is original historic fabric and is in good condition, given its protected location under the balcony.

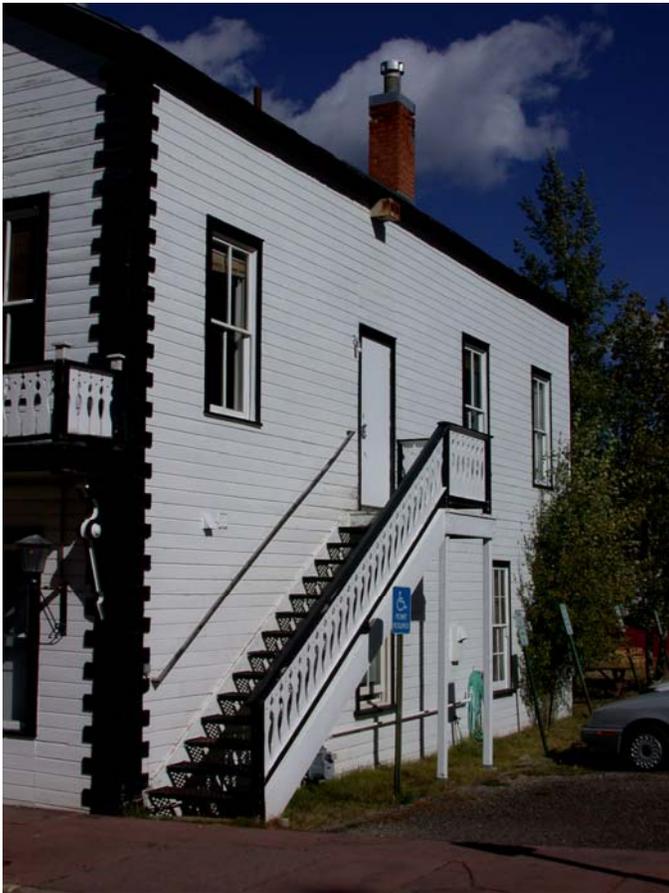
Although not confirmed, the exterior exit stair on the east side of the building was probably added when the second floor was renovated in 1967 for use as a melodrama theater; two exits were required for the space to be building code compliant. The wood-framed stair has a wood landing, open metal stair treads, and a wood balustrade similar in design to that of the south balcony. The stair is in fair condition. Although it is serving its intended purpose, the wood is showing signs of wear. Deterioration is especially noticeable at the upper wood landing. The design of the balustrade, which matches that of the south balcony, is misleading to the casual observer since it suggests that the stair is historic. *The east exterior stair should be rehabilitated by replacing the deteriorated wood at the upper landing and replacing the balustrade with one of a simpler design that is compatible with the historic building.*

Figure III-11. The stair on the east side of the building was probably added circa 1967 when the second floor was used as a melodrama theater. Its balustrade is similar to that of the south balcony.

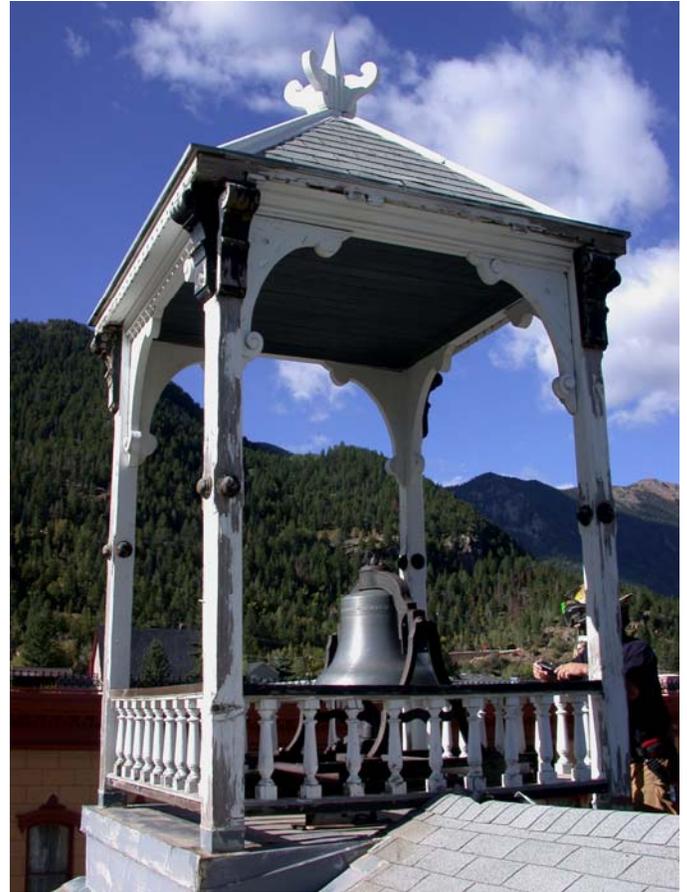
Wood corner posts, with incised wood brackets mounted on all four sides of each post, support a hipped roof with metal ridge caps, topped with a decorative wood finial. (The 1897 photograph of the building suggests that a lantern was mounted on top of the hipped roof. By 1941, it appears that the lantern was replaced with a decorative finial that supported a flag pole.) The roof eaves incorporate a decorative wood fascia. The flat ceiling of the bell tower is finished with tongue-and-groove wood siding, similar to the exterior walls. A low balustrade with turned wood posts surrounds a bell and supporting yoke that are mounted to a raised square platform on the roof. The bell is a Meneely bell, cast in West Troy, New York.

The platform's roof surface consists of single-ply membrane roofing with sheet metal flashing around the perimeter. Study of the early historic photographs of the building suggests that beadboard served as the finish for the two high sides of the platform; it is now replaced with sheet metal flashing. (Refer to the "Exterior Walls – Roofing" section of this assessment for additional information related to the bell tower's platform.)

Figure III-12. The bell tower appears to retain most of its original historic fabric with the exception of the finial and the sheet metal flashing on the sides of the platform.

The bell tower is in fair condition. Although many of the wood components of the tower are deteriorated, the architectural feature is generally structurally sound and performing its intended purpose. Portions of the decorative wood fascia are broken or missing. The top and bottom rails of the balustrade are deteriorated and some of the wood balusters are cracked from water infiltration. The bell yoke is rusty from exposure to the weather. *The bell tower should be rehabilitated by removing loose paint from the bell tower, epoxy-repairing the original wood components or replacing them with matching pieces, where highly deteriorated, and then repainting the bell tower in a historic color*

- Rehabilitate the bell tower by removing loose paint from the tower, epoxy-repairing the original wood components or replacing them with matching pieces, where highly deteriorated, and then repainting the bell tower in a historic color scheme. Protect the bell yoke from further deterioration by cleaning the metal and then applying a clear sealer that protects the yoke from corrosion. This is a *critical deficiency*.

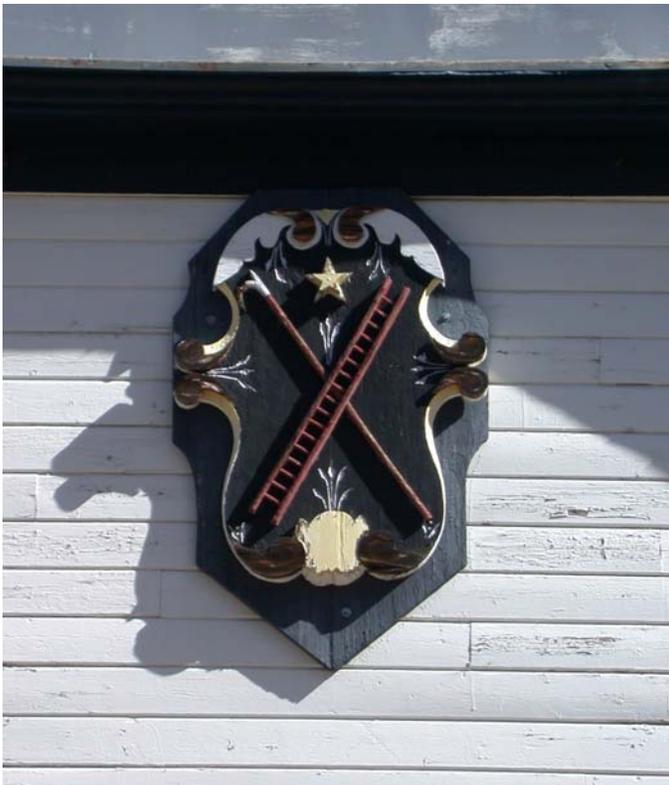
The wood shield, which is mounted at the top of the south wall, appears in the earliest available photograph of the building from 1897. (Refer to Figure II-7 on page 10.) Similar to the bell tower, the shield is missing in the photograph of the building in the Centennial Gazette, published in 1968. It is not known whether the historic shield was removed for restoration when the photograph was taken or whether the current shield is a replacement. (The historic plaque on the front of the building states that the shield was reconstructed.) The wood mounting plate appears to be a replacement but the shield's detailing suggests that it is original historic fabric; however, this could not be confirmed. The shield is in fair condition; it is an important architectural feature that should be preserved. When the siding is rehabilitated, the shield should be removed so that it can be repaired, if required, and paint samples can be removed for color analysis. *The shield should be preserved by epoxy-repairing any deteriorated wood, resecuring any loose elements that are applied to the face of the shield, and repainting the shield in its original historic colors, if evidence of these colors exists today.*

Figure III-13. The Star Hook and Ladder Company shield is mounted at the top of the building's south wall.
