National Register of Historic Places Registration Form

Historic name: Ute-Ulay Mine and Mill

Other names/site number: 5HN.77

Name of related multiple property listing: The Mining Industry in Colorado; Hinsdale County Metal Mining

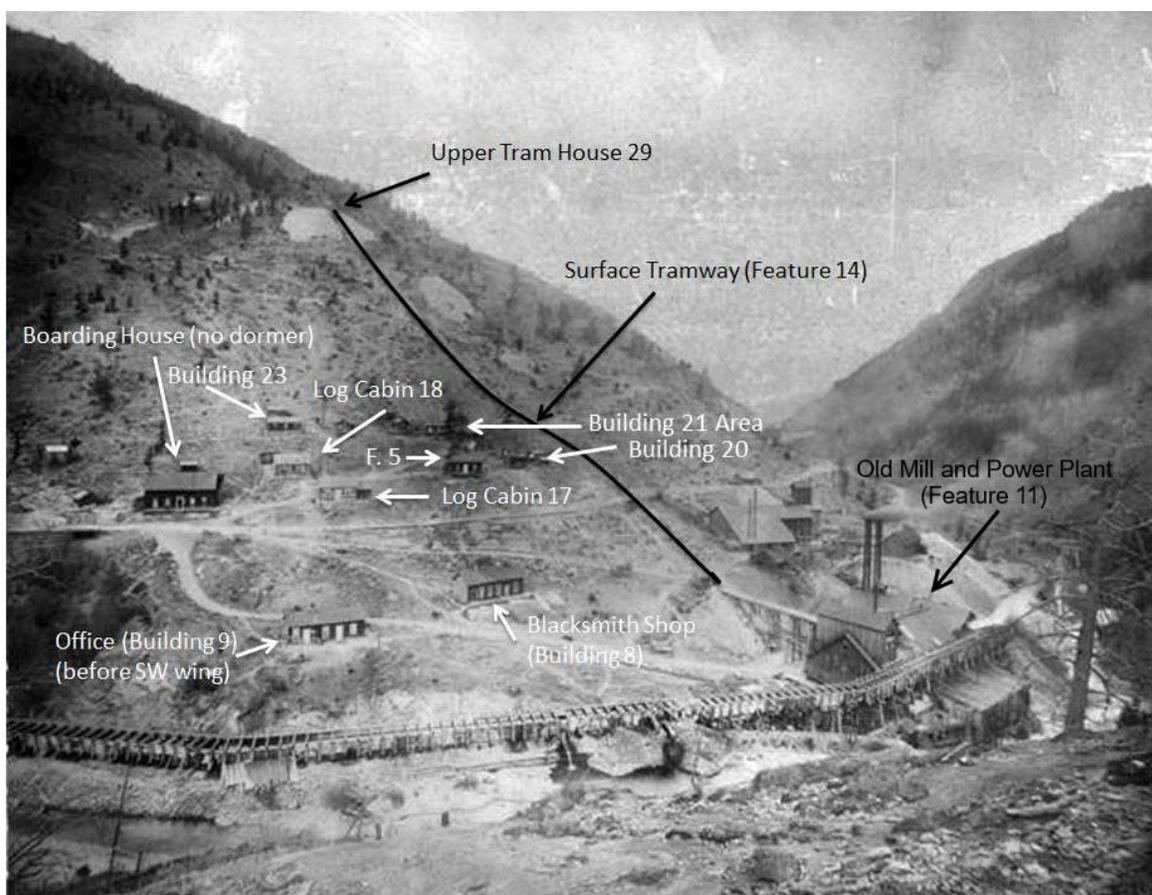
Figure 1. 1880s photograph of the Ute-Ulay Mine and Mill noting elements that have survived to the present day. The mill at the lower right was replaced by the current mill in 1930 with its lowest portion used as a power plant until 1951; portions of the mill are still visible today. Other industrial buildings in the eastern portion of the district to the right in the photo have been obliterated and replaced with more recent, but historic, elements. The flume along Henson Creek at the bottom of the photo was replaced in 1926 with the current flume that is extant today. Several of the buildings shown on the slope to the left of the tramway are represented by archaeological remains.

The building is in excellent condition and remarkably unmodified from its construction in the early 1880s (Figure 1). The noted siding and window installations may have been done in the 1890s and are noticeable only because of the use of wire nails. Installation of electrical wiring elements is also a historic modification, probably from the 1920s. Removal of the windows, presumably by Environmental Demolition, Inc. during remediation in 2013, is a temporary measure and they will be reinstalled after they are restored. The covering of the roof with corrugated sheet metal by HistoriCorps in 2016 is an expedient measure necessary to economically put a roof on the building to prevent its deterioration. Although not of original materials, the roof retains its original configuration. Covering of the door and window openings with plastic sheeting in 2013, is an expedient measure to keep moisture from entering the building and will be removed when the doors and windows are reinstalled. Historic Photo 8 shows the building in 2001.

The building is in very good condition and remarkably unmodified from its construction in the early 1880s (Figure 1) and the construction of the second wing probably in the 1890s or early 1900s. Installation of electrical wiring elements is also a historic modification, probably from the 1920s. Work conducted on the building in 2015 by HistoriCorps included roof repair, lifting and resupporting a corner of the building, and removal of soil accumulation along two of the walls. These actions have arrested ongoing deterioration. Removal of doors and windows, presumably by Environmental Demolition, Inc. during remediation in 2013, is a temporary measure and they will be reinstalled after they are restored. Covering of the door and window openings and a portion of the roof with plastic sheeting is an expedient measure to keep moisture from entering the building and will be removed when the doors and windows are reinstalled and final repair of the roof is made. Historic Photos 9 and 10 show the building in 2001.

The boarding house was built in the 1880s (Figure 1) has seen reuse as a residence and a bunkhouse but is remarkably intact. Historic modifications can be noted by the use of wire nails, whereas the original construction is evident because of the use of cut nails. In addition, the dormer on the southwestern side is not shown in the 1880s photograph (Figure 1) and was probably added in 1926. The sheet-metal roofing is not original; it was probably covered with a shingle roof when built. The current composition roll siding was probably a modification made during the 1950s, but the original vertical-board siding is still present beneath it. Most of the window sashes have been removed from their frames, presumably by Environmental Demolition, Inc. during remediation in 2013, and are in storage awaiting restoration and reinstallation. All of the doors and windows appear to be original. In 2001, the central entry on the southwestern side was covered with a corrugated sheet metal shed roof, angle-braced from the building; this is no longer in place.

The log cabin residence is in remarkably good condition and is virtually unmodified from its original construction in the early 1880s (Figure 1). The original shingle roof of the main cabin was covered with sheet metal roofing within the last 15 years. The shed addition is probably a historic early 1900s addition.

The log cabin residence is in remarkably good condition and is virtually unmodified from its original construction in the early 1880s (Figure 1). The only visible modification is the roofing material, which was originally probably wood shingles, but has since been covered with standing-seam metal roofing installed after 2001 over earlier composition roll roofing that was probably installed in the 1950s. The inscription in the cement daubing suggests that it dates to 1980.

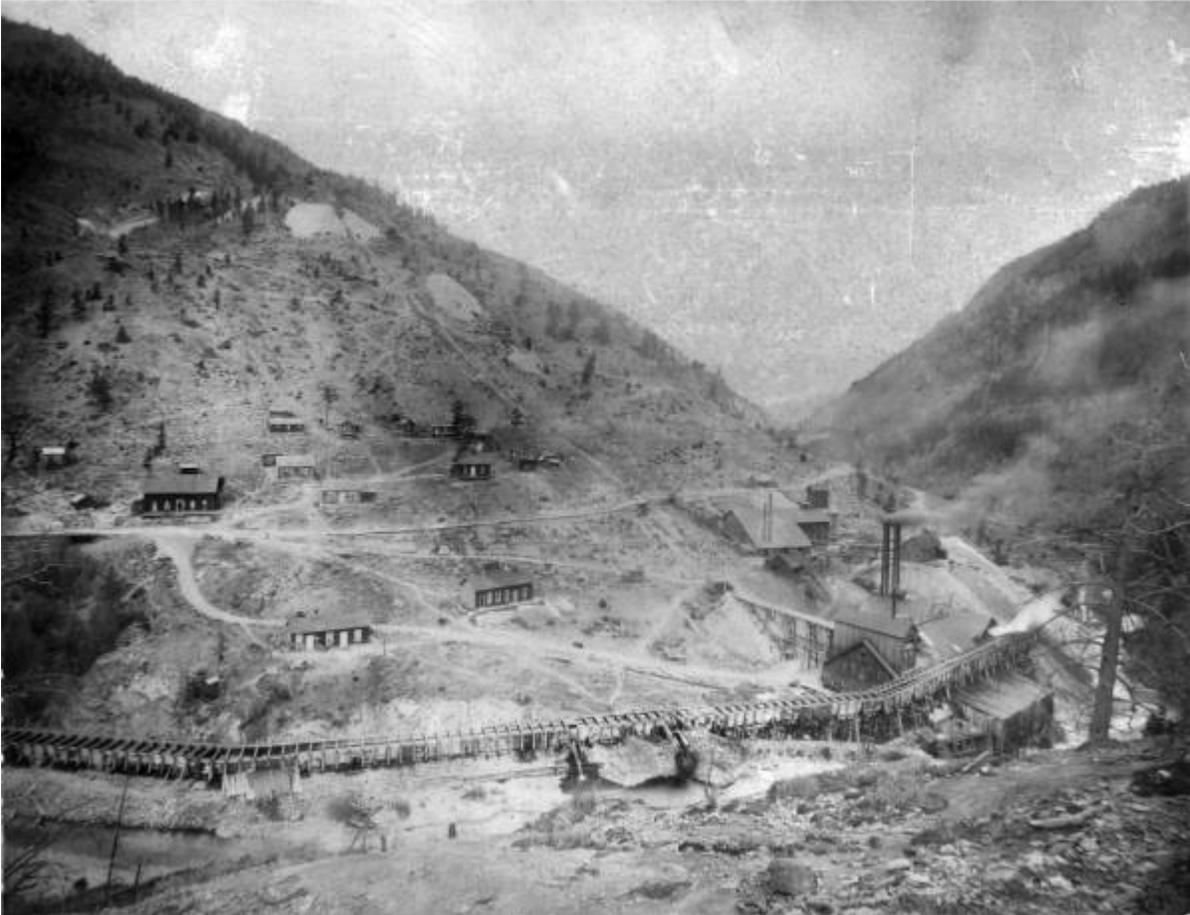
HP 1. Ute-Ulay Mine and Mill in the 1880s. See Figure 1 for explanation of buildings that still exist. Photo taken between 1883-89 by Frank E. Dean. DPL photo X-61914.

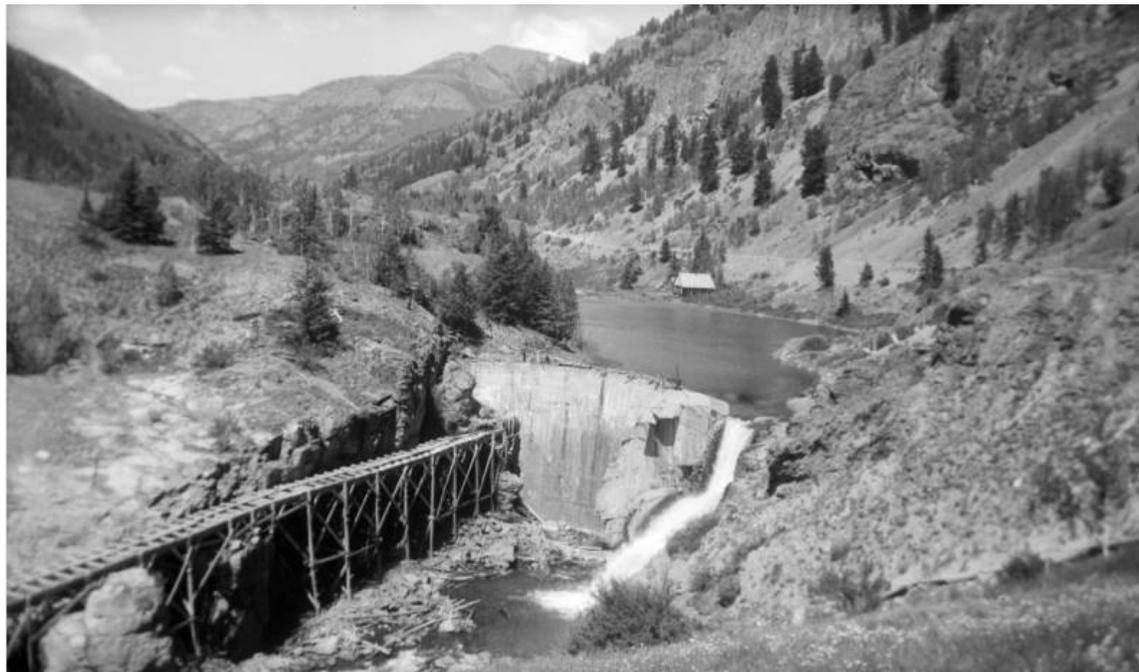
HP 2. The concrete dam (Feature 1) across Henson Creek and the initial part of the flume (Feature 2). Photo taken about 1942 by Muriel Sibell Wolle. DPL photo X-4166

The dam is in poor condition with deteriorating concrete and a large natural breach. The breach allows Henson Creek to flow unimpeded through the base of the dam. The lift gates, diversion with a debris grizzly, and the projecting pipe that fed the flume are all in good condition and demonstrate how the dam functioned.

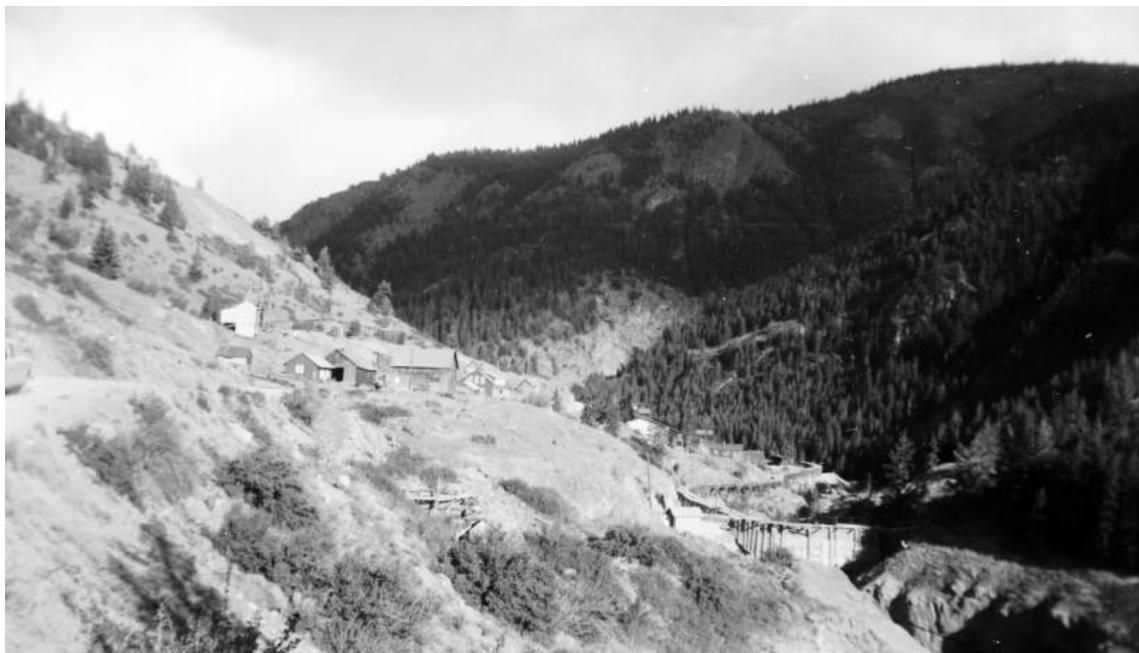
HP 3. Looking southeast at the Henson portion of the Ute-Ulay Mine and Mill. Note the concrete dam across Henson Creek with the gauging station (Building 35) to its left and the flume winding its way to the mill buildings in the distance. In the upper left is the hoist house/transformer house (Building 25). Immediately below it is the removed shed (Building 39) with Buildings 38 and 37 immediately to its right and removed Structure 36 farther right. In the distance can be seen the boarding house (Building 16). Photo taken about 1959 by Muriel Sibell Wolle. DPL photo X-3475.

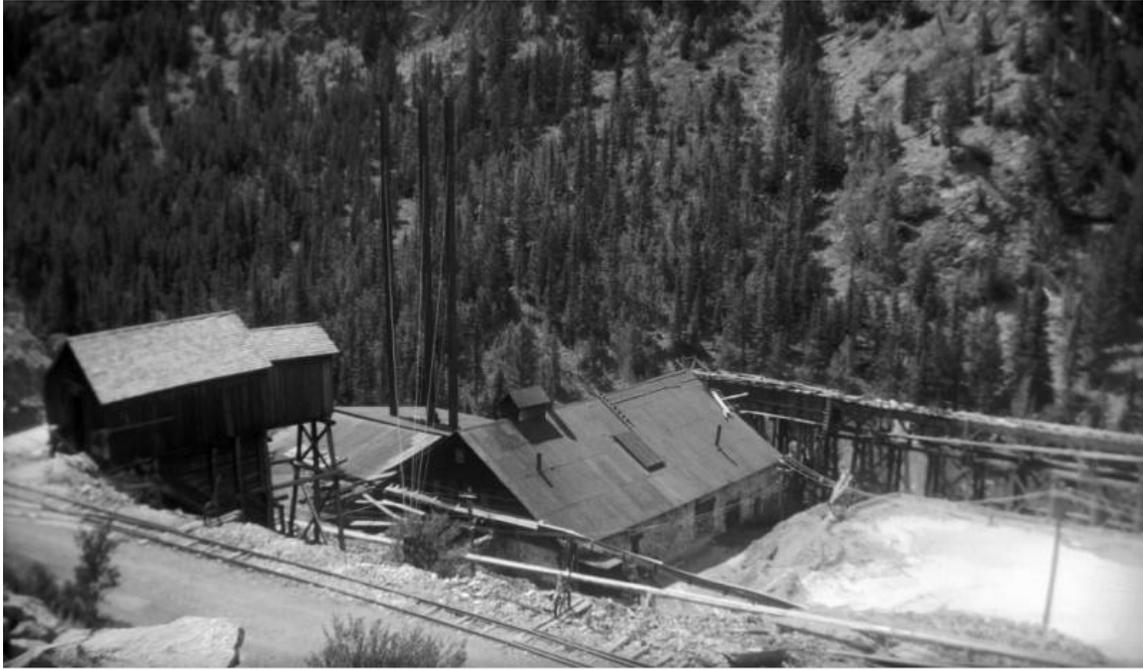
HP 4. The flume (Feature 2) terminating at the end of the old mill Structure 11 (no longer extant). Photo taken in 1942 by Muriel Sibell Wolle. DPL photo X-3471.

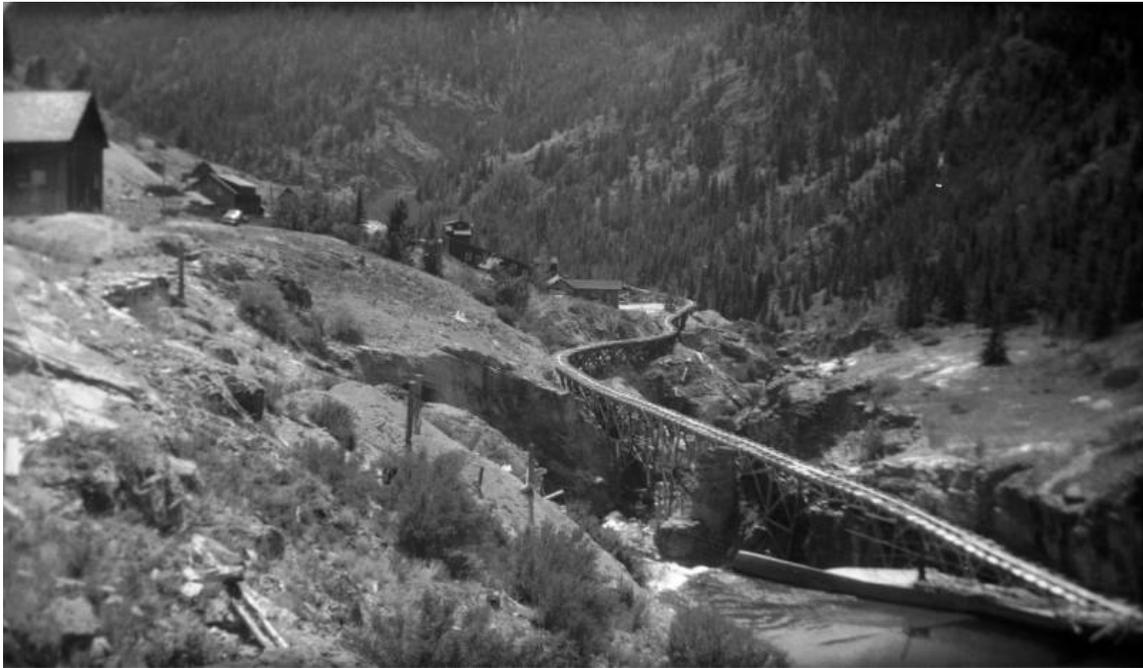
HP 5. The flume (Feature 2) winding southeastward down Henson Creek with the office (Building 9) just above the flume and the mill (Building 6) at center. At the far right is removed Building 36 with the boarding house (Building 16) in the distance. Photo taken in 1942 by Muriel Sibell Wolle. DPL photo X-3474

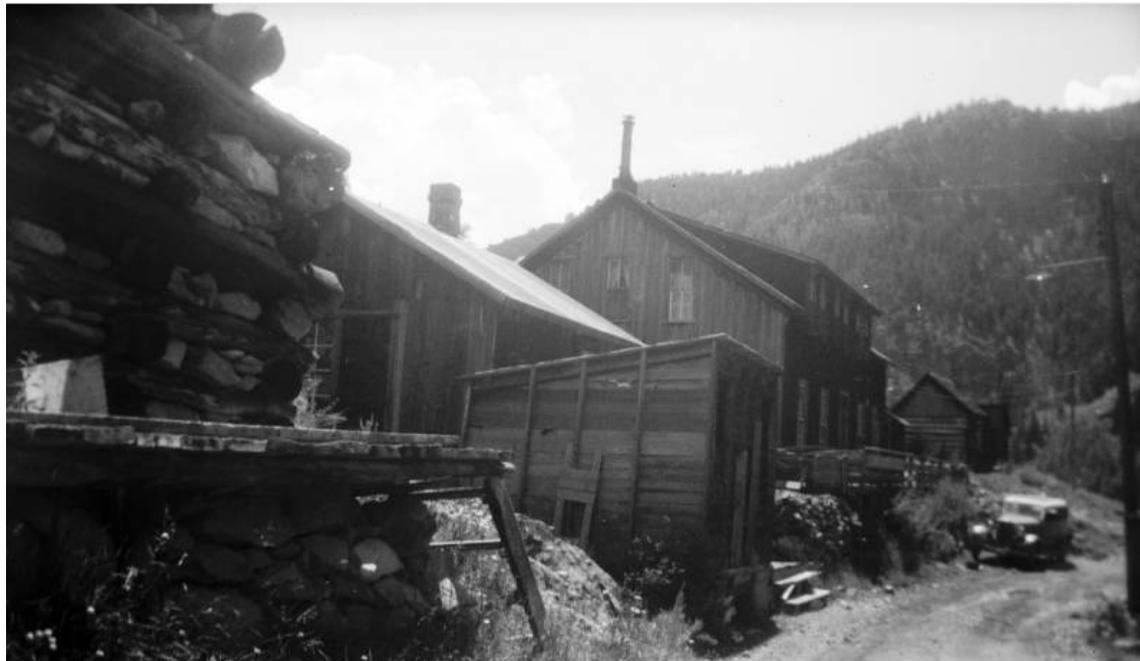
HP 6. Looking southeast at mostly obscured residence (Building 15) and the boarding house (Building 16) with the log cabin residence (Building 17) in the distance. Photo taken in 1942 by Muriel Sibell Wolle. DPL photo X-3466

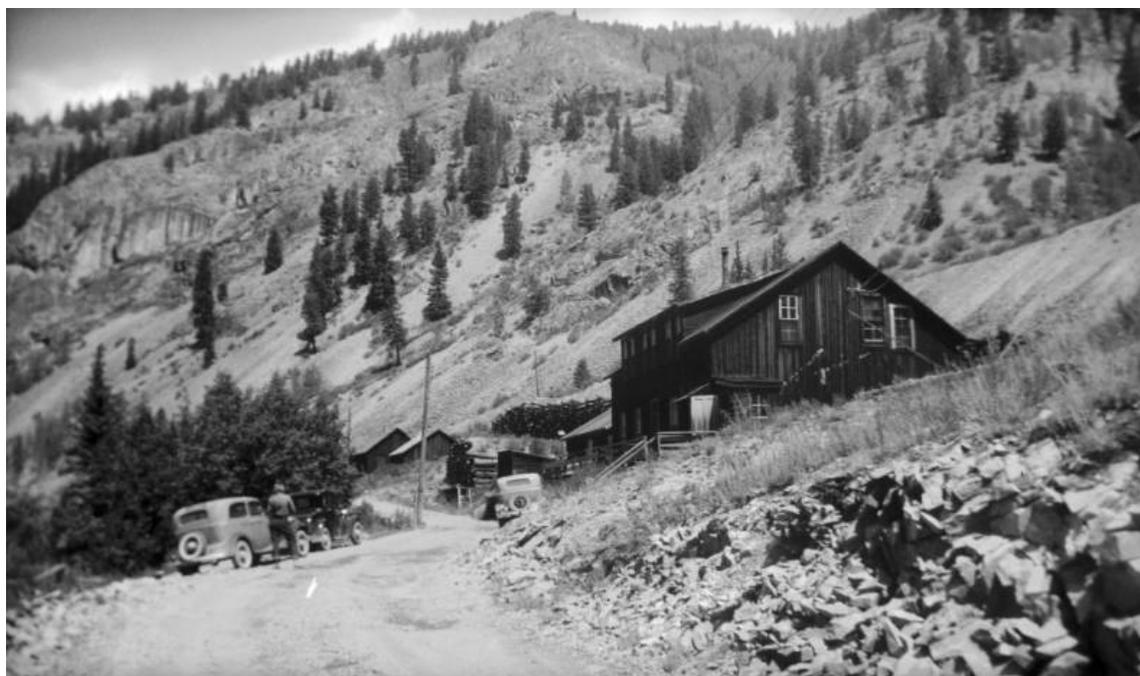
HP 7. Looking northwest at the boarding house (Building 16) with the residence (Building 15) partly visible behind, and Buildings 37 and 38 in the distance. Photo taken in 1942 by Muriel Sibell Wolle. DPL photo X-3467

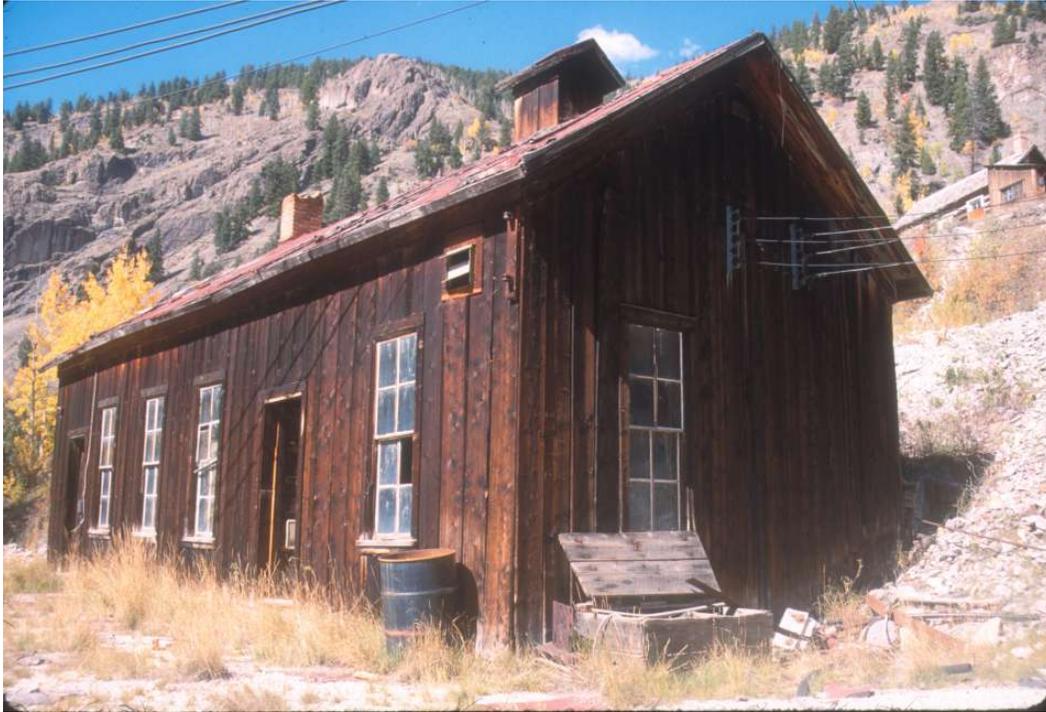
HP 8. 2001 photo of the southeastern and southwestern sides of the assay office (Building 8). View is to the north.

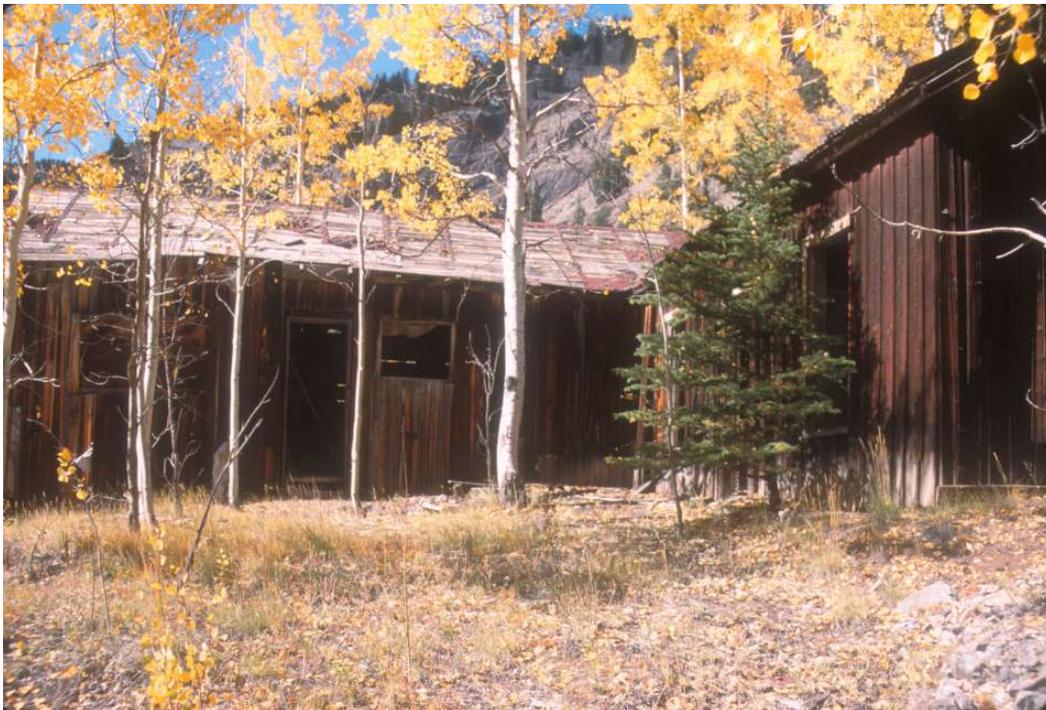
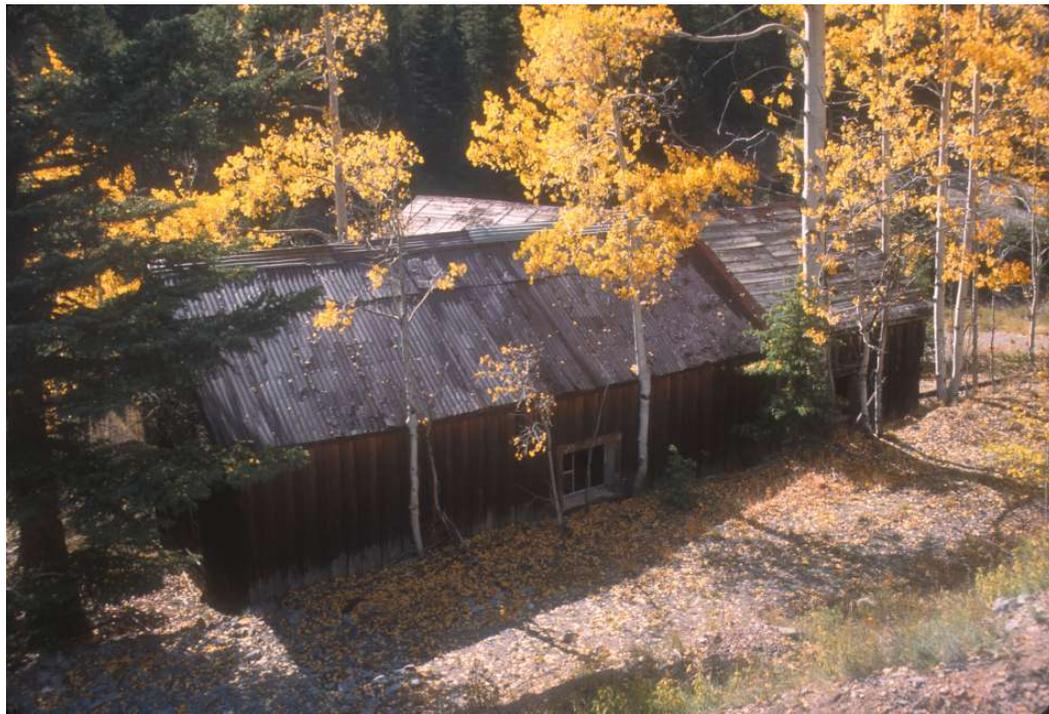
HP 9. 2001 photo of the southeastern side of the southwestern wing and southwestern side of the southeastern wing of the office (Building 9). View is to the northwest.

HP 10. 2001 photo of the northeastern side of the office (Building 9), looking west-northwest.

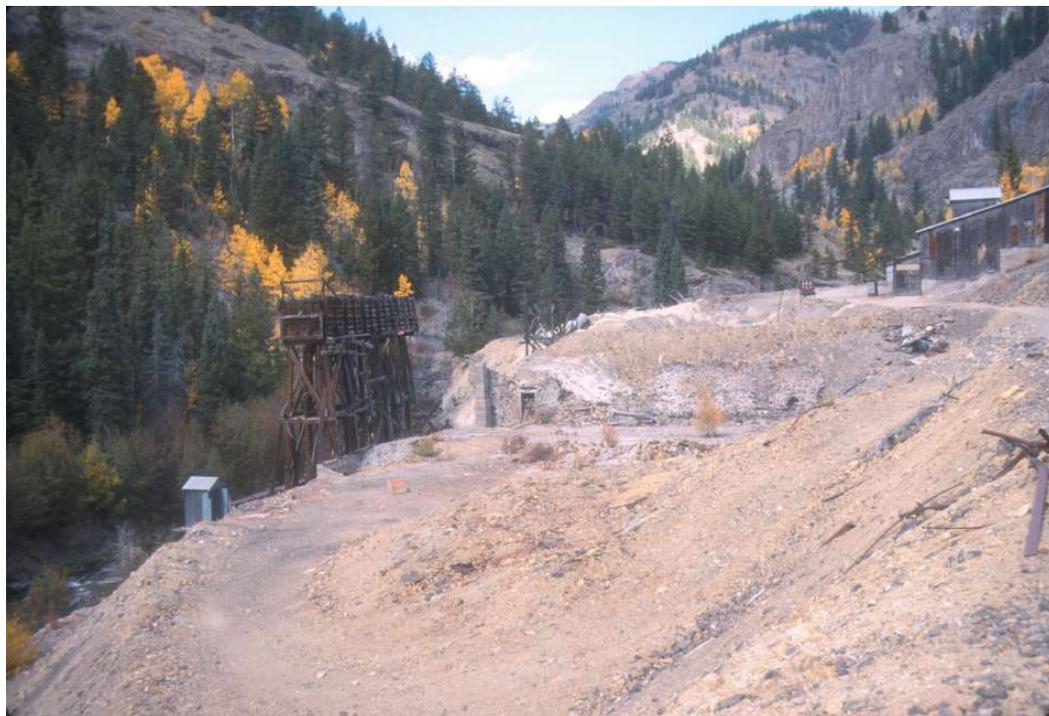
HP 11. 2001 view of the old mill and power plant area (Site Feature 11) with water tank (Structure 12) behind to left, small shed (Building 13) at far left, and the current mill (Building 6) at far right. View is to the west-northwest across Tailings Impoundment 7.

The water tank is in fair condition and is subject to ongoing natural deterioration. It is a monumental, highly visible element of the complex, standing dramatically above the ruins of the original mill and power plant along Henson Creek. The semicircular connection with the flume is readily visible, though the flume is no longer connected, and the iron pipes that dropped water from the upper reservoir box to the power plant are constituent elements still in place.

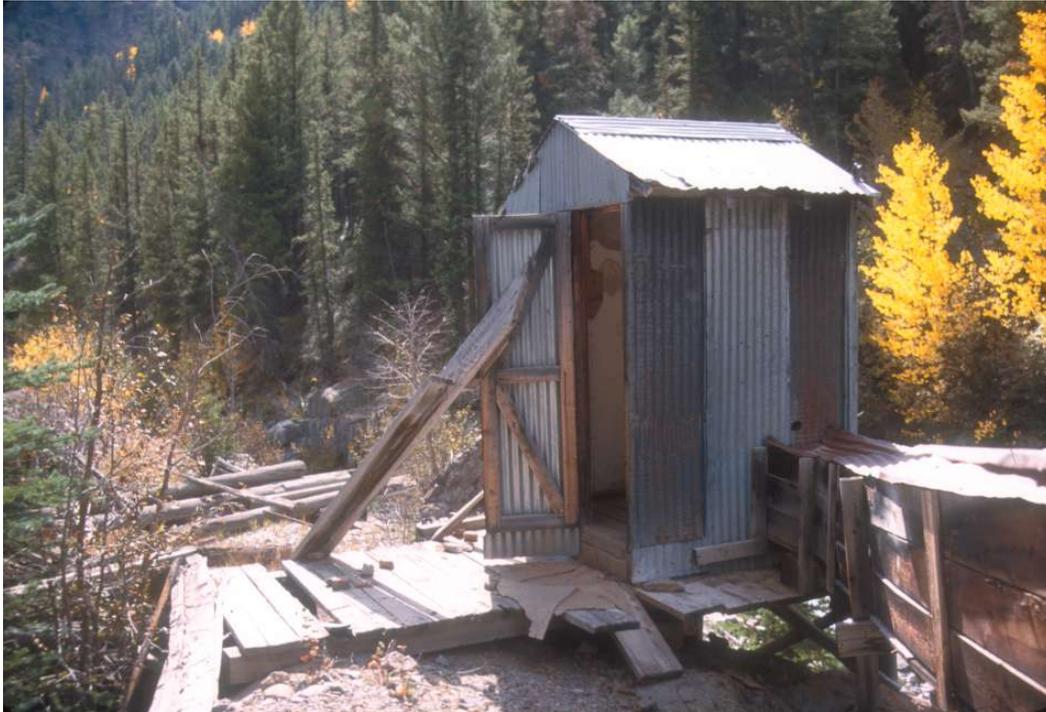
HP 12. 2001 photo of the small corrugated sheet metal shed (Building 13) with wooden boardwalk in front and water pipe in covered box to right. View is to the south. This building is now laying on its front side.

Except for having fallen or been laid on its side, the shed is in unmodified condition.

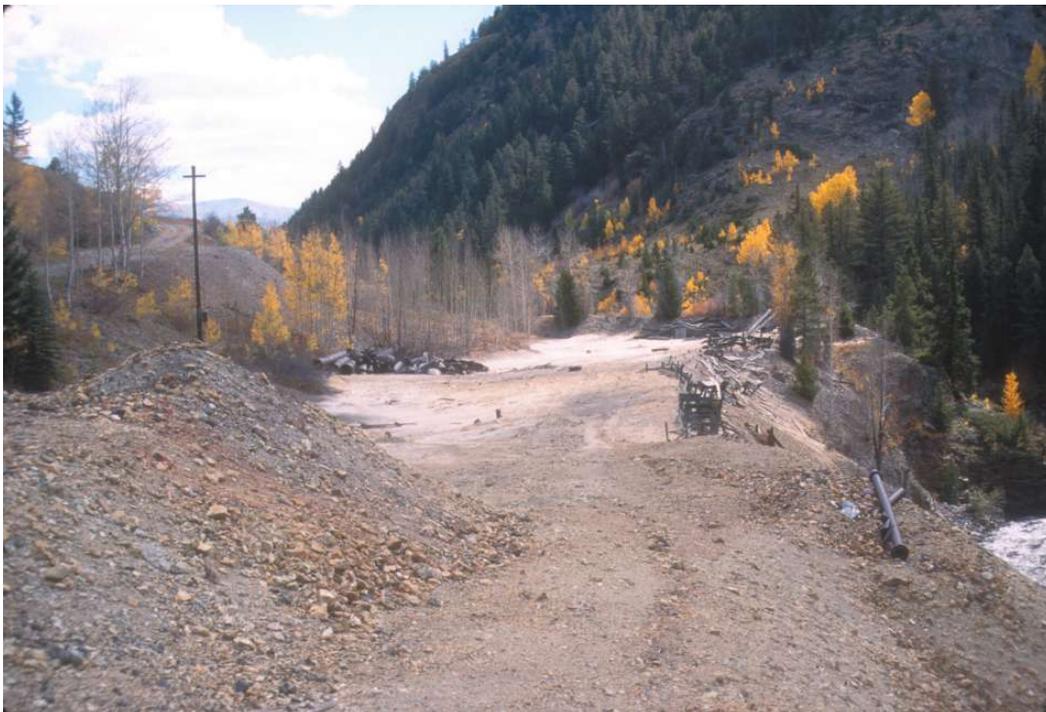
HP 13. 2001 photo of Tailings Impoundment 7 with Henson Creek adjacent to the right. View is to the east.

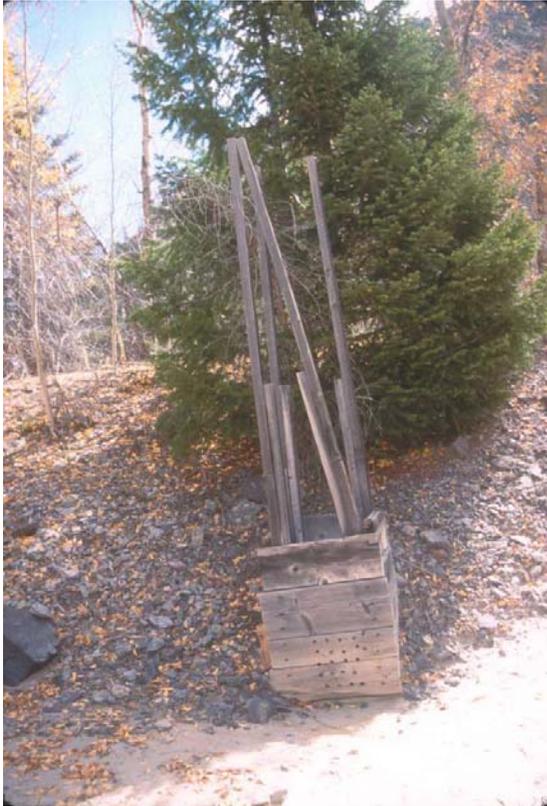
HP 14. Cribbed water drainage box (Feature 4) on east end of Tailings Impoundment 7 as it appeared in 2001, looking east-southeast. This was removed during mill tailings remediation in 2013.

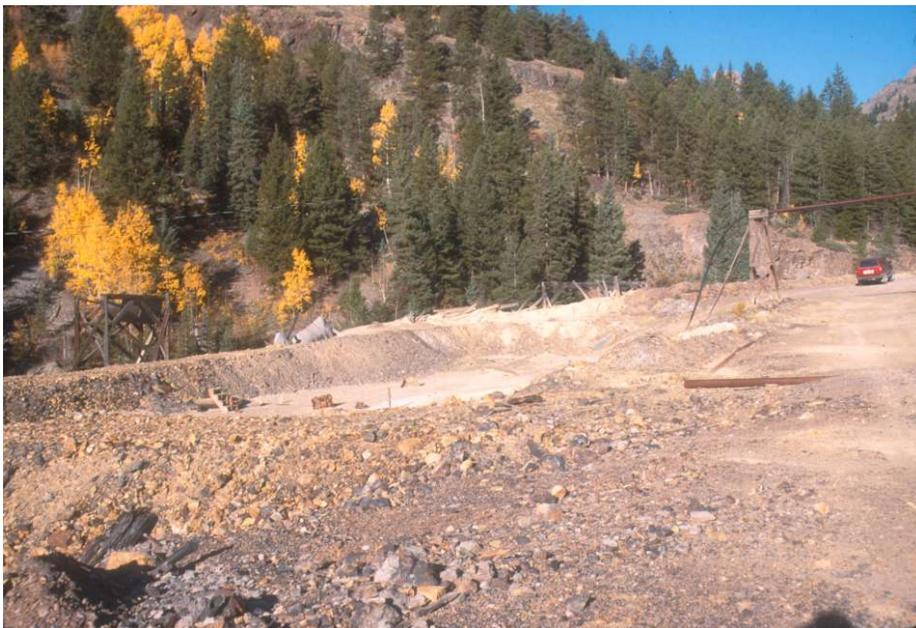
HP 15. 2001 photo of Tailings Impoundment 6, looking west. This area was remediated and covered with waste rock in 2013.

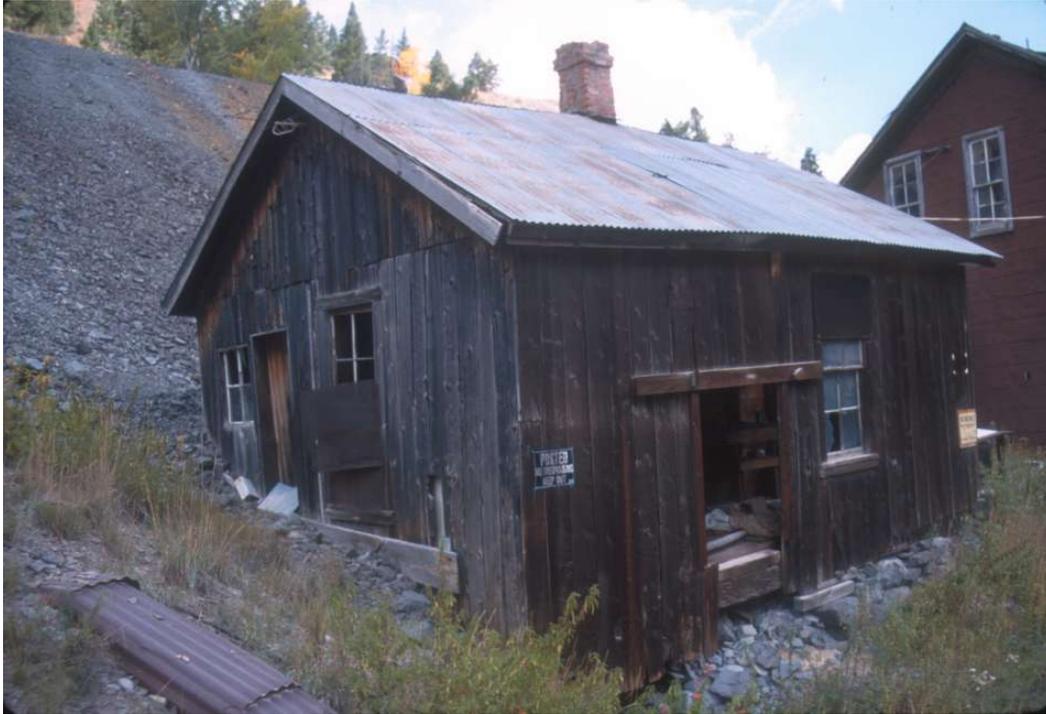
HP 16. 2001 photo of the southwestern and northwestern sides of Building 15, looking east.

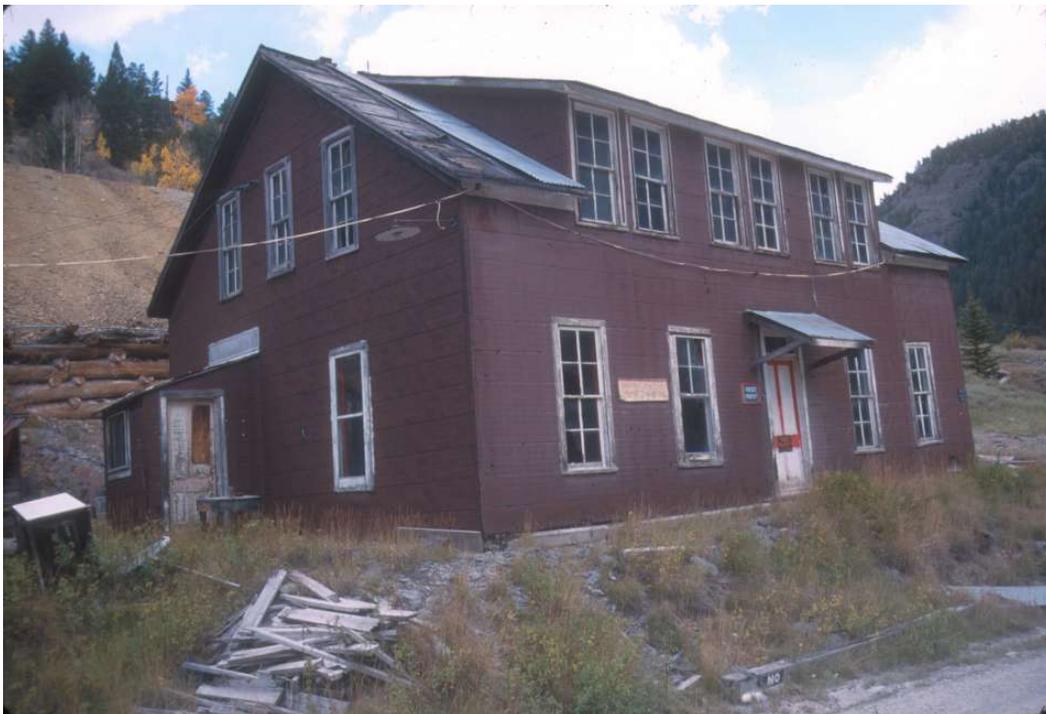
HP 17. 2001 photo of the southwestern and northwestern sides of the boarding house (Building 16), looking east-southeast. Note the original windows and door in place.

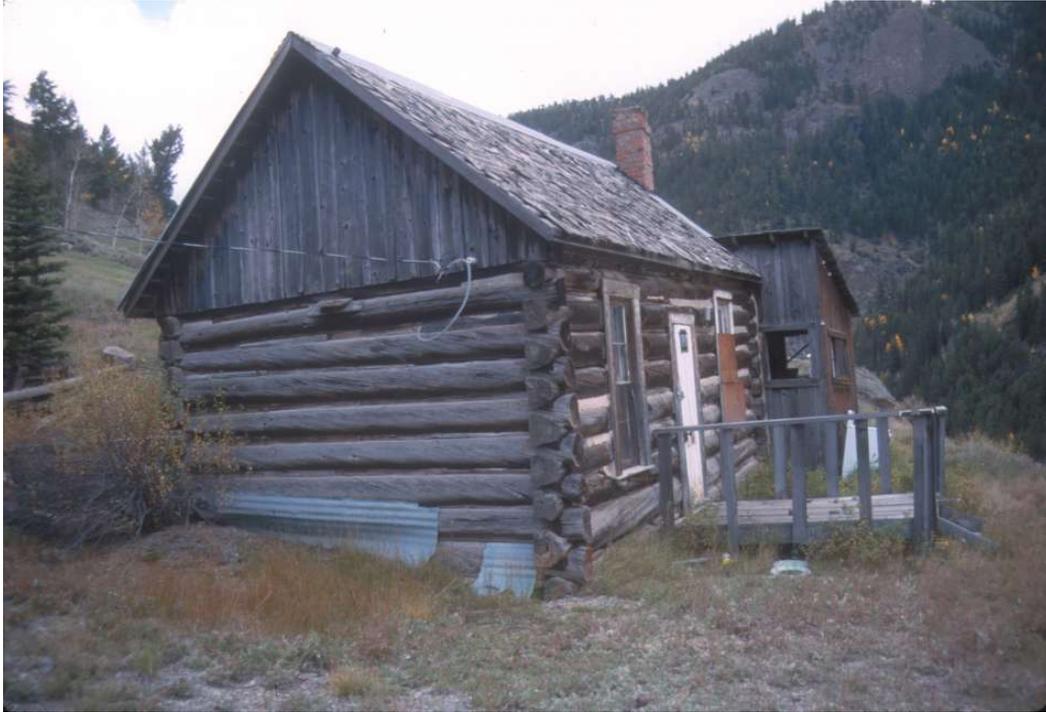
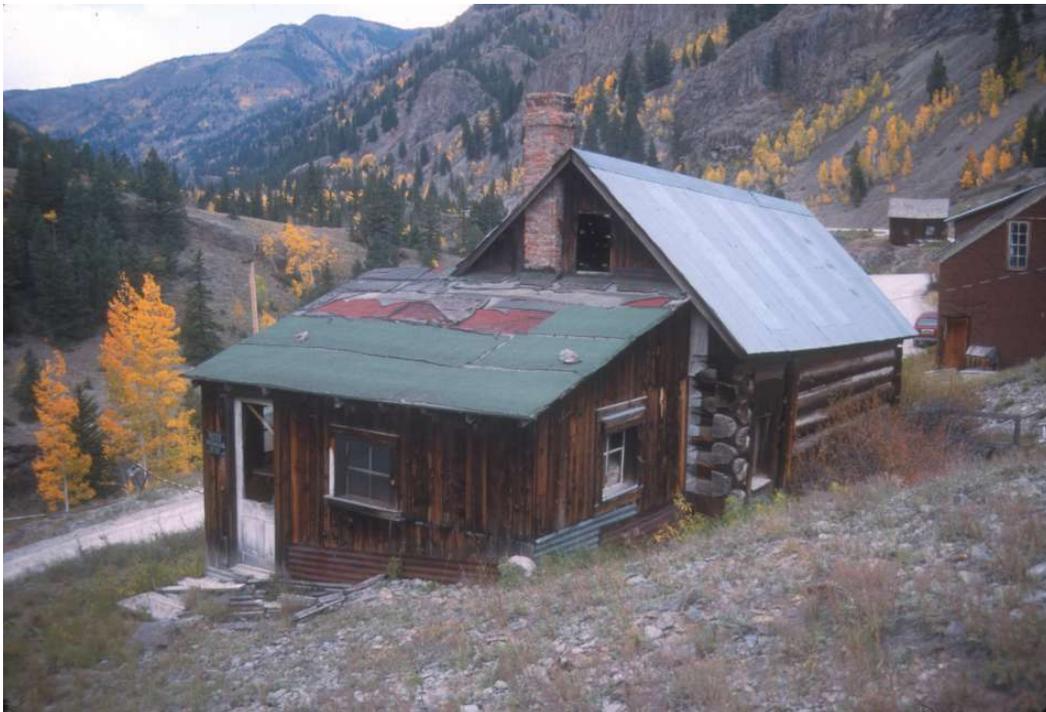
HP 18. Southwestern and northwestern sides of the log cabin residence (Building 17), looking southeast in 2001.

HP 19. Southeastern and northeastern sides of the log cabin residence (Building 17), looking northwest.

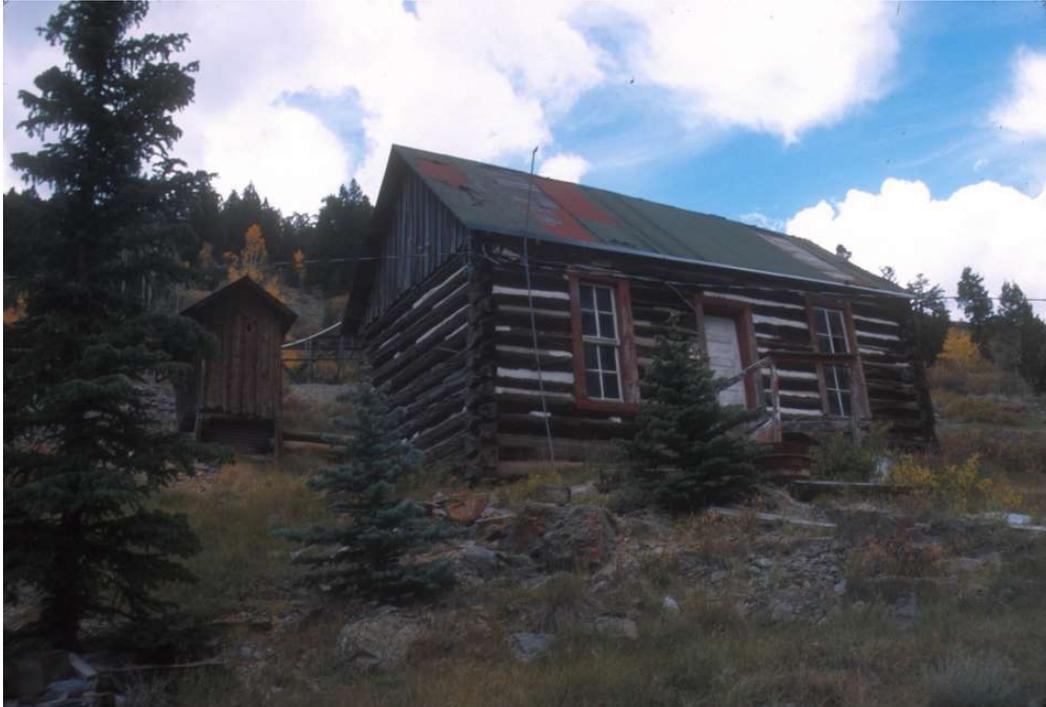
HP 20. 2001 photo of the southwestern and northwestern sides of the log residence (Building 18) with the outhouse (Building 19) to the left. View is to the east.

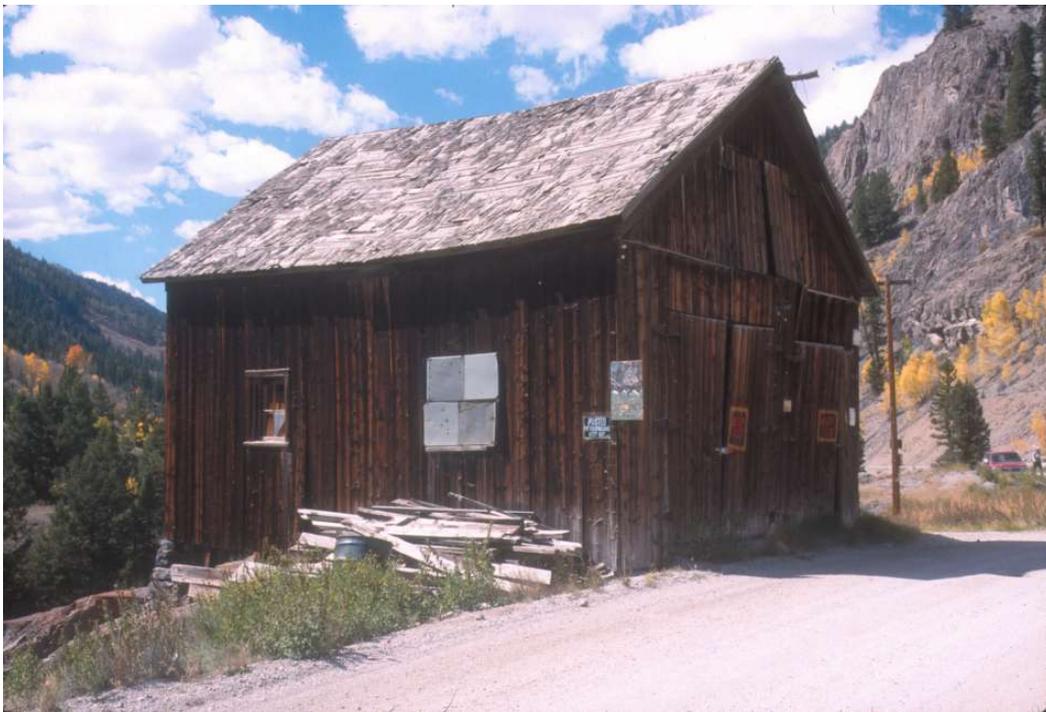
HP 21. 2001 photo of the southeastern and northeastern sides of Building 36, looking west. This building collapsed and was removed soon thereafter.

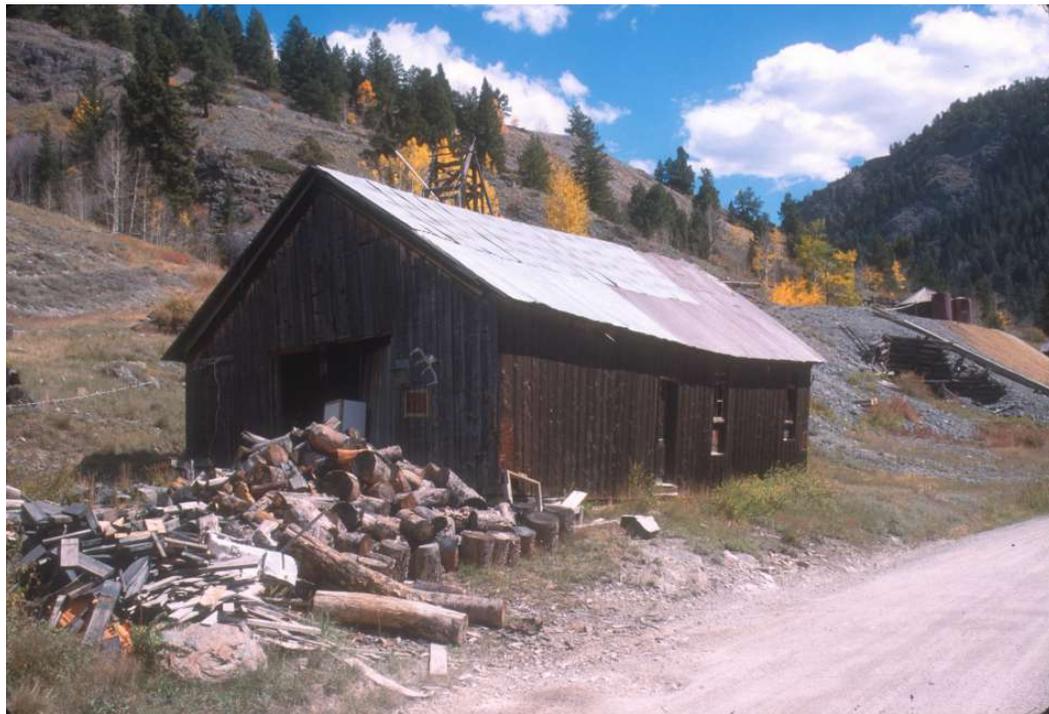
HP 22. Southwestern and northwestern sides of Building 37, looking east-southeast, in 2001.

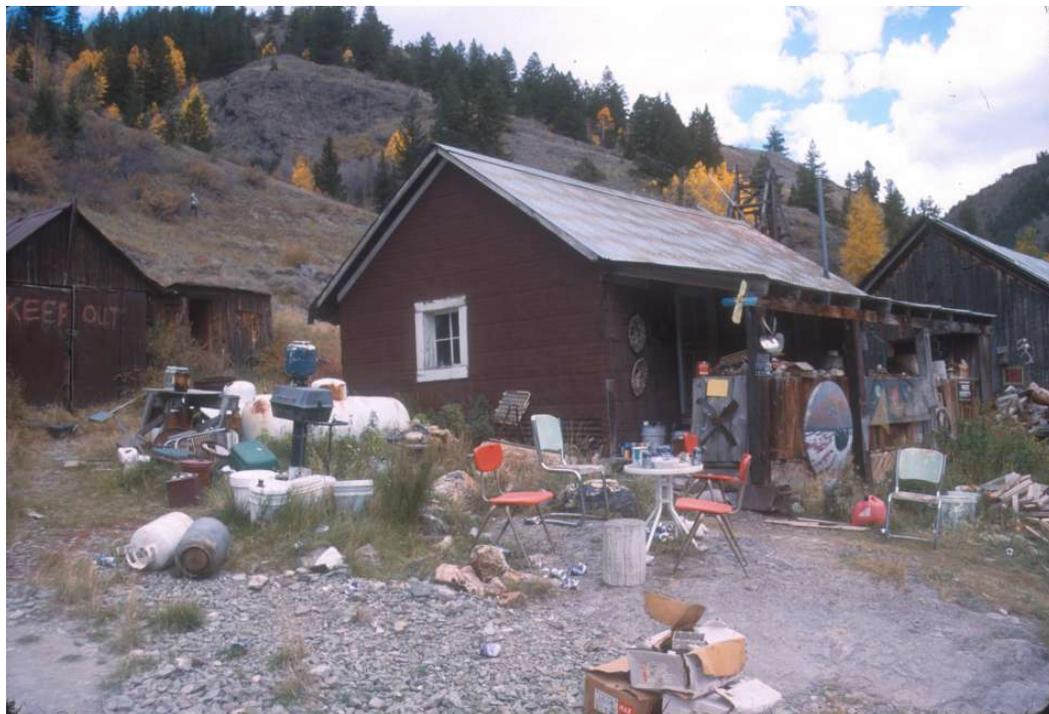
HP 23. 2001 photo of the southwestern and northwestern sides of residence (Building 38), looking east with removed Building 39 to left.

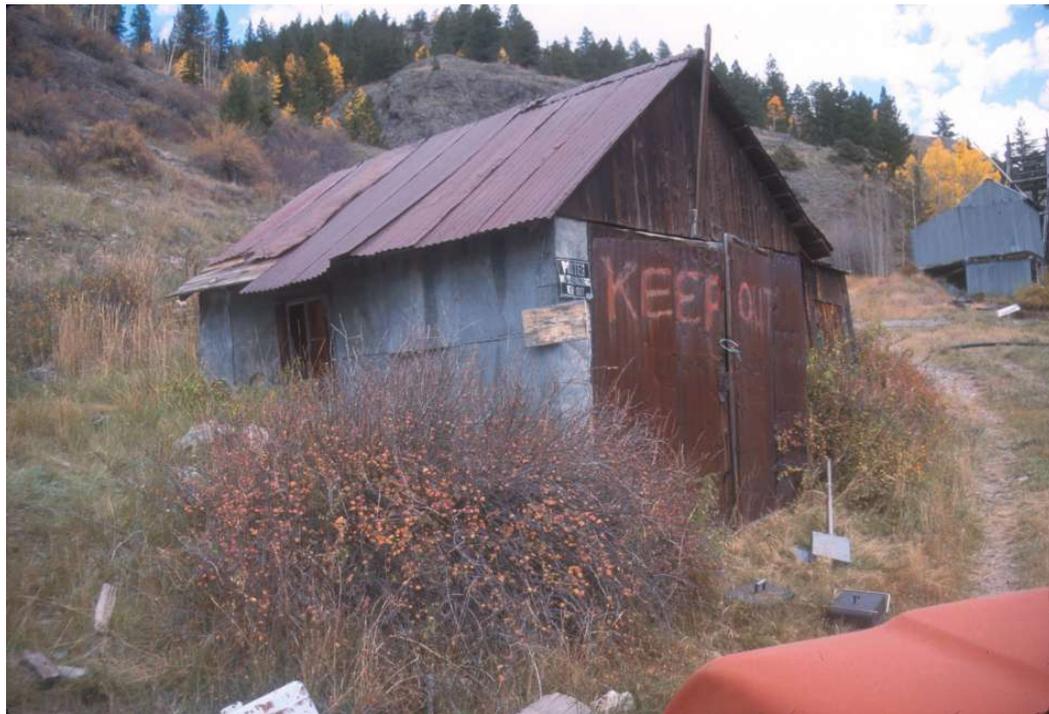
HP 24. 2001 photo of the southwestern and northwestern sides of Building 39, looking east. This building later collapsed and was removed.

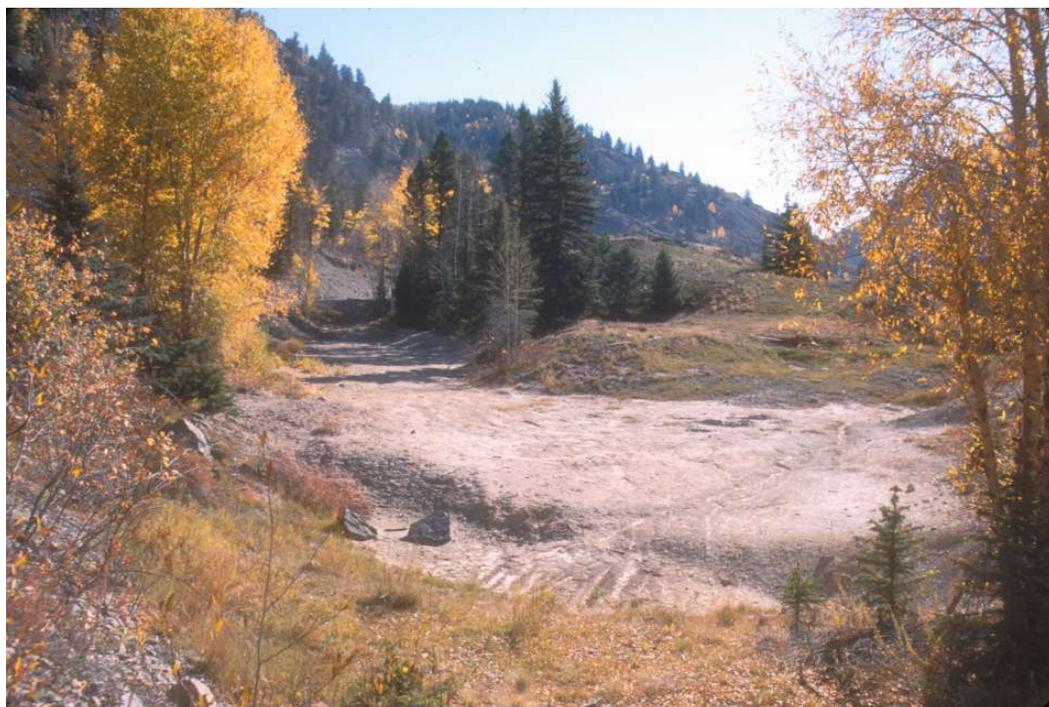
HP 25. Tailings Impoundment 1, looking east, in 2001. This area was remediated and revegetated in 2009.
