National Register of Historic Places Registration Form

Historic name: Ute-Ulay Mine and Mill

Other names/site number: 5HN.77

Name of related multiple property listing: The Mining Industry in Colorado; Hinsdale County Metal Mining

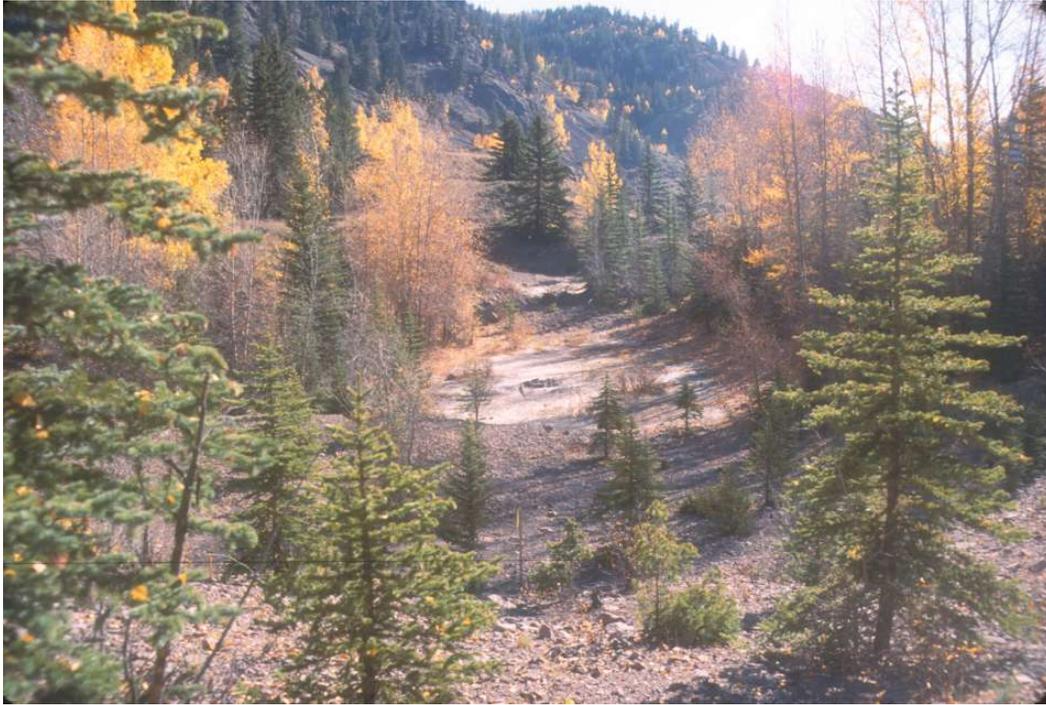
HP 26. 2001 photo of Tailings Impoundment 2, looking east. This area was remediated and revegetated in 2009.

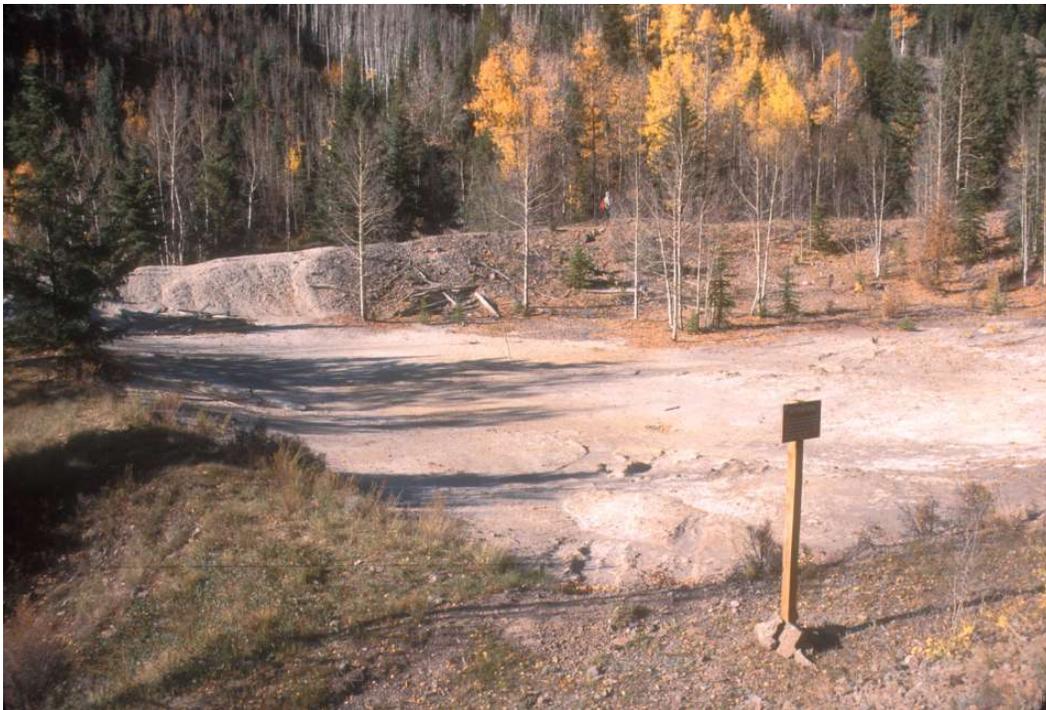
HP 27. Tailings Impoundment 3, looking southwest, in 2001. This area was remediated and revegetated in 2009.

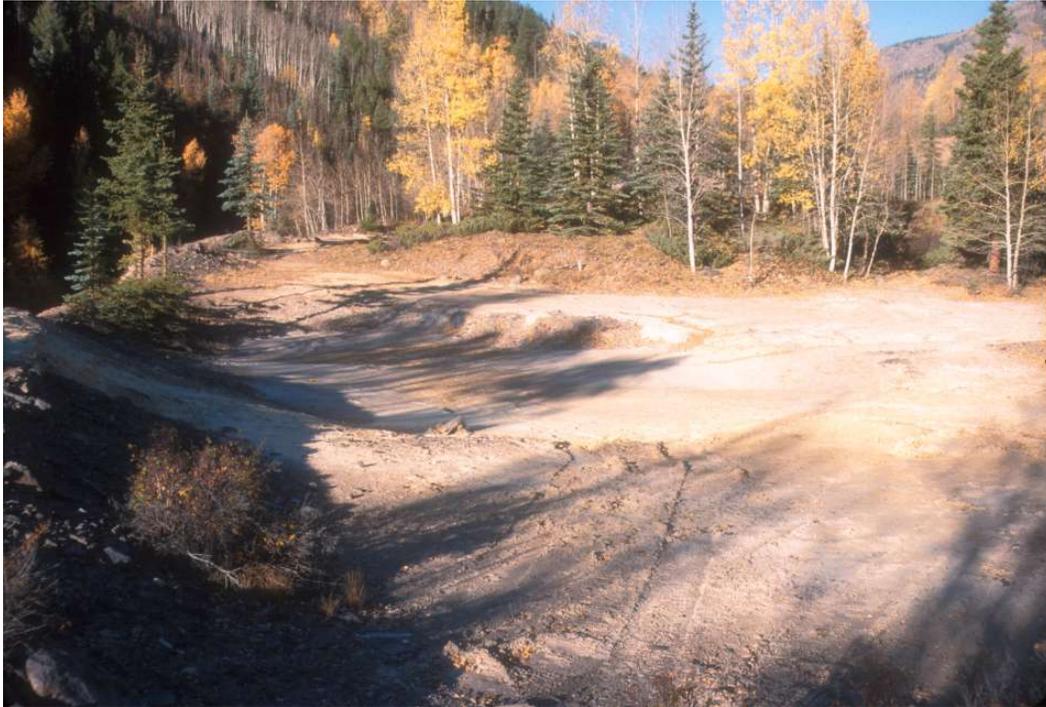
HP 28. Tailings Impoundment 4, looking west in 2001. This area was remediated and revegetated in 2009.

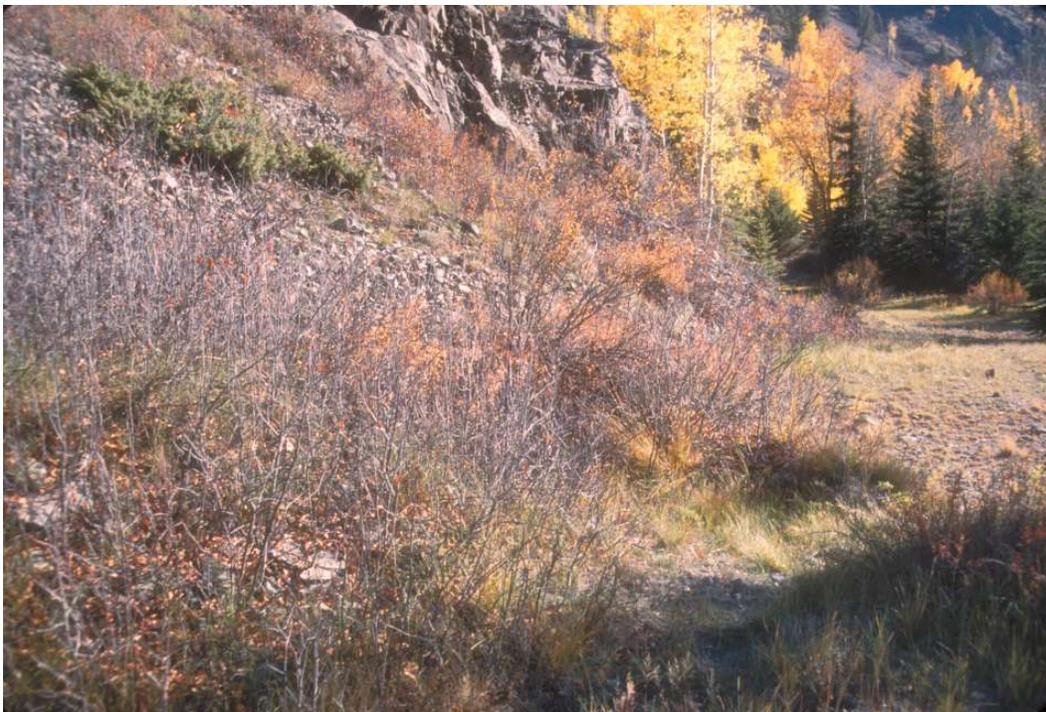
HP 29. 2001 photo of Structure 31 covered in brush in foreground with the leveled area and artifact scatter (Feature 15) behind. View is to the northeast looking into Tailings Impoundment 5. This area was remediated and revegetated in 2009.

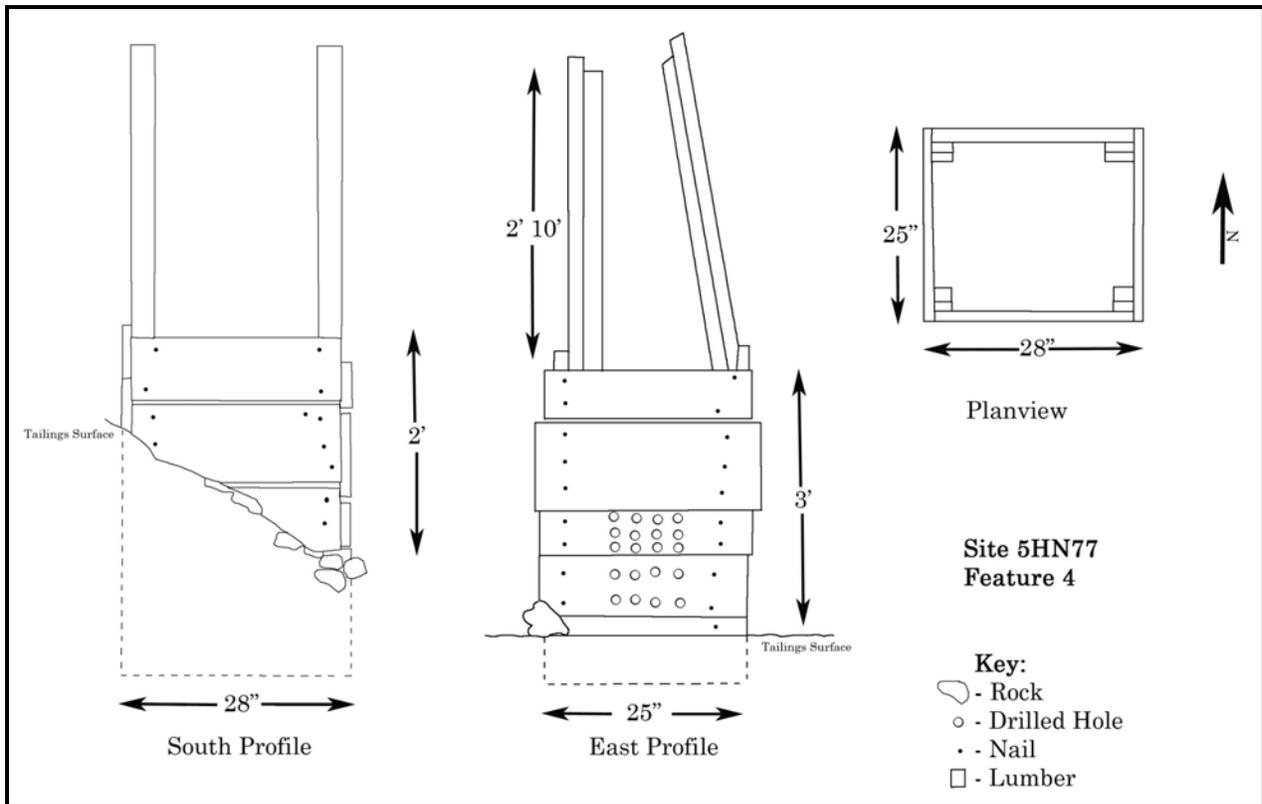
Illustration 1. Scale drawing of Feature 4 prepared during monitoring of 2013 remediation and stabilization of Tailings Impoundment 7.

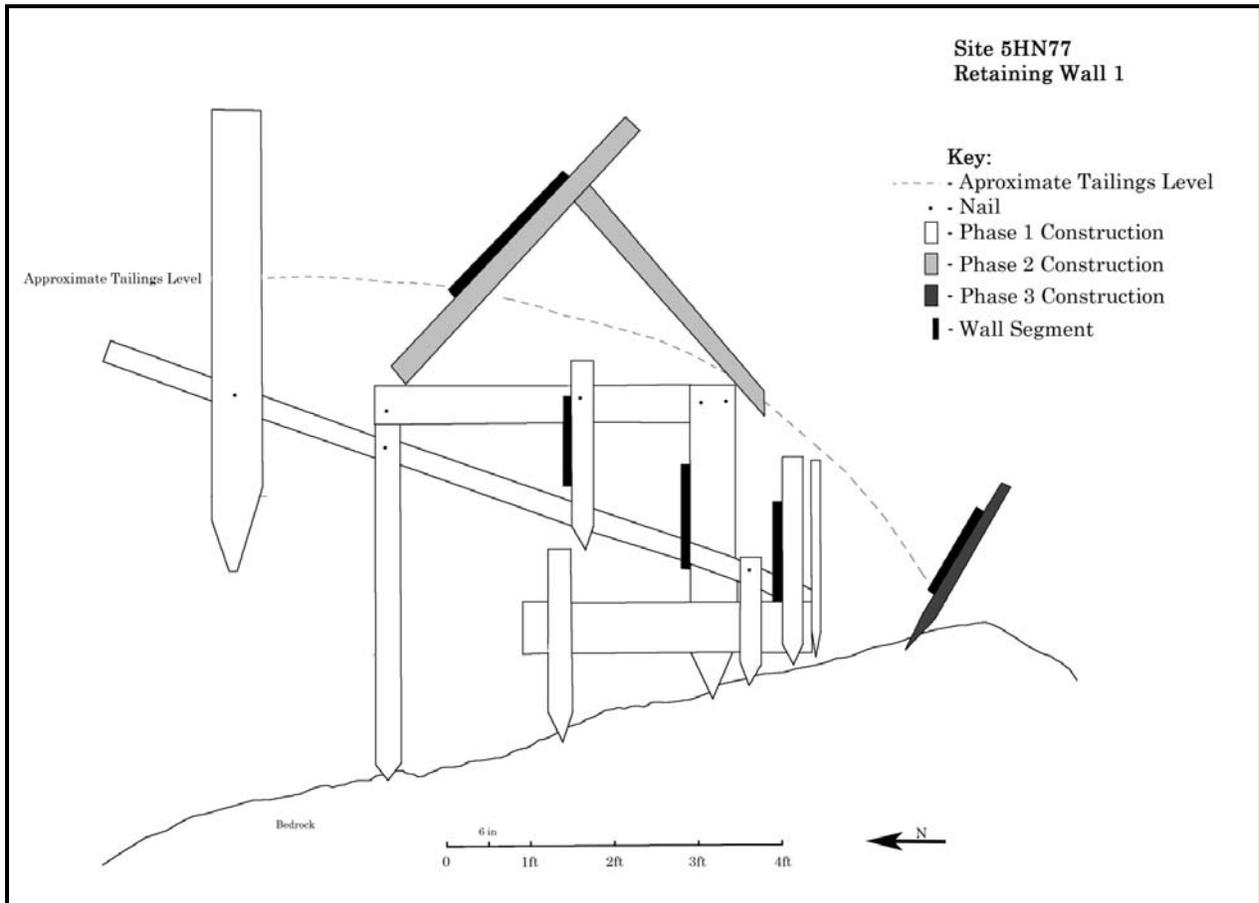
Illustration 2. Schematic profile scale drawing of Retaining Wall 1 uncovered during monitoring of 2013 remediation and stabilization of Tailings Impoundment 7.

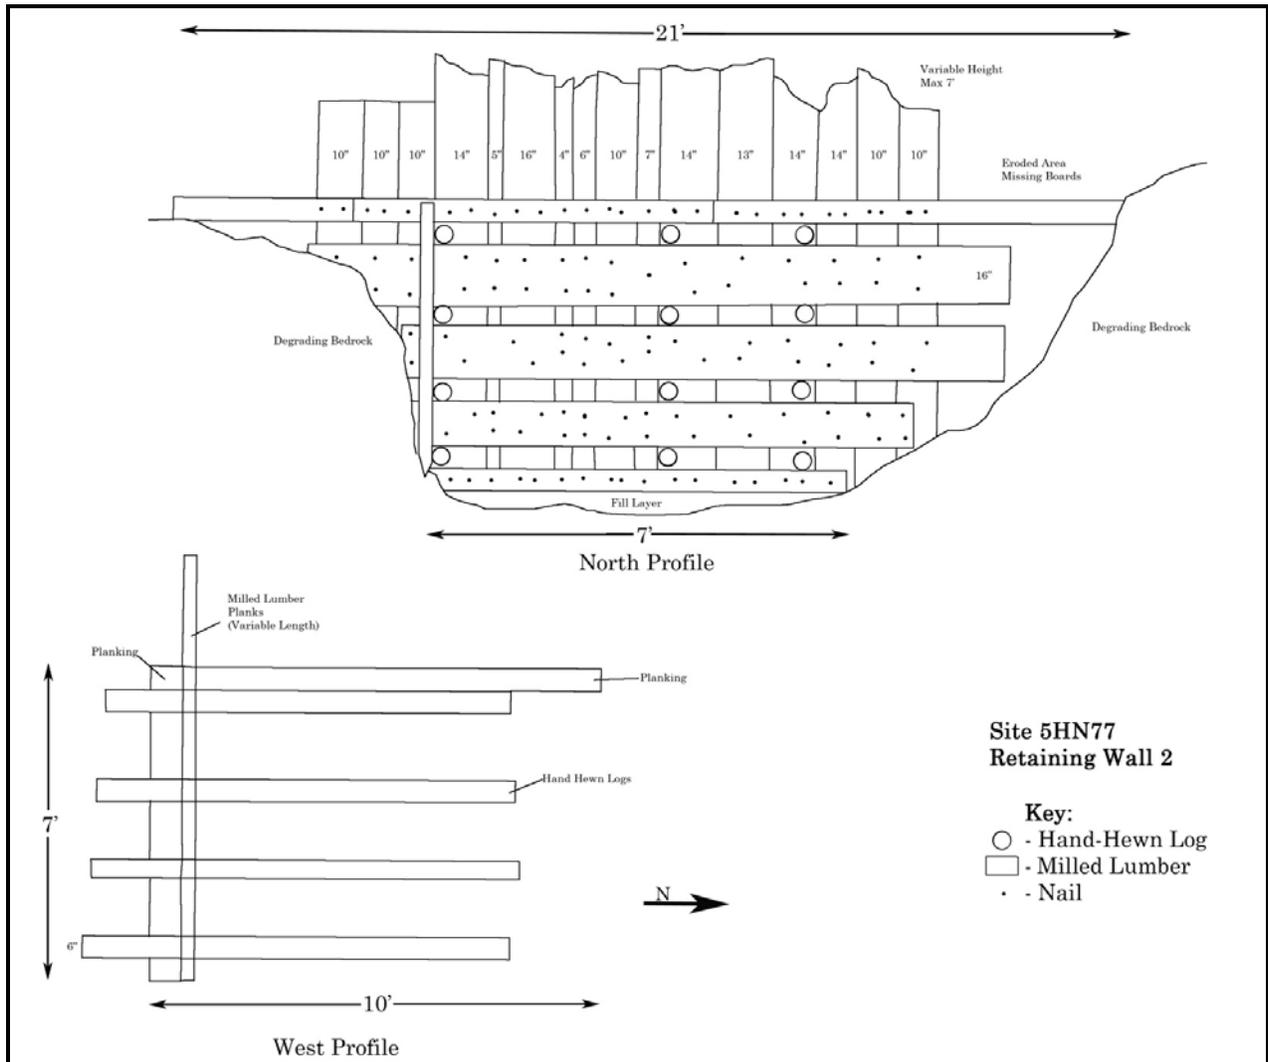
Illustration 3. Scale drawing of Retaining Wall 2 uncovered during monitoring of 2013 remediation and stabilization of Tailings Impoundment 7.

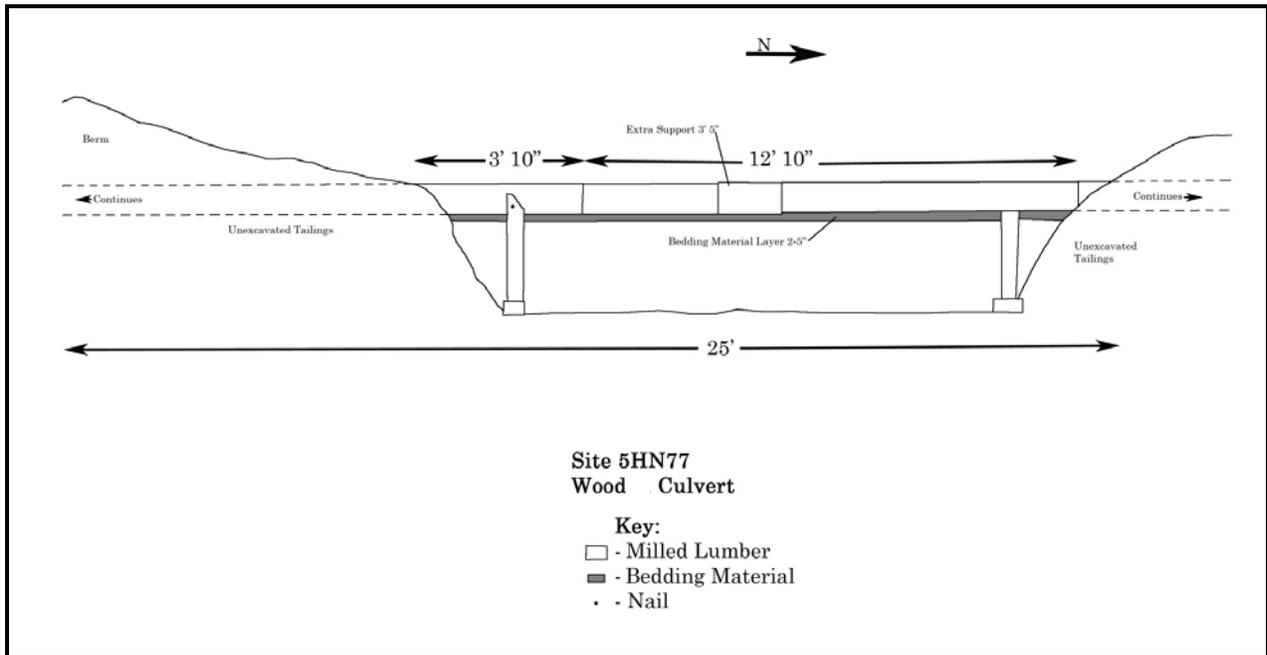
Illustration 4. Scale drawing of the wood drainage culvert uncovered during monitoring of 2013 remediation and stabilization of Tailings Impoundment 7.

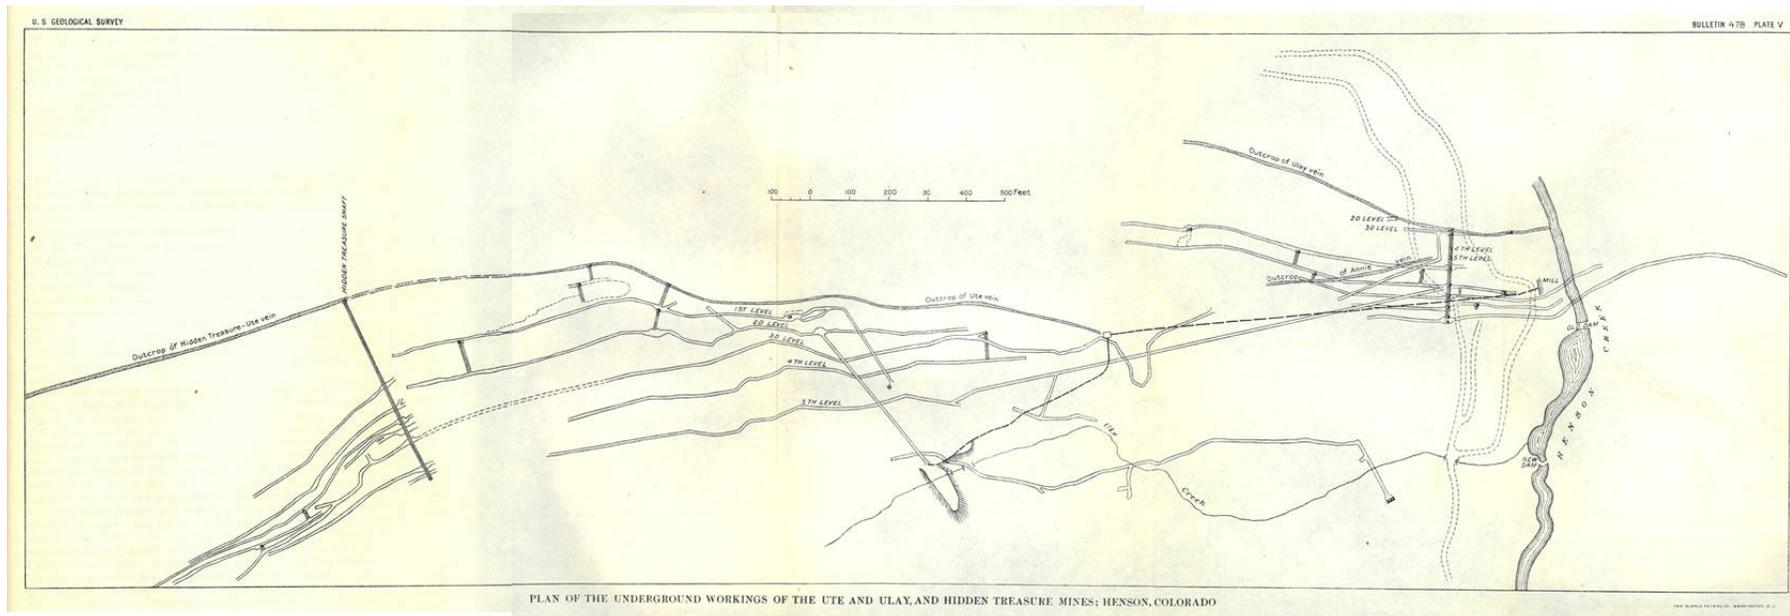
Map 3. Plan of the Underground Workings of the Ute and Ulay and Hidden Treasure Mines; Henson Colorado (Reproduction of Plat V in Irving and Bancroft 1911). Note that surface tram routes are shown as dashed lines. The map evidently shows the mine configuration as it existed in the 1880s and was not updated for the 1911 publication.
