# PRESERVATION MAINTENANCE:

A UNIVERSAL MANUAL FOR  
DEVELOPING CONSERVATION  
MAINTENANCE PLANS

April 2006

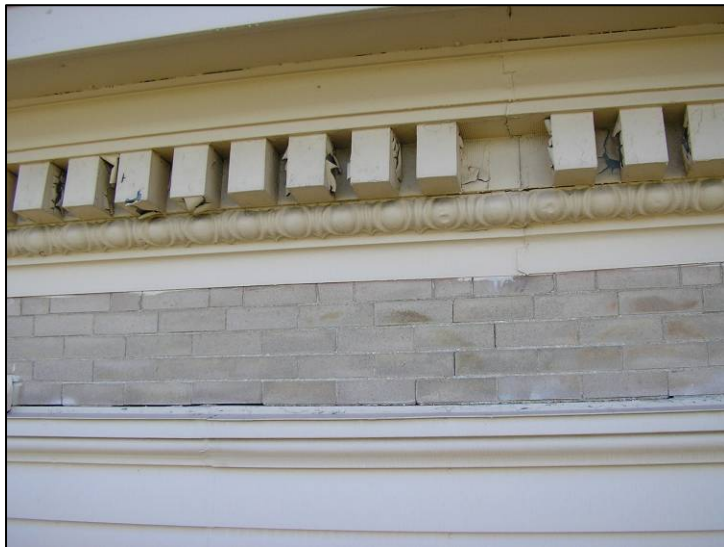
Building features such as these cornice dentils are important to maintain in order to avoid losing character-defining elements.

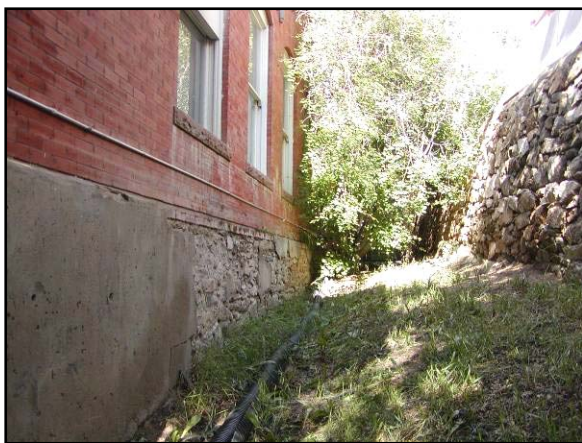
Ground that slopes towards the building foundation will bring unwanted moisture and should be addressed.

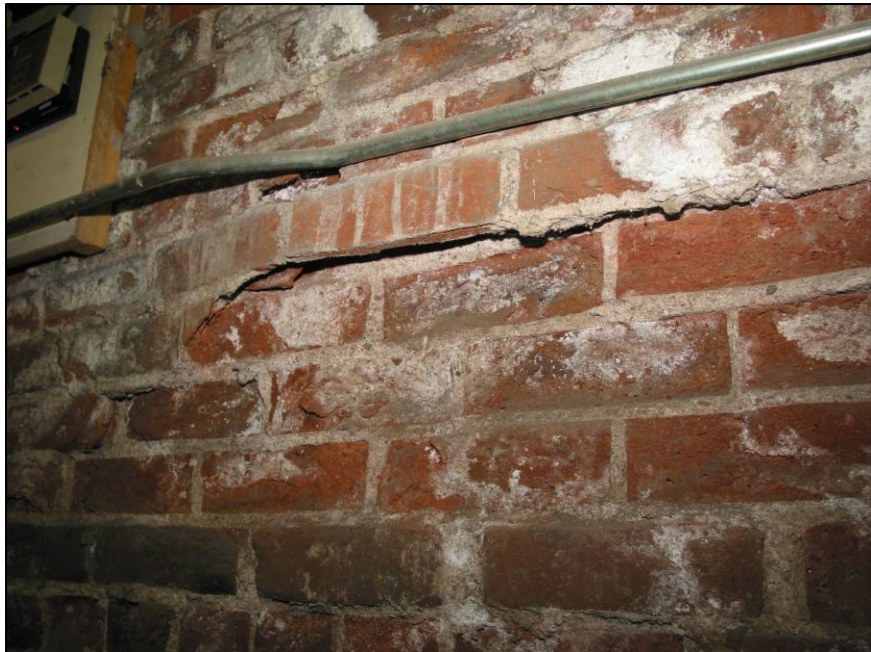
Efflorescence, a white chalky surface residue, indicates the presence of moisture and can cause significant deterioration of masonry.

Brick and Stone load-bearing masonry also require regular examination to prevent unnecessary deterioration. The mortar joint or pointing between individual bricks and stones is the most vulnerable element of these systems. Loose or damaged mortar should be repointed as needed. It is important to make sure replacement mortar closely matches the properties of the existing mortar in color, texture, and strength. Moisture problems in stonework may be evidenced by areas of discoloration. Such problems should be addressed to prevent eventual breakdown of the mortar or stone. Brick also may become discolored from moisture, but the more common symptom is efflorescence, which is a white, chalky, surface residue. In either case, moisture problems may lead to cracking, spalling, and disintegration of the masonry. Loose stones and bricks, as well as sagging and/or buckling in a masonry wall may indicate the early signs of failure. A skilled professional should evaluate the need for repairs if any of the above conditions are documented in an historic masonry building.

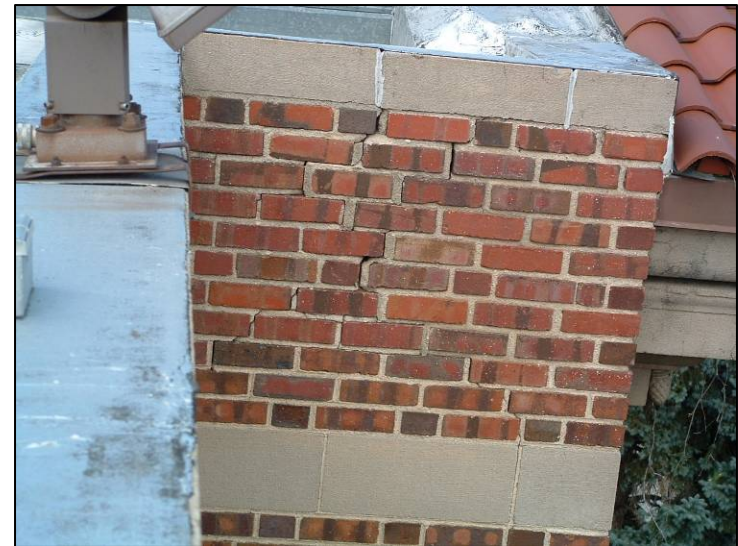
Masonry parapet walls are prone to moisture damage, such as deteriorated mortar joints, and should be examined regularly.

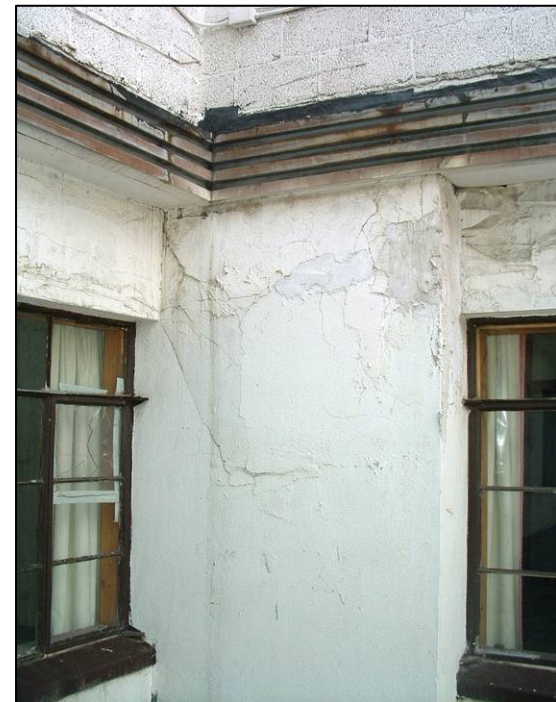
Cracks in stucco should be repaired to avoid moisture entering and enlarging them.

Stucco, like mortar, was historically a lime-based material until the popularization of Portland cement in the early 20<sup>th</sup> century changed its composition to a harder material. Like all exterior finishes, stucco is prone to deterioration from moisture, settlement, and surface damage due to impact. The most important rule of thumb for maintaining stucco is the timely repair of cracks and chipping. Moisture will enter these breaks in the surface and enlarge them by freezing and thawing. This action eventually will develop into erosion and/or peeling away of the stucco from the wall surface, leaving the wall structure exposed. When repairing cracks in stucco finish it is important to match the texture, consistency, and strength of the original stucco to avoid problems in the future. Active cracking or bulging may be a sign of structural problems as well and should be monitored and evaluated by a skilled professional.

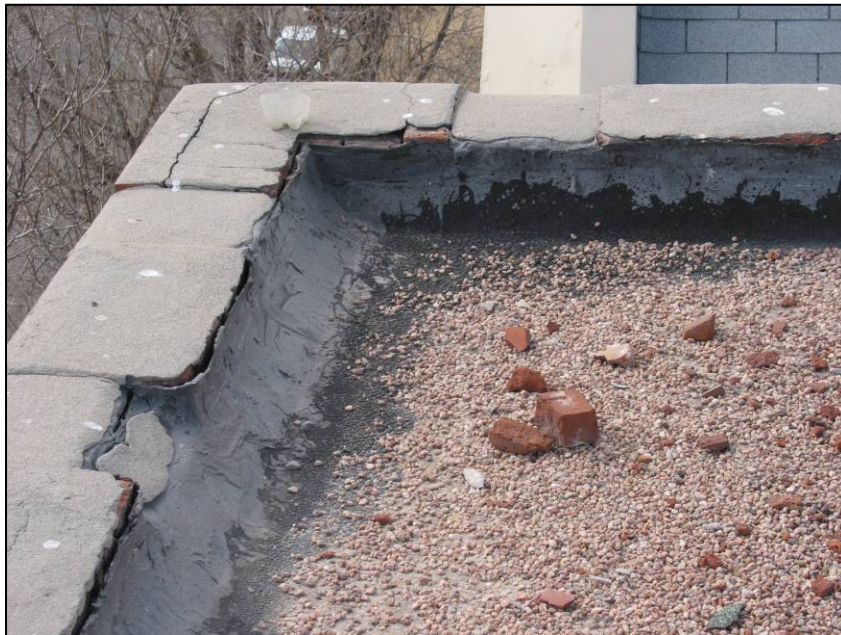
The failure of this built-up roof has allowed moisture to infiltrate along the parapet edge.

Built-up Roofing also has been used for more than 100 years. The main difference between a built-up roof and the roof systems discussed above is that a built-up roof must be water tight while the other systems are designed to be water shedding. As such, a built-up roof possesses some unique maintenance issues. It is crucial to avoid punctures or cuts in a built-up roofing system. Early signs of trouble may include “alligating” or a general brittleness in the membrane. Other defects in the membrane may include blisters, splits, or ridges. Since built-up roofs rely on a protective covering such as asphalt surfacing, gravel, or aluminum coating, it is particularly important to identify and prevent the erosion of these surfaces. Appropriately installed and maintained flashing is also crucial to preserving a built-up roof. The typical lifespan of a built up roof is approximately 20 years.

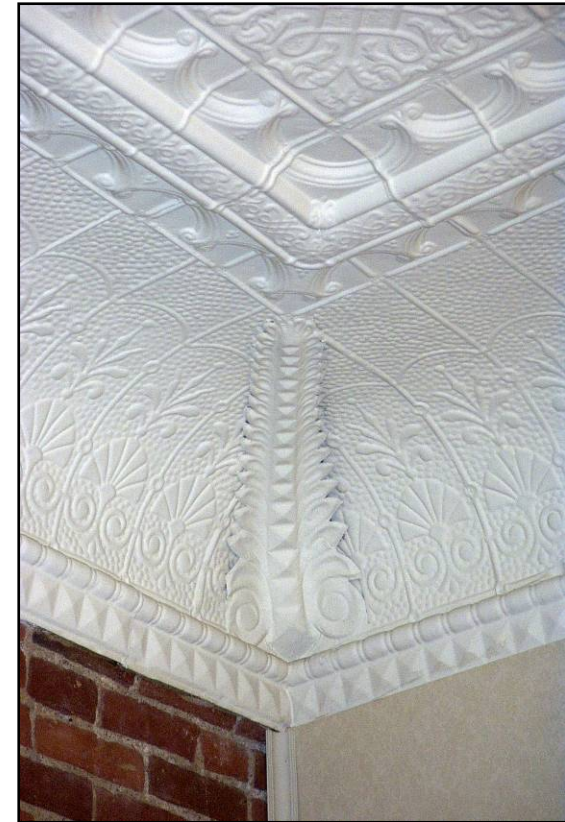
Tin ceilings should be checked for corrosion, staining, and other damage.

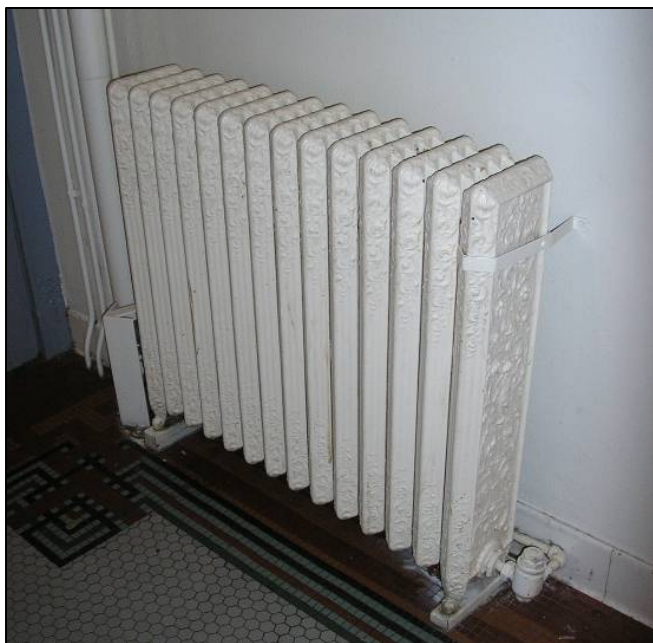
Prominent elements of historic mechanical systems, such as radiators, should be retained.

The condition and complexity of the mechanical systems in an historic building depend on several factors, including age, use, and climate. Hot water and steam were commonly used to heat buildings prior to World War II. These systems rely on the use of a boiler and associated radiators throughout the building. Forced-air heating systems using furnaces to heat the air were developed in the early 20<sup>th</sup> century. These systems incorporated ductwork and small registers throughout the building to distribute the heated air. By the mid-20<sup>th</sup> century, forced-air systems and their associated ductwork were used to distribute heated and cooled air through the same system. This breakthrough revolutionized how buildings are designed today. Historic buildings are not easily adapted to modern mechanical systems, therefore, maintenance of both old and new systems in an historic building can be particularly challenging. However, a well-maintained mechanical system is most often the best way to achieve energy efficiency in an historic building. At a minimum, heating and air conditioning equipment should be inspected by a skilled professional on an annual basis. Records should be kept on such maintenance examinations as well as on the hours of operation and fuel use of equipment. Changes or upgrades to systems may be made if they do not compromise historic building fabric. Because elements of historic mechanical systems such as radiators and decorative register covers are often times character-defining features of an historic interior, such elements should be retained even if equipment upgrades render their use obsolete.
