METALS NUMBER 1

Conserving Outdoor Bronze Sculpture

THADDEUS KOSCIUSZKO MONUMENT Washington, D.C.

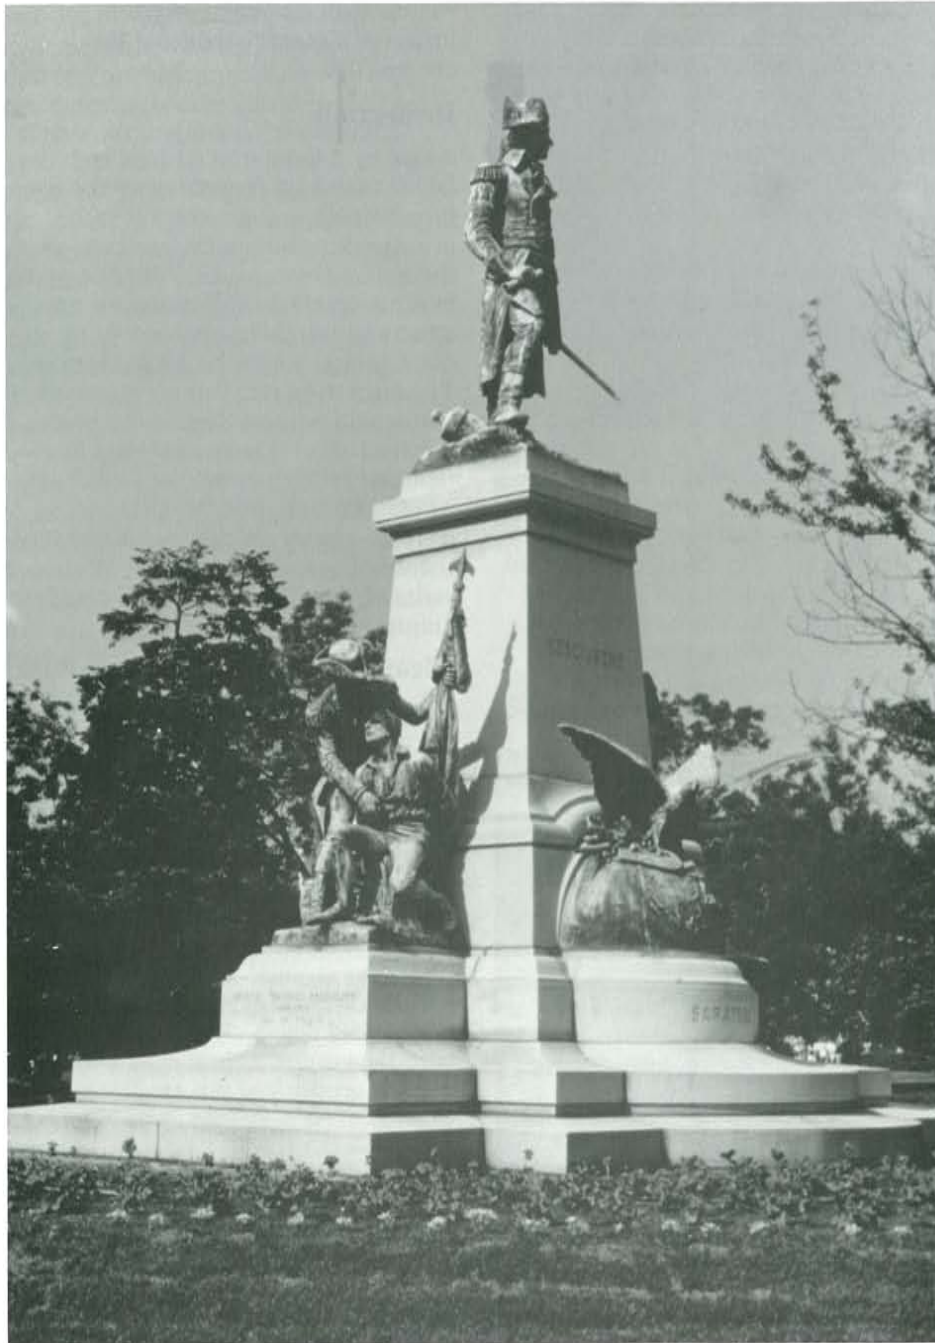
The Kosciuszko Monument is one of four sculptural memorials erected between 1890 and 1910 at the corners of Washington, D.C.'s Lafayette Park, across from the White House. Five sculptural groups comprise the Kosciuszko Monument. Standing atop the granite pedestal is a ten-foot bronze portrait of the general holding a map of the fortifications he devised to safeguard Saratoga, New York, against British attack during the American Revolution. At the monument's base

are four subsidiary groups designed to recognize Kosciuszko's role in both America's revolution and in his native Poland's fight for independence from Russia. As with most historic bronze sculptural monuments, the five groups comprising this monument had corroded over the past 80 years and required conservation. The treatment selected included an air abrasive cleaning with pulverized walnut shells, followed by applications of a corrosion inhibitor and protective wax coatings.

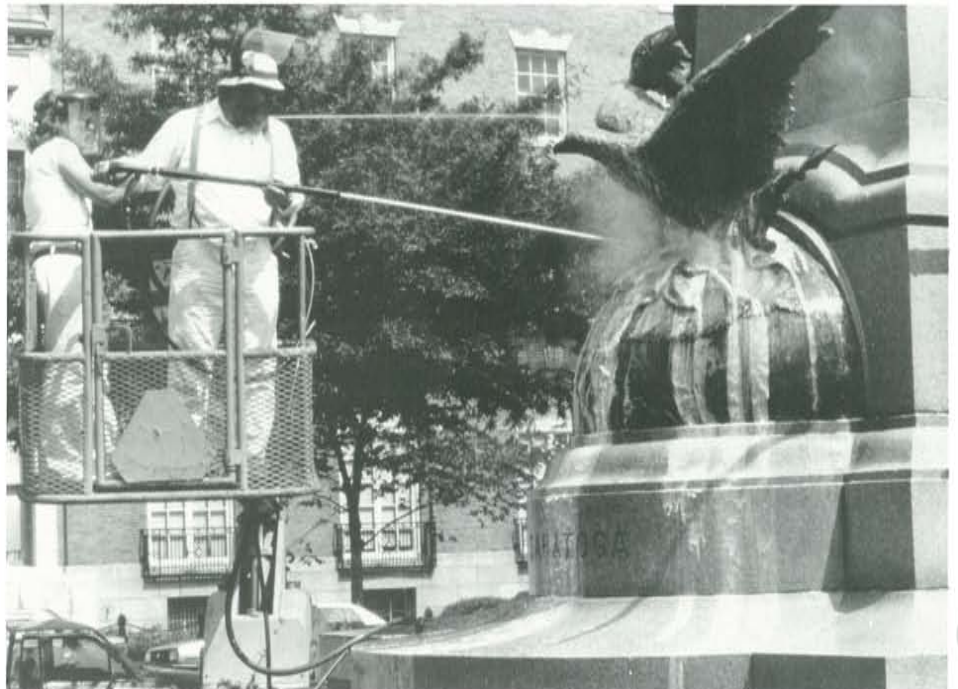
Figure 1. North sculpture group being pressure washed with detergent and water. Photo: Dennis R. Montagna

Cleaning began with a pressure washing using hot water (250 degrees Fahrenheit) and a non-ionic detergent at three gallon per minute (gpm) and 300–500 pounds per square inch gauged (psig) (*see figure 1*). This initial cleaning removed considerable amounts of encrusted bird droppings, twigs and leaves lodged behind sculptural groups, mud daubers' nests, and surface dirt and grime. Once the bronze had dried, cleaning continued with the ground walnut shell blasting, using a pressurized pot sandblaster, a

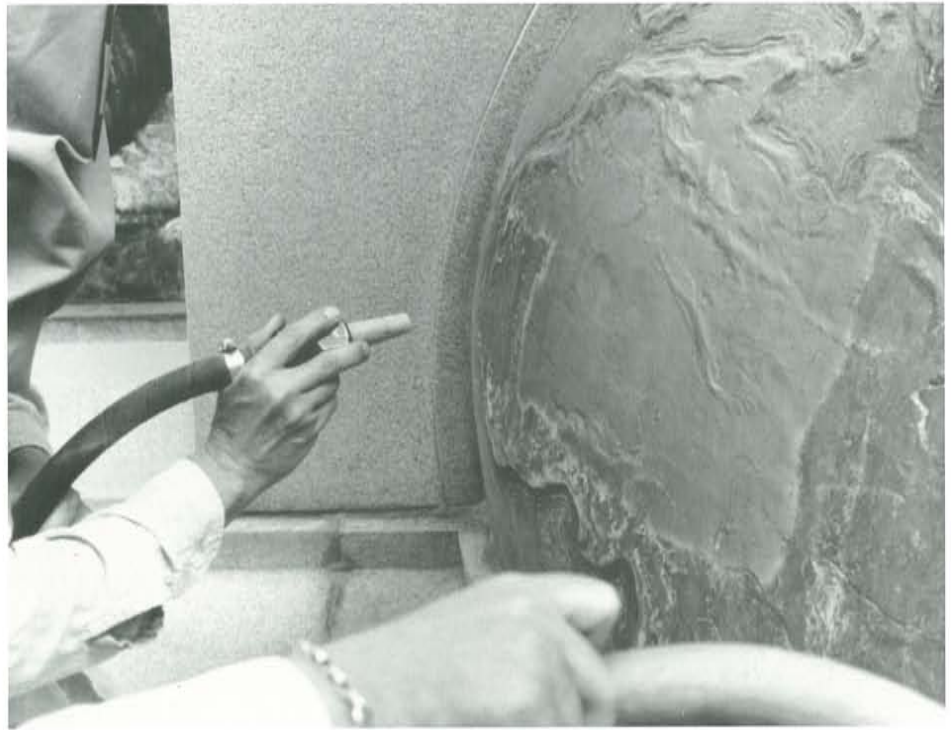
Figure 2. South sculpture group being cleaned with walnut shell blasting. Photo: Dennis R. Montagna

twelve-foot “sand hose”, and a 1/4-inch porcelain nozzle. Throughout the blasting, operating pressure was kept low, never exceeding 25–30 psig.

Operators maintained a normal working distance—measured from the nozzle tip to the statue’s surface—of three to six inches as they cleaned the sculptural groups, removing superficial dark grime and pale green corrosion products (see figure 2). An underlying denser layer of darker green corrosion products remained undisturbed. To achieve even cleaning and to avoid missing areas, the operators worked methodically. They tracked slowly, covering a small area of about 6 or 7 inches square at a time and being careful to always maintain a nozzle angle within 30 degrees perpendicular to the often undulating surface of the sculpture in order to obtain thorough and even cleaning.

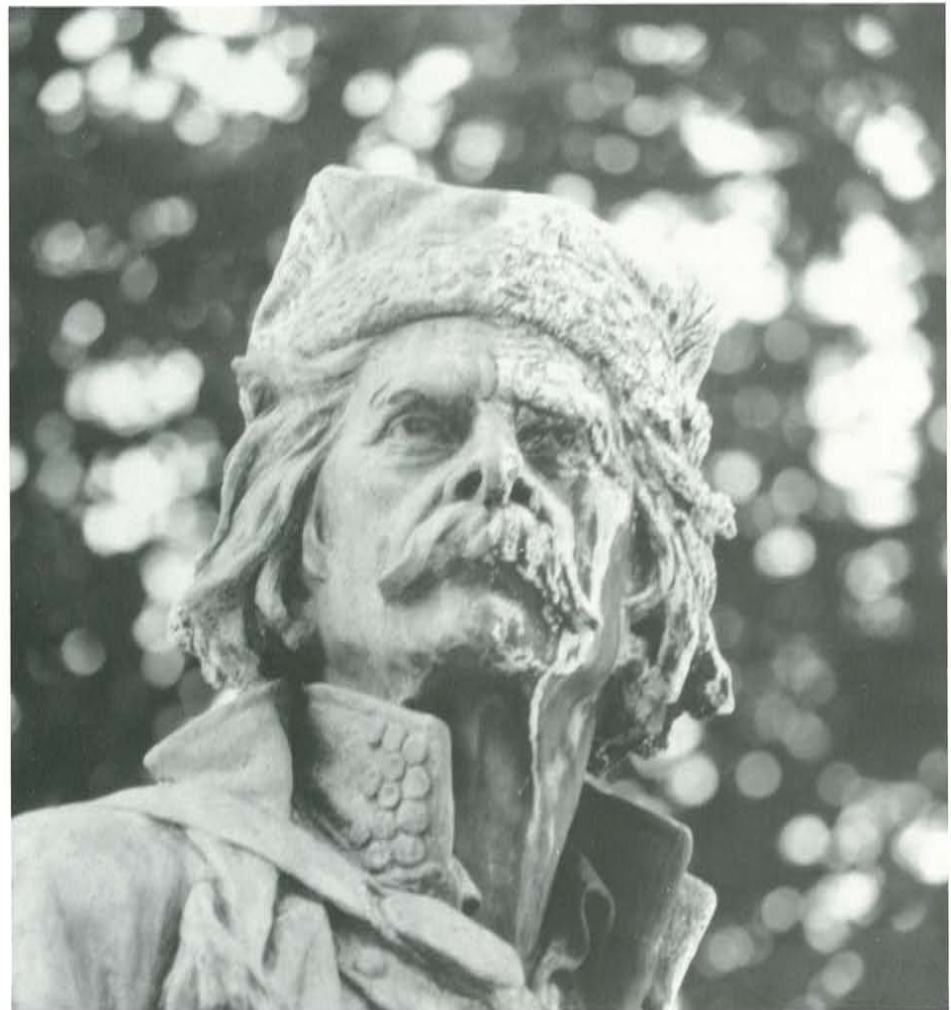
Figure 3. Detail of the west sculpture group, depicting a pair of soldiers. Left half of the face has been blasted and presents a more even appearance than the right half, which has not been blasted and exhibits the light/dark streaking common to corroded statuary. Photo: Dennis R. Montagna

As it removed surface grime and soft superficial corrosion, the walnut shell blasting procedure produced a smooth, clean surface that appeared darker and more uniform in color. There was also a noticeable reduction in the light and dark streaking that had characterized the surface before cleaning began. As a result, nuances of sculptural form became more easily discernible (see figure 3). The blasting process required approximately 750 pounds of 60/200 mesh ground walnut shells. Because the medium is biodegradable, no special measures were taken to contain or collect it.

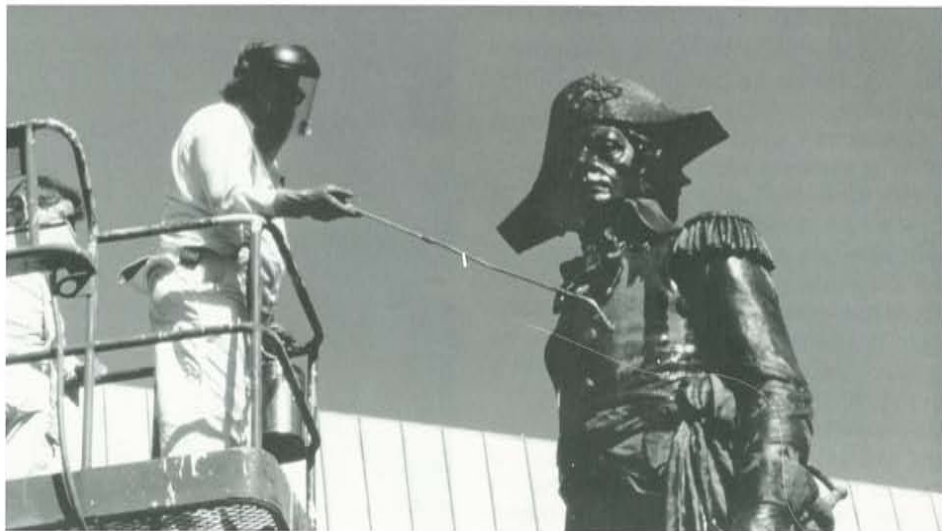
Figure 4. Solution of Benzotriazole (BTA) being sprayed onto the Kosciuszko portrait atop the monument after cleaning with walnut shells. Photo: Dennis R. Montagna

After the sculptural groups had dried, they were treated with a two percent solution of the corrosion inhibitor Benzotriazole (BTA) suspended in a 4:1 mixture of hot water and ethanol (see figure 4). The solution was applied using a pump sprayer of the type used by insect exterminators. The

initial application was followed by another about thirty minutes later. Areas most exposed to the ravages of the environment—arms, shoulders and heads—received additional coats. Crystalline deposits of BTA were evident in areas where pools of the solution collected, usually in depressions on the plinths. These were rinsed with water before proceeding to the final step in the treatment.

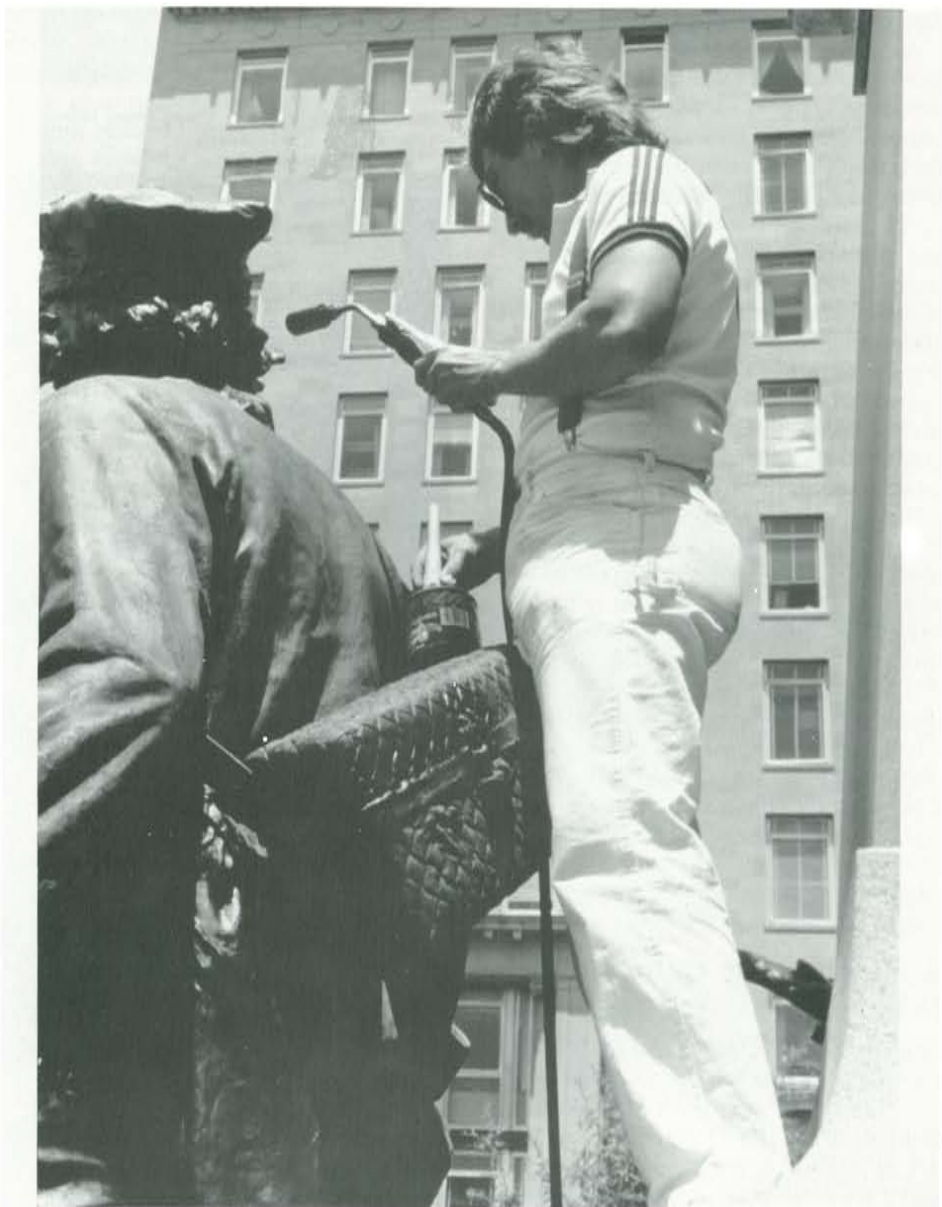
Figure 5. Heating the surface of the west sculpture group in preparation for the application of wax. Photo: Dennis R. Montagna

The application and buffing of a protective wax coating was the final step. It was also the most critical one, both for the final appearance of the conserved sculptural work and also for its long-term preservation. The waxing procedure used to treat the Kosciuszko Monument called for the use of propane torches to heat the bronze surface to approximately 175 degrees F, slightly above the melting point of the wax but well below the melting point of the welds used to join bronze sections (see figure 5). While heating areas of bronze adjacent to the granite pedestal, technicians used extreme care to protect the stone from heat. Failure to do so could have seriously damaged the stone's surface by cracking the minerals in the granite.

Once the metal had reached the appropriate temperature, discernible when the applied wax would melt on contact, a prepared mixture of microcrystalline waxes, mineral spirits and BTA was applied sparingly with short bristled natural brushes (See Project Data section for components of the wax). To apply the wax, a scrubbing or jabbing motion was used to insure thorough coverage in corrosion-produced pits and irregularities in the surface that had resulted during casting. Once the bronze had received a coating of wax, it assumed a much darker green-brown color, a semi-glossy surface, and an overall uniformity of appearance far beyond that produced by the earlier walnut shell blasting (see figure 6). A second coating of wax was applied using the same method described above. The technicians found that less heat from the torches was needed during the second waxing. Because the sculptural groups had darkened with the first application, they attracted more solar radiation and therefore reached the necessary working temperature more rapidly. In addition, the technicians were careful not to apply excessive

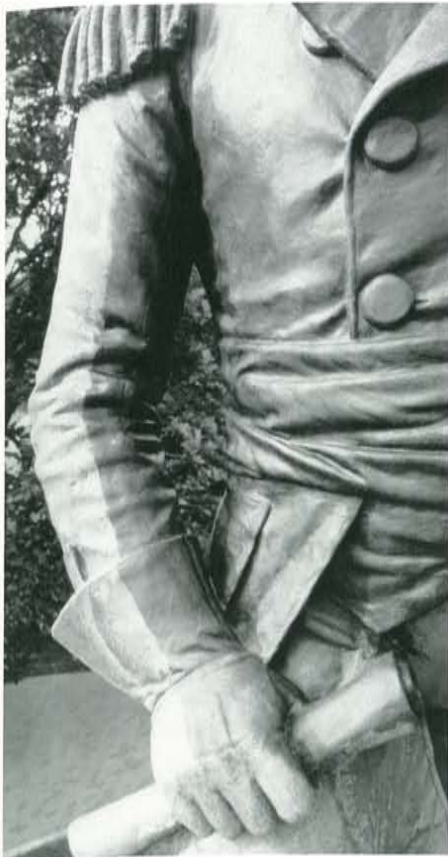
Figure 6. Detail of the Kosciuszko portrait. The chest and inside section of the arm has received its first coating of wax. The outside section of the arm has not.
Photo: Dennis R. Montagna

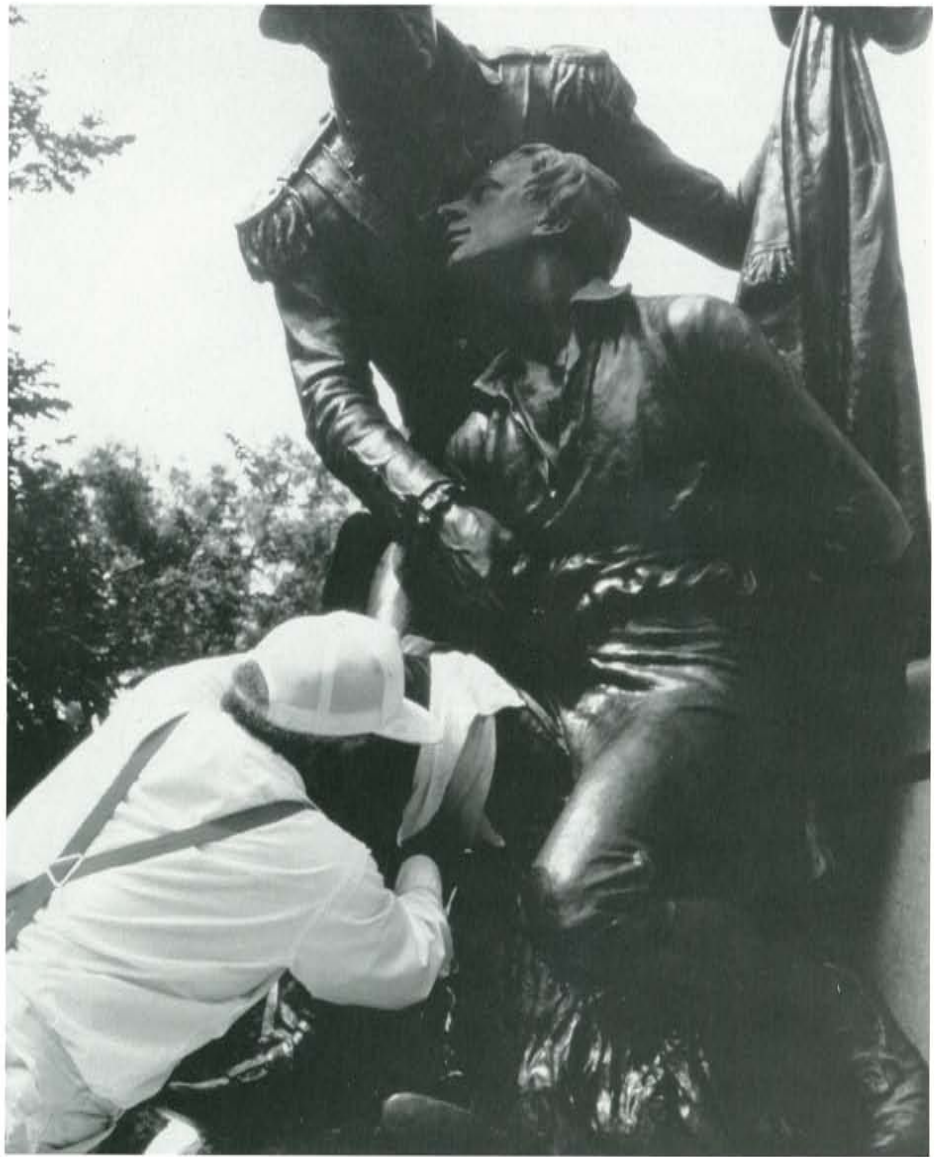
Figure 7. East sculpture groups being buffed after it had received its final wax coating.
Photo: Dennis R. Montagna

The second waxing served two purposes. Primarily, it provided a thicker and more durable protective layer. In addition, it enabled the technicians to detect and fill any areas they may have missed during the initial waxing. After completing the second wax coating, the statues were allowed to cool, expedited by being sprayed with water from a garden hose. Once they were cool and dry, a final paste wax coating was thinly applied without using heat. Soft brushes and damp terrycloth rags were used to apply the paste in much the same manner one would use to wax an automobile. Allowed to cool overnight, the final wax coat was lightly buffed to a gloss with barely damp terrycloth towels (see figure 7). Like the additional coating of BTA discussed earlier, the final application of a cold wax concentrated on the more highly exposed areas that were subject to greatest atmospheric degradation. The final waxing also helped to remove any brushstrokes that may have remained from the two hot waxings (see figure 8).

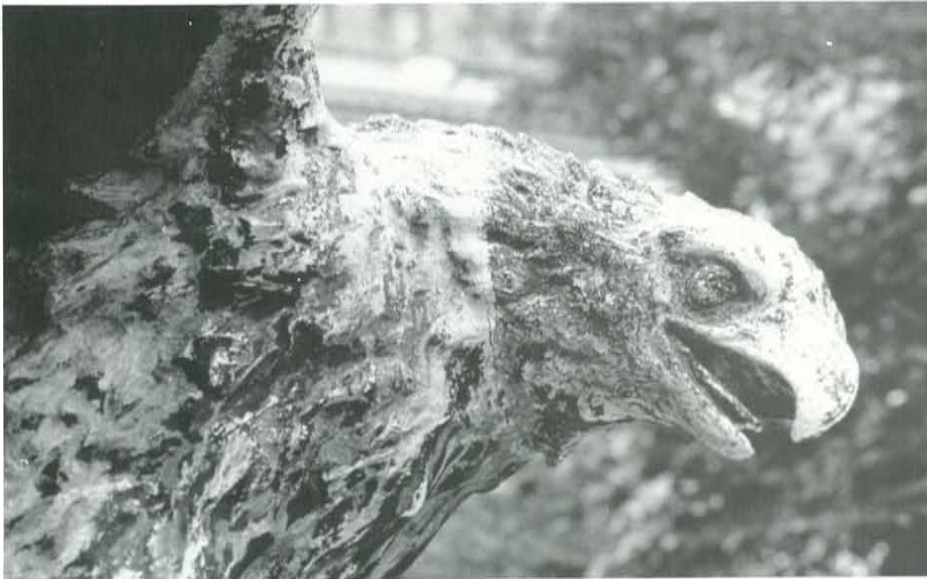
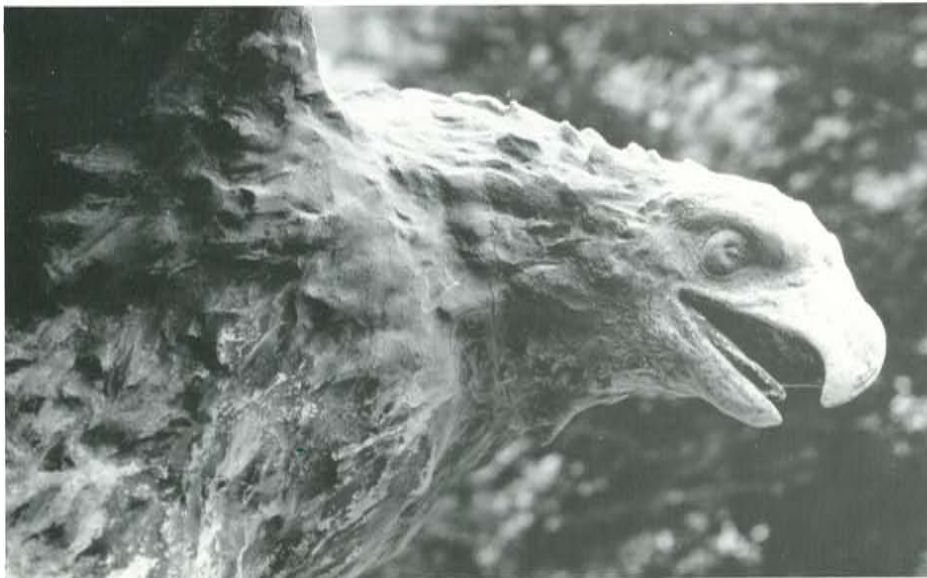
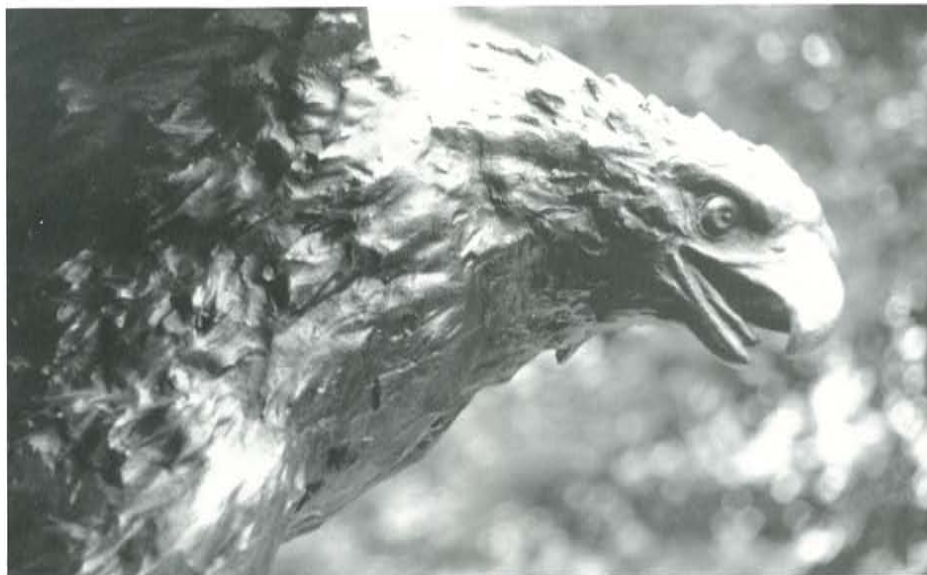
a. Before

b. During

c. After

Figure 8. Details of the eagle's head from the south sculpture group: (a) before cleaning began, (b) following walnut shell blasting, (c) following final waxing and buffing.
Photos: Dennis R. Montagna

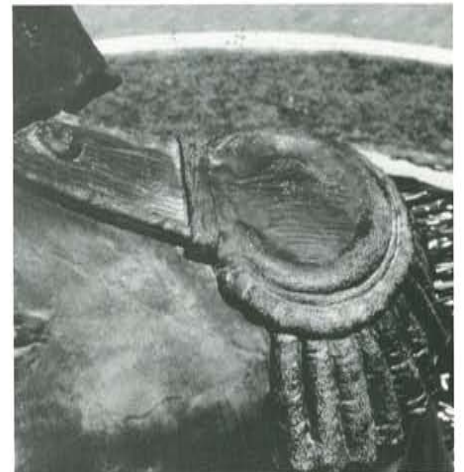
In June 1988, the bronze groups comprising the Kosciuszko Monument received their first annual inspection and subsequent maintenance. The inspection revealed that the wax coating remained in good condition except on those areas most exposed to the environment—shoulders, the tops of heads, and other similar areas (see figure 9). As anticipated, with little of the protective wax remaining, these areas had assumed a matte appearance and were beginning to return to a paler green color. After the inspection, all of the bronze groups were washed with a non-ionic detergent in cold

Figure 9. Detail of Kosciuszko's right epaulet [photo taken in June, 1988] showing degradation of the wax coating that occurred during the year following its initial cleaning and waxing.
Photo: Philip Walsh

water. Wax was then reapplied to the areas that had suffered degradation by using the hot waxing procedure that had been used during the initial work the previous summer. A cold paste waxing and buffing of all bronze surfaces then followed, carried out at ambient temperature.

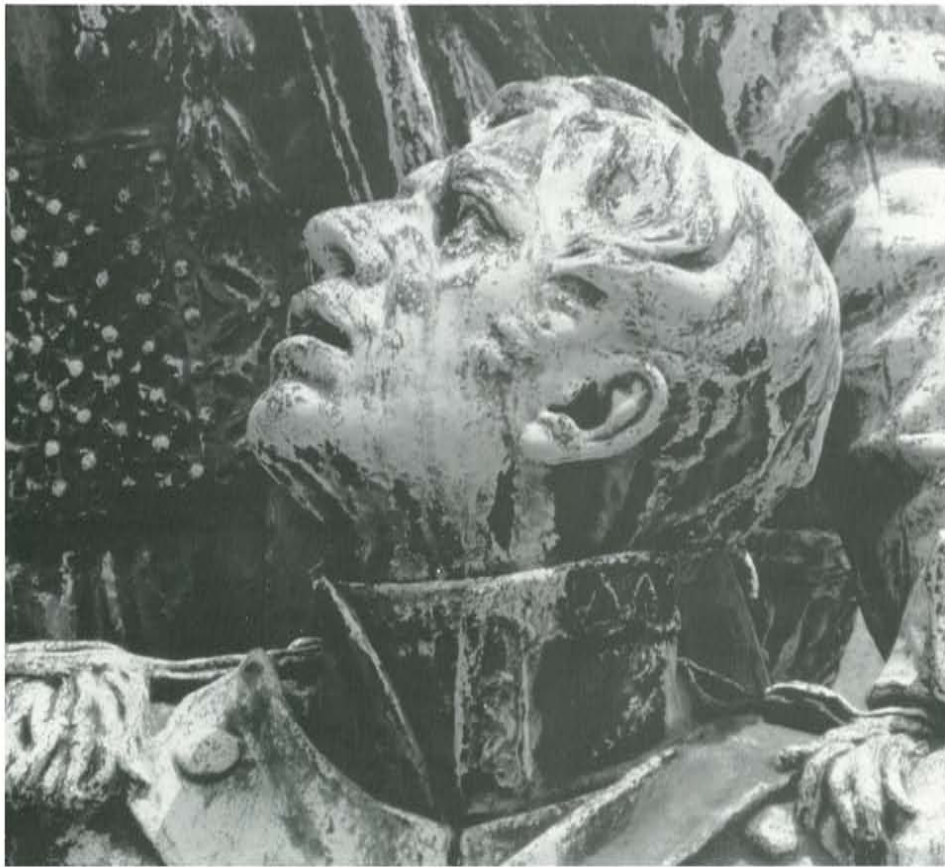
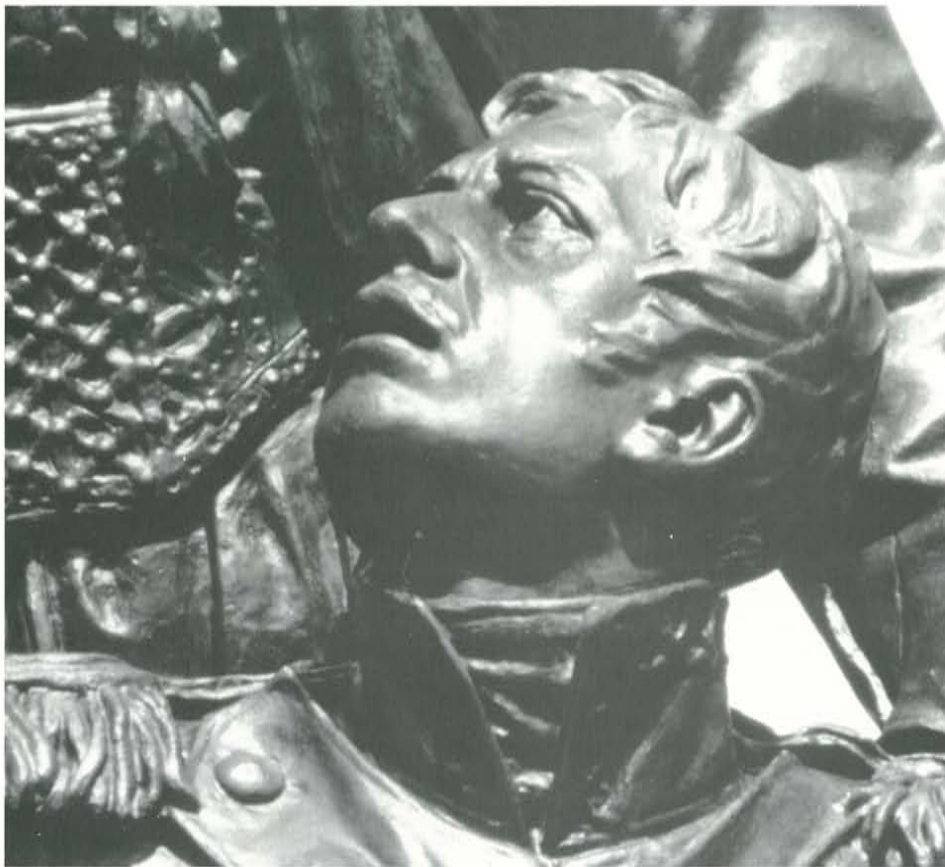
Before

After

Figure 10. These two views, taken before and after the conservation work, reveal how the aesthetic qualities of the original bronze sculpture have been restored, using walnut shell blasting, without removal of original fabric that is common in more aggressive cleaning methods.
Photos: Dennis R. Montagna

With the measures taken to clean and wax the bronze statuary of the Kosciuszko Monument, the statues regained the uniform color and the metallic sheen they had possessed before being subjected to years of neglect and the vicissitudes of a hostile environment (*see figure 10*). Moreover, with regular low-cost maintenance, these statues can be protected from further environmental degradation. Unlike other cleaning methods that remove all existing corrosion, those described here represent minimal intervention and, in accord with accepted conservation standards, are reversible.
