# Tech Notes

## HISTORIC INTERIOR SPACES

### Preserving Historic Corridors in Open Office Plans

#### **FIDELITY-PHILADELPHIA TRUST BUILDING** Philadelphia, Pennsylvania

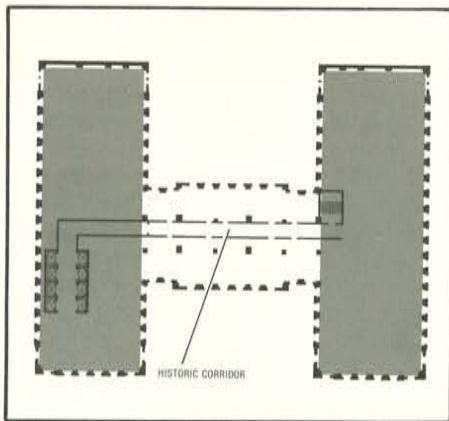
Figure 1. The double-loaded corridor, which forms the cross-bar of the H-shaped plan on each of the upper floors, is significant to the historic character of the building. Drawing: 2 Chris Henry.

The double-loaded corridor on each of the office floors, which forms the cross-bar of the H-shaped plan, is a significant feature of the interior, and these corridors are important surviving elements of the historic office plan (see figure 1). While various offices have been altered over time, the corridors retain a high degree of architectural integrity; their historic appearance and materials, including original light fixtures, marble floors and marble wainscoting, paneled doors, and wooden trim, have all survived largely intact.

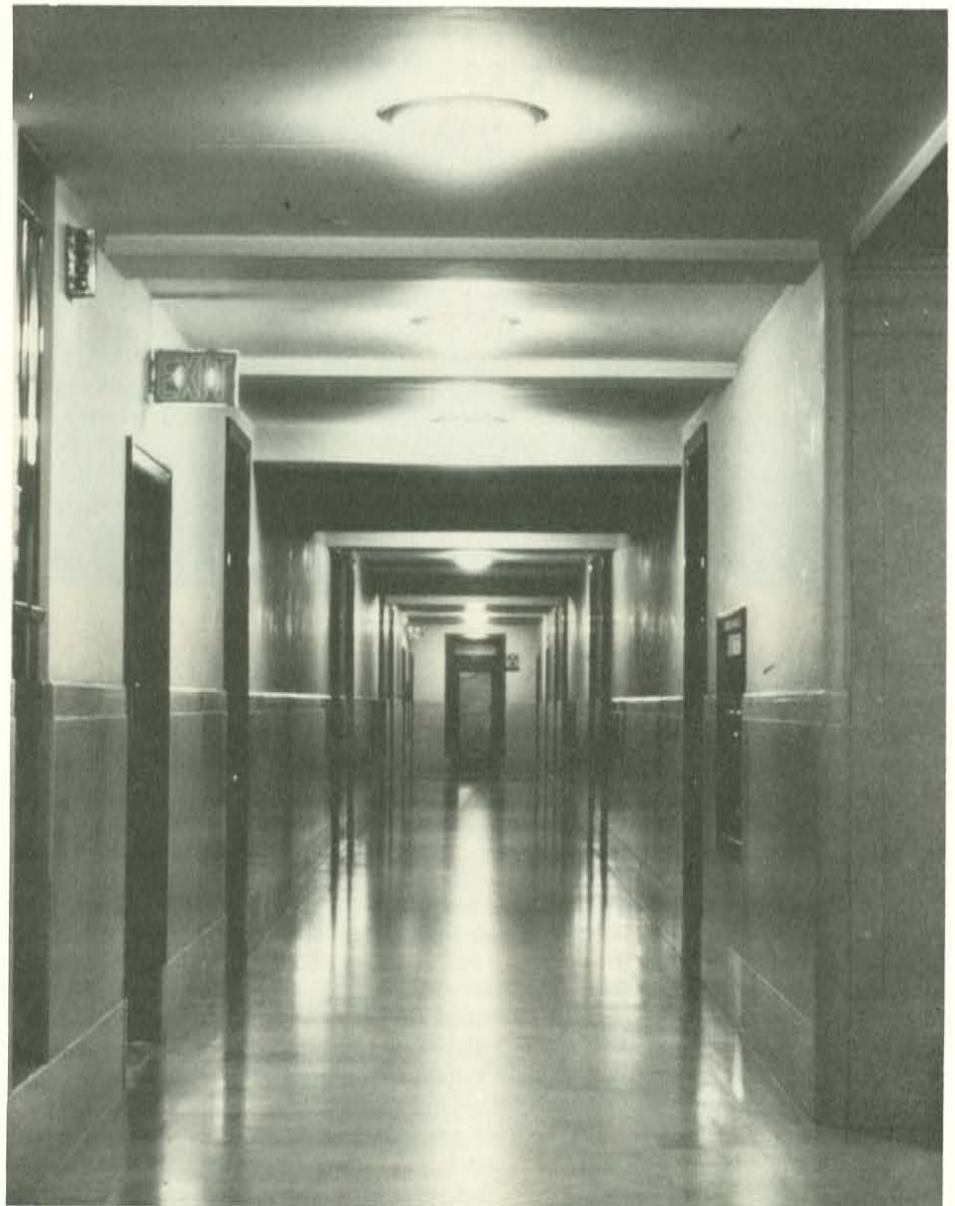
Figure 2. The central corridors, which help define the historic office plan, retain a high degree of architectural integrity, including the marble wainscoting and original light fixtures. Photo: Tom Crane.

Two factors were recognized quite early in the planning. First, any office plan selected would still require an ordered circulation spine from the elevator lobby to the far end of the hall where additional offices were located — a function currently served

by the historic corridor (see figure 2). Second, the design solution chosen would have to improve the lighting, since the halls, still lit by the historic fixtures, were considered too dim and the long windowless corridor created an extensive "tunnel" effect.

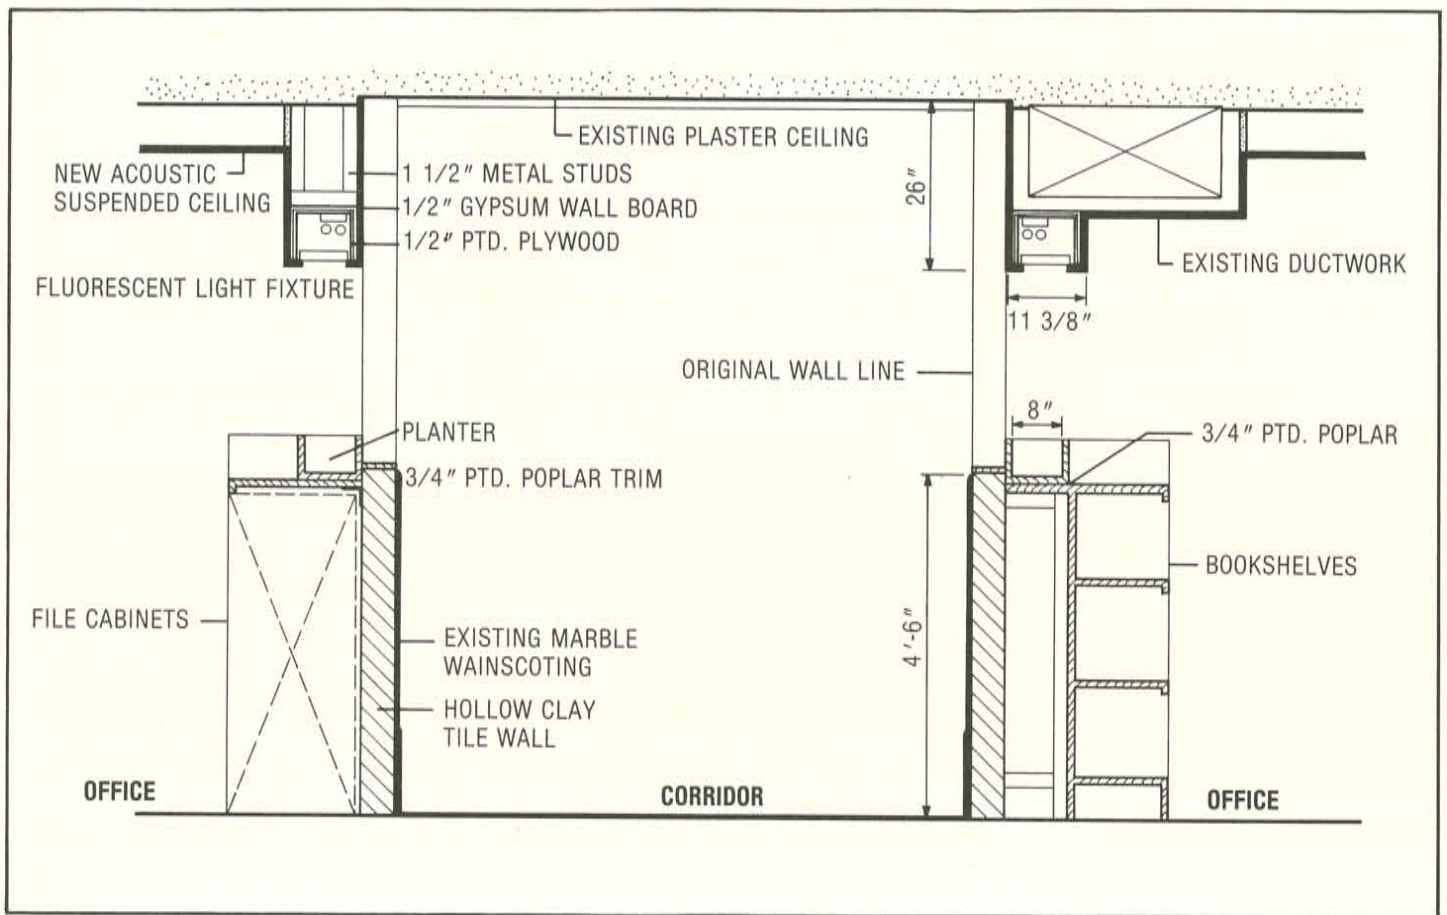
**Figure 3.** The innovative rehabilitation solution involved removing sections of wall above the marble wainscoting, leaving the historic door frames and transoms in place, and constructing soffits above. Drawing: Chris Henry.

The innovative solution arrived at by the design team involved modifications that satisfied the concerns of the bank management and yet substantially preserved the central corridor. Along the corridor, sections of the plaster-covered clay tile wall were removed above the wainscoting and a soffit constructed above, leaving the historic door frames and transoms in

place, and forming a series of window-like openings which introduced visual continuity across the office floor (see figure 3).

Window-like openings were created by removing selected sections of the existing plaster-finished 6" thick walls while retaining many of the significant hall features and preserving a sense of the historic corridor (see figure 4). The 4'-6" height of the historic marble wainscoting which was being retained in place determined the height of the lower wall sections. To finish off the lower wall section, the marble cap along the upper edge of the wainscoting served as a trim piece (see figure 3). During

Soffits were constructed, extending from the ceiling, directly above the new built-in file cabinets and bookcases (see figure 3). The soffits establish visual continuity along the upper wall of the corridor, horizontally connecting the door frames and

The soffits are simple boxes constructed of poplar and plywood faced with drywall. The soffits located beneath the 18" high duct on one side are 11 3/8" deep and 8" high. On the opposite side the soffits are 26" high so that the visual appearance of the two sides along the corridor is identical (see figure 3). Since the soffits are set back from the corridor wall line, a 6" gap in the corridor ceiling had to be patched.

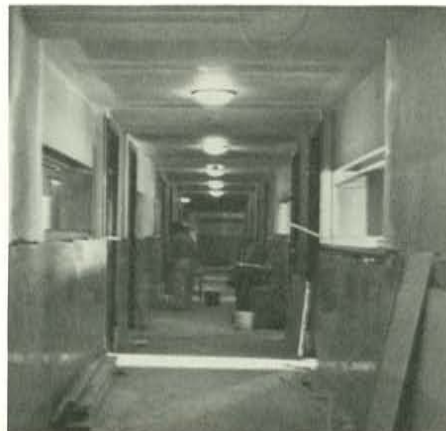
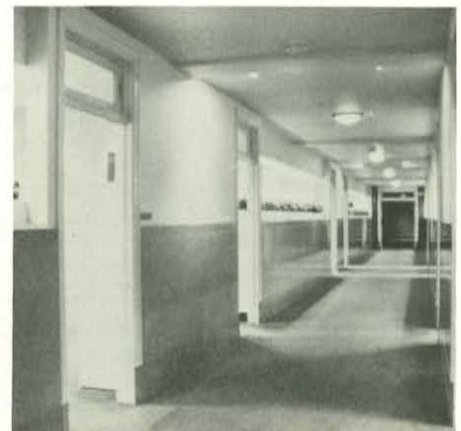
**Figure 4.** The window-like openings introduced by the wall removal greatly reduced the "tunnel" quality of the corridor and noticeably opened up the office spaces. Photos: Chris Henry.

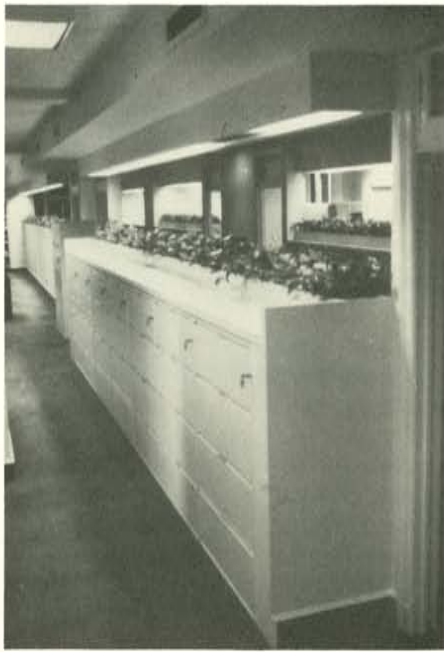
**Figure 5.** Banks of file cabinets and shelving were set flush against the existing wall and enclosed on the sides and tops. Photo: Nelson & Associates.

Flush to the existing corridor wall, on the office side, file cabinets and bookcases were installed, enclosed on the sides and tops with poplar in order to give a more uniform appearance (see figure 5). Planters were constructed on top of the built-in units flush to the back side of the existing corridor wall and extending approximately 5" above the height of the wainscoting. The built-in planters provide screening so that employees working at desks near the wall would not be distracted by corridor traffic and so that their workspaces would not be readily visible from the hallway. The planter boxes, 6" deep and 8" wide, were constructed of poplar and have a waterproof liner. For the boxes, heart-leafed philodendron plants were selected because of their low height, fullness and ease of care. As a final step, the stored marble pieces were replaced and the historic marble cleaned with a mild detergent.

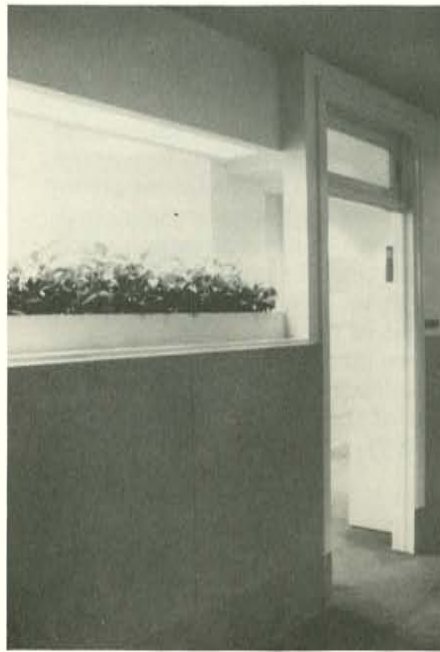
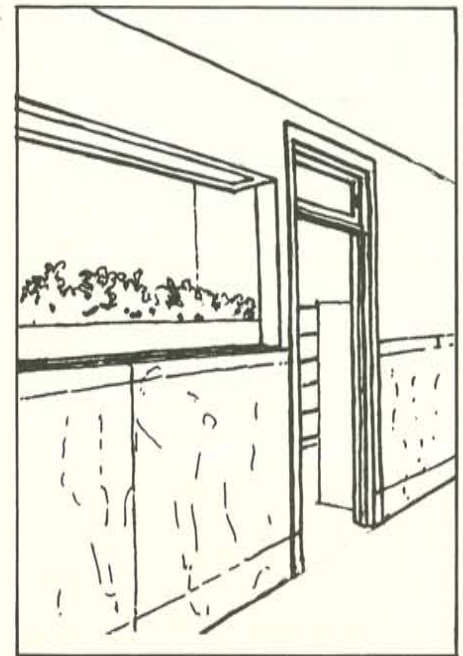
**Figure 6.** An alternate detail retaining the soffit at the original corridor wall plane would achieve a greater visual continuity of the historic walls, ceilings and doorways. Photo and Drawing: Chris Henry.

An alternate design solution for the soffit that might be considered in similar situations involves aligning the soffit with the plane of the historic marble wainscoting rather than setting it back from this wall (see figure 6). By retaining the historic wall plane in the corridor, the necessity for extensive repair of the ceiling could be avoided. In addition, the upper frames of the doors would not project as they do in the Fidelity Building and there would be greater

visual continuity between the half and full wall sections as they are perceived down the hall.

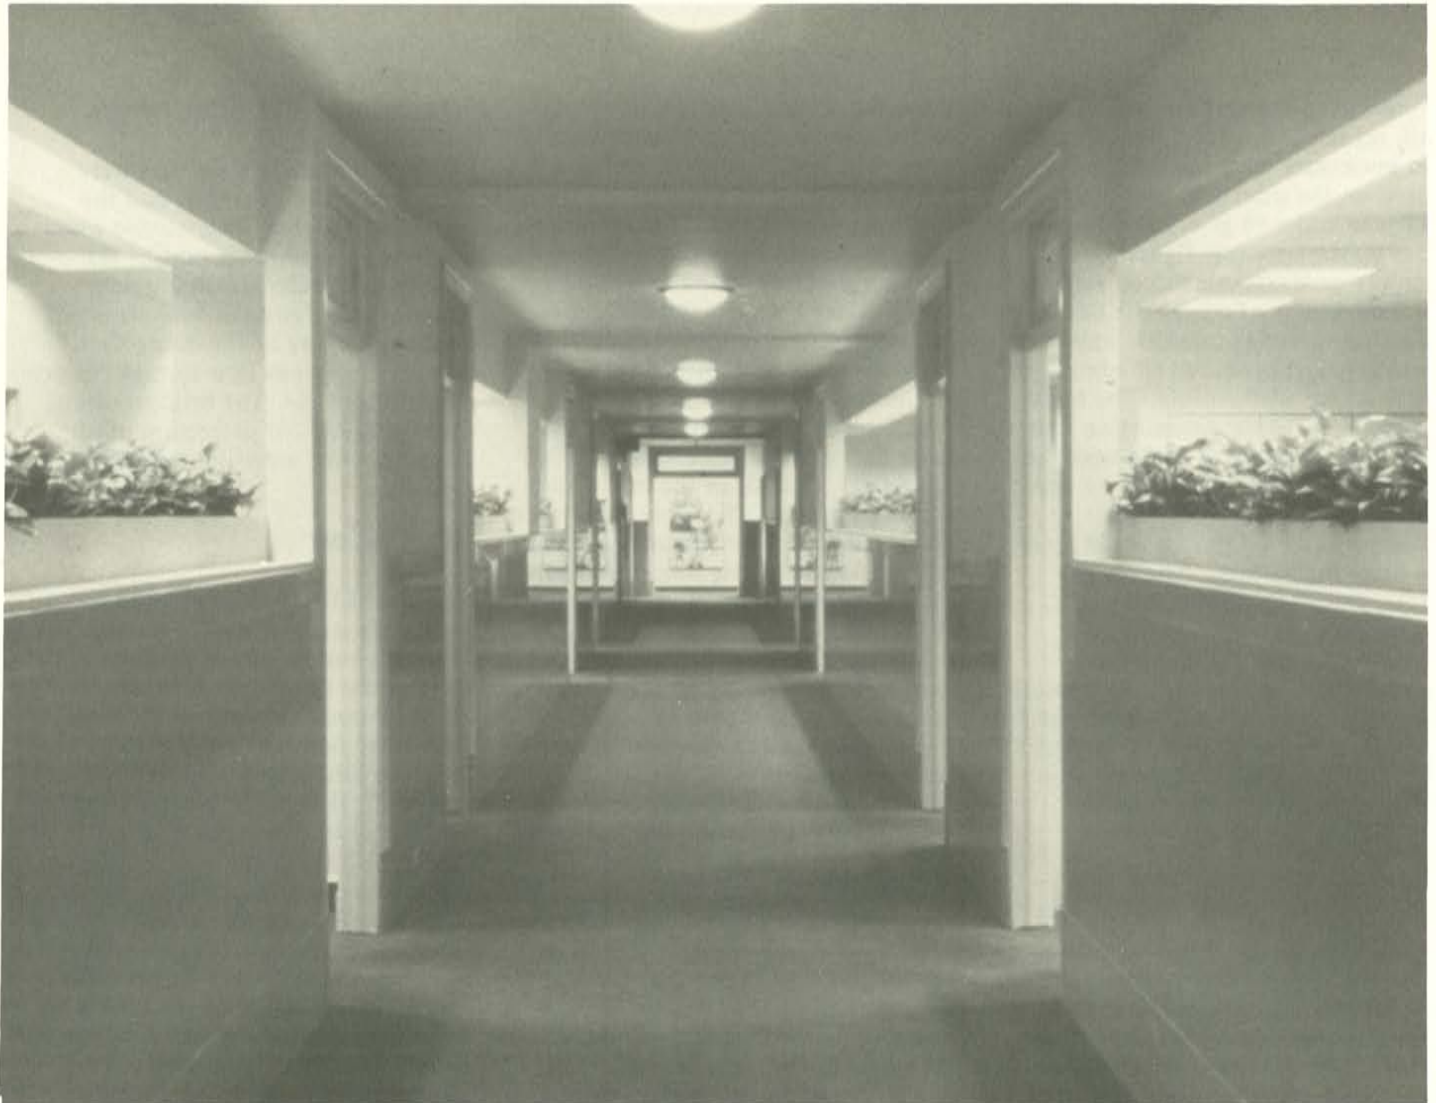
**Figure 7.** The historic double-loaded corridor plan, most of the hallway's significant features and sense of space have been retained while utilizing an innovative design to achieve a more open, flexible office plan. Photo: Tom Crane.

nificant, the hall detail is richer, or the historic office space off the corridors is finer, such a design solution as described may not be appropriate, because the significance of such features would warrant more complete preservation. The conditions present at the Fidelity Bank, however, lent themselves to some alteration work. The successful results can be attributed to sensitive planning and a willingness of the bank management to explore innovative design solutions appropriate to their needs and to those of the historic building (see figure 7).
