## SITE

### NUMBER 1

## Restoring Vine Coverage to Historic Buildings

### **FAIRSTED** **Frederick Law Olmsted** **National Historic Site** **Brookline, Massachusetts**

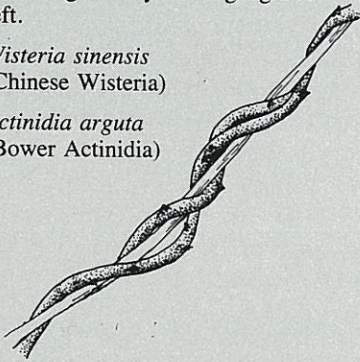
### Twining

Vines may climb by twining from left to right or by twining right to left.

*Wisteria sinensis*  
(Chinese Wisteria)

*Actinidia arguta*  
(Bower Actinidia)

growth habits. *Twining* vines climb by sending out shoots that wrap around objects and grow in both length and width. As the vine grows thicker, it can constrict these objects, causing features such as louver shutters to snap under the increasing pressure. Furthermore, the spreading shoots penetrate openings and crevices. In time, the growing vine can loosen and separate building materials.

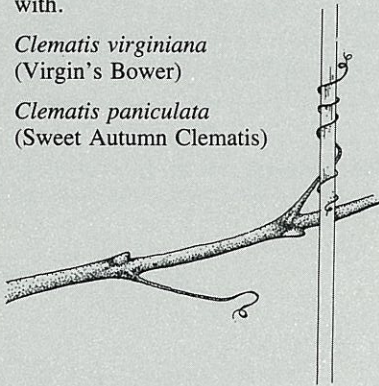
### Tendrils

The tendrils wrap themselves around anything that they come in contact with.

*Clematis virginiana*  
(Virgin's Bower)

*Clematis paniculata*  
(Sweet Autumn Clematis)

Like twining vines, *tendrils* vines wrap around objects for support. Because they are actually extended leaves, tendrils do not grow in width, only in length. Both twining and tendril vines, however, can break weather seals on wooden facades, separating wood shingles and siding, as well as fascia and soffit boards on porches. Other vine types include *Aerial* vines which grow small roots along the length of the stem. These rootlets cling to the wall and can force their way into crevices. The fineness and density of the rootlets makes

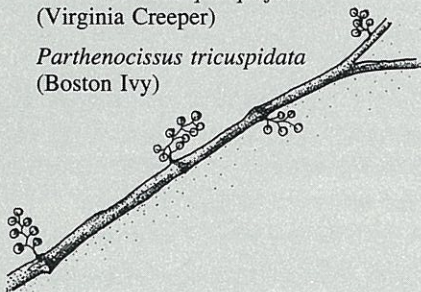
### Creeper

This vine clings by sending out small tendrils with adhesive discs that attach themselves to surfaces.

*Parthenocissus quinquefolia*  
(Virginia Creeper)

*Parthenocissus tricuspidata*  
(Boston Ivy)

removal difficult. *Creeping* vines have tiny adhesive pads that cling to the building surface. Commonly found on masonry brick buildings, creeping vines do not generally cause extensive damage to structures while growing, although they may abrade softer mortar. However, they attach themselves so thoroughly to the building surface that paint, mortar, and brick are likely to be damaged when the vines are removed.

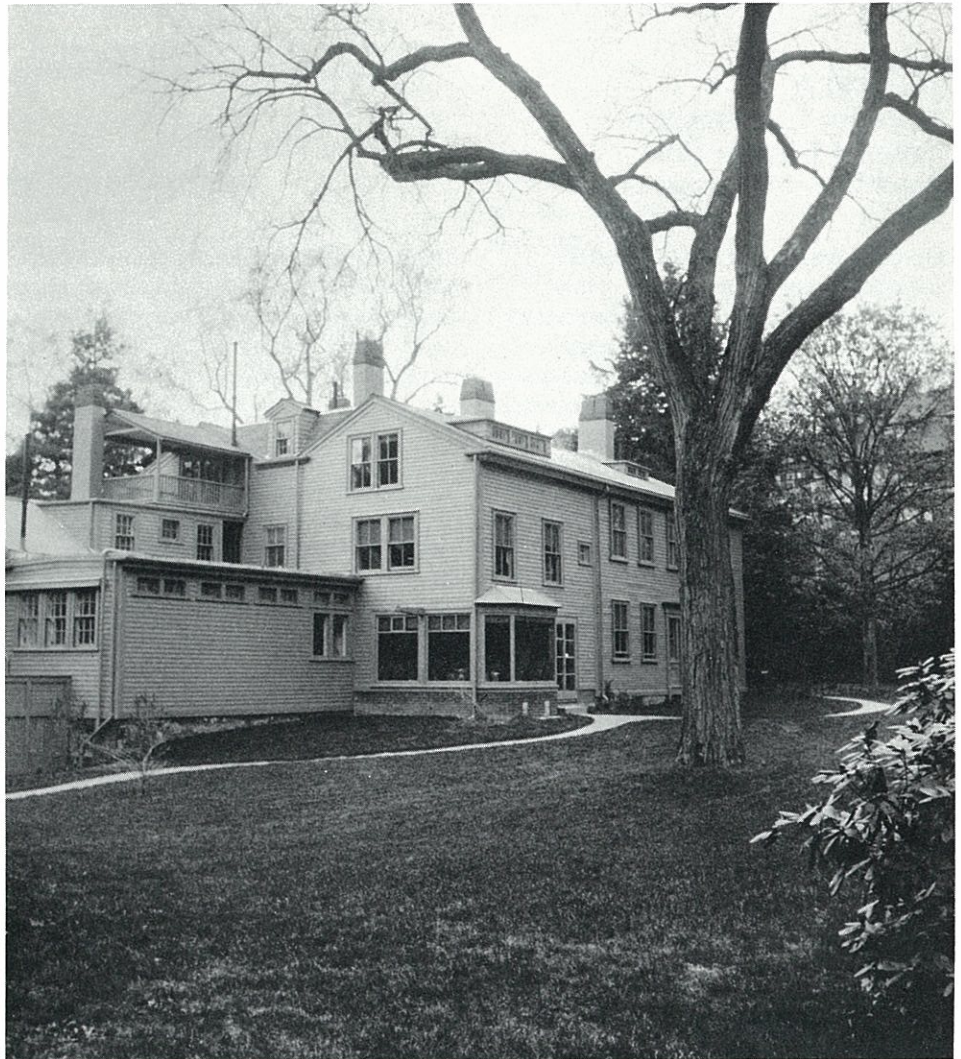
Figure 1. Historic plant materials can be retained while restoration of the historic structure is underway. The *Wisteria* and *Actinidia* vines that were historically used by Olmsted, were cut back during the restoration of Fairsted in 1988. Photo by Charles Pepper, courtesy of the Olmsted National Historic Site.

In 1980, The National Park Service began structural restoration of the house at Fairsted. To facilitate this work, the historic vines were removed from the facade and cut back to the ground. Since the vines were both historic plant material and an important feature of the property, complete removal was avoided. The vines were kept at ground level, but pruned frequently to prevent reattachment to the house. This situation resulted in weakened plant growth and an appearance quite different from

Olmsted's intention (see figure 1). Furthermore, long-term frequent pruning risked a higher incidence of pest-related problems to the plants and restricted their natural climbing habit. It was therefore important to the public site that a new trellis system be devised that would protect both the historic vegetation and the historic structure, while re-establishing the appearance of a "vine clad mansion."

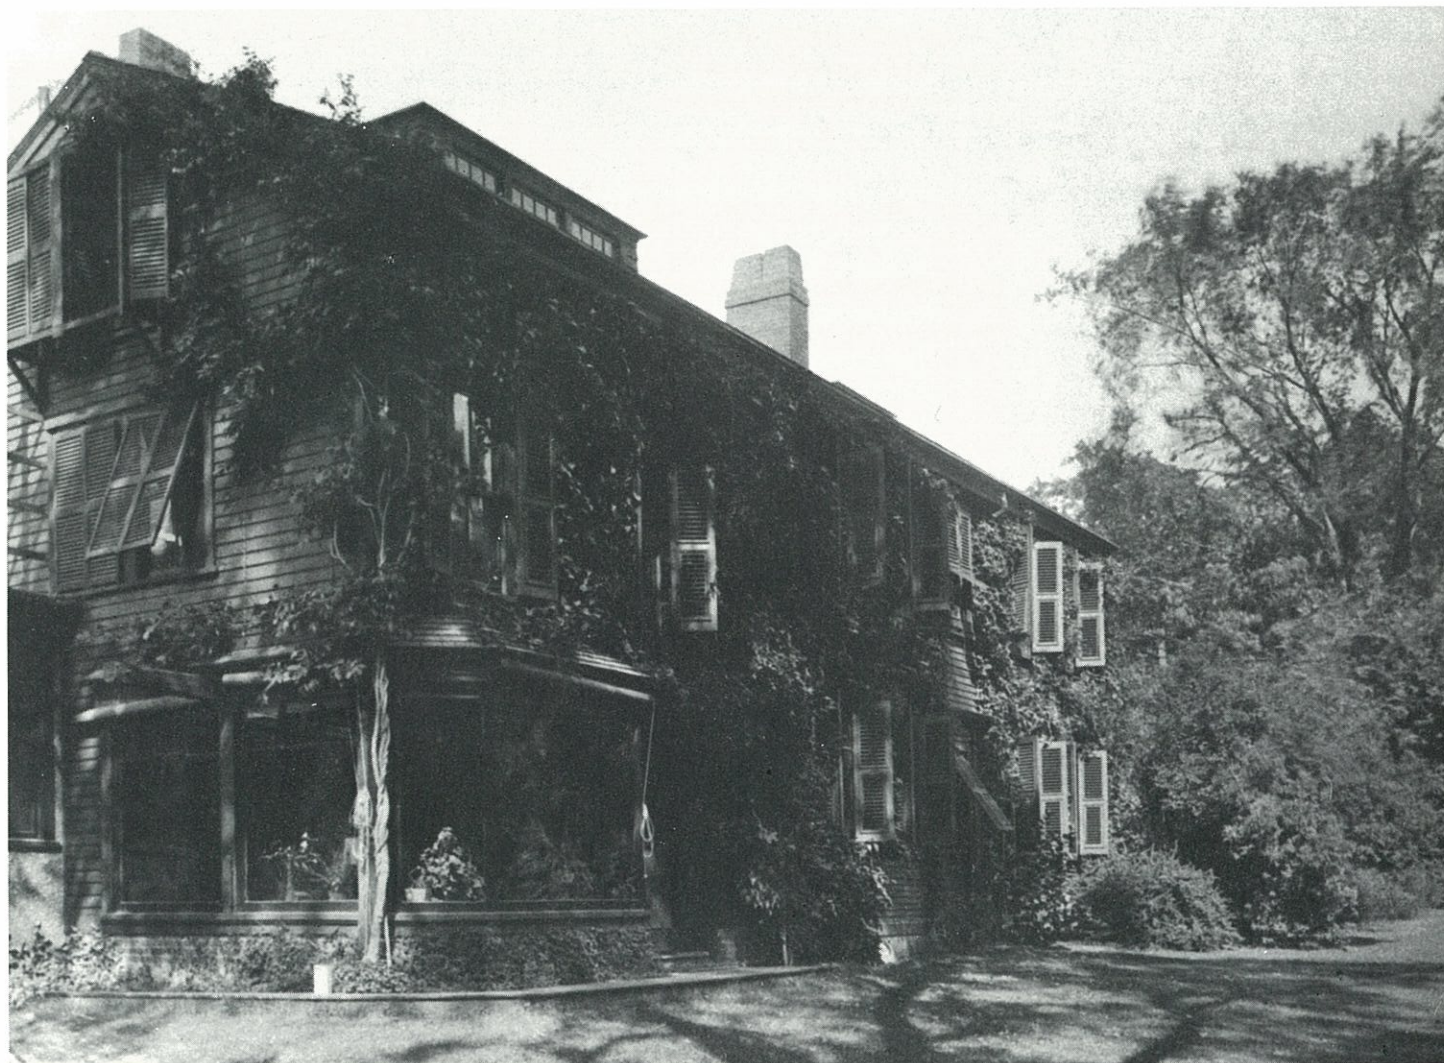
Figure 2. View of the west elevation at Fairsted which shows a steel strapping trellis system built as early as 1884. Photo courtesy of Olmsted National Historic Site.

Development of a new trellis system began with research into the materials, techniques and hardware used in New England between 1880 and 1930, as well as specific investigation into the various techniques used at Fairsted during those years. Historically, the east elevation of the house had two trellis structures supporting *Wisteria sinensis* (Chinese Wisteria). Photographs from as early as 1884 show a wooden trellis system at the entry porch and a spiraled steel strapping system along the house facade (see figure 2). Remnants of these

systems, such as eyebolts and hooks, were found intact at several locations on the structure. The kitchen wall had an interesting trellis consisting of posts with protruding pegs located between windows. Holes in the post indicated that pegs could be added or removed depending on the growth of the plant.

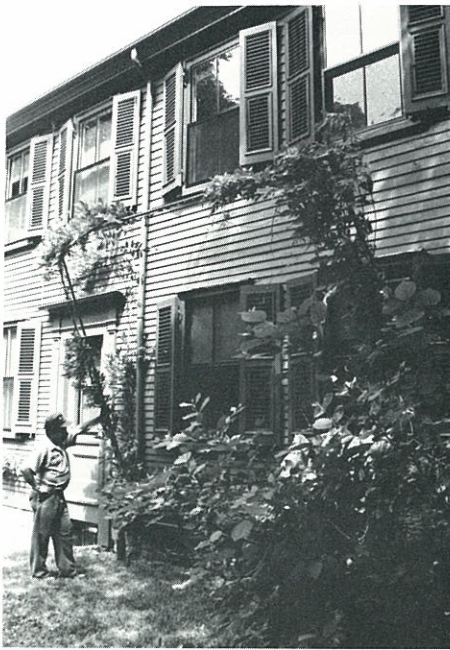
**Figure 4.** The pipe and strapping system, constructed with swivel sockets, allows the rigid support system to fold down away from the house. The strapping can also be removed from the pipe support for limited maintenance. Photo by Karen Day.

More than one person is required to remove this system. The rigid system folds out away from the house on the swivel sockets near the base of the house (see figure 4).

Materials: spiraled steel strapping, galvanized metal pipe, fittings, eyebolts, and swivel sockets. This solution is a combination of spiraled strapping, galvanized metal pipe and fittings. Eyebolts will separate the strapping from the supporting pipe structure. Swivel sockets near the base of the pipe structure allow the trellis to be tilted away from the house. This combination system provides a historic trellis appearance with the addition of rigid support. The vines are physically separated from the house, thus reducing potential damage to the facade.

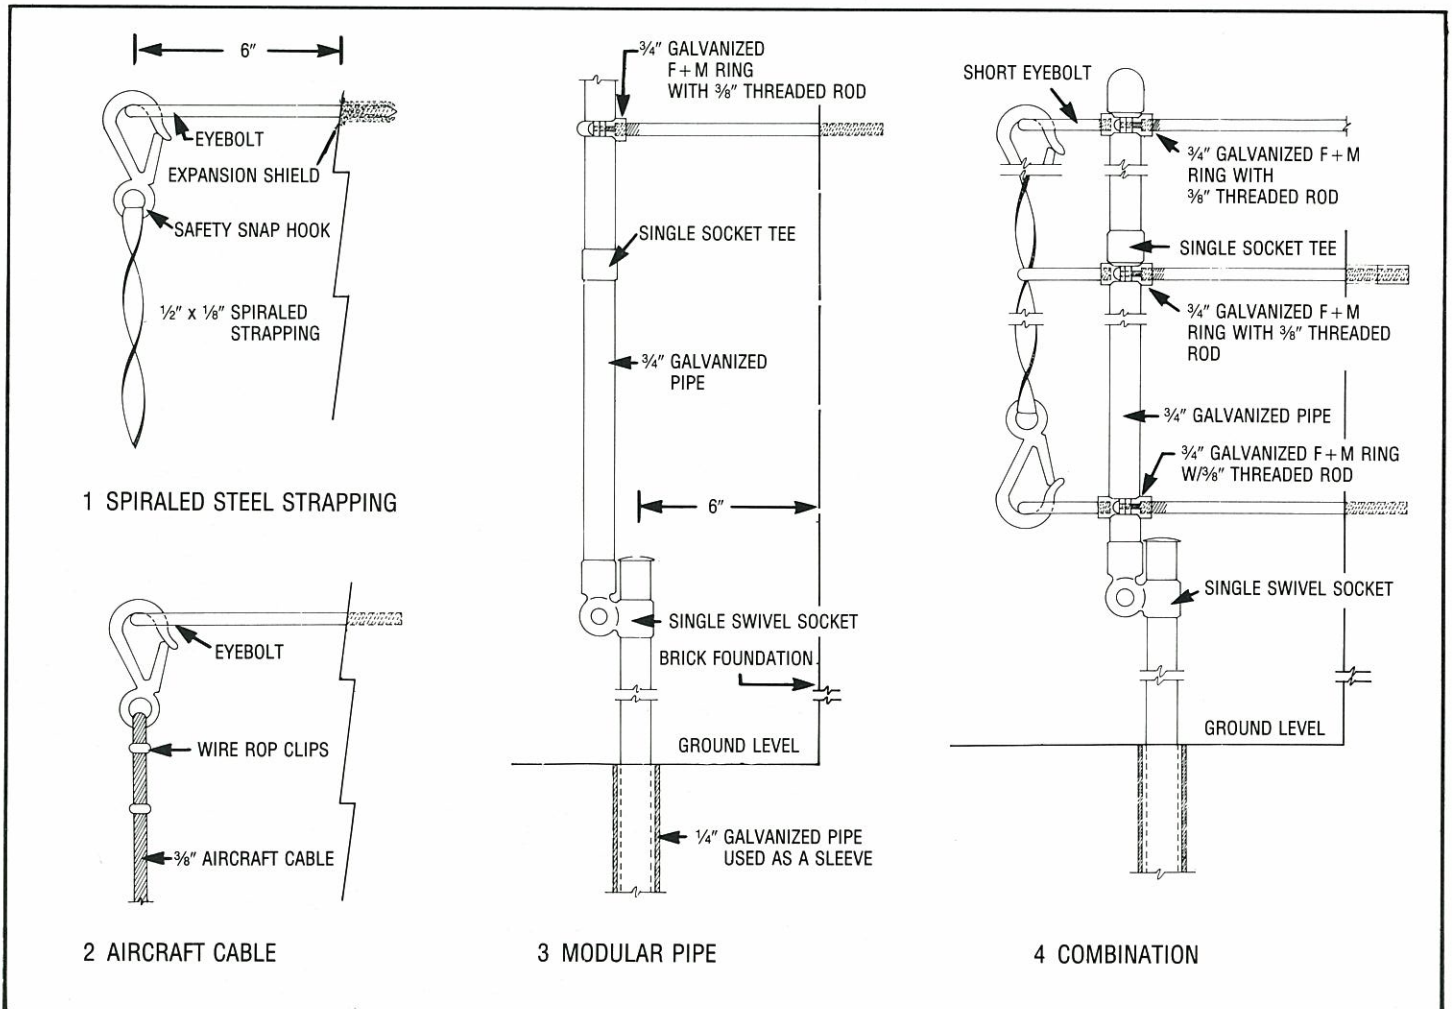
**Figure 5.** Details of the four experimental trellis systems. Drawings by Sharon Runner, National Park Service.

Materials: 1/8" x 1/2" spiraled steel strapping, hooks, snap hooks, eyebolts, and F & M rings. The steel strapping trellis is modeled after the historic design (c. 1885) developed by Olmsted. Spiraled metal strapping were attached to the house by a series of hooks and metal eyebolts. The eyebolts for this system, as well as the attachment devices for the other trellis systems, are held at least 6" away from the house to allow for air circulation between the plant material, trellis system and building facade. The strapping was fed through intermediate F & M rings located at regular intervals vertically and horizontally along the side of the house.

Materials: 3/8" aircraft cable, eyebolts, and hooks. 3/8" aircraft cable was substituted for the spiraled strapping in the first system. A system of eyebolts and hooks was used to secure the aircraft cable to the house.

Materials: galvanized metal pipe, fittings, eyebolts, and swivel sockets. This modular pipe system is composed of galvanized metal pipe and a series of pipe fittings. This system was hinged at the base to allow the rigid trellis structure to be tilted away from the house. The support pipes were anchored in the ground by inserting them in galvanized metal sleeves that were placed 4' below the ground surface and 6" away from the house. The top portion of the trellis structure was secured to the house by a bolt and clamp combination.

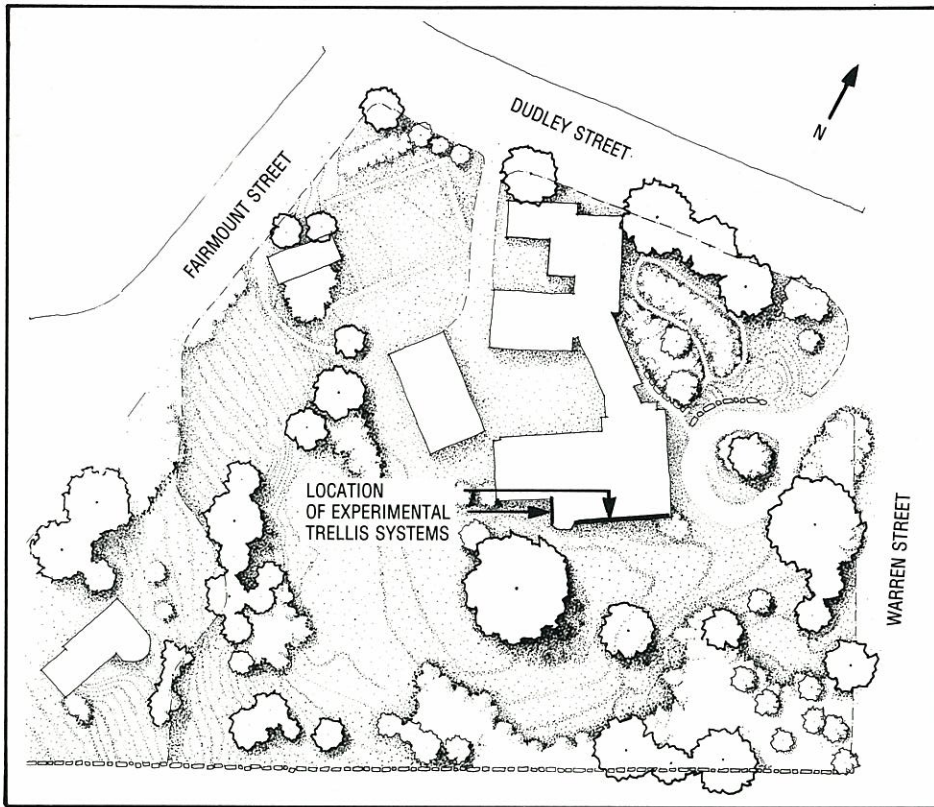
Figure 6. Site plan of Fairsted; the experimental trellis systems were installed on the south and west elevations. Drawing by Karen Day.

The experimental trellis systems were constructed and installed on the south and west elevations (where the historic plant material is located) in 1989, and have been monitored for the past two years (see figure 6). Plant growth and development, ease of removal, appearance, and effect on the historic structure are being observed and documented regularly. Some recommendations for modification have already been made.

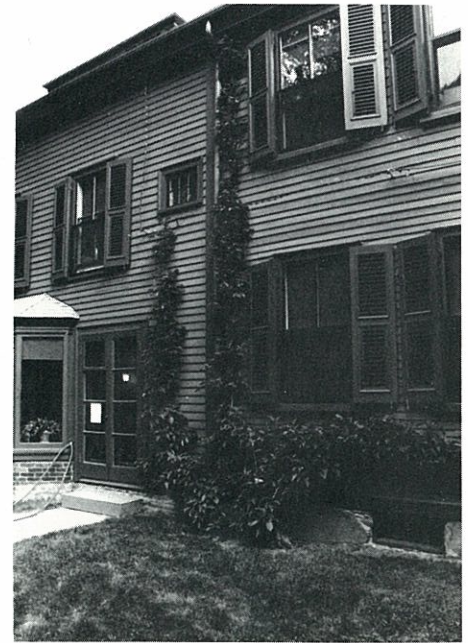
Figure 7. View of south facade, the experimental trellis systems have been in place for two growing seasons. Photo by Karen Day.

aged rapid rusting. The flexible aircraft cable (system 2), with the added weight of a mature vine, will make removal and replacement difficult for one person. A temporary pulley system is recommended to aid in hoisting the vines back into place. The third design is a rigid modular pipe system (system 3). Although the rigidity of the system is advantageous to the stability of the vegetation, the weight of the vines may also be prohibitive for easy removal and replacement. The combination strapping and pipe system (system 4) does not re-create a historically accurate appearance. The system was designed in order to remove the vines on the strapping without removing the pipe supporting system. The vines growing on the strapping do not provide sufficient coverage to hide the pipe system behind. Furthermore, additional maintenance is required to keep the vines from growing on the pipe. After the multi-year test period is complete, one of the four systems will be selected, modified as needed, and installed to the east, south and west facades of the house (see figure 7).
