**MUSEUM  
COLLECTION  
STORAGE**

NUMBER 1

**FORT PULASKI NATIONAL  
MONUMENT****Savannah, Georgia**

**Museum Collection  
Storage in an Historic  
Building Using a  
Prefabricated Structure**

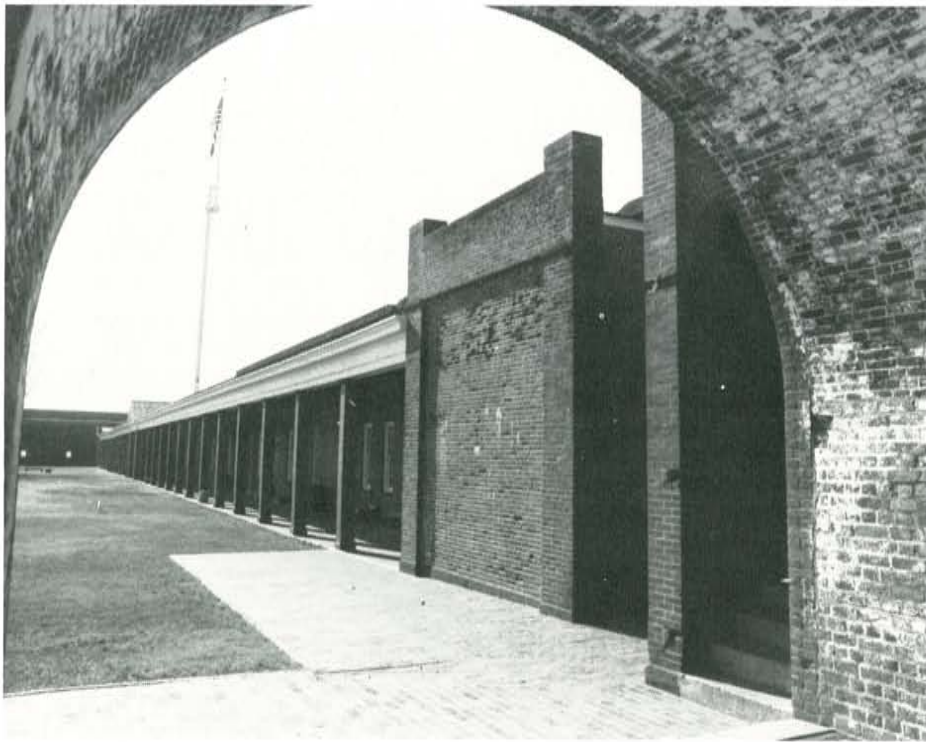
**Figure 2.** View from one of the open casemates, looking across a portion of the parade ground. The piazza provides a covered access to the enclosed casemates which flank the sally port. It was one of these enclosed casemates (each has a door and one or two windows) that was selected to house the museum object storage facility.  
**Photo: Robert Darrigan**

The park staff decided to install within a casemate a free-standing structure that could maintain the appropriate environmental conditions necessary to preserve the collection (see figures 1 and 2). They considered both retrofitting a casemate using conventional construction methods and assembling a prefabricated structure within a casemate. A prefabricated thermally efficient structure was selected because of easy assembly, lower cost, minimal physical and visual impact on the structure, high insulation characteristics, and ease of future removal. With the assistance of the author and the staff curator of the National Park Service, Southeast Regional Office, the park staff assembled a museum storage facility within an historic casemate utilizing a commercially available prefab building system (see figure 3).

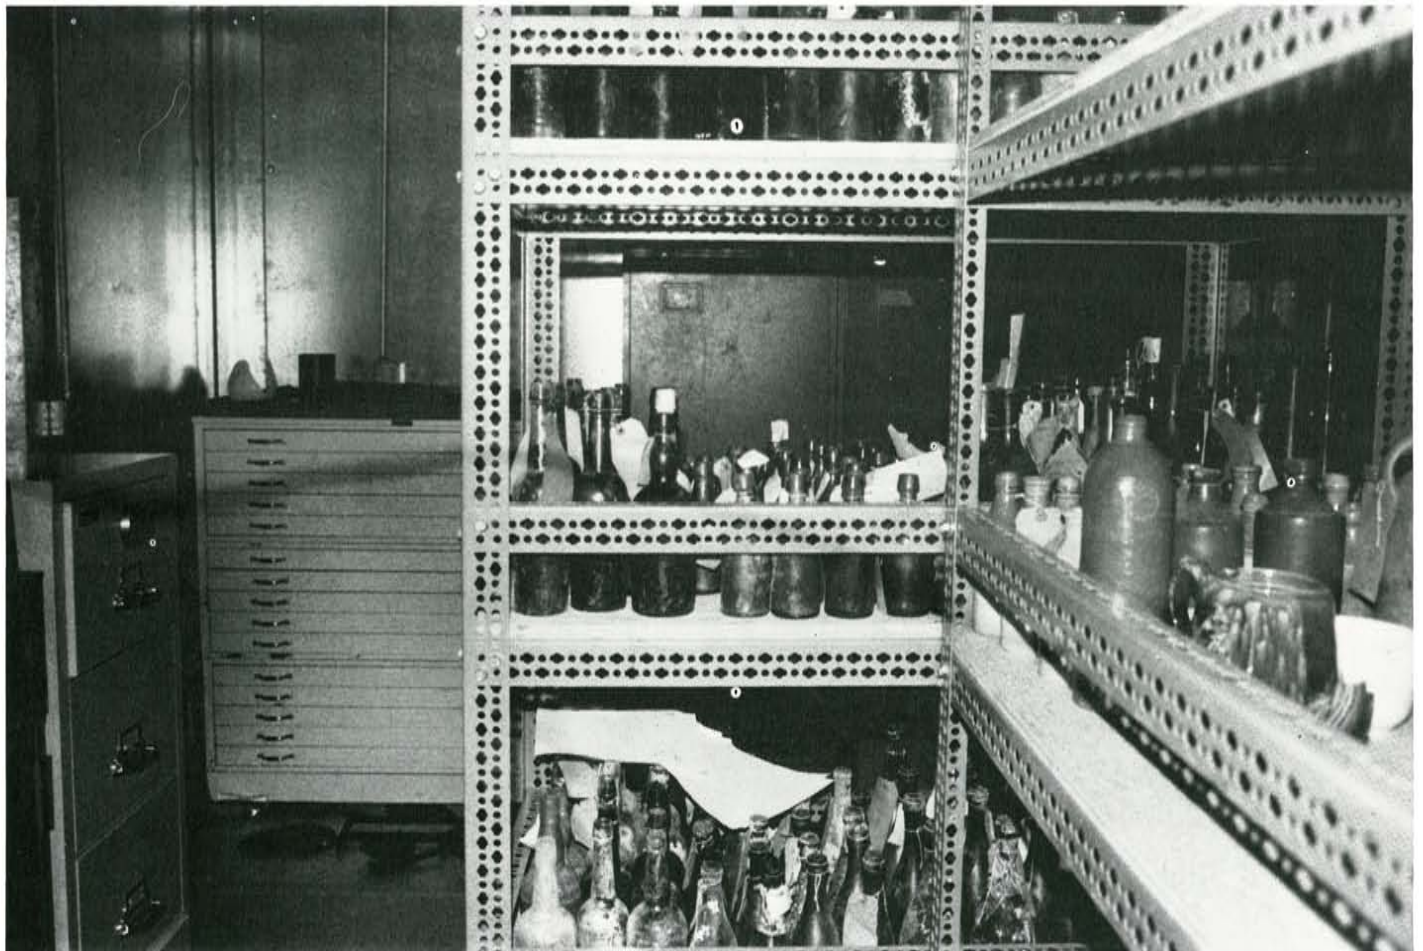
**Figure 5. View inside the object storage room, showing the open steel shelving for bottles and similar objects. Beyond are the map and drawing cabinets and the insulated file cabinet for storage of museum documents. Photo: Raymond Powers**

This structure provides sufficient space to house the park's museum collections and the necessary storage equipment for containing them (see figure 5). Additional benefits of this system are its flexibility for future enlargement (up to the limits of the historic casemate) if the museum col-
