Tech Notes

NUMBER 1

Process-Printing Decals as a Substitute for Hand-Stencilled Ceiling Medallions

Sharon C. Park, AIA
Preservation Assistance Division
National Park Service

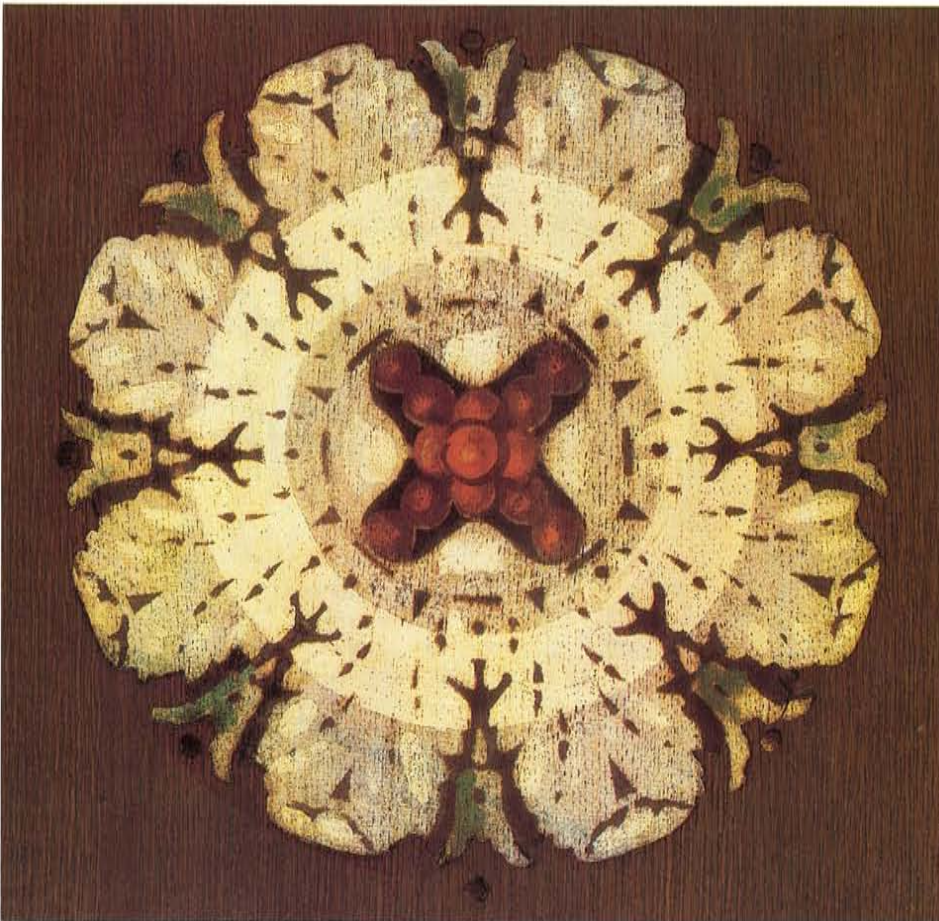
The decals were made using a photograph transparency of the original cleaned medallion. The decals were a water-release type printed with light-stable ink colors. The process-printing technique takes the

photographic positive and with the use of a computer makes color separation negatives. Quality control is obtained by using a gray scale and color bar. Inks are not solid films of color, but rather transparent dots of color laid out in a pattern of 180 dots per inch. The variation in colors in the final product is achieved by printing the three primary colors (red, blue, yellow) and all the other resulting colors are from

the overlapping of the color dot negatives. This way, as few as three screens with inks and a fourth screen of black for shading and depth are used. Each medallion decal required 7 runs through the printer (clear base, white background, 3 colors, black, clear top coat). Thus, it was critical to have precision registration to avoid blurred detail or a shift in color. Once the printing process was perfected, all

the decals were printed in one day, and left to dry overnight (*see cover photo*).

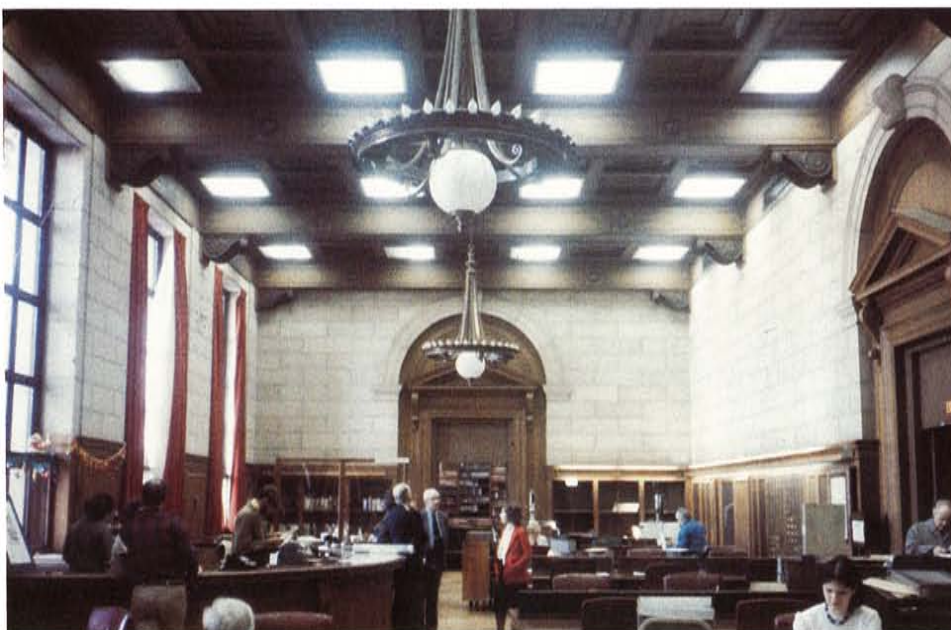
The coffered ceiling had been badly damaged in 1962 with the installation

of fluorescent light fixtures (see figure 2). Forty of the coffers had been drilled with large holes to attach the light fixtures and the central medallions had been removed (see figure 3). In 1988, the General Services Administration (GSA) authorized a new sprinkler system in the Central Search Room. As part of the sprinkler project, the 1962 intrusive fluorescent lights were proposed for removal, with attendant enhancement of the desk level lighting. The two historic chandeliers were to be retained.

2. The 40 large visually obtrusive fluorescent lights, installed in 1962, damaged the coffered ceiling in the Central Search Room. Photo: Dell Corporation.

Using the ceiling openings created by removal of the modern light fixtures, 2" diameter pipes were installed for the new sprinkler system. Because the intact historic panels were so tightly glued in place, it was difficult to remove them without damage. Therefore, the new sprinkler heads were located at the centers of the 40 replacement panels, which were evenly spaced across the ceiling. One historic panel was removed to serve as a model for the replacement panels.

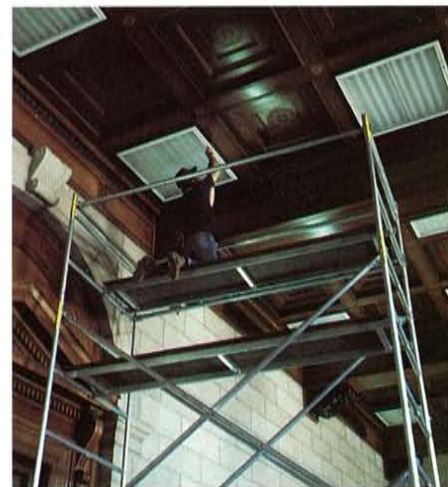
3. The light fixtures were carefully removed to permit installation of a sprinkler system behind the coffered ceiling and to restore the ceiling to its original appearance. It was necessary to reproduce 40 new panels for installation in the coffered ceiling, due to the damage resulting from the 1962 lighting work. Photo: Dell Corporation

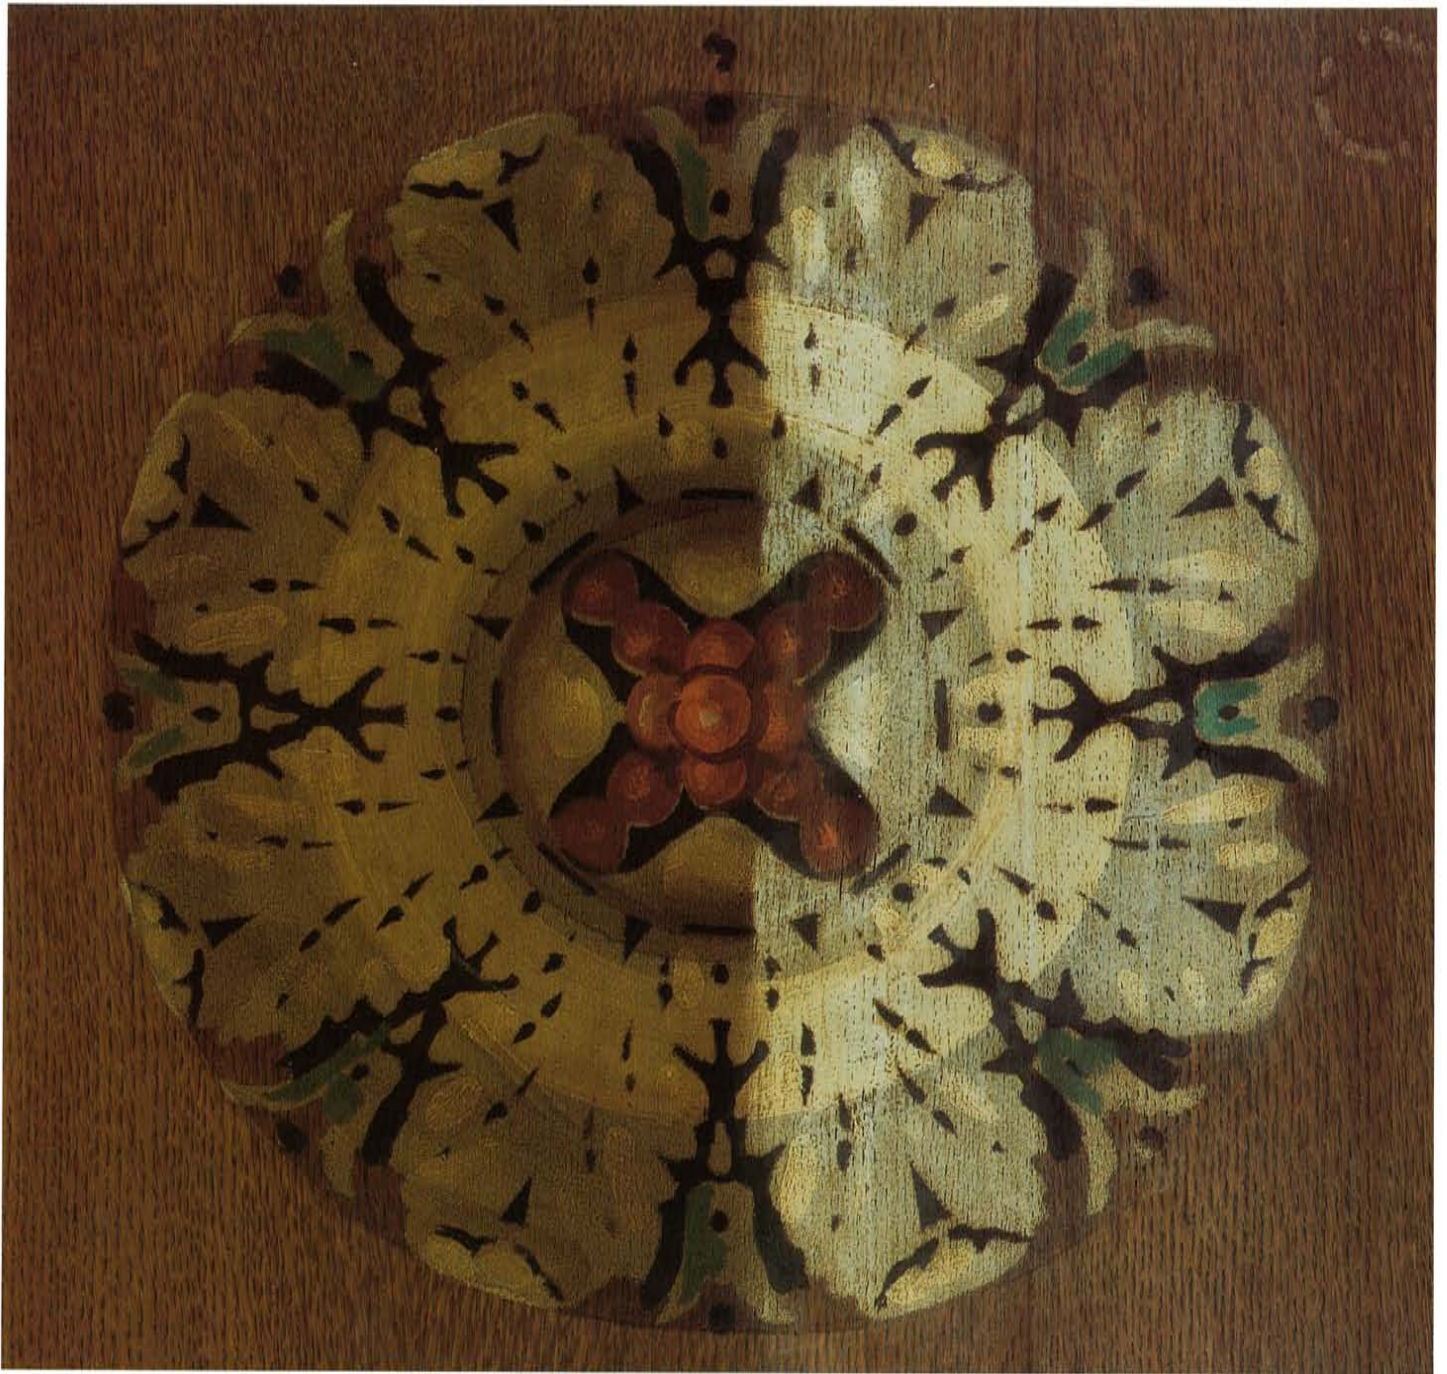
Original medallions used as backing for access panels and shim pieces when the fluorescent lights were installed served as test panels for cleaning. Various chemicals were tested to find a treatment that would remove the old varnish without removing the paint. One entire undamaged panel was removed and cleaned, based on the test results, and served as the model for the replacement work. The varnish overcoat was removed using cotton swabs dipped in a solvent solution. It took 6 applications to carefully strip the varnish without removing the original brush marks. This was followed with up to 6 cleanings of the paint and highlights using a

commercial stripper of toluene, acetone, and butyl-acetate. The result was that the original lighter tones of the white oak background were also revealed along with the bright colors of the original painted medallions (see figure 4).

4. A historic stencilled panel was removed and cleaned in order to have a model for the replacement panels. In this view, only half of the panel has been cleaned, revealing the difference between the aged and original appearance of the ceiling. Since the ceiling was not scheduled to be cleaned, a decision was made to reproduce the original panel appearance and then artificially age the replacement panels to blend in with the existing ceiling. Photo: Dell Corporation.

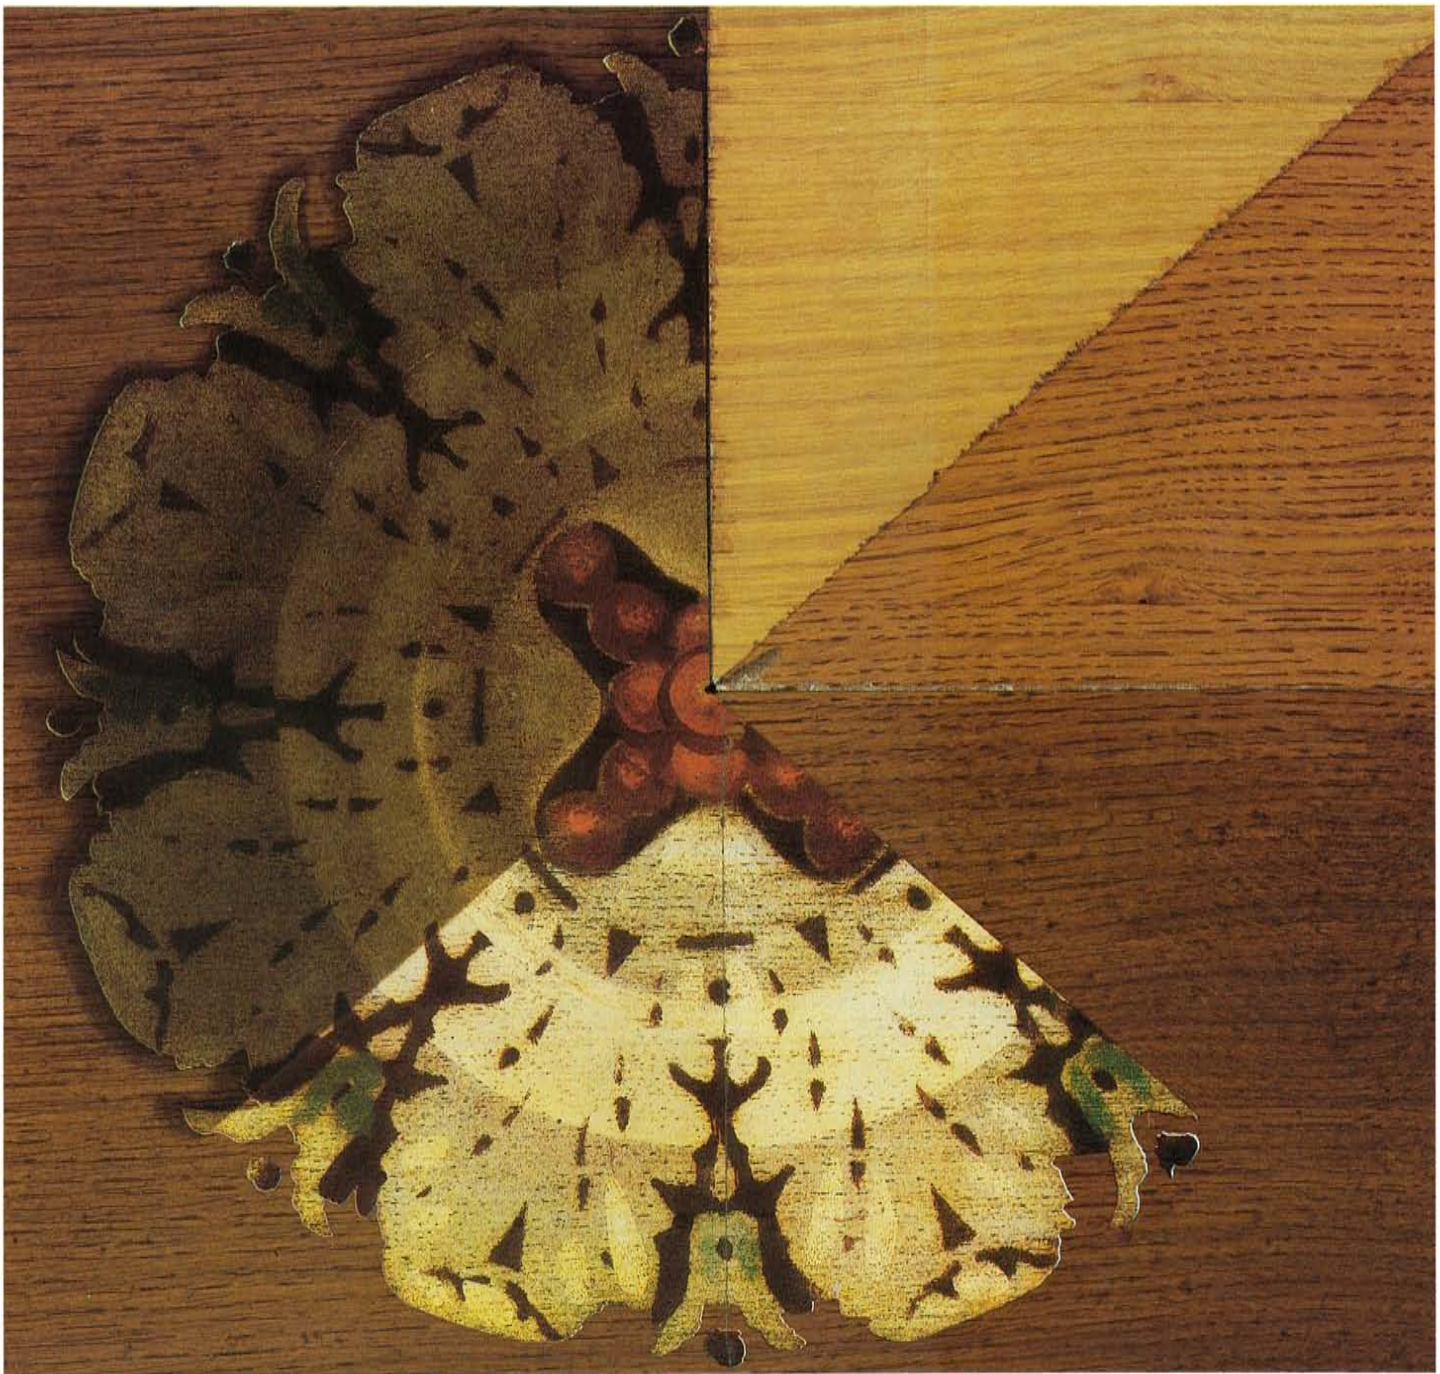
5. This demonstration model shows the various stages involved in finishing the ceiling panel. Starting with the raw wood panel in the upper right corner (1) and moving clockwise, a penetrating stain was applied (2) that matched the historic stain. A tinted varnish, or sealer, (3) was then applied to ready the backing panel to receive the decal (4). Two coats of acrylic sealer were used to protect this "cleaned" condition. The next 3 steps (5, 6, 7) produced the "aged" appearance with tinted varnish layers sprayed on using cardboard masks to produce the proper tones. A top coat of clear varnish (8) provided the final protective layer. Photo: Dell Corporation.

Because the original panels were not to be cleaned at this time, the replacement panels were artificially aged to match the current appearance of the historic panels. To give an individual appearance to each medallion with a minimum amount of hand work, highlighting was done by rubbing a solvent soaked cotton swab over the tinted overcoats, removing some of the topcoat varnish in selected areas. A clear coat was sprayed over the tinted coat to provide a final protective layer (*see figure 5*).

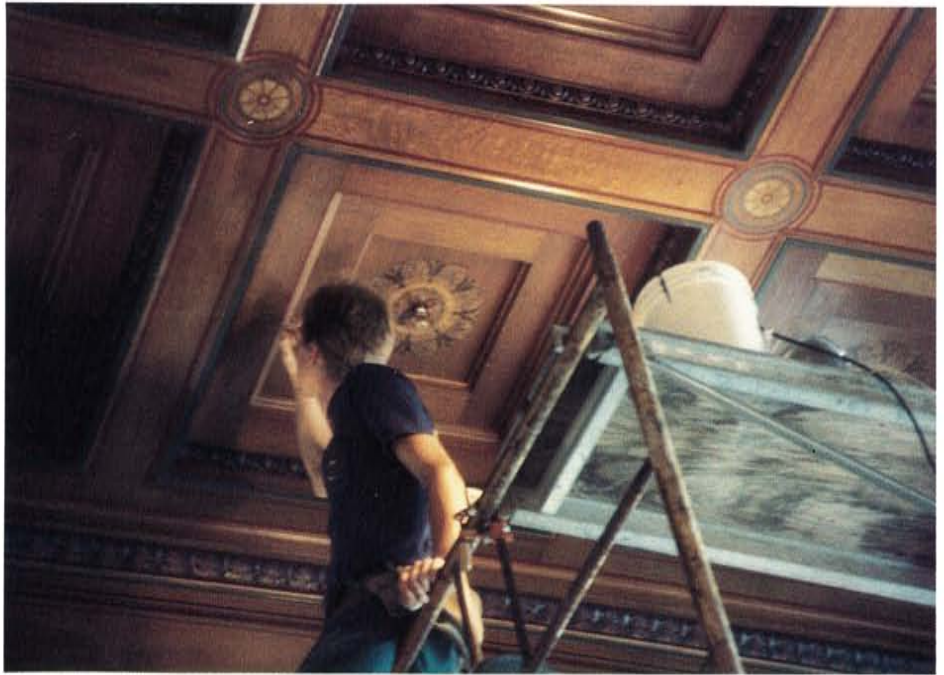
6. The finished panels were installed in the ceiling with new sprinkler heads located in the center of the cherry motif. Stainless steel pins were used to set the panels, since there was no room to lift the panels in place from above the ceiling once the wet piping system was in place. Photo: Dell Corporation.

Upon the completion of the sprinkler piping system, the finished panels were installed using 1 3/4" long stainless steel pins to set the panels into the coffers (*see figure 6*). This side pinning (6 per panel) was necessary, as the panel had to fit around the sprinkler head and there was no room to manipulate the panel up into the small cavity space. The 40 panels were reinstalled over a one week period using a rolling scaffold and a crew of four. Upon completion, the replacement panels were virtually indistinguishable from the historic panels when viewed from below (*see figure 7*).

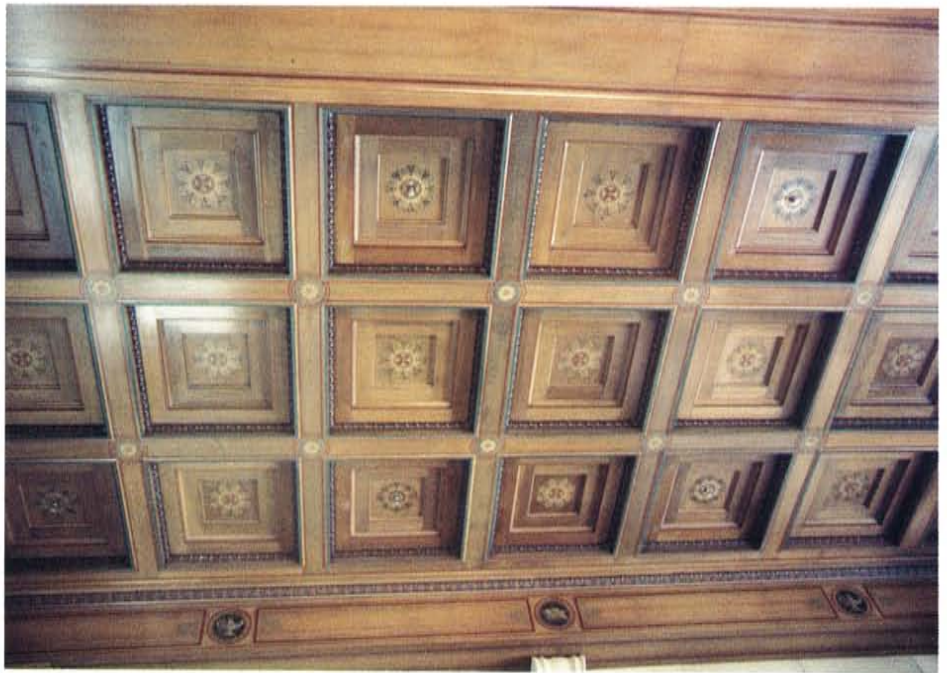
7. Following the work, the difference between the decal replacements and the historic stencilled panels is not discernible from the floor of the Central Search Room. Photo: Dell Corporation.
