United States Department of the Interior National Park Service National Register of Historic Places Registration Form

historic name Spruce Lodge
other names/site number 5RN.1043

Section number 7 Page 1**DESCRIPTION**

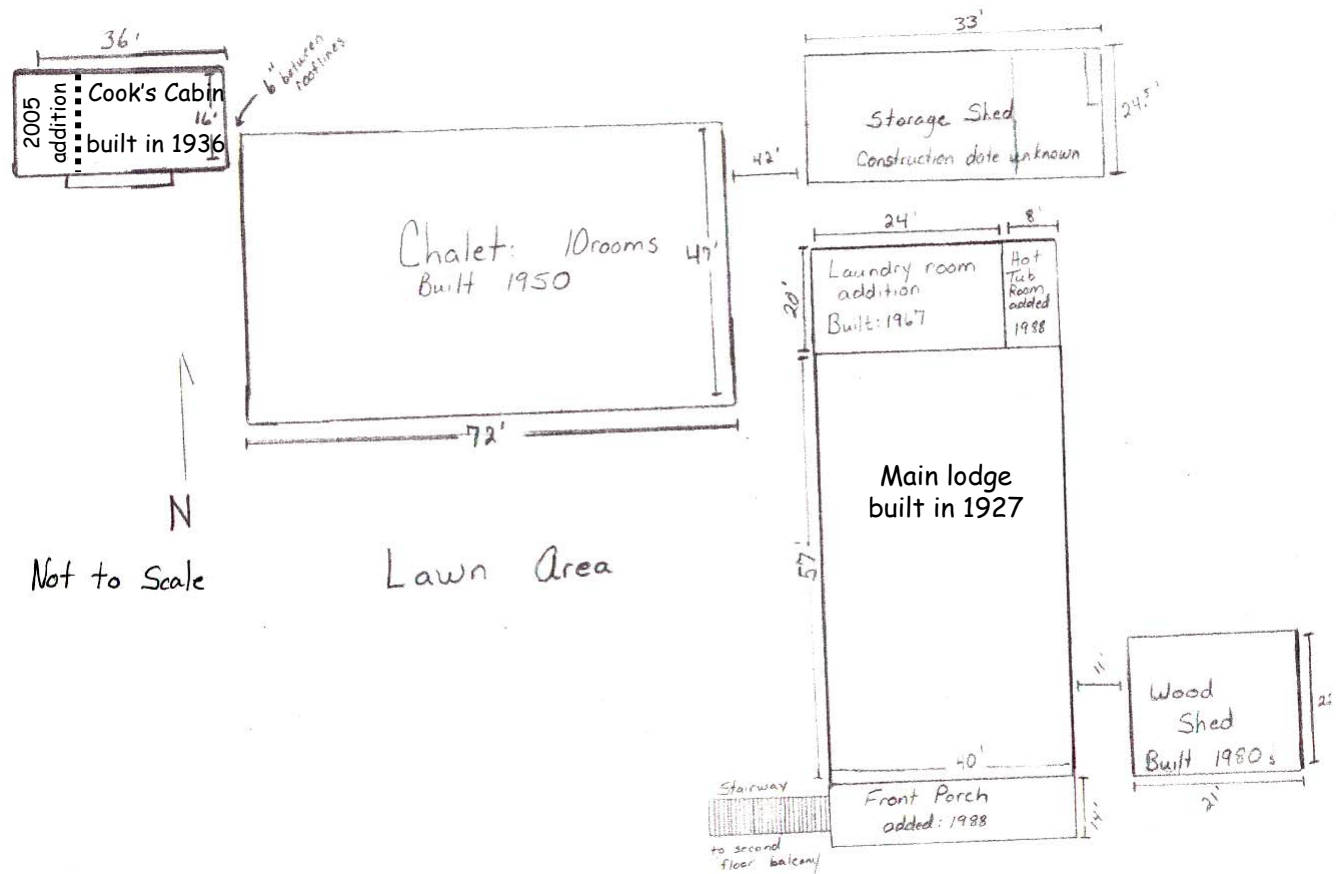
Site Map

The Spruce Lodge in South Fork consists of five buildings on the north side of US Highway 160 and south of the Rio Grande. The main lodge building, completed in 1927, dominates the site. The lodge fronts south and sits 22 feet back from the frontage road that runs east-west along the north side of US Highway 160. A large woodshed stands 11 feet to the east of the southeast corner of the lodge building. Directly behind the lodge to the north is a large storage shed. Forty-two feet from the northwest corner of the main lodge is the 10-room Chalet. The "Cook's Cabin" sits only 6 inches from the northwest corner of the Chalet's back porch roof. The site includes a large plot of grass to the west of the lodge building. Tall Engelmann spruce trees dominate the south side of the property with several scattered deciduous trees completing the landscape. Owner O.C. Galbreath planted the spruce trees in 1941.

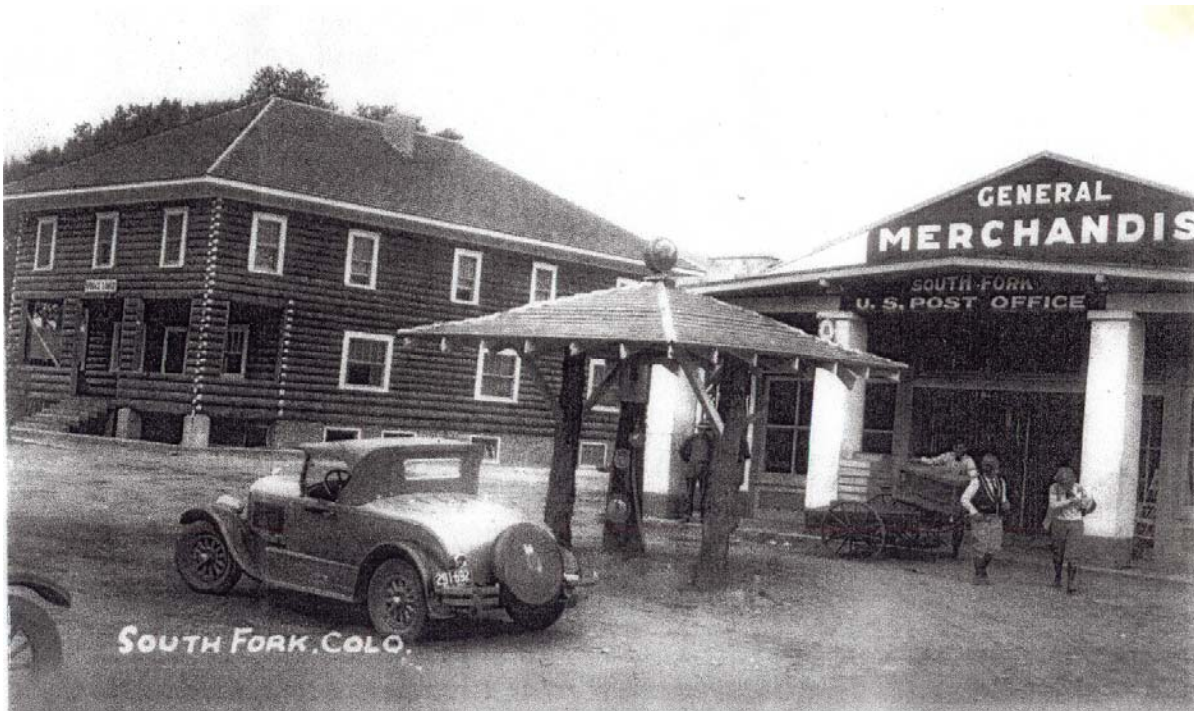
Photo No. H1: This ca. 1930 photograph shows the Galbreaths' store and the newly constructed Spruce Lodge. Note the original appearance of the integral porch.

The most noticeable addition is the 1988 two-story porch and stairway on the front of the lodge. The second-story porch and stair act as an emergency exit from the second story. The center facade window evident in the circa 1930 photograph of the lodge exterior now contains an egress door. The balcony and stairway are both of rough hewn pine logs and planks. At the main entrance under the new balcony, new concrete steps were added and the original integral porch was enclosed with thermal pane windows and storm doors to serve as a vestibule.

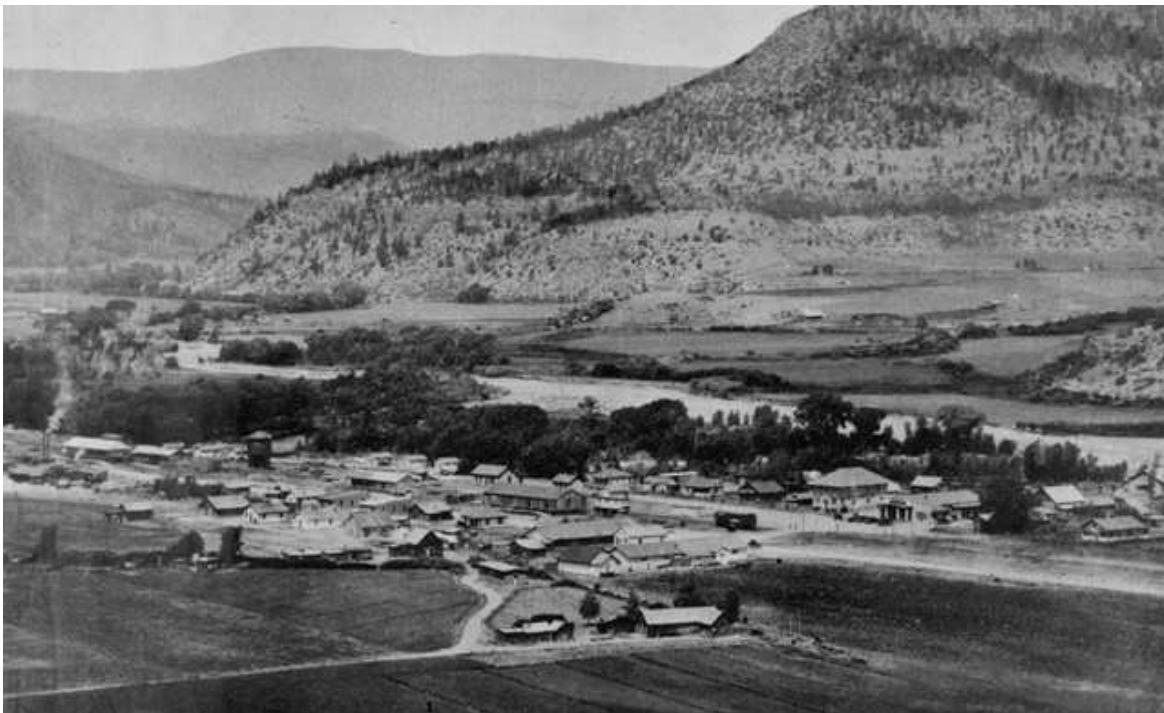
Photo No. H2: This ca. 1930 photograph looking northwest shows the two-story Spruce Lodge at the east end of South Fork across the railroad tracks from the Galbreath Tie and Timber Company sawmill. Source: Western History/Genealogy Department, Denver Public Library, call number X-13611.

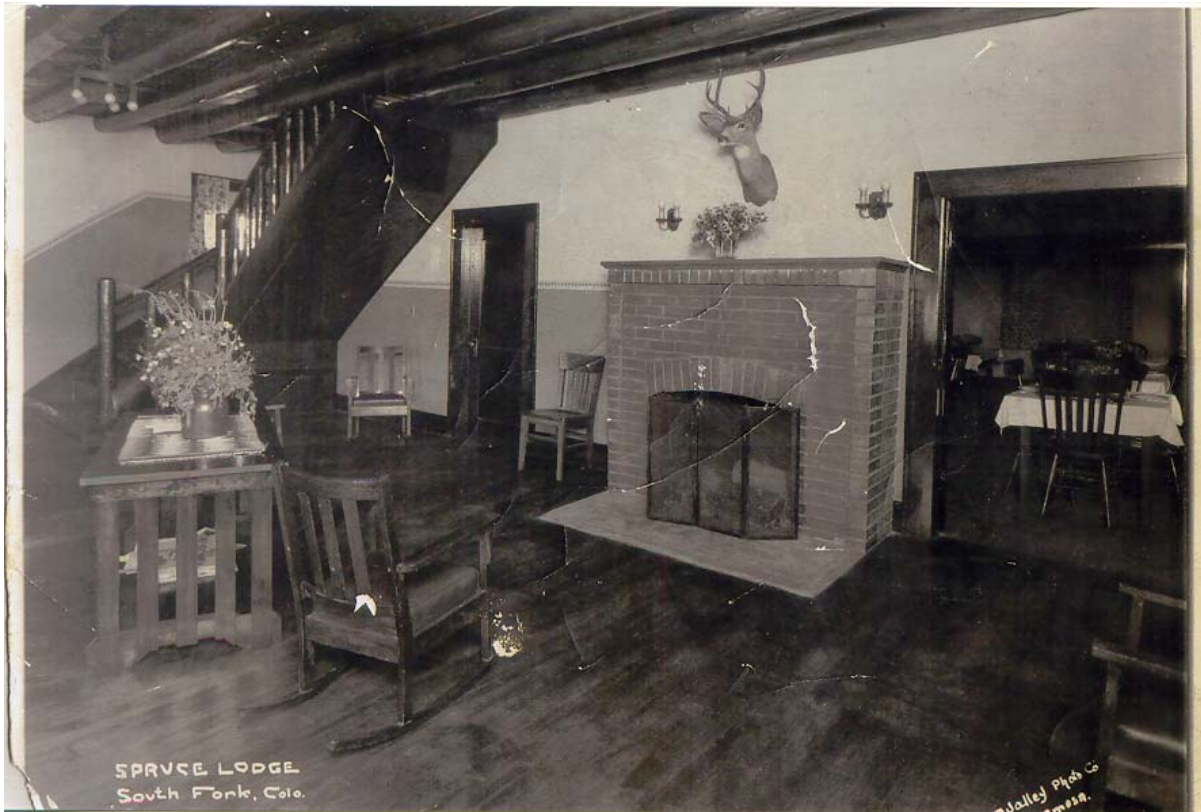
Photo No. H3: This 1938 photograph shows the lodge's lobby and the appearance of the fireplace before being covered with stone.

Three-quarter round Engelmann spruce support beams run the width of the lodge as second-story floor joists. A native river rock fireplace fills the north wall in the lobby. A natural log
