# National Register of Historic Places Registration Form

Historic name: John C. Shaffer Barn

Other names/site number: Ken-Caryl Ranch Equestrian Center/5JF.7501

Street & number: 14422 West Ken Caryl Avenue

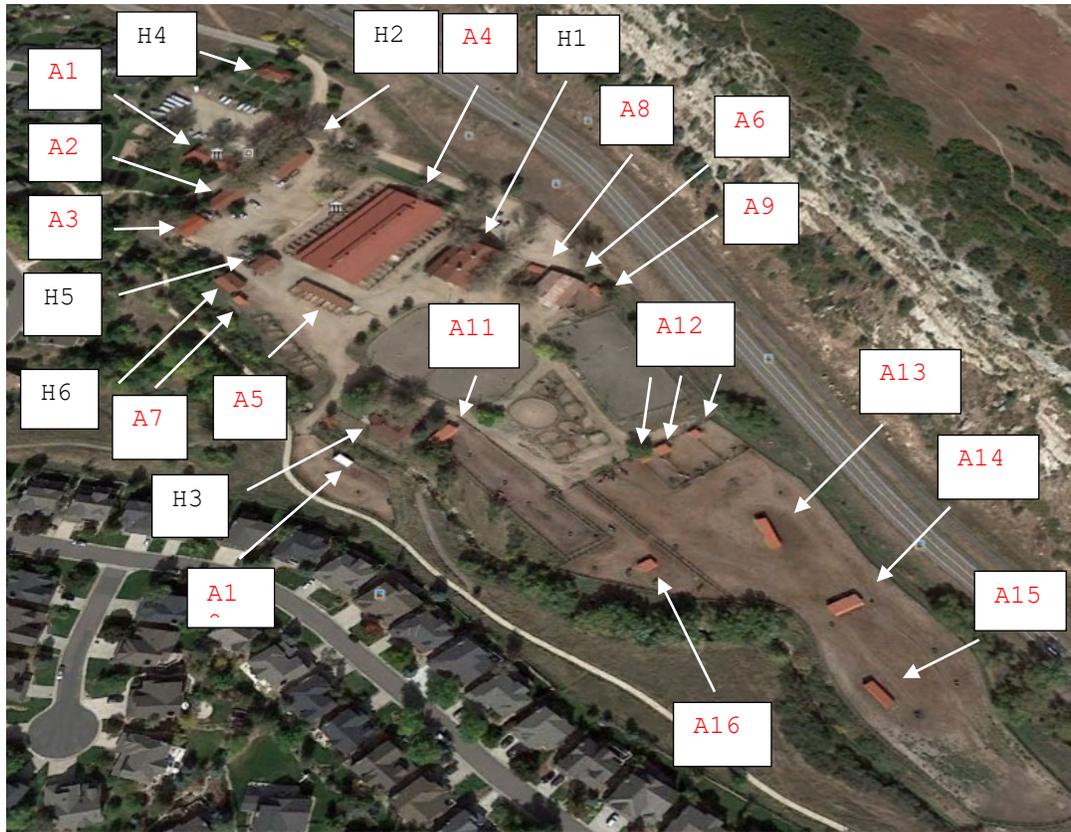
**Site Map 1: Equestrian Center Complex**

Historic Buildings		Associated Buildings	
Number	Building	Number	Building
H1	Shaffer Barn	A1	Dakota Lodge
H2	Small Barn	A2	Ranger Office
H3	Manager's Residence (Office)	A3	Hay Shed
H4	Ranch Residence	A4	Riding Arena
H5	Tack Building	A5	Horse Stable
H6	Carriage House (Storage Building)	A6	Riding School
		A7	Horse Shelter 1
		A8	Horse Shelter 2
		A9	Horse Shelter 3
		A10	Horse Shelter 4
		A11	Horse Shelter 5
		A12	Horse Shelters 6, 7, 8
		A13	Horse Shelter 9
		A14	Horse Shelter 10
		A15	Horse Shelter 11
		A16	Horse Shelter 12

The Shaffer Barn is one of several buildings located at the 10-acre Equestrian Center. There are five other historic buildings on the property, built between about 1917 and 1930. These include (1) another barn, currently used for storage; (2) the manager's residence, currently used as the main Equestrian Center office; (3) a ranch residence, currently used as a residence for Equestrian Center staff; (4) the tack building, used for storage; and (5) the carriage house, currently used for storage. There are two other buildings that were built at about the same time but are no longer considered historic because of extensive modifications: (1) a maintenance building, now used as an office and work area for the Ranch ranger staff; and (2) a veterinary building, modified extensively and now called Dakota Lodge, used as a child care and activity/event center. In addition, there are 16 other non-historic structures, including a riding arena, riding school, horse stable, hay shed, and 12 horse shelters (enclosed on three sides). See Site Map 1 for an aerial view of the site, with identifying labels for each building.

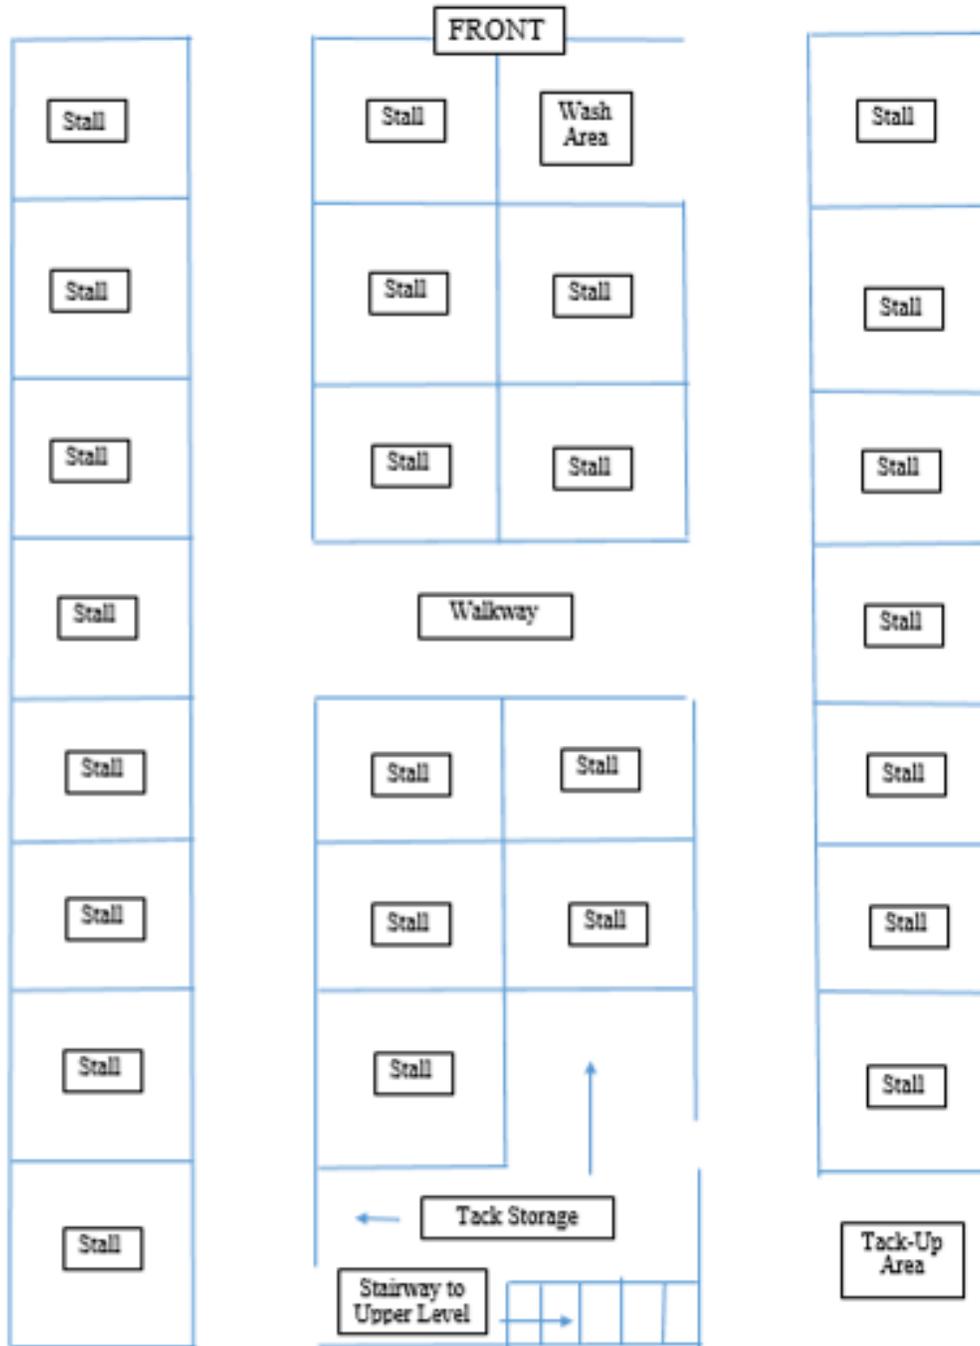
**Current Floor Plan 1**

**First Floor**

The first floor interior is organized symmetrically, with rows of horse stalls flanking two approximately 8'-wide aisles that run the north/south length of the barn (See Current Floor Plan 1). The aisles have concrete floors and are accessed via the sliding doors on the barn's front and rear sides. The aisles are connected at their midpoint by a 12" x 23" aisle running east/west (Photo 10). There are eight 11' x 11' modular stalls with wooden floors running the length of the building against the west and east walls. These sixteen stalls are enclosed by gates facing the center of the barn, except for the stall at the northwest corner, which is open and used as a tack-up area. Horses are housed in the other fifteen stalls. Running the length of the barn at its center are two contiguous rows of 11' x 11' stalls with wooden floors that open onto the north/south aisles. There are a total of 13 stalls in this central area. The stall at the southwest corner is open and used as a horse bathing area. At the north end of these stalls is an L-shaped tack room with a concrete floor occupying the area of approximately three stalls. In this tack area, abutting the rear wall, are wooden stairs leading to the upper level.

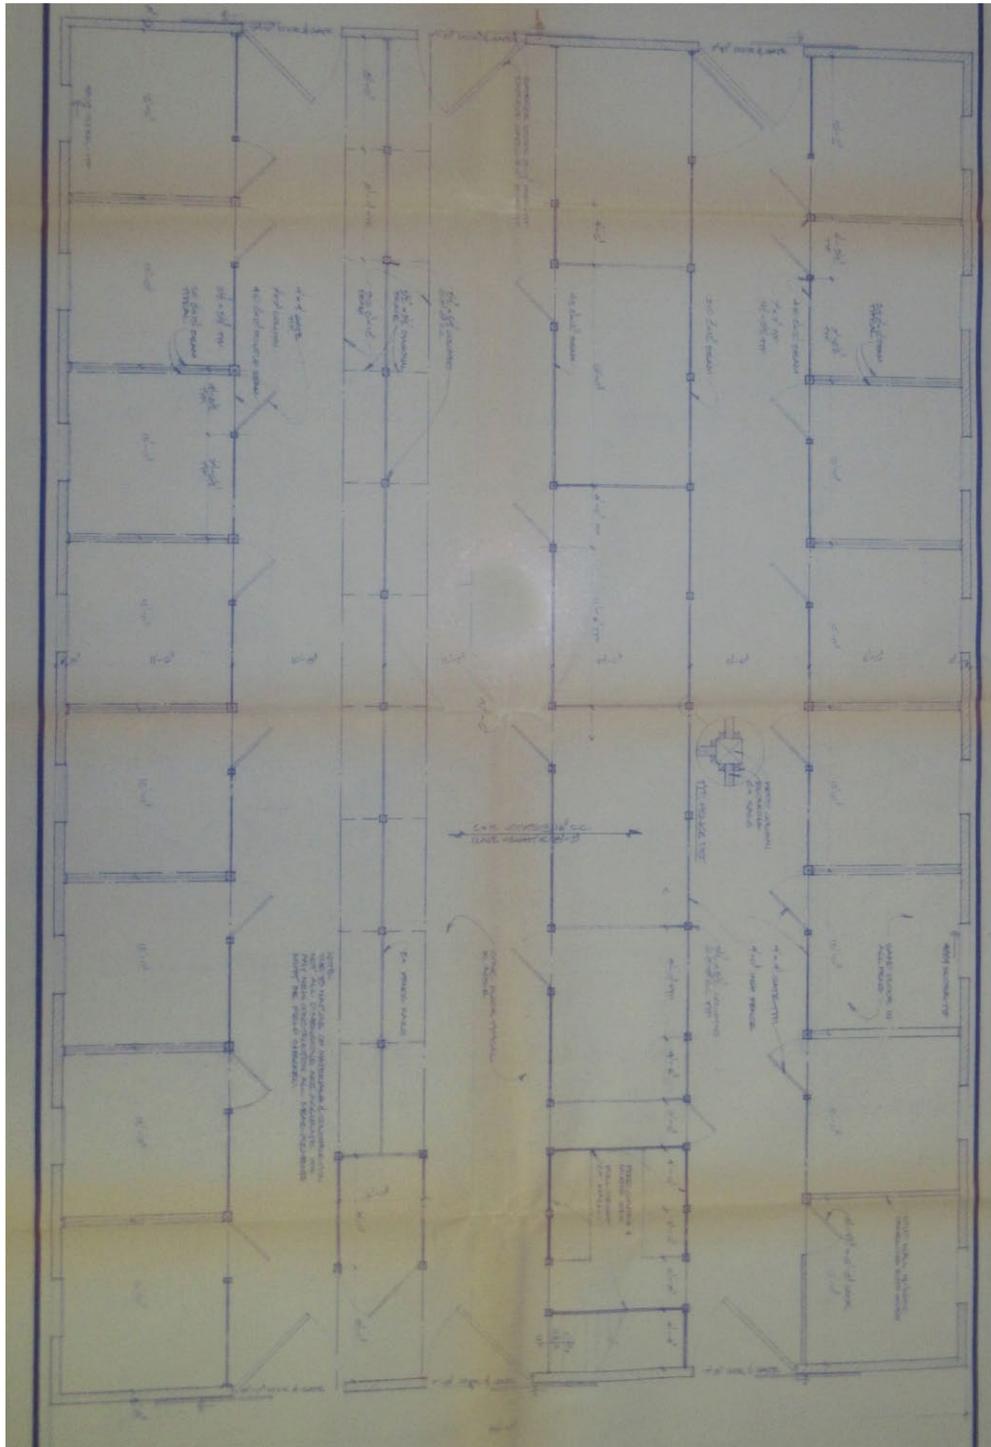
Figure 1: Blueprint of the original floor plan of the first floor, prior to the 1980s remodeling. (Ken-Caryl Ranch archives)

Figure 1 shows the floor plan of the main floor prior to the early-1980s remodeling, and documents a slightly-off-center aisle running down the middle of the barn. This diagram does not necessarily show the original floor plan, but illustrates the layout of the main floor as it appeared during the cattle operation of the 1970s before the interior of the building was last remodeled. Although the stalls running the length of the barn along the outer walls are the same in number and similar in size as the current stalls, none of the current stalls are historic. The current stalls are modular and are not framed by wooden beams as described on the early 1980s blueprint (Figure 1). The blueprint indicates that the earlier stalls had sand floors and the current stalls have wood floors. The aisle, stalls, and pens running lengthwise along the center of the barn shown in Figure 1 have been replaced mostly with modular stalls. At the north end of this central area the feed chutes and mixing bins identified in Figure 1 have been replaced by a tack storage area with a cement floor. The exact date of these changes is unknown, but probably occurred in 1980 or later. In 1940, then-owner William Allen described "air vents" for

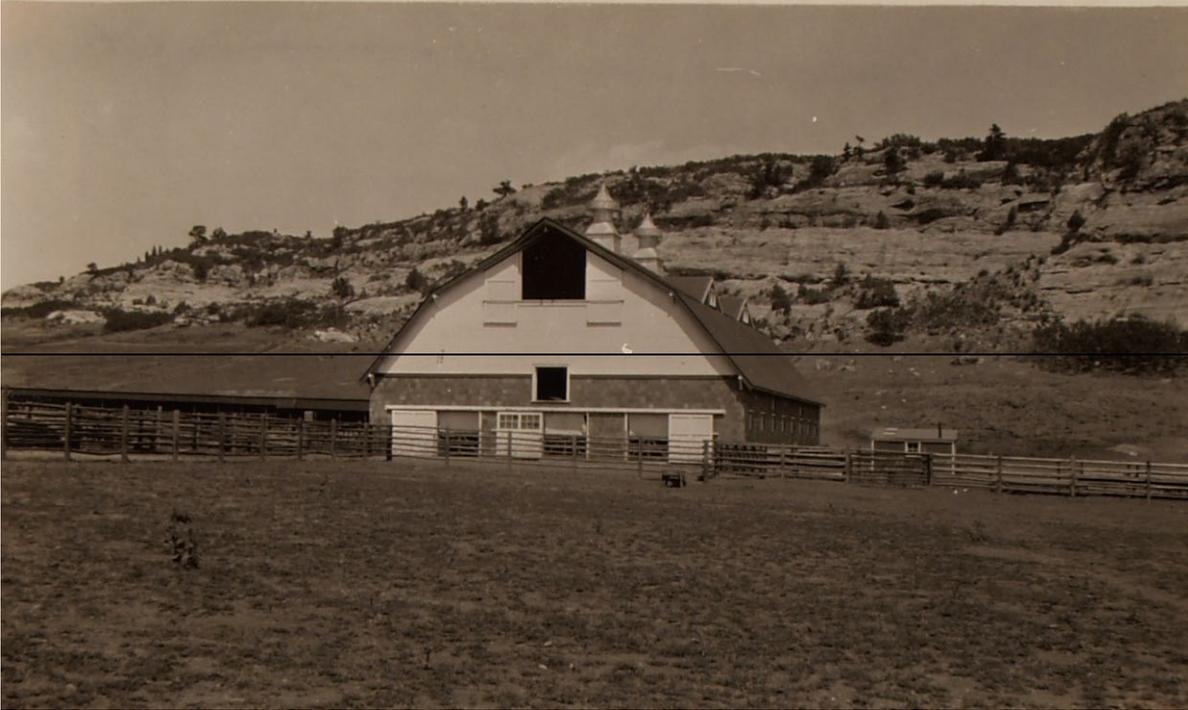
**Figure 2: Front of barn, with Lyons Hogback in background, 1924. Camera facing NNE.**

Exterior changes to the barn have been minimal. Comparison with a 1924 historic photo (Figure 2) reveals minor changes to the front facade. The non-operative door panel on the first floor, designed and painted to match the sliding doors on either side of it, replaced a door of a similar size but different design documented in the 1924 photo. This change was made in the early 1980s when the barn was remodeled to house horses rather than cattle. The same alteration was made at the rear of the barn at this time. Additionally, an opening above the central door shown in the 1924 photograph is now covered with a sliding door compatible in design with the historic sliding doors below. This change was made in the 1980s or later. The original double doors were removed, but the opening remains unaltered. Two non-historic light fixtures have been added to the front and rear walls of the barn, and the exact dates of these additions are unknown. There are no historic photos of the rear of the barn. However, as described above, it is likely that a wood panel has been added to the small 12" x 36" opening at the ground level to the right of the non-operative door. The change was likely occurred because this access for grain or hay transport was no longer needed. The date of this modification is unknown. It is unknown if the grain chute, the external portion of which is visible at the back of the barn, is original but it appears to be historic. It is very likely that some form of grain delivery apparatus was present at this location of the barn when it was built, given the practice of feeding grain to show cattle. Grain-fed cattle more easily gain weight than hay- or range-fed cattle.<sup>5</sup> And, as described above, this chute is connected to the historic grain bin on the barn's second floor. There are no historic photos of the west side of the barn. Several of the historic photos show the east side of the barn, and its appearance in those photos is very similar to its appearance today. Given their material and design, it is assumed that the eight one-by-one sliding aluminum windows on both the east and west sides are replacement windows installed at an unknown date.

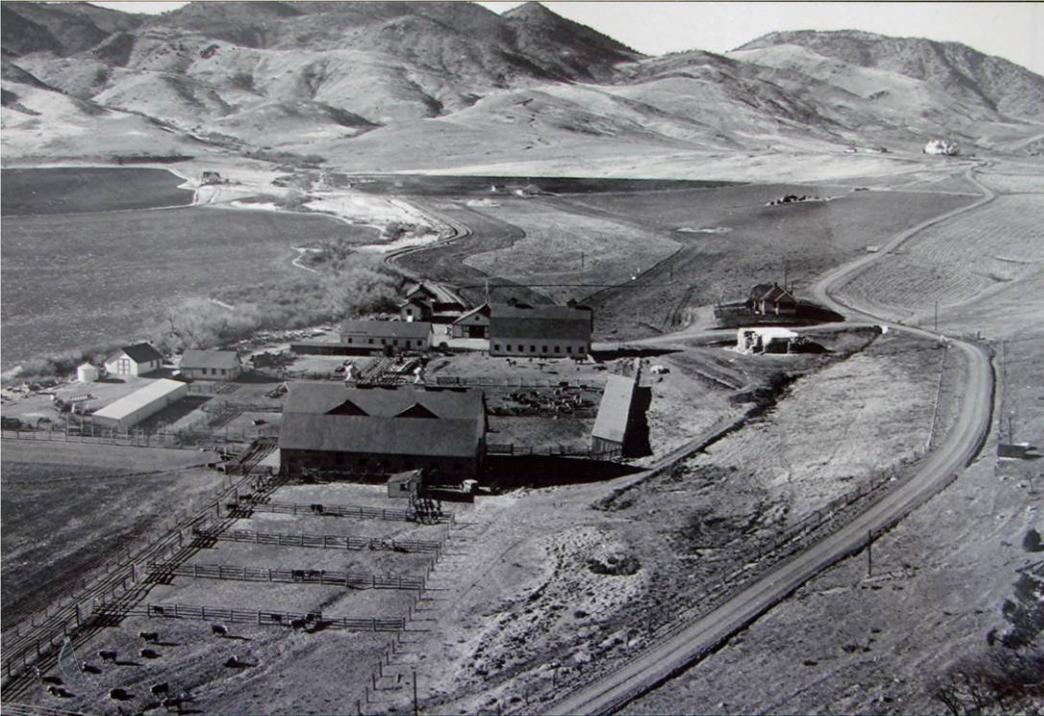
**Figure 4: Aerial view of barn (barn in foreground). Note Shaffer summer home top right, circa 1945. Camera facing WNW.**

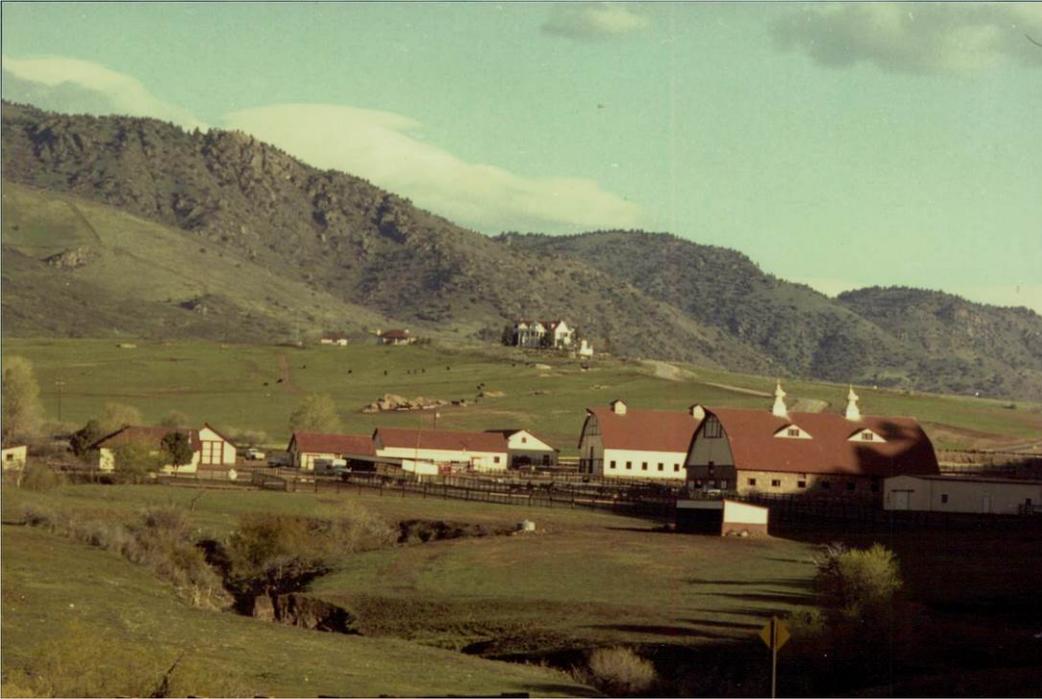
**Figure 6: Barn in right foreground, Shaffer summer home in background, 1980s. Camera facing NW.**

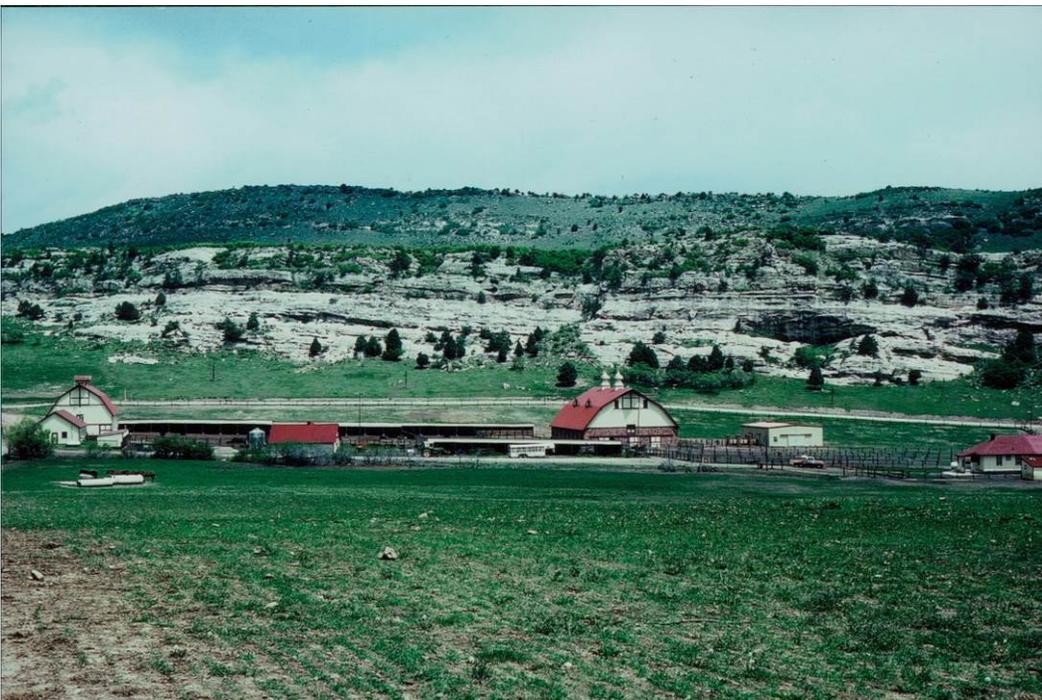
**Figure 7: Barn in right center, with Lyons and Dakota Hogbacks behind, 1980s. Camera facing NNE.**

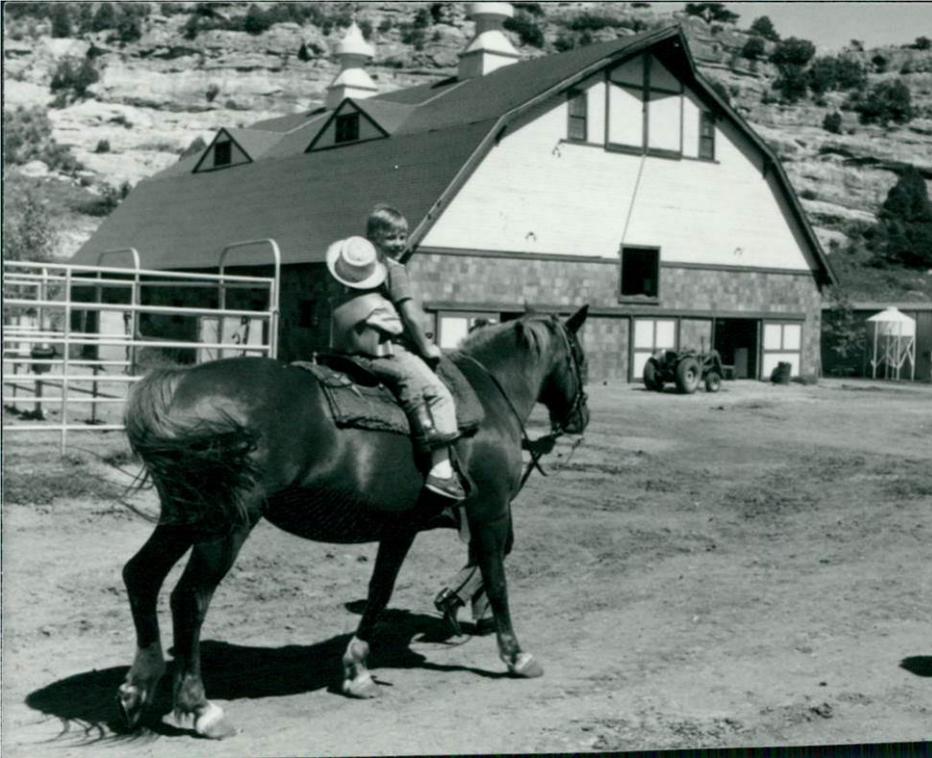
**Figure 8: Front and west side of barn prior to replacement of doors to hayloft, 1980s. Camera facing NE.**
