Tech Notes

Restoring Metal Roof Cornices

32 EAST 64TH STREET New York City

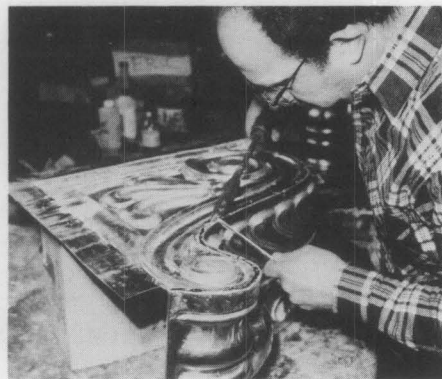
removal was dismissed because of environmental and public safety considerations and potential problems of the residue soiling the exterior masonry. Tests of water spray removal techniques showed that successful cleaning was achieved with a rotating tip spray device, which removed nearly all paint without harming the metal substrate (*see figure 7*). Care was required when spraying the zinc molding that was to remain, since the water pressure required to remove the paint was sufficient to dimple the projecting metal of the ornament. Water and paint chips were collected in troughs of sheet plastic. Paint residue was gathered to the extent possible, but the spray effluent was difficult to control and some spilled onto the building and sidewalk bridging. In some areas it was necessary to supplement water removal with light hand scraping, using a flat scraper after most paint had been removed.

A number of factors contributed to the success of the cleaning and paint removal technique. Because the cornice on this building was accessible from behind, it was possible to monitor and remove any excess water that penetrated various openings in the cornice caused by deterioration. Weep holes at the base allowed water to seep out of the cornice. For other projects where less extensive work is required and particularly where the cornice is backed with wood, other paint removal and cleaning methods may be necessary.
