Tech Notes

WINDOWS NUMBER 2

Installing Insulating Glass in Existing Steel Windows

MERGENTHALER LINOTYPE BUILDING

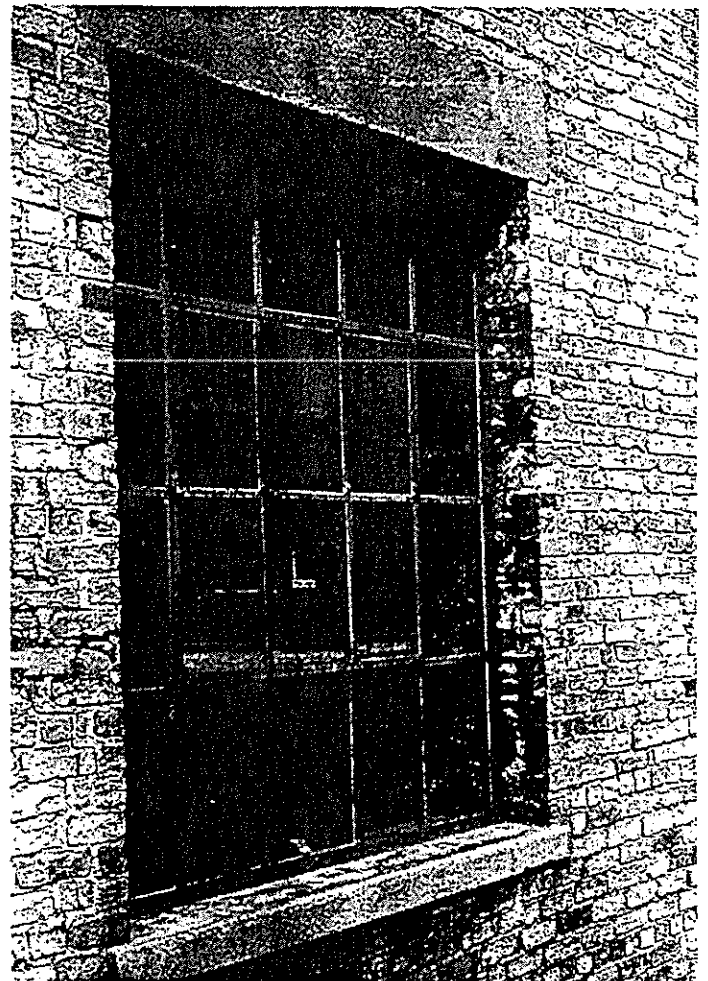
After the metal glazing angles and glass were removed, the old frames were scraped off and existing paint layers and rust were removed using sand under air pressure. After cleaning, sections from several old windows that had been removed were welded into the remaining windows to replace missing

or deteriorated metal pieces. At the same time, racked metal sections, especially the center-pivoting hopper units, were realigned by applying heat and pressure. All the metal was then painted with an anti-corrosive paint.
