OLD WATKINS NATIONAL BANK

Lawrence, Kansas

WINDOWS NUMBER 5

Interior Metal Storm Windows

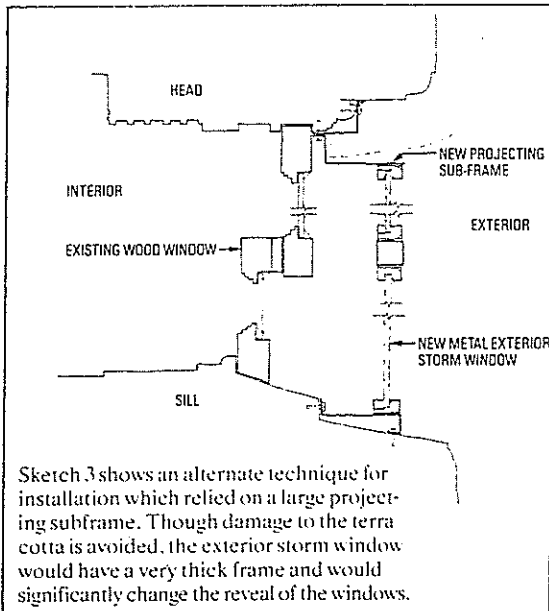
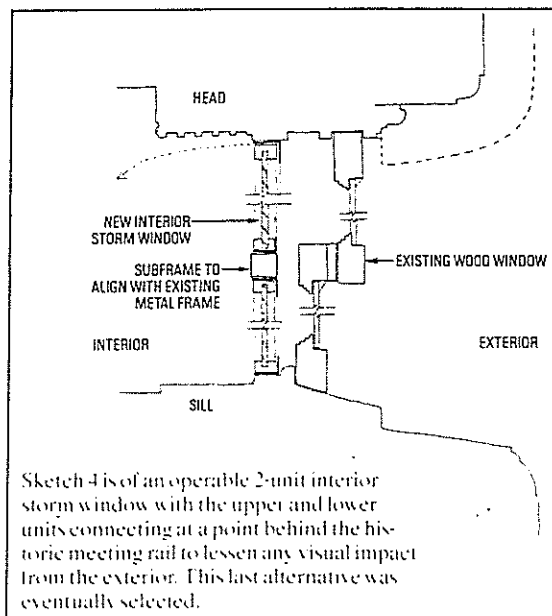
Use of exterior storm windows was initially explored both for energy conservation purposes and as a way to extend the useful life of the original windows (*see figure 2*). Unfortunately, the prices quoted for exterior storm windows by local contractors were around \$65,000, nearly double the budgeted amount. In addition to the high cost of exterior storm windows, one further problem with an exterior storm application arose when it was discovered that the decorative terra cotta capitals adjacent to the upper level window openings returned against the original frames. As a result, the proposed exterior storm windows could not be easily installed in these locations without cutting back or covering portions of the terra cotta (*see figure 3*).

Figure 3. Exterior storm windows were initially considered but presented several problems. The terra cotta capitals on the pilasters returned against the windows, making normal installation difficult without damaging the terra cotta. Many of the windows also had round heads which would require additional custom work—these same windows on the interior had square tops. Photo: Charles E. Fisher
