Tech Notes

WINDOWS NUMBER 11

Installing Insulating Glass In Existing Wooden Sash Incorporating the Historic Glass

DELAWARE BUILDING Chicago, Illinois

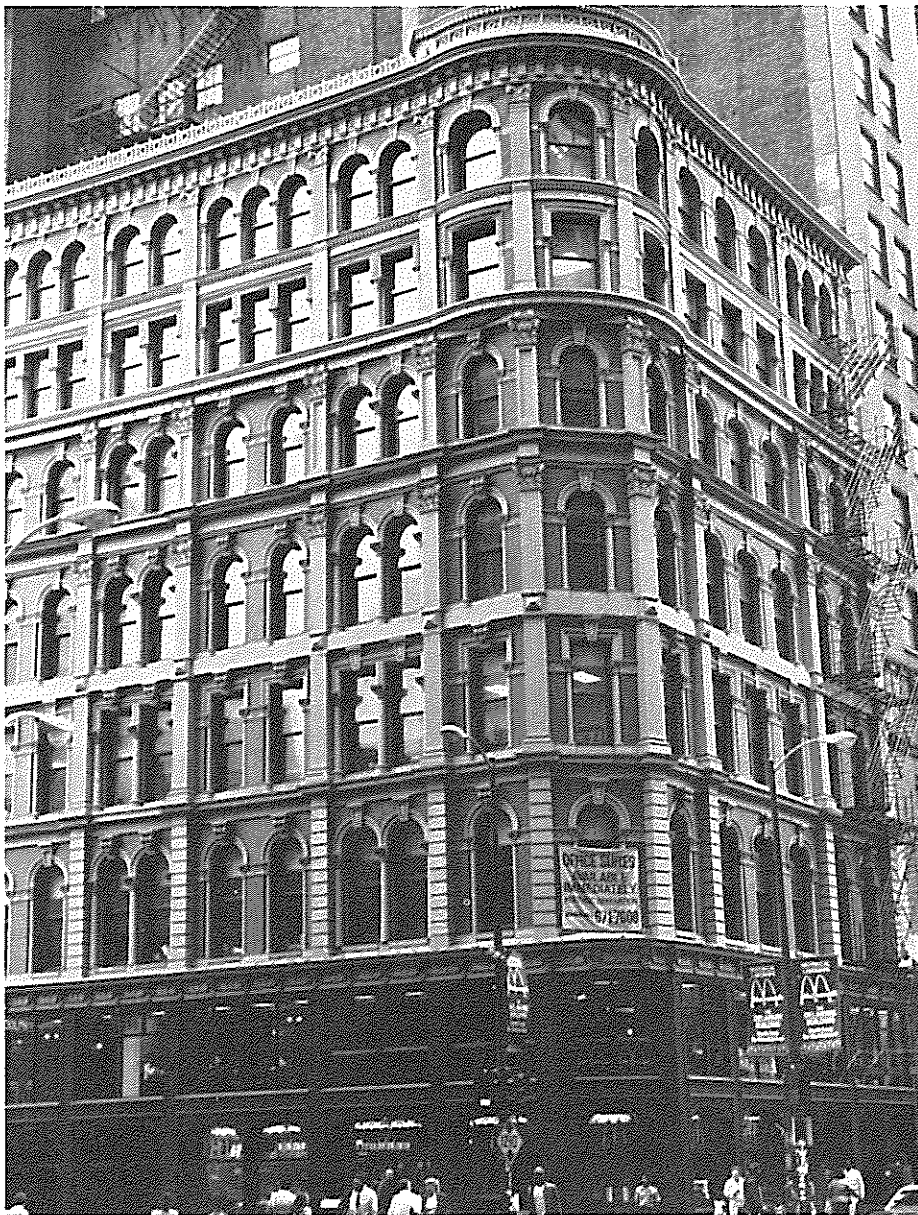
The Delaware Building was constructed shortly after the Chicago Fire of 1871 using pre-cast concrete panels on the outside. Originally six stories in height, the Italianate-style office building received an additional two floors around 1890 that were faced with sheet metal to resemble the appearance of the facade below. The lower two floors were originally dressed with ornamental cast iron arches. Later removed, they have been recently restored. Individually listed on the National Register of Historic Places, the building has an impressive interior atrium that survives, providing light to offices on the upper floors.
