# Tech Notes

## WINDOWS

### CHALMERS UNITED CHURCH

### Reinforcing Deteriorated Wooden Windows

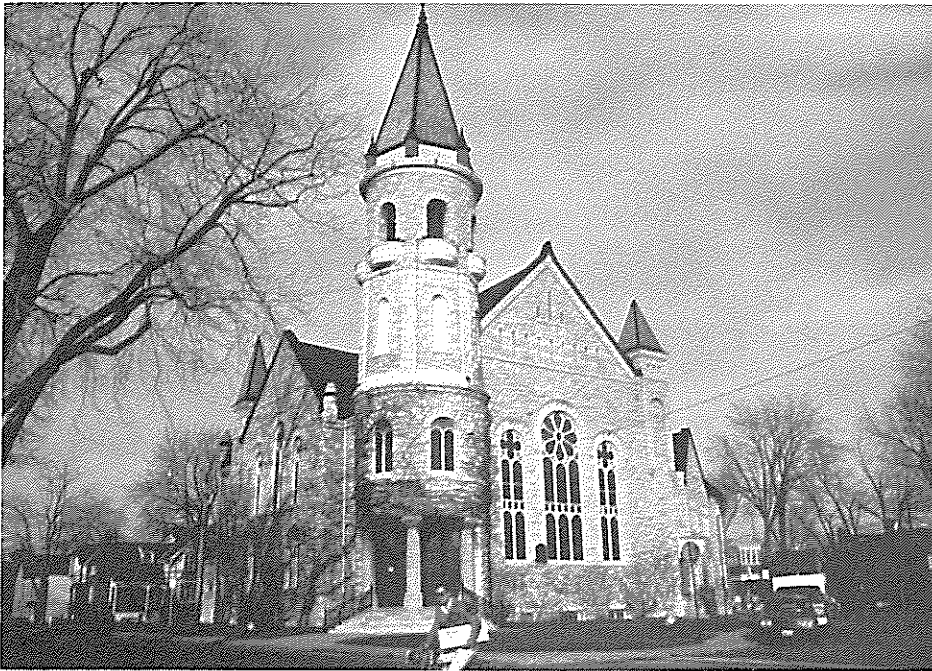
Over time the windows had suffered severely on the southern facade of the church, which is exposed to sun and constant strong winds blowing in from nearby Lake Ontario (see figure 1). This wind not only carries dust and dirt, but also has a high moisture content. Because of weathering and the lack of regular maintenance, the wooden frames which secured the stain glass panels had gradually deteriorated. The decay finally became so acute that by 1982 the windows were in imminent danger of collapsing. The parishioners at that point had no choice but to ar-

Figure 1. Considerable deterioration had occurred to the tripartite windows as shown in the close-up view of a portion of the mullion. (The stained glass is protected by individual sheets of wire glass set within the wood mullions)

The first step in the restoration process was the careful removal of the remains of old paint on the wood frame. This exposed the true extent of the deterioration. In some areas, as much as 40-50% of the wood had been lost. The wooden parts of the window frame that were found to be crumbling were saturated and consolidated with a commercially available liquid epoxy.

of damage during removal and transportation. Instead of making new mullions, the decayed frame was reinforced in an unusual manner, using a method developed by Paul Stumes, the consulting engineer for the project. The method involved the use of epoxy consolidants along with steel reinforcement rods (see figure 2). To permit the work to take place undisturbed by the weather, a "cocoon" formed out of vinyl sheet was attached to the temporary bracing installed to stabilize the windows while the restoration work was underway (see figure 3).
