Tech Notes

WINDOWS

Repairing and Upgrading Multi-Light Wooden Mill Windows

SAWYER MILLS Dover, New Hampshire

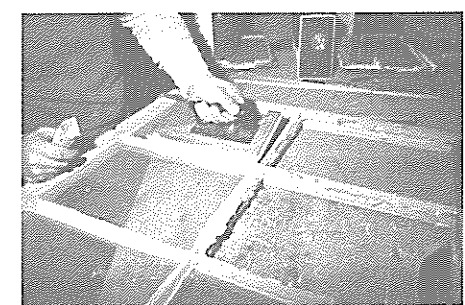
3

The most typical problem encountered was loose or failed mortise and tenon joints; this was remedied by drilling out the old pegs with a slightly oversize bit and then drawing the sash frame together tightly with pipe clamps (see figure 4). Fluted,

Figure 4. The basic repair: cleaning sash frame and drilling out pegs to tighten corner joints. Glue purchased in bulk was transferred to squeeze-bottles for ease of application. Oversize bit and new hardwood dowel shown ready for use. Glazing has not yet been completely removed. Photo: Christopher Closs

hardwood cabinet dowels, liberally coated with waterproof glue, were then driven in to secure the joints. To allow for natural movement, the mortise and tenon joints were not glued. In some instances, deteriorated tenons were cut off and bored out, and new tenons installed, using glue to secure the tenons in their seats but not inside the joints. This worked well providing the receiving mortises were sound. If muntins required selective replacement, this was done before clamping. It was critically important to "true" each sash square before re-pinning the corner joints.
